# A890 Stromeferry Bypass

Annual Slope Inspection Report 2022

The Highland Council

07 September 2022

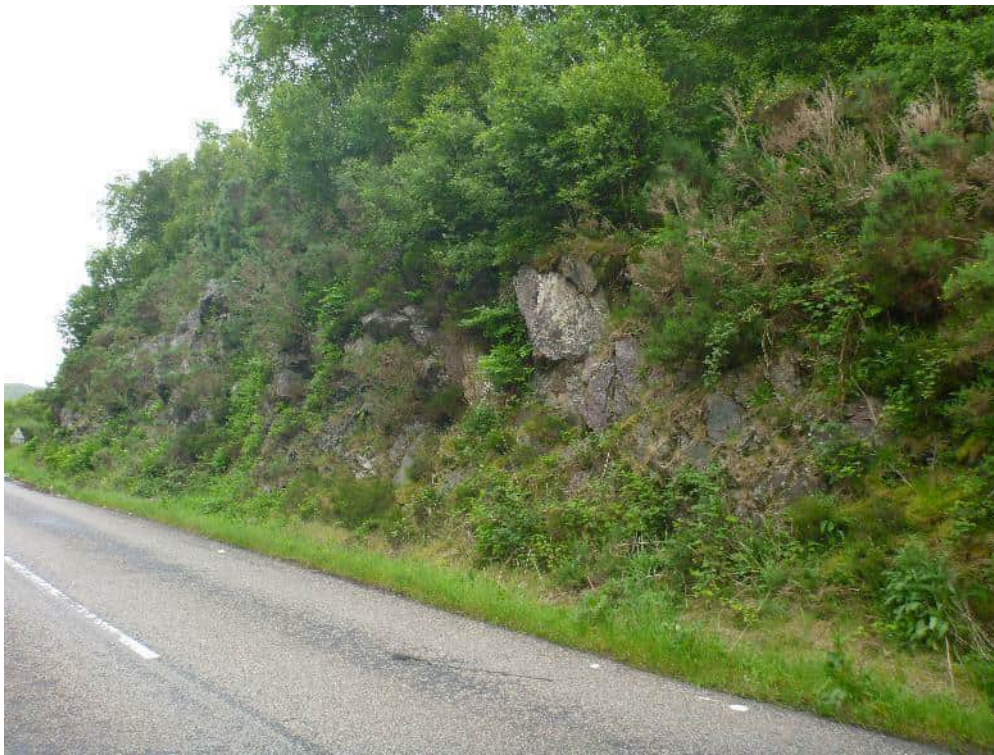
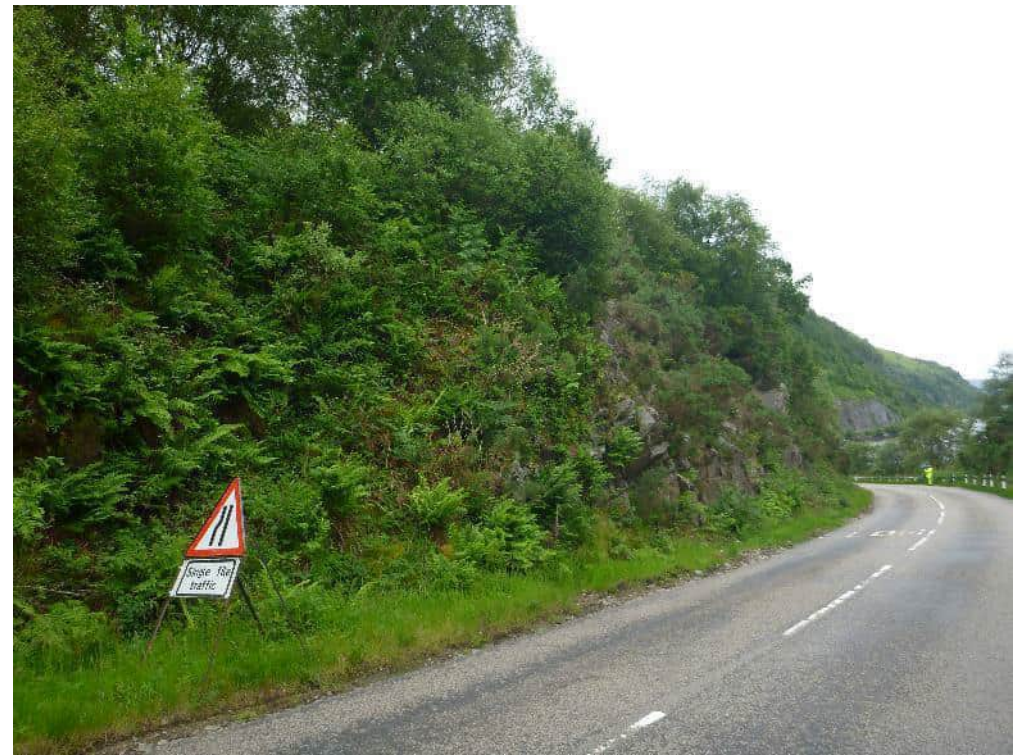
Dip:	70	Azimuth:	324	Height (m):	8	Length (m):	78	Vegetation Cover:	30-40% cover. Grass, gorse, saplings.	Ditch Details:	Width 1.0m Depth 0.5m	Roughness (Profile):	Rough	Verge Details:	1m
------	----	----------	-----	-------------	---	-------------	----	-------------------	---------------------------------------	----------------	--------------------------	----------------------	-------	----------------	----

Hazards Observed:			
Location	Comments		
Ch. 3665-3687	Rock mass is very broken with potential for small blocks to fail due to raveling / root jacking.		
Ch. 3671	In October 2021, there was a block fall of approx. size 0.25m <sup>3</sup> . It originated c.7m above the toe of slope. It split into several pieces on landing in the ditch. The debris was cleared during the Phase 12 works.		
Ch. 3680	Boulders and cobbles weathering out of exposed soil slope and landing in ditch below.		
Whole section	Presence of trees immediately above rock face may lead to root jacking / failures associated with uprooted trees.		
SUMMARY		Comments	
Overall Hazard Rating =	2		
Pathway Rating =	3		
Receptor Rating =	1.2		
Risk Value =	<b>7.2</b>		
Risk Level =	<b>Low</b>		
Recommended Remedial Works / Actions			
<ul style="list-style-type: none"> <li>- Install fence/barrier on verge between Ch. 3665-3687. If not possible, netting should be considered for this section.</li> <li>- De-vegetate and light scale rock face.</li> <li>- Coppice trees within 5m of crest of slope.</li> <li>- Build-up of debris in ditch should be monitored and clearance works undertaken as required to maintain its capacity.</li> </ul>

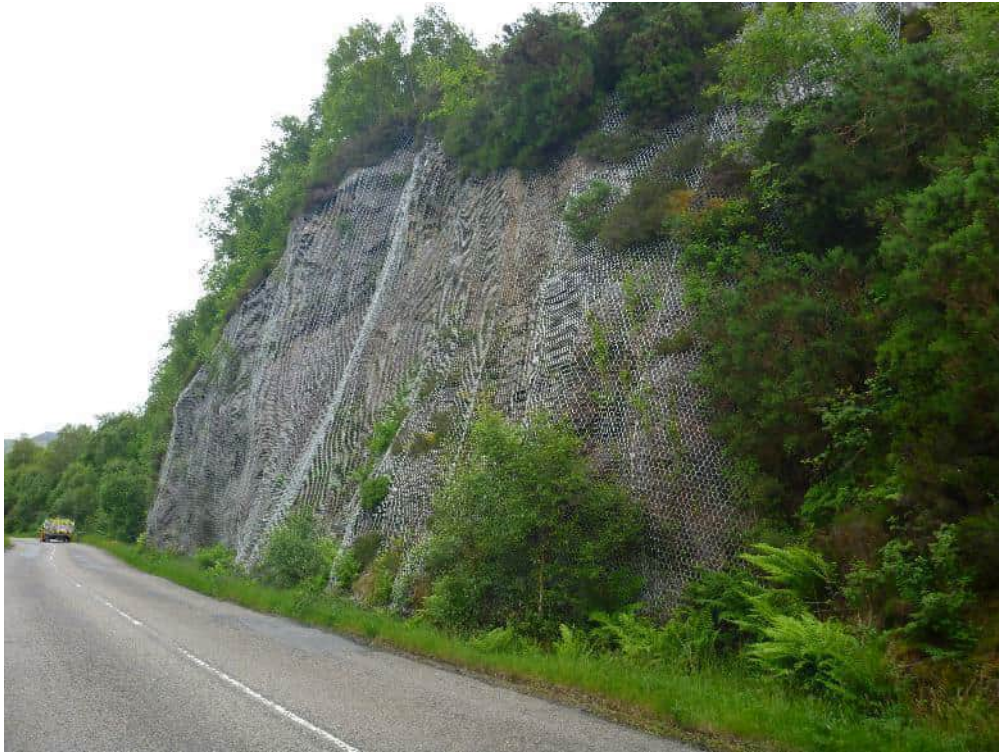
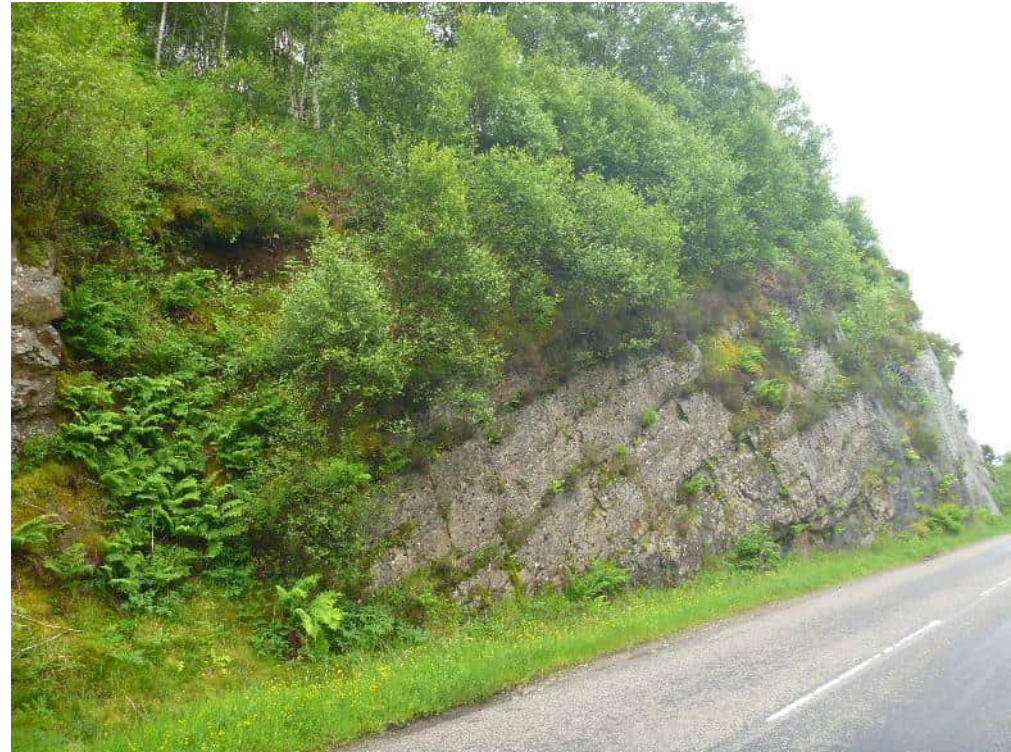
Dip:	80	Azimuth:	340	Height (m):	12	Length (m):	18 4	Vegetation Cover:	30% cover over highest rock slope, increasing to 80% cover towards N of section. Generally comprised grass, ferns and gorse.	Ditch Details:	Typical width 0.5m, depth 0.3m From Ch.3790 2m wide, 0.6m deep.	Roughness (Profile):	Rough	Verge Details:	Typically 0.5m. From Ch.3790 1.5m
------	----	----------	-----	-------------	----	-------------	---------	-------------------	--	----------------	---	----------------------	-------	----------------	-----------------------------------

Engineering Description of Rock:									
Very strong very thinly banded grey and white GNEISS with occasional quartz foliation.									
Existing Netting Details or other remedial work details:									
Netting Type	Top cable	Typical anchor spacing (m)	Anchor Type	Cable-Anchor connection	No. of cable clamps	Netting lap connections	Laps on anchors	Vertical Reinforcing	Notes
PVC coated double twist	8mm galvanised	5m	18mm machine threaded bars (top anchors visibly corroded)	D shackle (connected on one side only)	3	Cable twists	No	None	Netting only present across highest area of the rock slope.

- Chainlink netting is locally present on slope above Maccaferri netting and is broken in places.									
Hazards Observed:									
Location	Comments								
Ch.3740 to 3745	Several blocks with dilated fractures and / or root jacking potential have been identified that are likely to fail in the future but should be contained by the Maccaferri netting.								
Ch. 3748	Small accumulation of debris at toe of slope behind netting c.1m x 0.4m x 0.2m. Source c.4m above toe. Material not loading net. Keep under observation.								
Ch. 3783 - 3792	Exposed soil slope 4m above road level with boulders in back scar of previous failure which could weather out and reach road. Slumping is also noted upslope from back scar.								
Ch. 3762-3800	Trees at crest of slope could cause block fall associated with root jacking/ uprooted trees.								
Ch. 3783 to 3892	Potential for ravelling of small blocks, however, ditch below sufficiently wide/deep to retain.

Ch. 3870	Potential planar failure 3m above road. Small tabular blocks likely to be contained by ditch below.								
SUMMARY		Comments							
Overall Hazard Rating =	3								
Pathway Rating =	2								
Receptor Rating =	1.2								
Risk Value =	7.2								
Risk Level =	Moderate								
Recommended Remedial Works / Actions									
<ul style="list-style-type: none"> <li>- Ch. 3783: Re-profile vertical soil slope and install erosion control matting;</li> <li>- Ch. 3762-3800: Coppice trees within 5m of crest of rock slope;</li> <li>- Build-up of debris within ditch should be monitored and clearance works undertaken as required to maintain its capacity.</li> </ul>									
Assessed in field by:	PLM/JG	Date:	22/06/2022	Reviewed by:	Martha Taylor	Date:	06/09/2022
