A890 Maman Hill

Annual Slope Inspection Report 2022

The Highland Council

Project Number: 60658712
AECOM Report Ref: GLRP0002

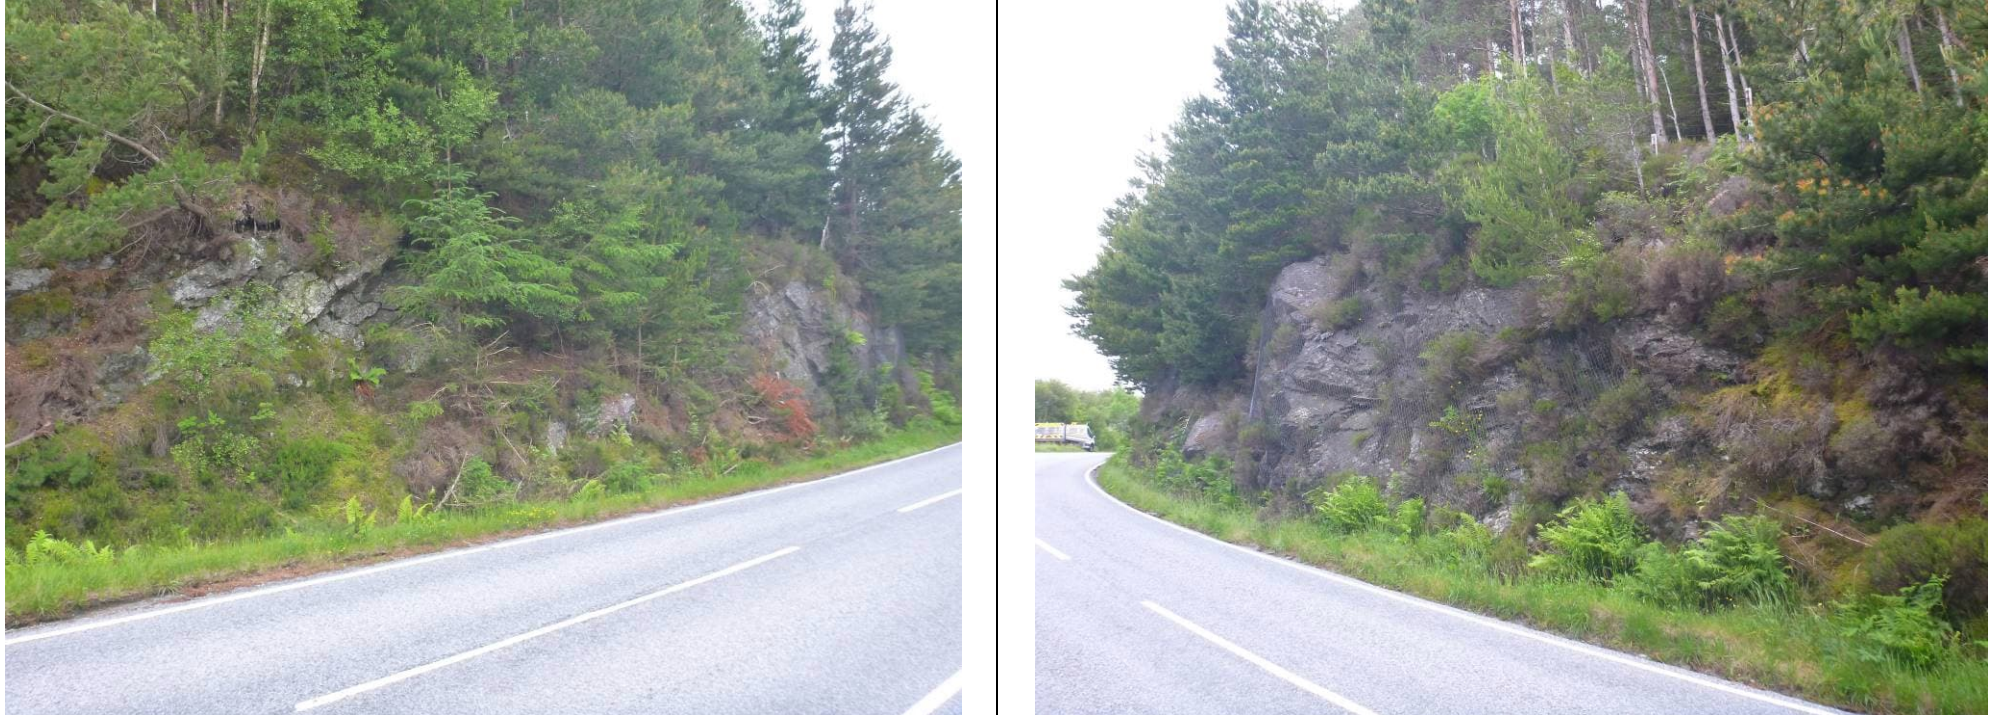
Dip (°): 70	Azimuth (°): 310	Height (m): 7	Length (m): 60	Vegetation Cover: 30% of slope covered in heather and grass. Trees along crest.	Ditch Details: No ditch.	Roughness (Profile): Rough	Verge Width (m): 0.9
-------------	------------------	---------------	----------------	---	--------------------------	----------------------------	----------------------

Localised chainlink drape netting between Ch. 030 and Ch. 070 (ca. 65% of slope). Highly corroded and locally damaged. Anchorages not inspected.

Other Comments:							
No surface or groundwater flows. Rock mass generally in good condition, although dilated fractures noted locally. Potential for kinematic failure is low. Ch. 018 to 030: there is vegetation in the ditch that could be cleared.							
Hazards Observed:							
Location		Comments					
Throughout M1		Small scale (<0.01m ³) raveling type rock falls likely as rock mass continues to weather.					
Throughout M1		Trees at crest have potential to cause root jacking (e.g. Ch. 018)					
Ch. 018		Approx. 6 blocks in verge c.2m x 0.1m x 0.1m					
Ch. 020		Block (c.2m x 1m x 1.5m) with dilated back fracture (low risk due to presence of ditch)					
SUMMARY			Comments				
Hazard Rating =		2		Generally limited to small scale raveling although locally potential for larger block fall(s) associated with root jacking. Block size not expected to exceed 1m ³ .			
Pathway Rating =		2		Most rock fall debris likely to land in verge.

Receptor Rating =		1.2		Minimum sightline 45m.			
Risk Value =		4.8					
Risk Level =		Low					
Recommended Remedial Works / Actions							
Re-inspection by end of June 2023. Low risk so remedial works not deemed necessary, however, felling of trees along crest would reduce risk further. Recommend monitoring ditch and clearing when required to maintain its capacity.							
Assessed in field by:	JG/PLM	Date:	22/06/2022	Reviewed by:	PLM	Date:	26/08/2022

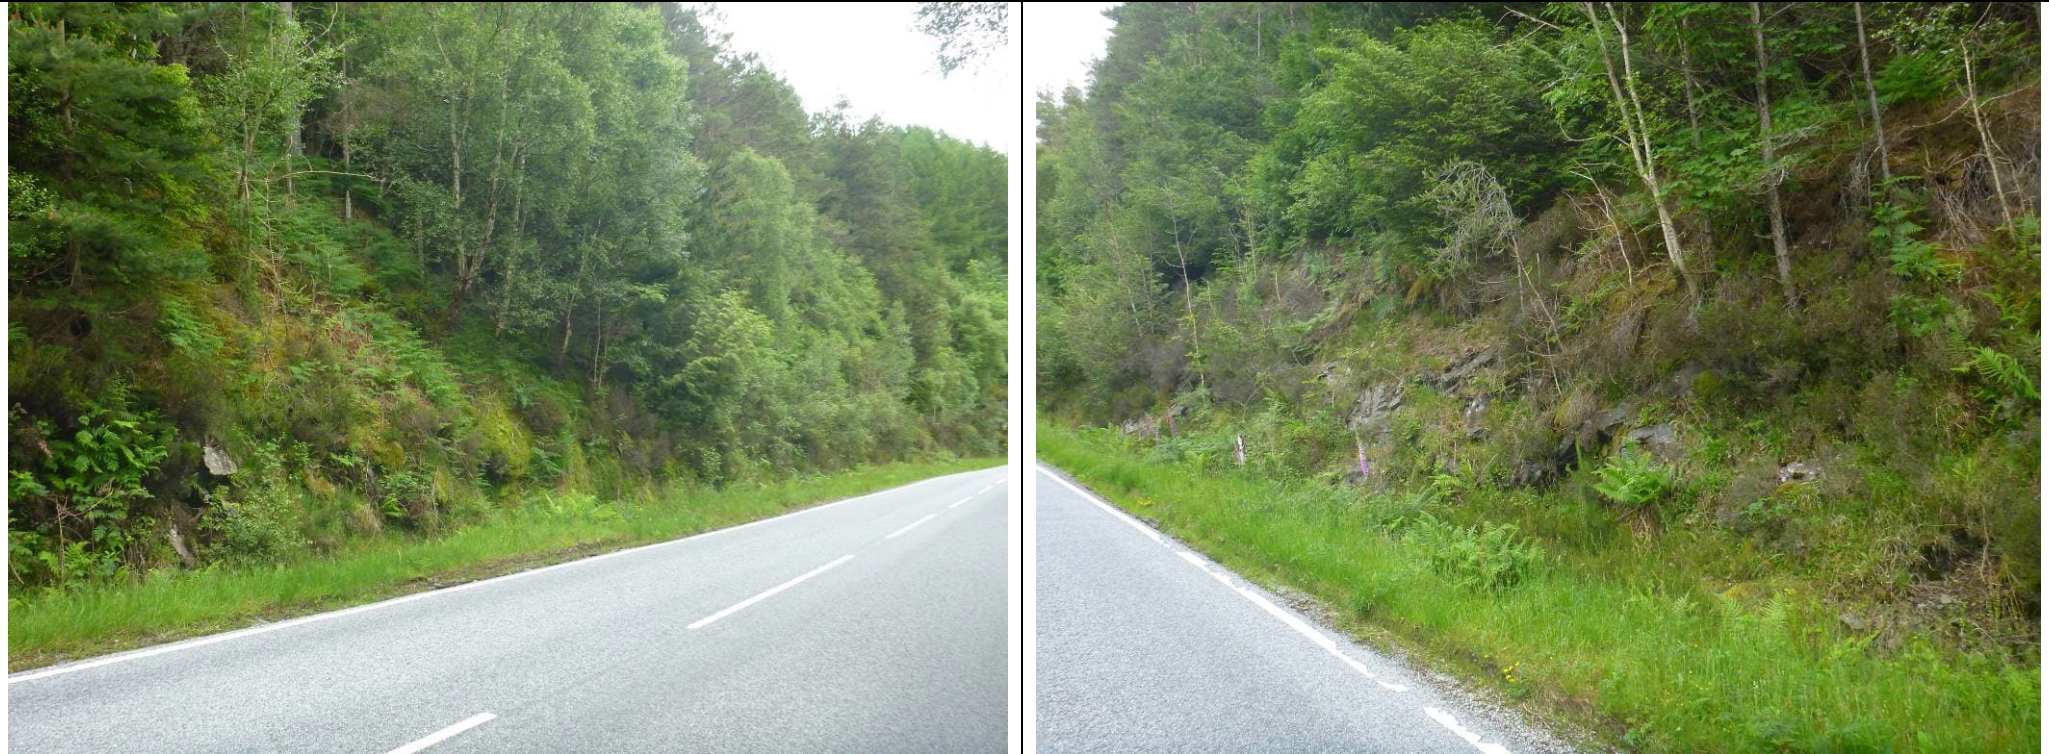
Dip (°): 60	Azimuth (°): 305	Height (m): 2	Length (m): 80	Vegetation Cover: 95% of slope covered in heather and grass and semi-mature trees.	Ditch Details: 0.5m deep, 1m wide ditch.	Roughness (Profile): Rough	Verge Width (m): 1.0
-------------	------------------	---------------	----------------	--	--	----------------------------	----------------------

None observed.

Other Comments:							
No surface or groundwater flows. Isolated low height (2m max) rock exposures. Rock mass generally in good condition, although dilated fractures noted locally. Potential for kinematic failure is low. No debris at toe or other evidence of previous rock falls at this location. Presence of effective ditch and verge.							
Hazards Observed:							
Location		Comments					
Throughout M1		Small scale (<0.02m ³) ravelling / root jacking rock falls likely as rock mass continues to weather.					
SUMMARY			Comments				
Hazard Rating =		1		Generally limited to small scale ravelling.			
Pathway Rating =		1		Ditch considered effective.			
Receptor Rating =		N/A		Minimum sightline 65m. No falling blocks are expected to reach the road so receptor rating not applied.			
Risk Value =		1.0					
Risk Level =		Low					
Recommended Remedial Works / Actions							
Re-inspection by end of June 2023. Low risk so remedial works not deemed necessary.

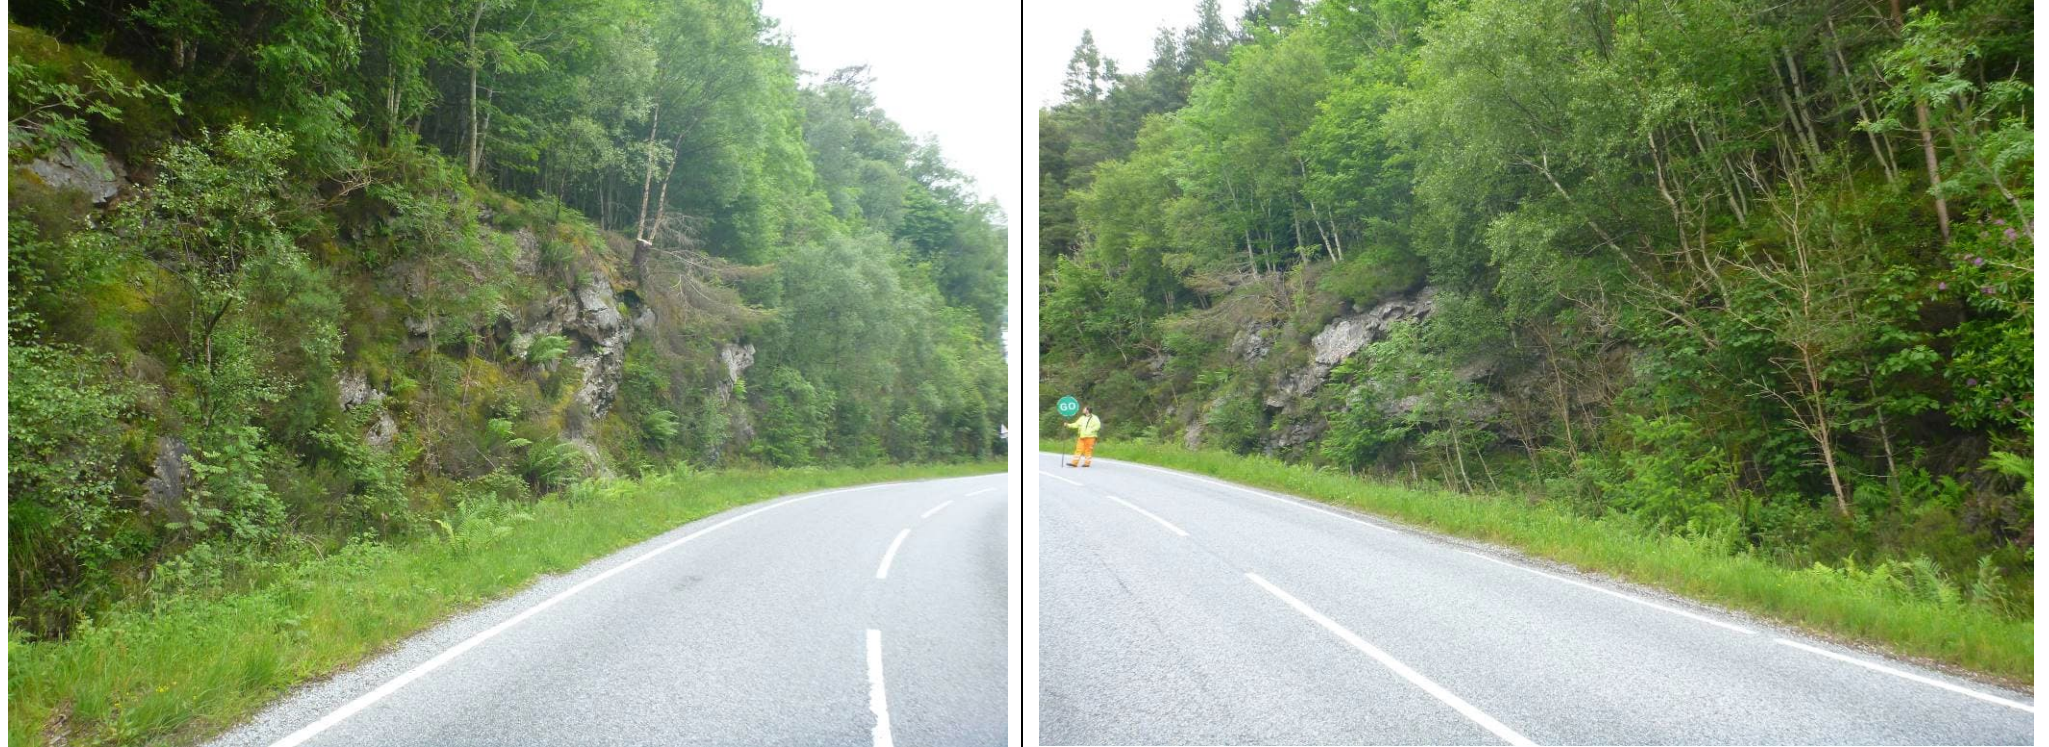
Dip (°):	65	Azimuth (°):	300	Height (m):	4 to 8	Length (m):	50	Vegetation Cover:	25% of slope covered in heather, grass and occasional small trees. Trees along crest.	Ditch Details:	0.4 to 0.75m deep, 1.2m wide.	Roughness (Profile):	Rough	Verge Width (m):	1.0
----------	----	--------------	-----	-------------	--------	-------------	----	-------------------	---	----------------	-------------------------------	----------------------	-------	------------------	-----

Other Comments:							
No surface or groundwater flows. Rock mass generally in good condition, although dilated fractures associated with blast damage and root jacking noted locally. Potential for kinematic failure is low but ravelling, root jacking and block falls from above overhangs possible. Maximum rock fall size 0.5m ³ . Ditch and verge likely to retain debris from some small scale rock falls. Occasional blocks observed at toe – typical dimensions 0.1 x 0.1 x 0.1m.							
Hazards Observed:							
Location		Comments					
Throughout M3		Numerous small scale (<0.02m ³) ravelling type rock falls observed, some of which were deemed to be imminent (i.e. readily dislodged by hand).					
Ch. 304		Large fir tree growing from crest of rock face. Evidence of root jacking. Potential rock fall volume up to 0.5m³. Tree felled by THC in Dec 2020.					
Throughout M3		Localised overhangs with potential for rock fall of unsupported blocks. Individual block size typically <0.1m ³ .

SUMMARY			Comments				
Hazard Rating =		2		Generally limited to small scale ravelling although locally potential for larger block fall(s) associated with root jacking. Rock fall volume not expected to exceed 0.5m ³ .			
Pathway Rating =		2		Most rock fall debris likely to land in ditch verge.			
Receptor Rating =		1.2		Minimum sightline 60m.			
Risk Value =		4.8					
Risk Level =		Low					
Recommended Remedial Works / Actions							
Re-inspection by end of June 2023. Low risk so remedial works not deemed necessary, however, felling of trees along crest would reduce risk further.							
Assessed in field by:	JG/PLM	Date:	22/06/2022	Reviewed by:	PLM	Date:	26/08/2022

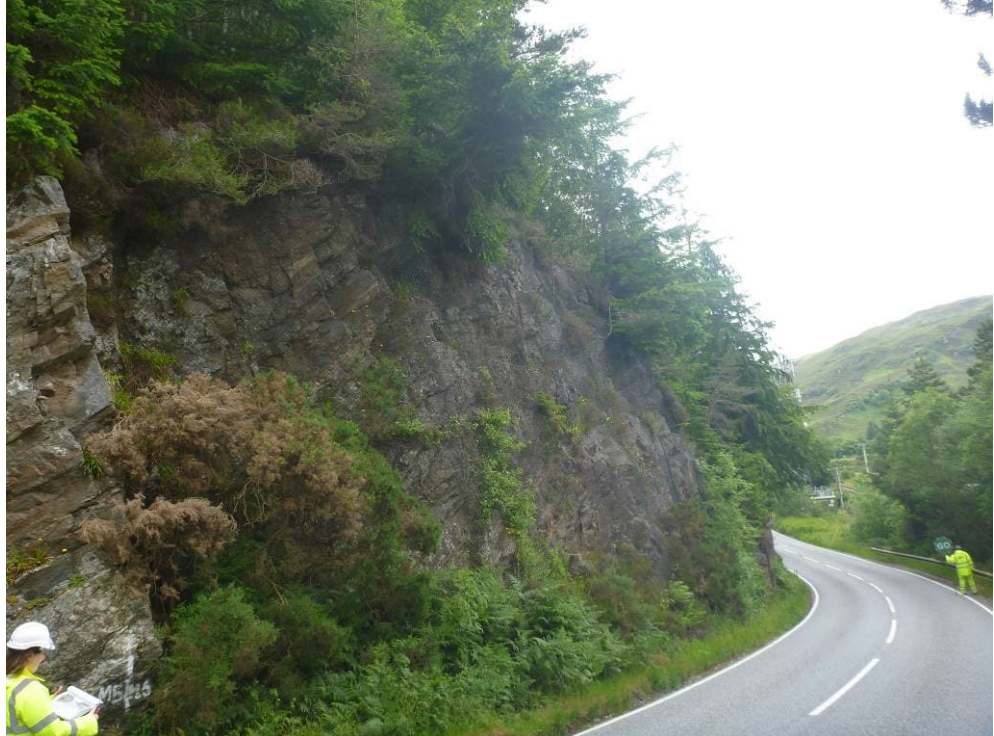
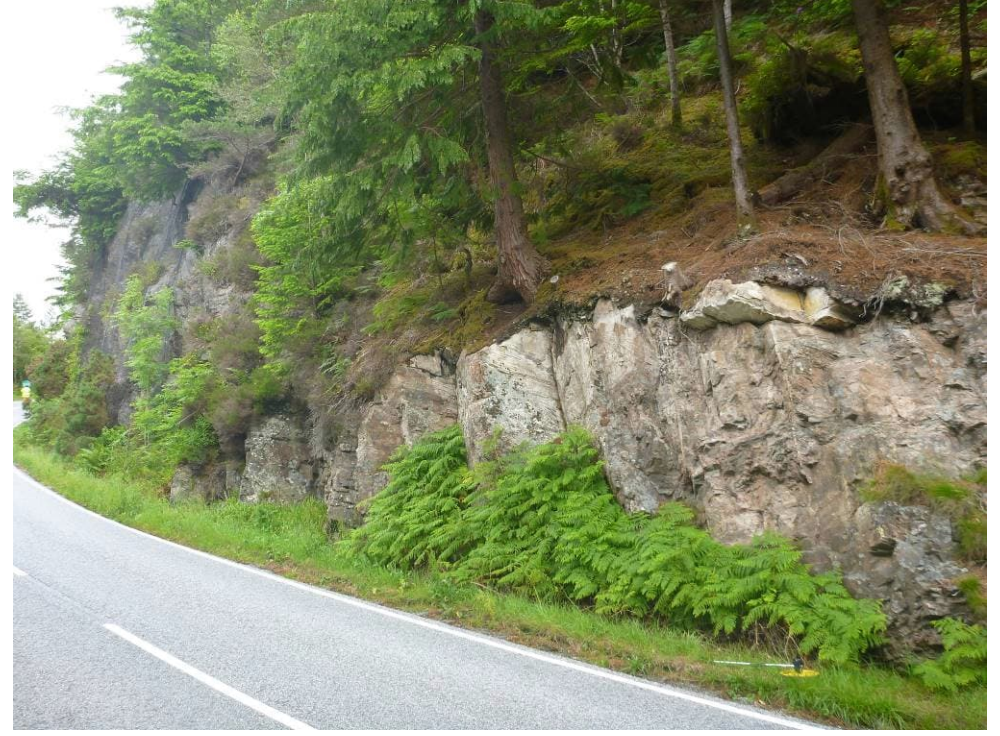
Dip (°): 80	Azimuth (°): 285	Height (m): 3 to 10	Length (m): 45	Vegetation Cover: 15% vegetation cover – gorse, heather and grass. Trees at crest.	Ditch Details: None	Roughness (Profile): Smooth	Verge Width (m): 0.5 to 1.0
-------------	------------------	---------------------	----------------	--	---------------------	-----------------------------	-----------------------------

Chainlink drape netting between Ch. 415 and 435. Corroded and locally damaged but effective for small scale ravelling type rock falls.

Other Comments:							
No surface or groundwater flows. Rock mass generally favourable with tight fractures but occasionally noted to be dilated where affected by blasting, weathering and/or root jacking. Potential for kinematic failures is generally low, although localised toppling potential observed (up to 1m ³). Ongoing ravelling and root jacking of small blocks from crest should also be anticipated. No ditch and only a narrow verge so there is potential for some small blocks to reach road.							
Hazards Observed:							
Location		Comments					
Throughout M6		Ongoing ravelling and root jacking, particularly along crest.					
Ch. 420		Potential toppling failure identified ca. 6m above road level. Dilated fractures. 0.5-1.0m ³ .					
Ch. 455		Fallen tree c.3m back from crest of slope. Tree has been cut (unsure when this was completed but present when slope first inspected by AECOM in 2019). Not posing risk to road.
