# A890 Maman Hill

Annual Slope Inspection Report 2023

The Highland Council

Project number: 60658712  
AECOM Report Ref: GLRP0004

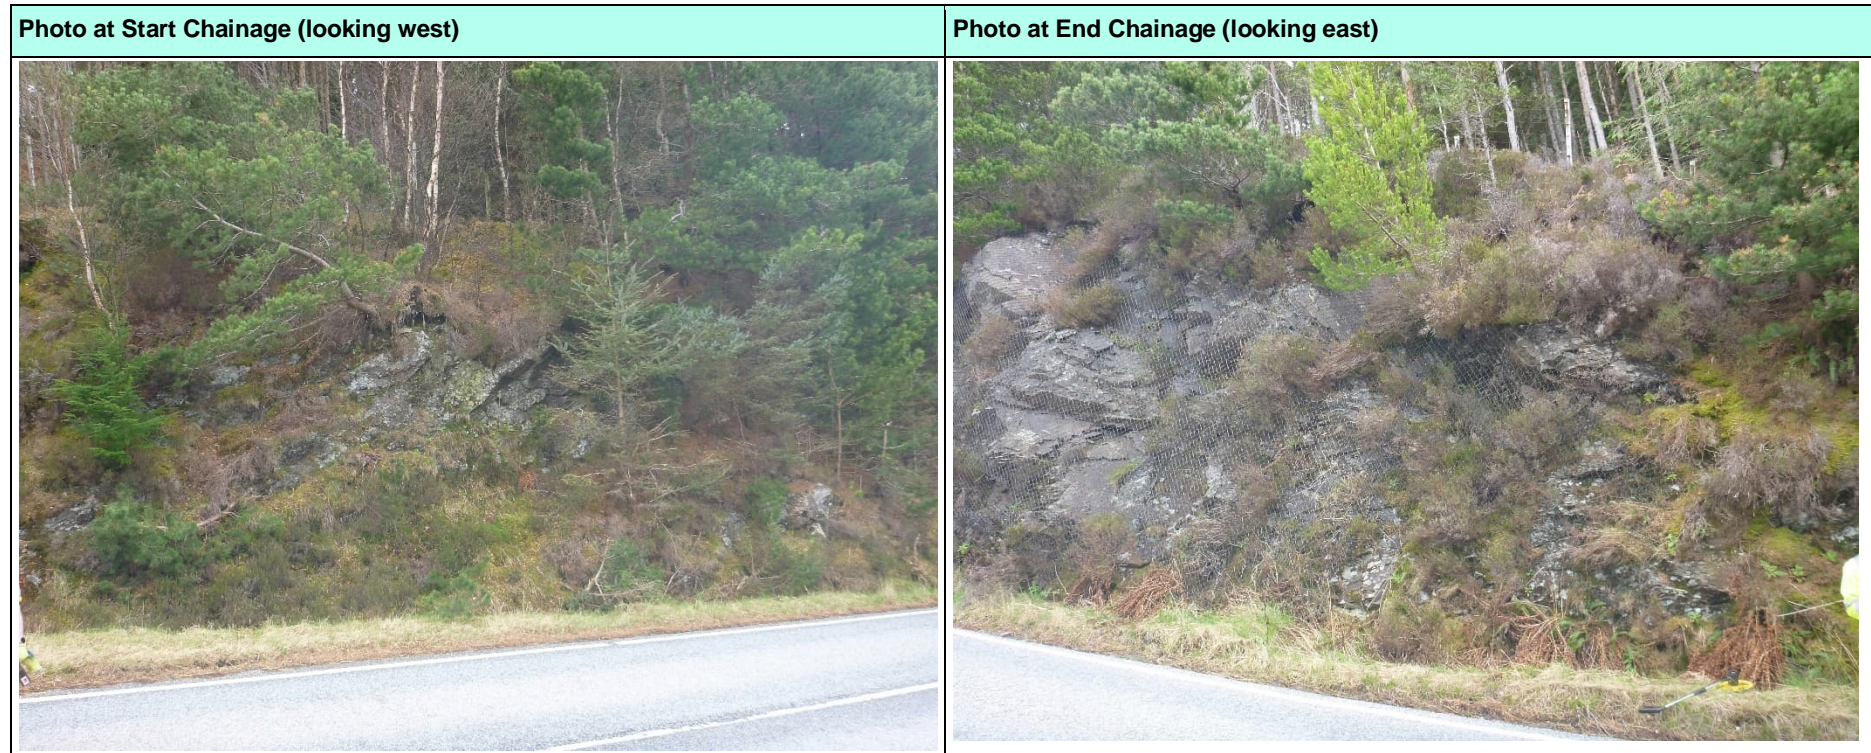
### 3.1.1 Slope Ref. M1

<b>Other Comments:</b>
No surface or groundwater flows. Rock mass generally in good condition, although dilated fractures noted locally. Potential for kinematic failure is low. Based on the current condition of the rock slope and the presence of a 0.9m verge at the toe of the slope the likelihood of debris from a rock fall landing on the road is considered to be relatively low.

RISK RATING		Comments
Hazard Rating =	2	Generally limited to small scale ravelling although locally potential for larger block fall(s) associated with root jacking. Block size not expected to exceed 1m <sup>3</sup> .
Pathway Rating =	2	Most rock fall debris likely to land in verge.
Receptor Rating =	1.2	Minimum sightline 45m.
Risk Value =	<b>4.8</b>	
Risk Level =	<b>Low</b>

Recommended Remedial Works / Actions					
Large Scale Rock Fall Protection Works (Category 3)		Localised Targeted Rock Fall Protection Works (Category 2)		Ongoing Maintenance (Category 1)	
N/A		N/A		<ul style="list-style-type: none"> <li>- Re-inspection by end of April 2024</li> <li>- Felling of trees along crest</li> <li>- Scaling of loose rock behind netting (between Ch. 030 to 070)</li> </ul>	
<b>Assessed in field by:</b>	MT/JG/PLM	<b>Date:</b>	17/04/2023	<b>Reviewed by:</b>	PLM
				<b>Date:</b>	15/06/2023

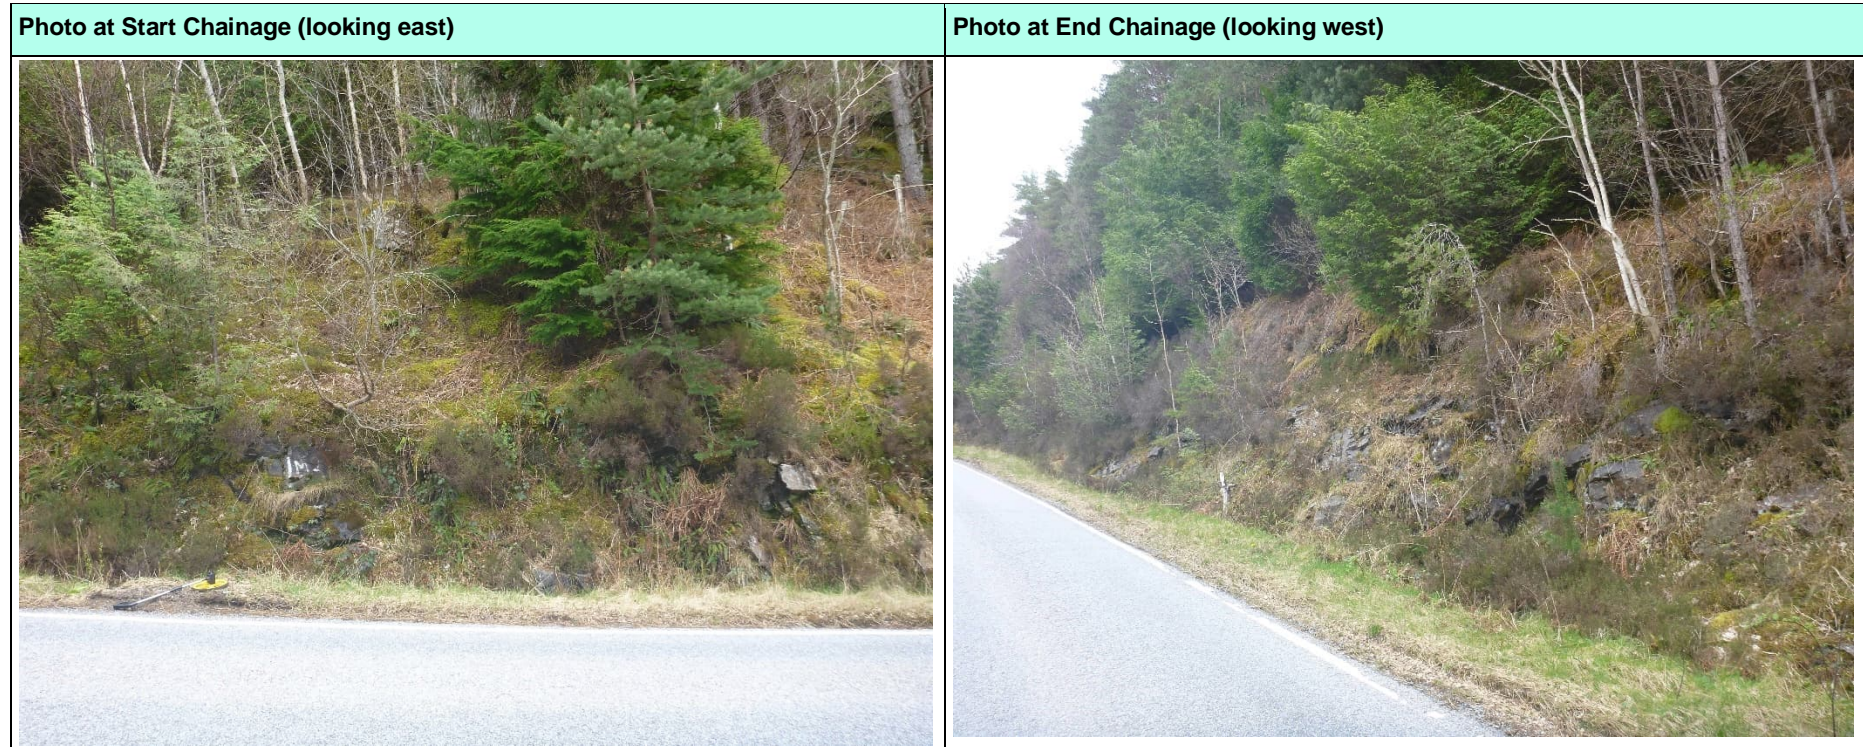
**3.1.2 Slope Ref. M2**

No surface or groundwater flows.  
 Isolated low height (2m max) rock exposures. Rock mass generally in good condition, although dilated fractures noted locally. Potential for kinematic failure is low.  
 No debris at toe or other evidence of previous rock falls at this location. Presence of effective ditch and verge.

RISK RATING		Comments
Hazard Rating =	1	Generally limited to small scale ravelling.
Pathway Rating =	1	Ditch considered effective.
Receptor Rating =	N/A	Receptor rating only applicable when pathway rating is $\geq 2$ .
Risk Value =	1	
Risk Level =	<b>Low</b>

Recommended Remedial Works / Actions		
Large Scale Rock Fall Protection Works (Category 3)	Localised Targeted Rock Fall Protection Works (Category 2)	Ongoing Maintenance (Category 1)
N/A	N/A	- Re-inspection by end of April 2024

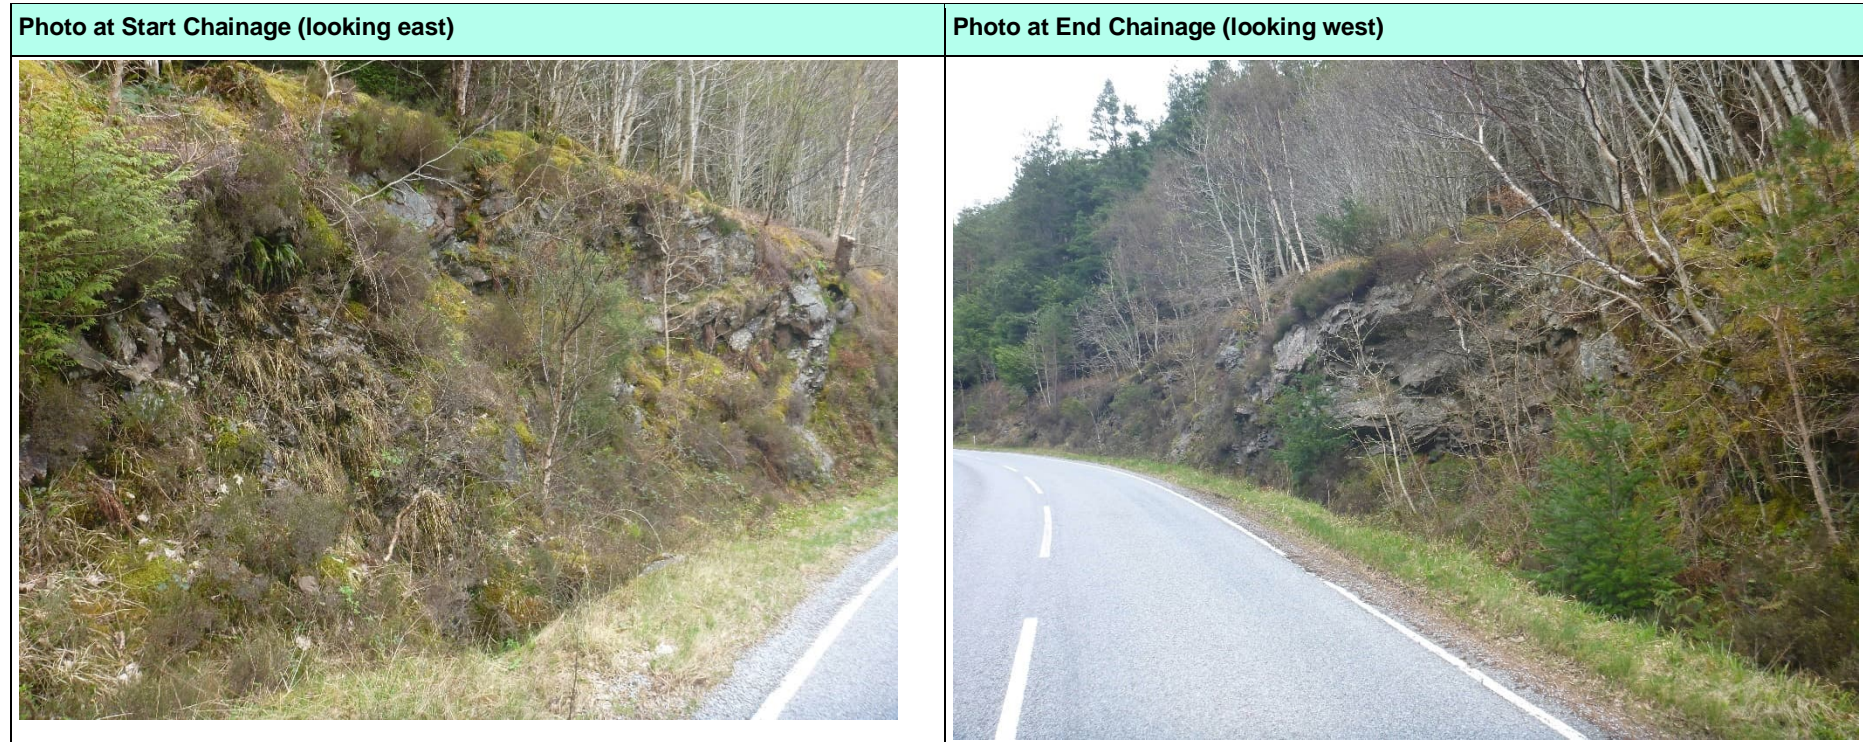
**3.1.3 Slope Ref. M3**

Rock mass generally in good condition, although dilated fractures associated with blast damage and root jacking noted locally. Potential for kinematic failure is low but ravelling, root jacking and block falls from above overhangs possible. Maximum rock fall size 0.5m<sup>3</sup>.  
Ditch and verge likely to retain debris from most small scale rock falls. Occasional blocks observed at toe – typical dimensions 0.1 x 0.1 x 0.1m.

RISK RATING		Comments
Hazard Rating =	2	Generally limited to small scale ravelling although locally potential for larger block fall(s) associated with root jacking. Rock fall volume not expected to exceed 0.5m <sup>3</sup> .
Pathway Rating =	2	Most rock fall debris likely to land in ditch verge.
Receptor Rating =	1.2	Minimum sightline 60m.
Risk Value =	<b>4.8</b>	
Risk Level =	<b>Low</b>

Recommended Remedial Works / Actions					
Large Scale Rock Fall Protection Works (Category 3)		Localised Targeted Rock Fall Protection Works (Category 2)		Ongoing Maintenance (Category 1)	
N/A		N/A		<ul style="list-style-type: none"> <li>- Re-inspection by end of April 2023</li> <li>- Fell trees along crest</li> </ul>	
<b>Assessed in field by:</b>	MT/JG/PLM	<b>Date:</b>	17/04/2023	<b>Reviewed by:</b>	PLM
		<b>Date:</b>		<b>Date:</b>	151/06/2023

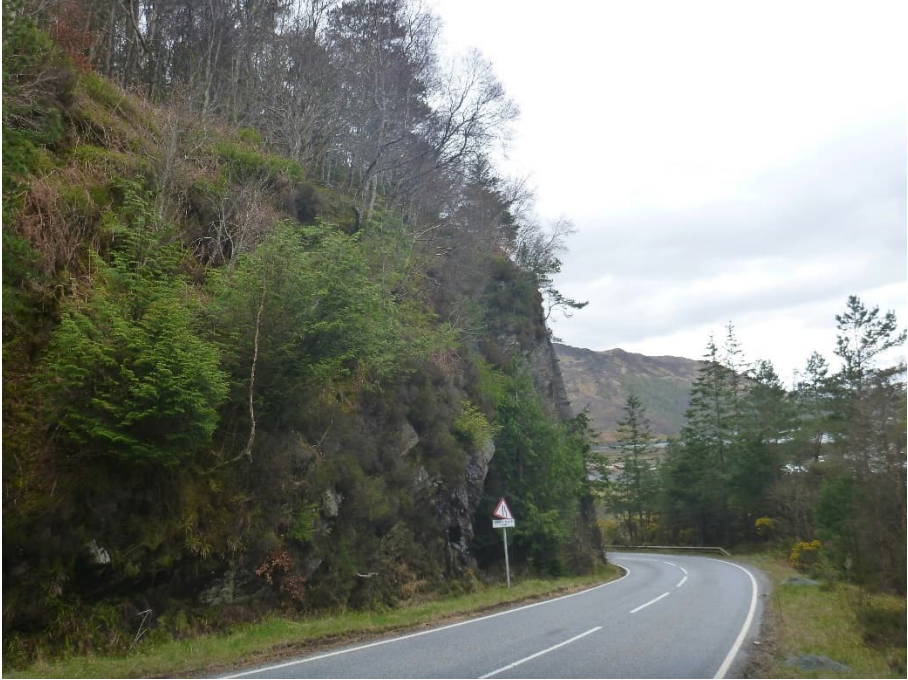
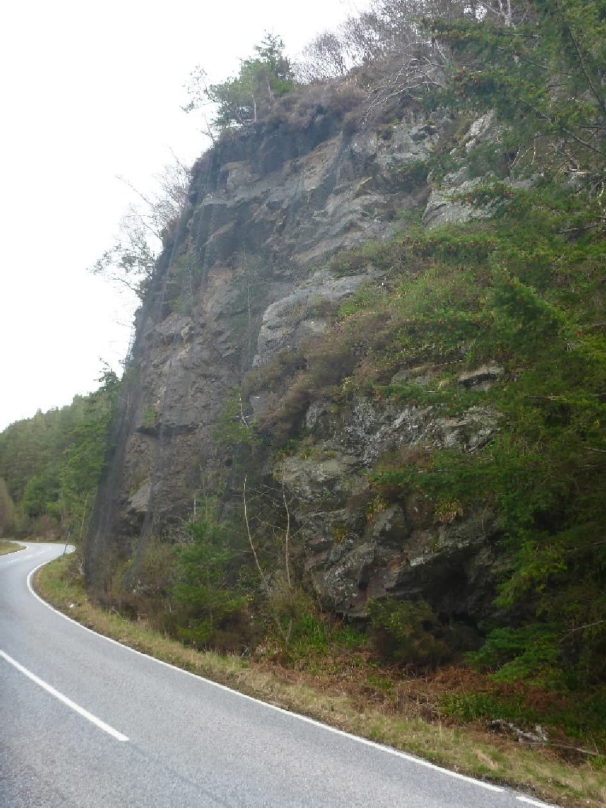
Photo at Start Chainage (looking east)	Photo at End Chainage (looking west)

Ditch and verge likely to retain debris from some small scale rock falls but locally absent / narrow. Occasional blocks observed at toe – typical dimensions 0.1 x 0.1 x 0.1m.
