A890 Maman Hill

Annual Slope Inspection 2024

The Highland Council

Project number: 60685712
AECOM Report Ref: GLRP0009

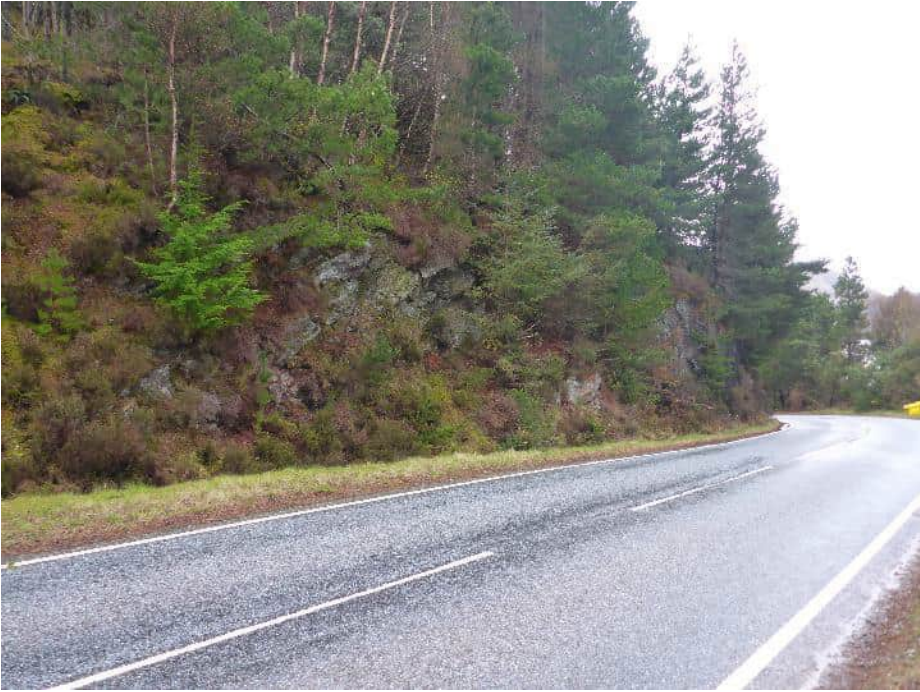
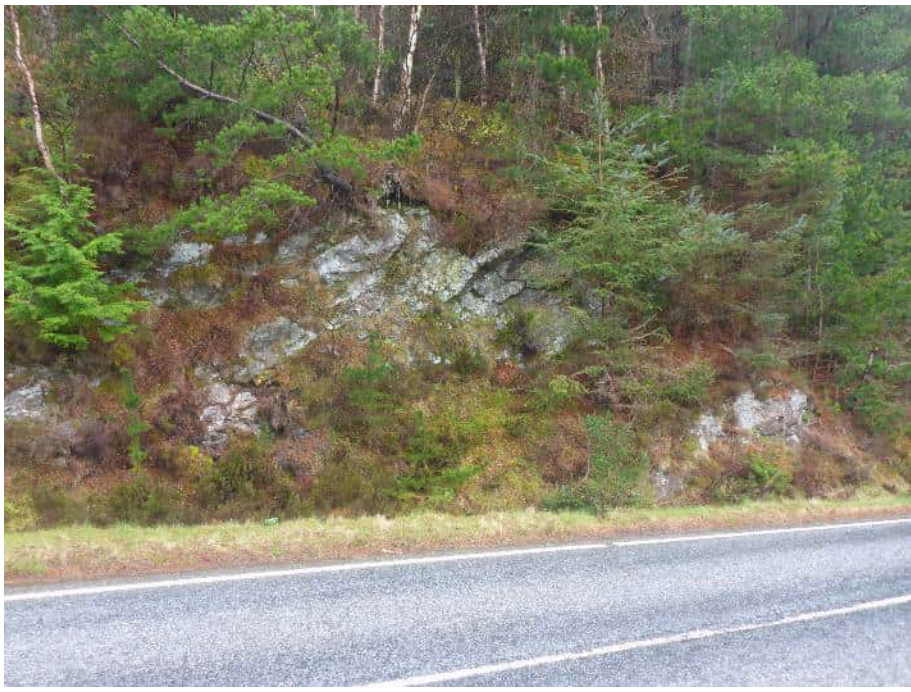
Photo at Start Chainage (looking west)	Photo at End Chainage (looking east)

Location	Description of Hazard (s) from Previous Inspections	2024 Inspection Observations	Photo Reference
Throughout M1	2019 Inspection: Small scale (<0.01m ³) ravelling type rock falls likely as rock mass continues to weather. 2023 Inspection: There are a few dilated blocks behind the netting (between Ch. 030 to 070) which look keyed in – could benefit from scaling.	No change noted during the 2024 inspection.	N/A
Throughout M1	2019 Inspection: Semi-mature coniferous trees growing at crest have potential to cause root jacking (e.g. Ch. 018)	No change noted during the 2024 inspection.	N/A

Hazards Observed:			
Location	Description of Hazard (s) from Previous Inspections	2024 Inspection Observations	Photo Reference
Ch. 018	2022 Inspection: Trees at crest of slope presenting risk of root-jacking. Approx. 6 blocks c.2m x 0.1m x 0.1m are in the verge.	No change noted during the 2024 inspection.	N/A
Ch. 020	2022 Inspection: Block (c.2m x 1m x 1.5m) with dilated back fracture (low risk due to presence of verge)	No change noted during the 2024 inspection.	M1-1
Ch. 032	N/A	Tree root has rotated out from slope. Rock slope behind is clean and does not present a hazard.	M1-2
Ch. 053	N/A	Several small blocks present in the verge which have a source location 5m high, at the crest of the slope. There is potential for more blocks to fall and land on the verge or edge of the road.	M1-3

Other Comments:
<p>No surface or groundwater flows.</p> <p>Rock mass generally in good condition, although dilated fractures noted locally. Potential for kinematic failure is low.</p> <p>Based on the current condition of the rock slope and the presence of a 0.9m verge at the toe of the slope the likelihood of debris from a rock fall landing on the road is considered to be relatively low.</p>

RISK RATING		Comments
Hazard Rating =	2	Generally limited to small scale ravelling although locally potential for larger block fall(s) associated with root jacking. Block size not expected to exceed 1m ³ .
Pathway Rating =	2	Most rock fall debris likely to land in verge.
Receptor Rating =	1.2	Minimum sightline 45m.
Risk Value =	4.8	
Risk Level =	Low

Recommended Remedial Works / Actions							
N/A		N/A		<ul style="list-style-type: none">- Re-inspection by end of April 2025- Felling of trees along crest- Scaling of loose rock behind netting (between Ch. 030 to 070)			
Assessed in field by:	MT/SB/PLM	Date:	15/04/2024	Reviewed by:	PLM	Date:	28/05/2024

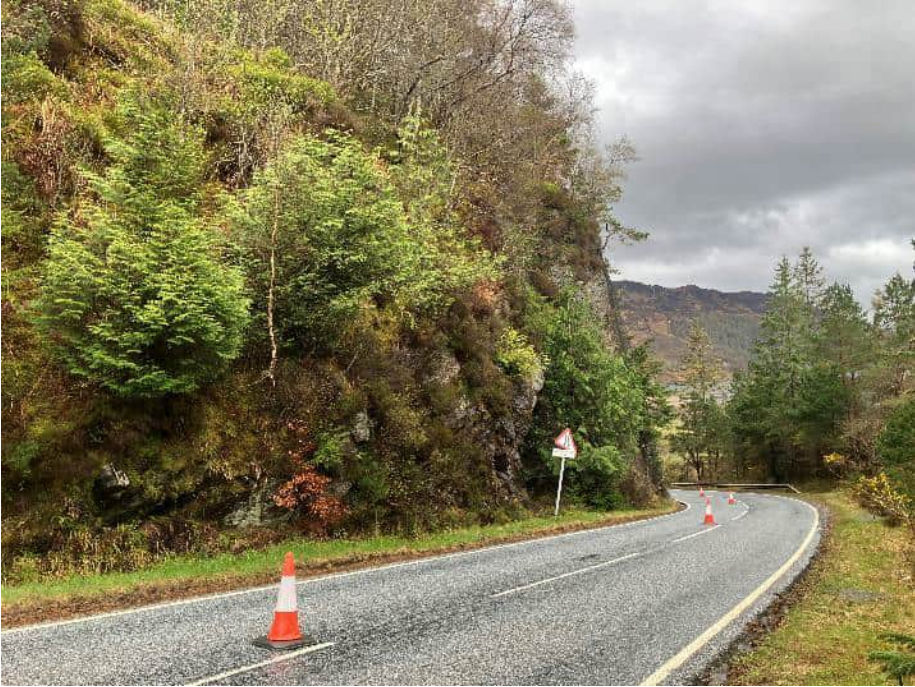
Photo at Start Chainage (looking east)	Photo at End Chainage (looking west)

Rock Slope Characteristics:															
Dip (°):	80	Azimuth (°):	300	Height (m):	4 to 15	Length (m):	60	Vegetation Cover:	15% of slope covered in heather, grass and occasional small trees.	Ditch Details:	0 to 0.4m deep, 0 to 1m wide.	Roughness:	Rough	Verge Width (m):	0.5 to 1

Engineering Description of Rock:
Strong psammite.

Following recent discussions with THC it is understood that it is intended to undertake the designed remedial works at slopes M4 and M5 later in 2024. Additionally, the urgent remedial works already described are to be commissioned by THC imminently.

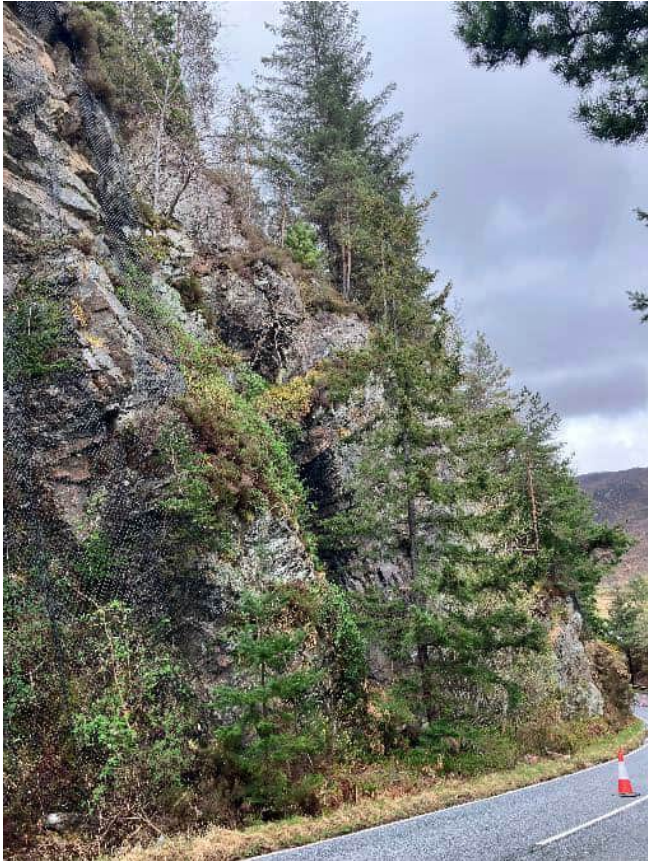
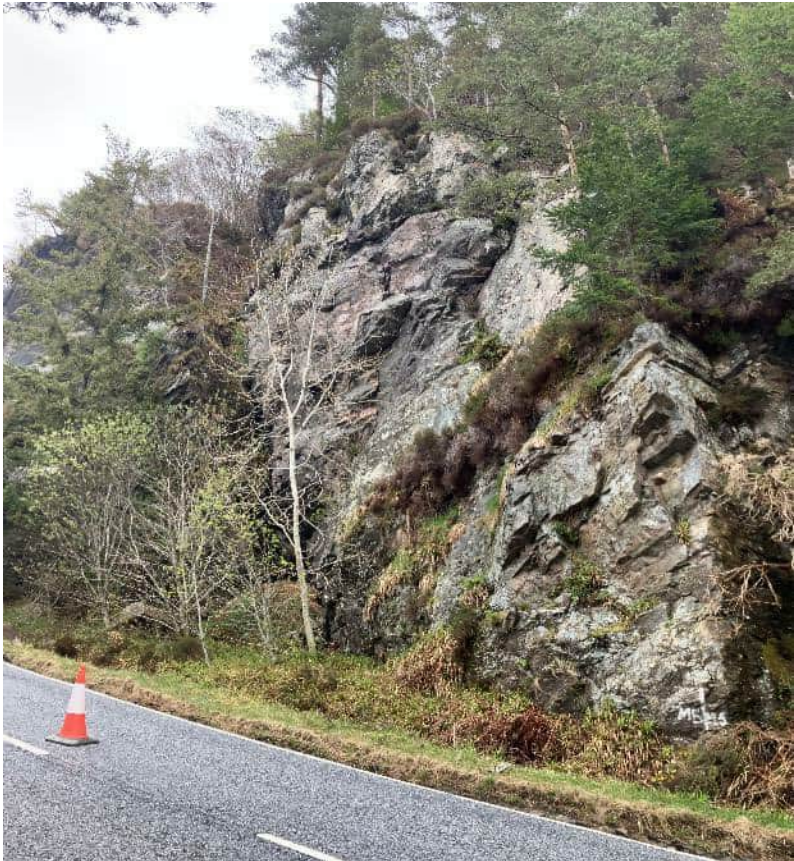
Photo at Start Chainage (looking east)	Photo at End Chainage (looking west)

Rock Slope Characteristics:									
Dip (°):	80 to 90	Azimuth (°):	315	Height (m):	15 to 20	Length (m):	20	Vegetation Cover:	<10% of slope is vegetated. Localised heather and grass. Trees also present at crest.
								Ditch Details:	No ditch
								Roughness:	Rough
								Verge Width (m):	5
