Appendices

A Summary of Biennial Report information relating to burns

B.1 Culloden Burn West

D.1 Smithton Burn

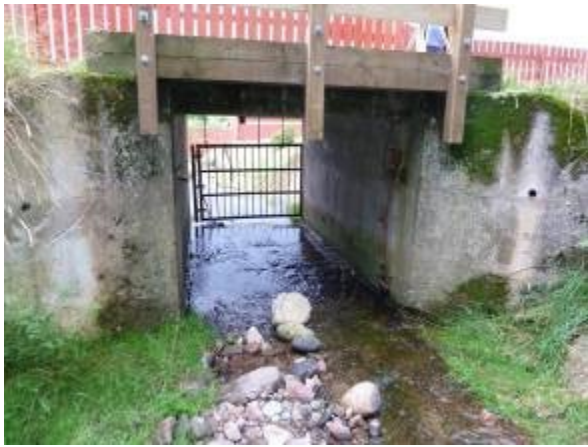
Name: Forestry Track Bridge

Upstream face of bridge

Description: Single span concrete bridge
OS NGR: NH
Opening area: 3.18 m²
Screen?: Swinging gate on downstream side
Blockage Risk: Medium
Access: Access from forestry track and forestry car park to the west off Tower Road.
Maintenance: Maintenance during flooding is difficult and complicated by water gate on downstream side.
Other: Gate was moved from upstream side to downstream side after 2002 floods.

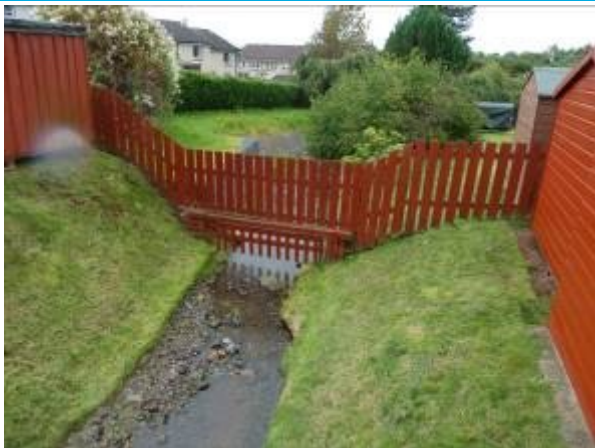
Name: Third party boundary fence and water gate

Upstream face of bridge

Description: Property boundary fence
OS NGR: NH
Opening area: 5.10 m²
Screen?: Water gate, but clearance is relatively low.
Blockage Risk: Medium
Access: Access through gardens off Redburn Avenue
Maintenance: Steep sided grassy banks constrained on upstream side by sheds. Potentially high risk for maintenance during flood.
Other:

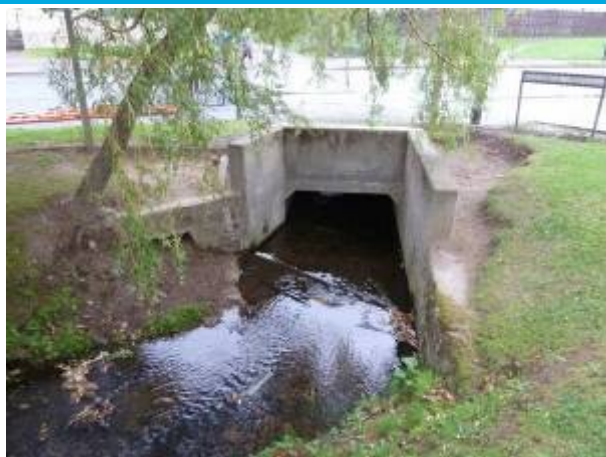
Name: Culvert beneath Keppoch Road

Upstream face of culvert

Description: Rectangular concrete culvert

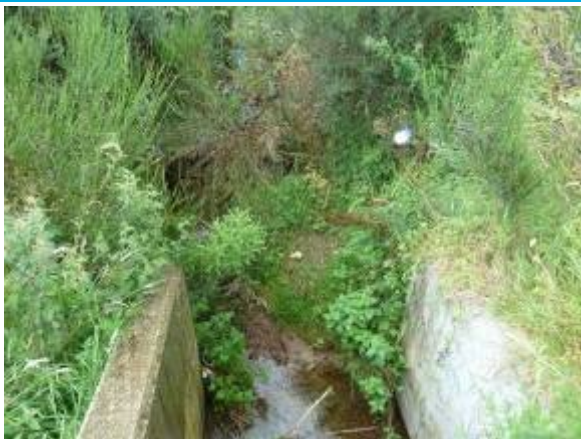
Name: Culvert beneath Woodside Farm Drive

Channel upstream of culvert

Description: Circular concrete culvert - 1050mm diameter

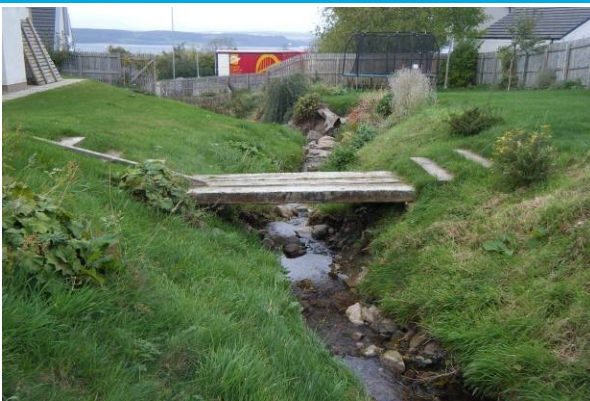
Name: Property boundary fence

Upstream face of fence

Description: Property access bridge over channel
OS NGR: NH
Opening area: 1.48 m²
Screen?: No
Blockage Risk: Low
Access: Access via garden of No. [redacted] Woodside Court
Maintenance:
Other:

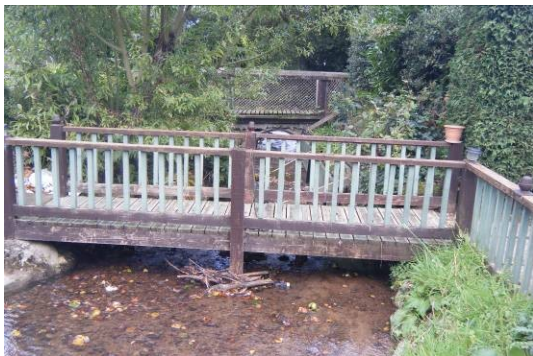
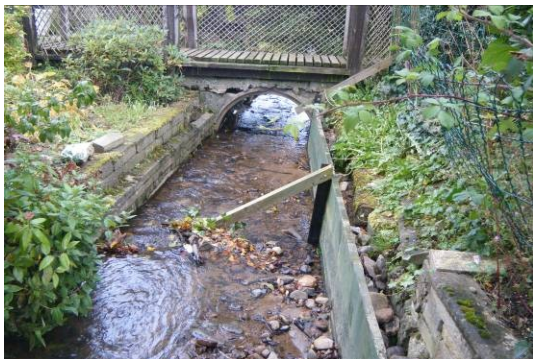
Upstream faces of structures

Description: Various
OS NGR: NH
Opening area: As small as 0.41 m²
Screen?: No
Blockage Risk: High
Access: Access from Murray Place
Maintenance: Maintenance during flood conditions is difficult due to restricted access.
Other: Numerous structures present. Key structures were surveyed and included within the model.

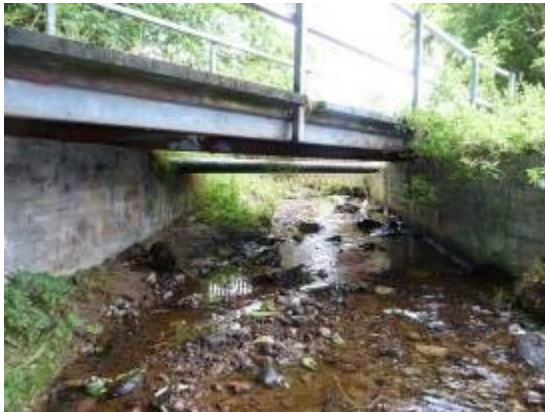
Name: Footbridge on footpath leading to Forbes Plan

Downstream face of footbridge

Description: Single span footbridge

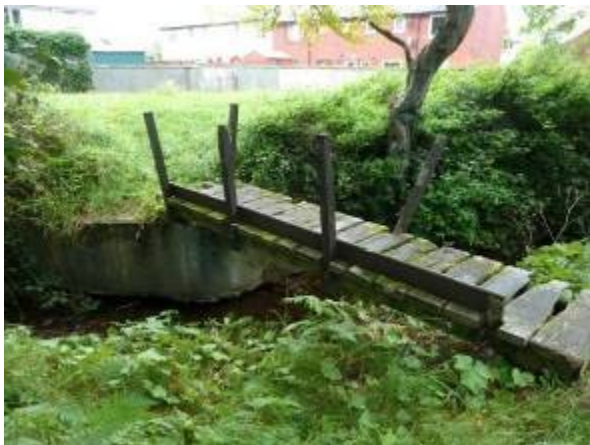
Name: Footbridge at rear of Smithton Villas

Upstream face of footbridge

Description: Single span wooden footbridge

Other: Bridge being replaced as part of new development off Tower Road.

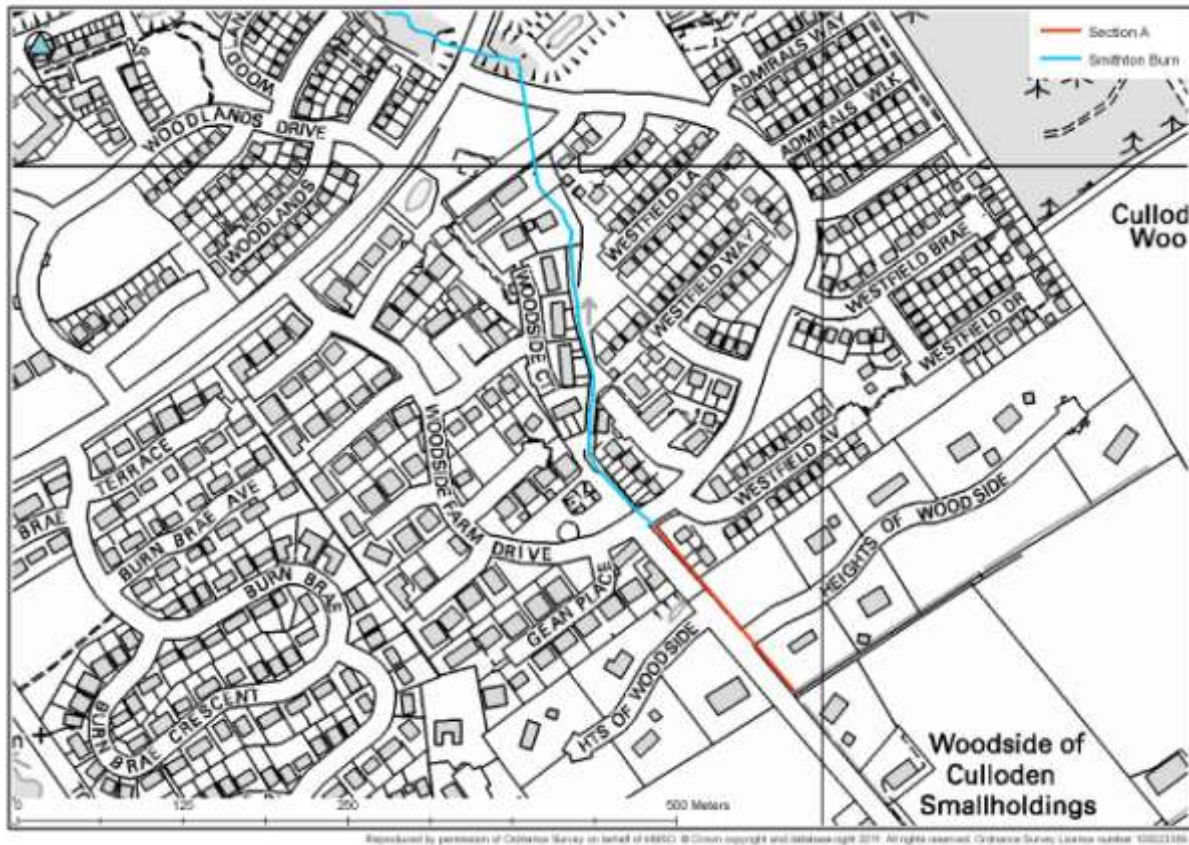
Section A

Channel narrow (0.3-0.5m wide), very straight and no natural valley.

Banks lined with stone pitching – this is very old and there are small isolated pockets of bank erosion where the pitching has failed.

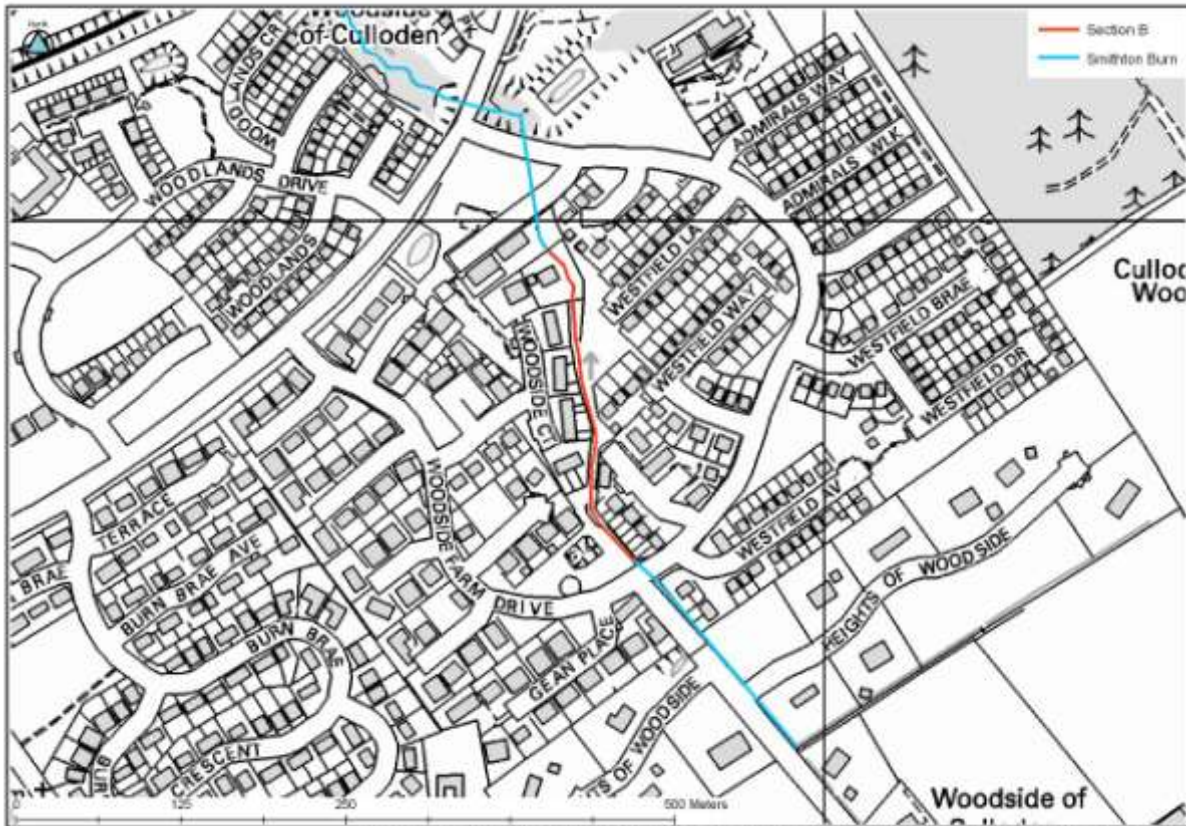
Section B

Narrow and deep with steep banks and obvious recent bed incision at the base of either bank – in some places this has resulted in full bank collapse. A step in bed level is formed by a logjam at approximately NH 71809 44920, with a large pool and severe bank erosion downstream of the jam.

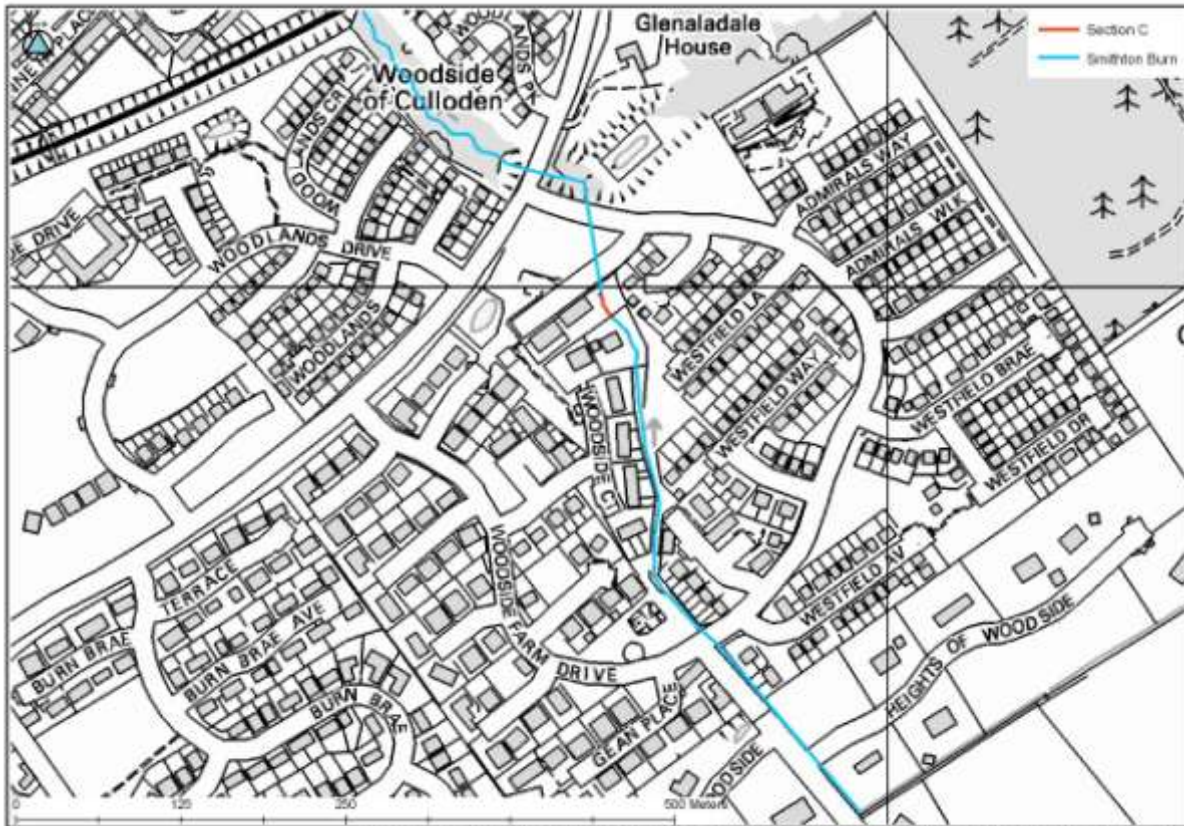
Section C

Narrow with evidence of recent sediment deposition immediately upstream of the culvert inlet. Upstream the bed level rises steeply with severe erosion of the left bank and minor erosion in the channel bed at the base of the slope.

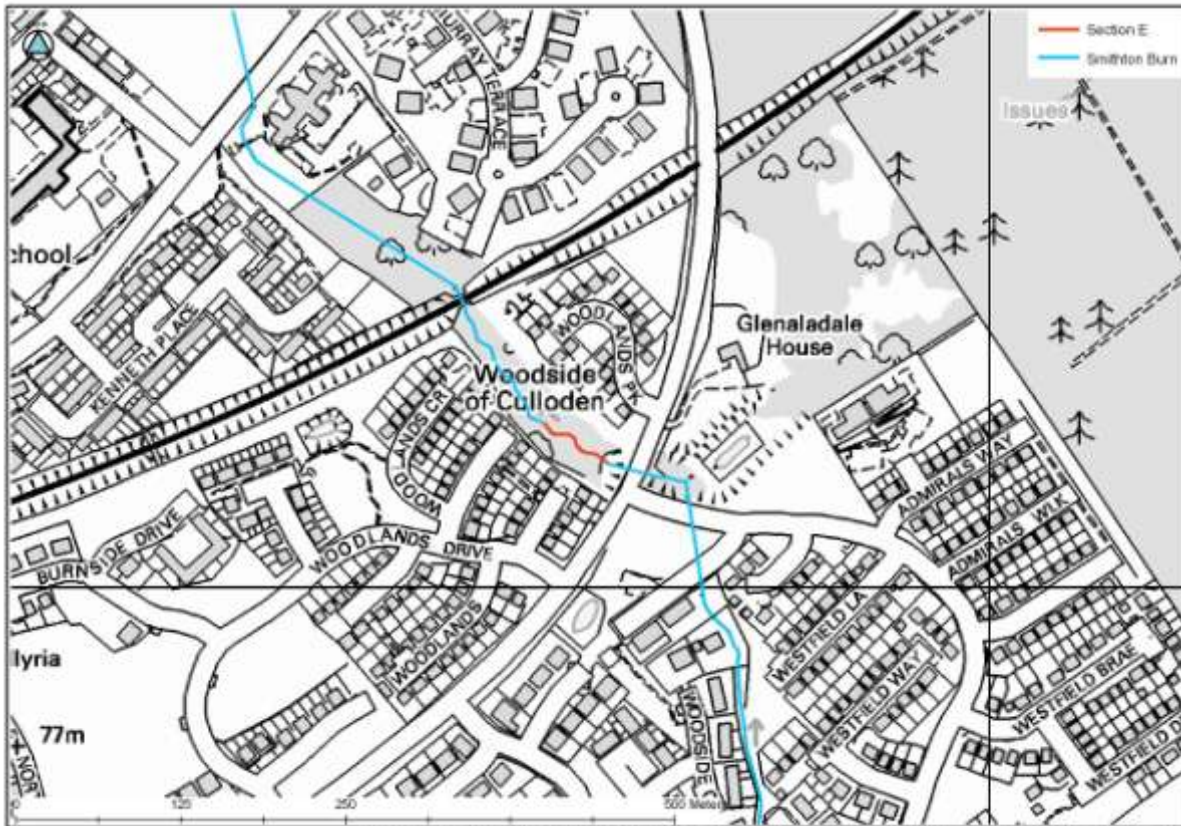
Section E

Steep till banks – eroded at the base of either bank. Significant erosion on the left bank downstream of the pool at the end of Tower Road culvert.

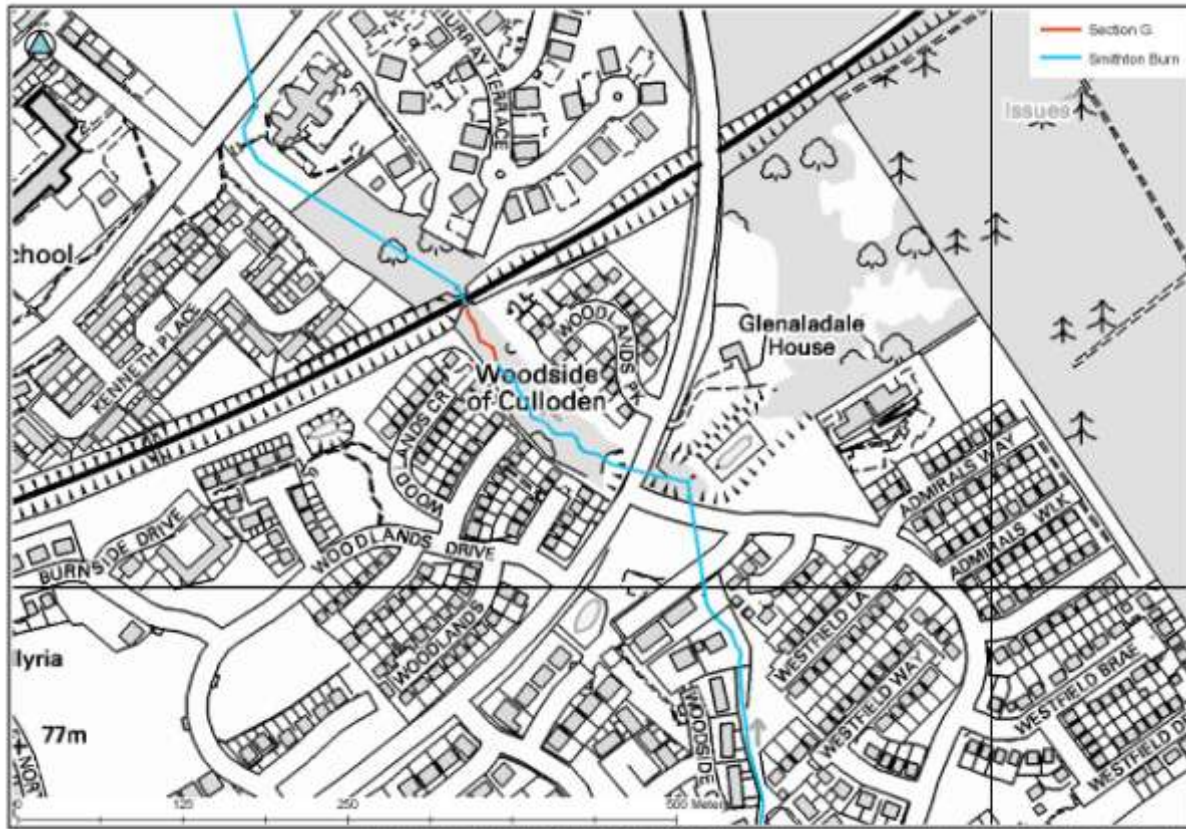
Section G

Channel is wide and poorly defined in base of steep sided valley. The gradient of the channel decreases from this reach downstream, with this area seeing significant sediment accumulation. This is exemplified by the buried surface water drain visible.

Steep, densely vegetated banks. Sediment has also accumulated on the banks within the narrow floodplain.

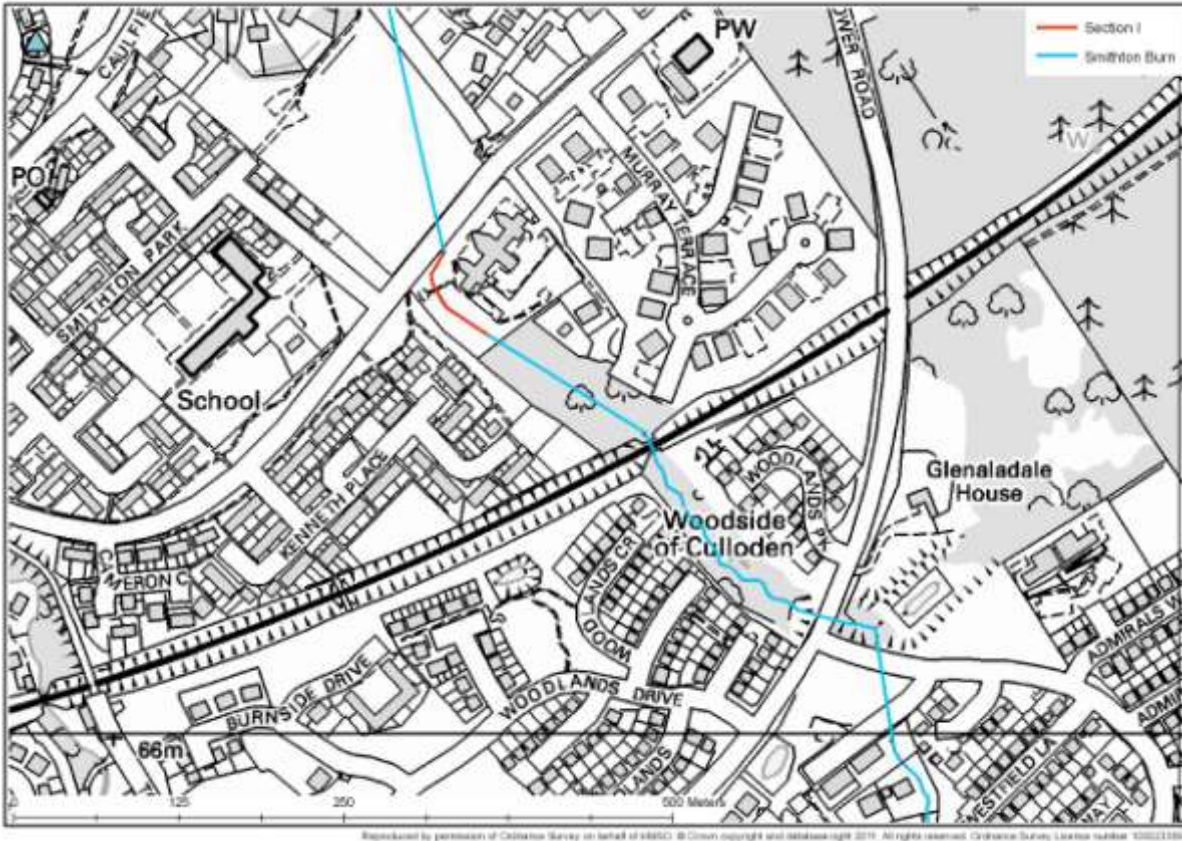
Section I

Narrow and fairly deep channel with evidence of small areas of sediment deposition. This confirms that some sediment can pass through the Murray Terrace culvert upstream.

Densely vegetated, steep banks with till evident at the base of the banks.

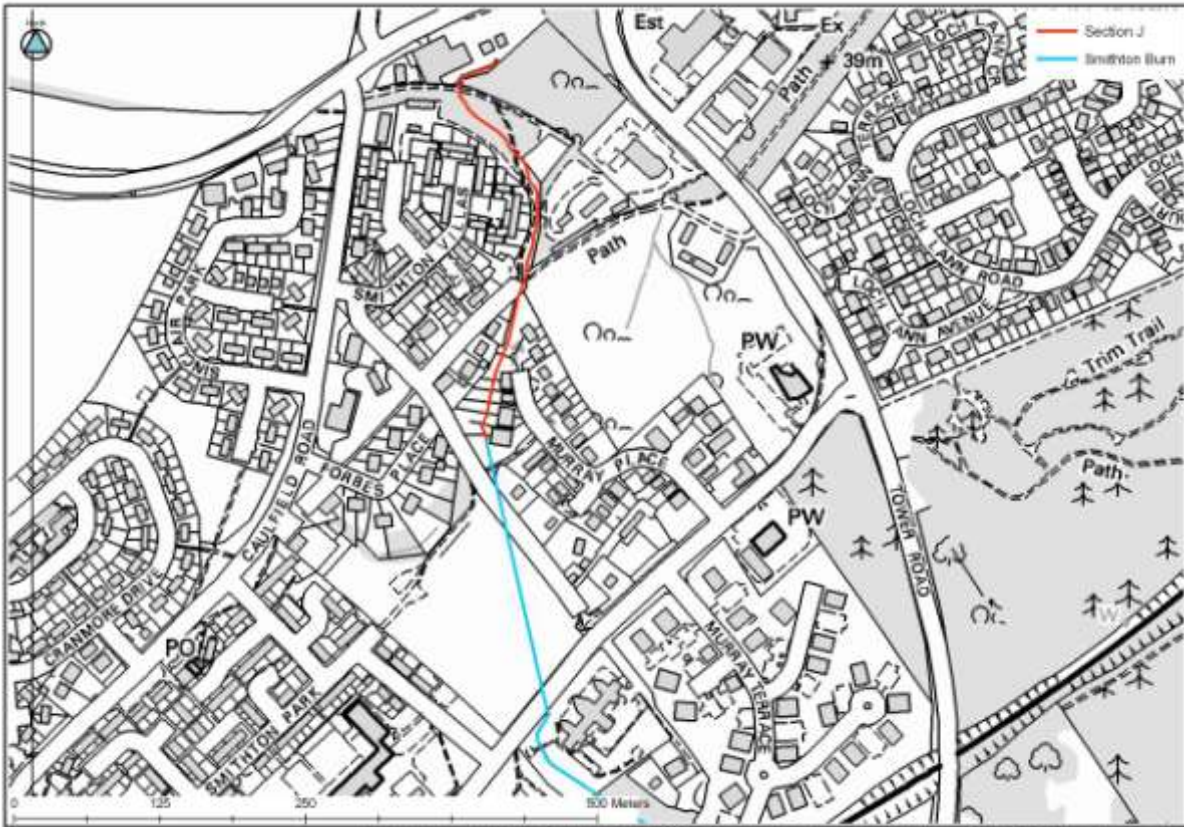
Section J

Stable reach with little evidence of erosion or deposition. The channel varies in width between 0.5 and 2m, and is largely confined by development.

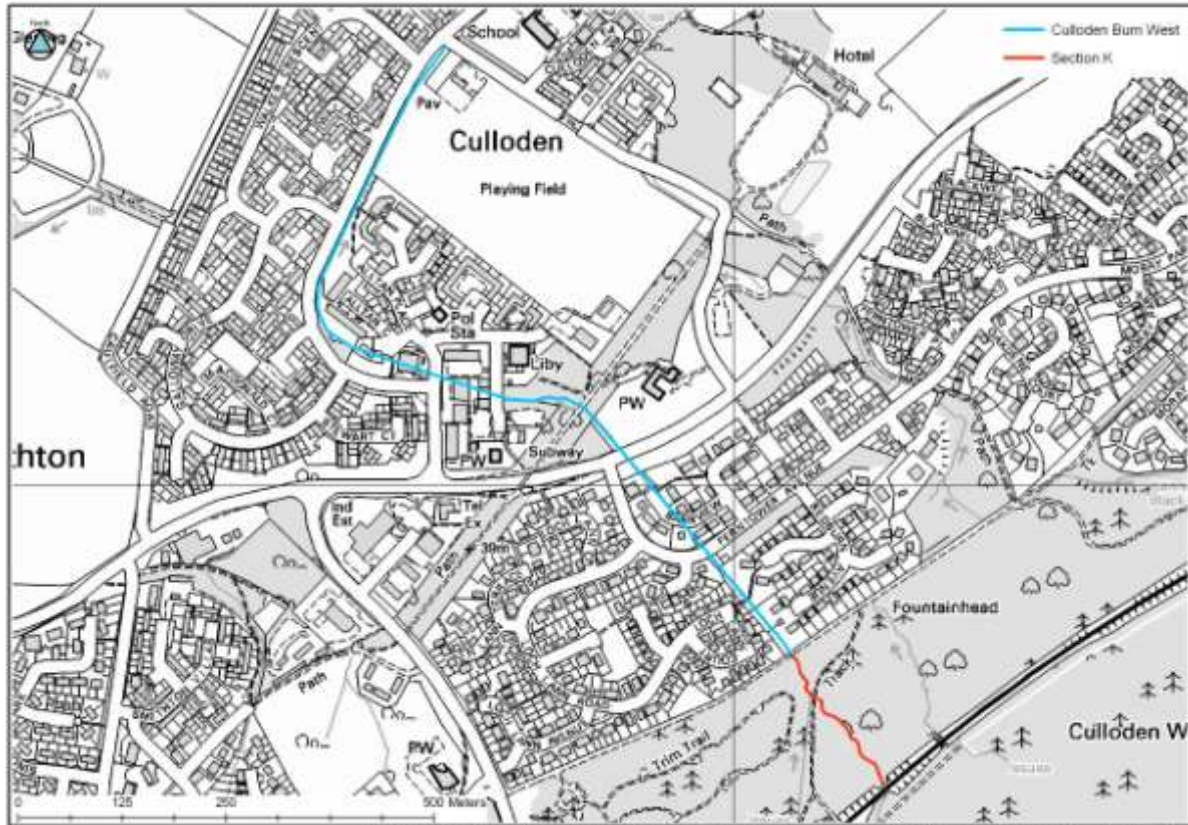
Section K

The channel flows through dense woodland and has a steep gradient. The reach takes a step-pool form, with a number of the steps formed by natural logjams across the channel. Sediment is accumulated upstream of these jams, and would therefore be released downstream should the logjams fail. Overall the reach is erosive, with sediment passing downstream.

The banks are generally steep and vegetated. However, where erosion has taken place till is evident within the channel banks.

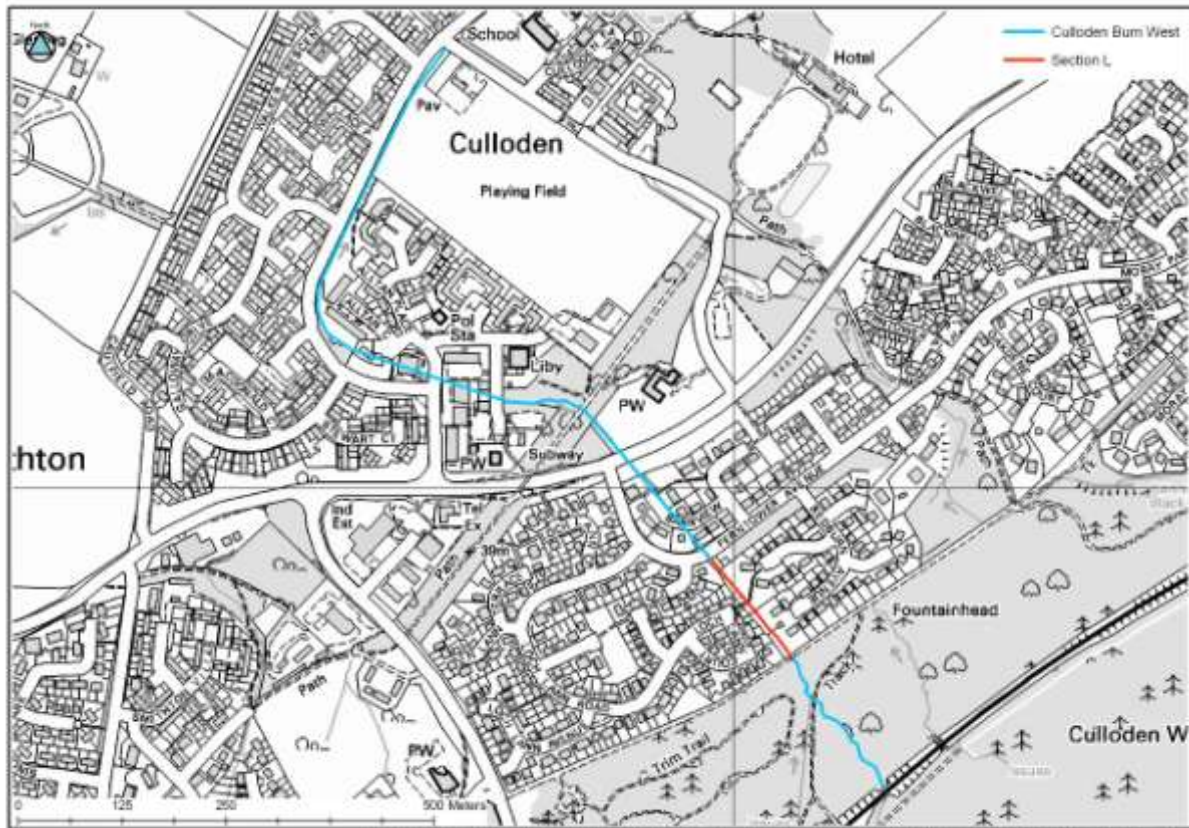
Section L

The channel is highly modified throughout the reach, and is straightened and lined with gabion baskets along the reach length. The form of the channel varies between a rectangular form and a trapezoidal channel. There is evidence of sediment accumulation, particularly at the downstream extent of the reach, upstream of Ferntower Avenue culvert. In addition, there is vegetation (grass) growing within the channel.

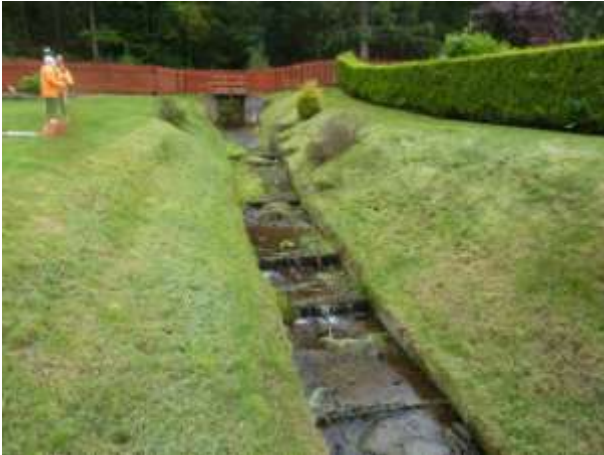
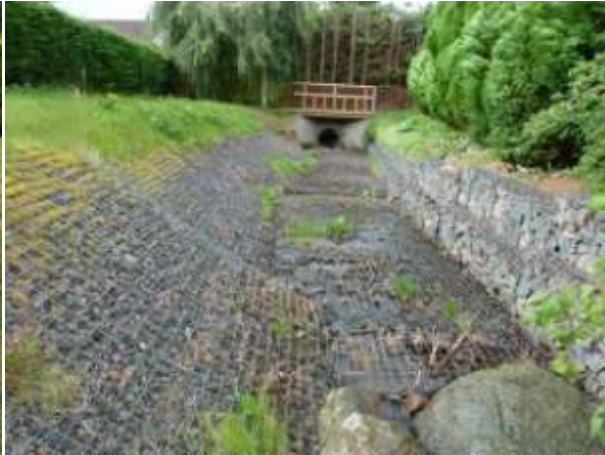
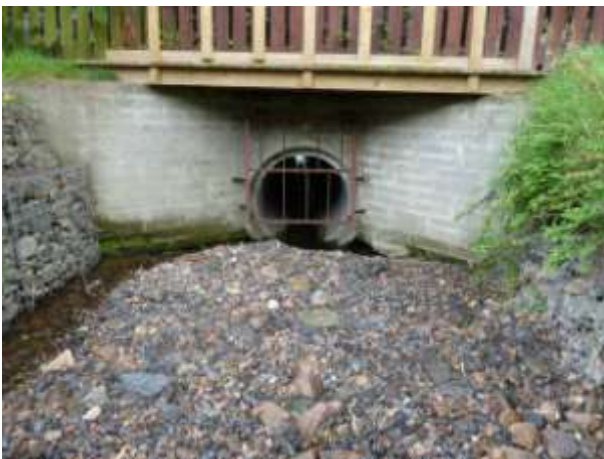
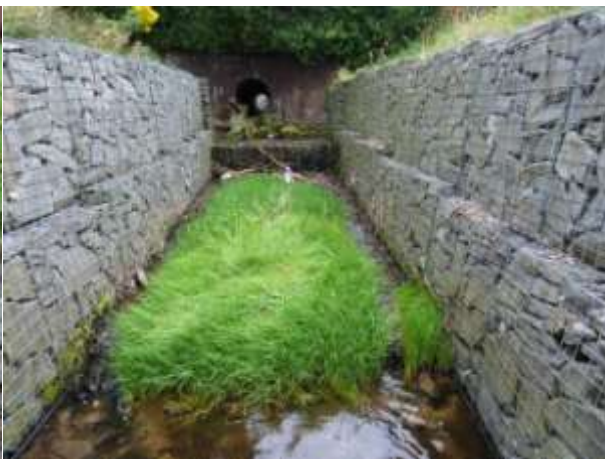
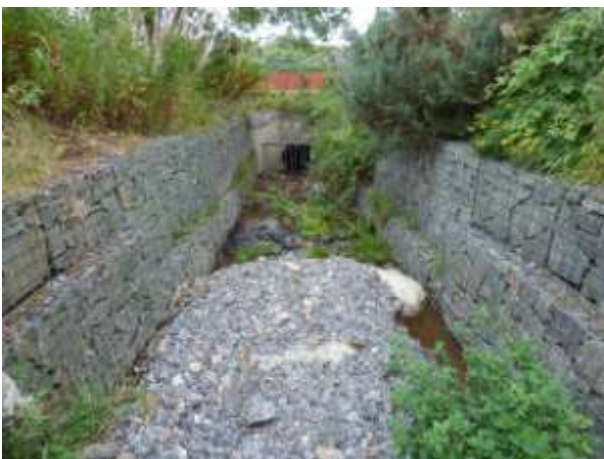
The banks are lined by gabions along much of the reach length, with a short section at the upstream of the reach with sloped grass banks.

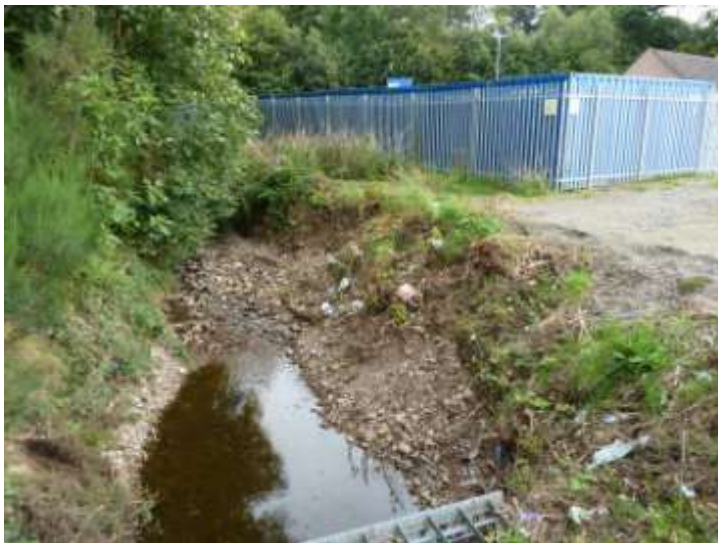
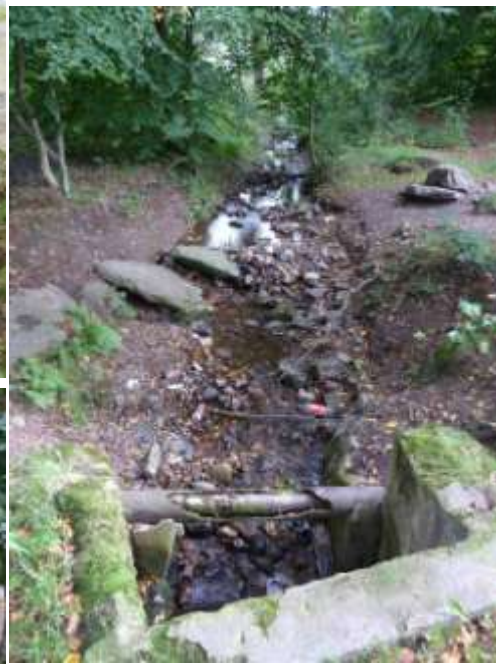
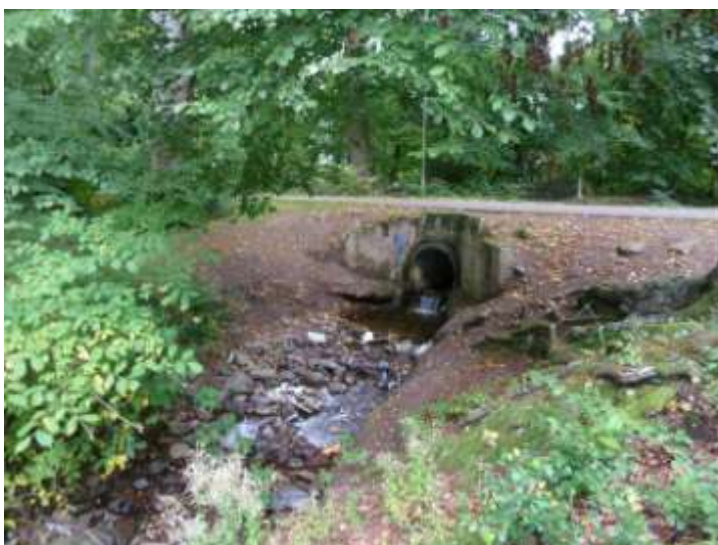
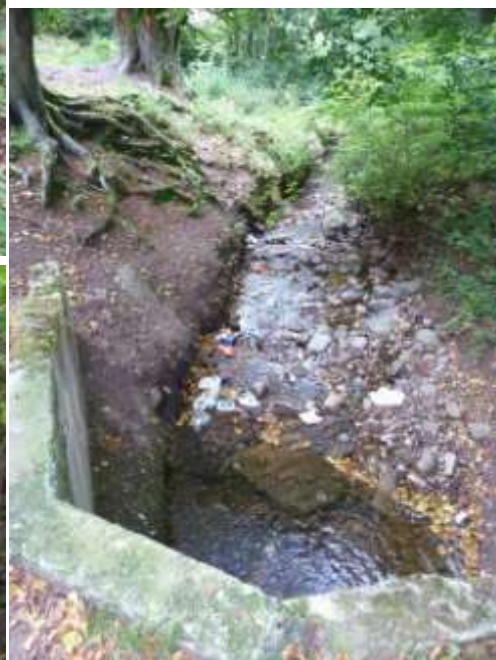
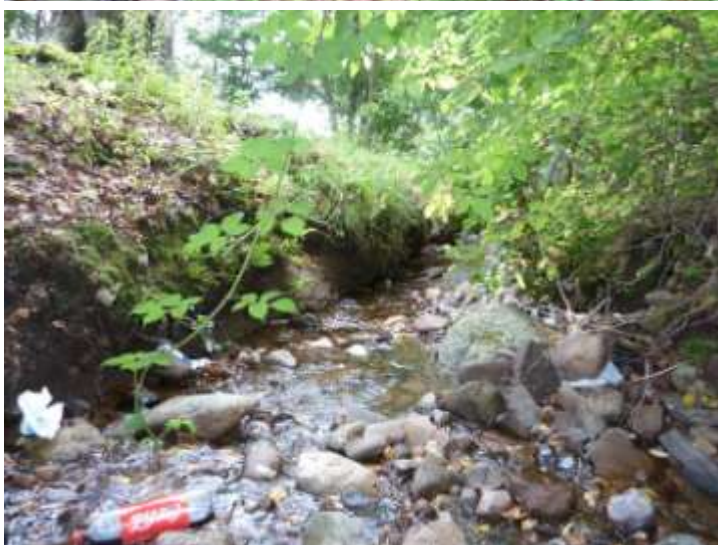
Section M

The channel is located within a small, fairly shallow sided and vegetated valley. There are sections of erosion (particularly bank erosion) present within the reach, as well as sediment accumulation within the channel bed.

The banks are well vegetated and are comprised of till. There are ad-hoc areas of severe bank erosion.
