A890 Maman Hill

Annual Slope Inspection 2025

The Highland Council

Project number: 60685712
AECOM Report Ref.: GLRP0011

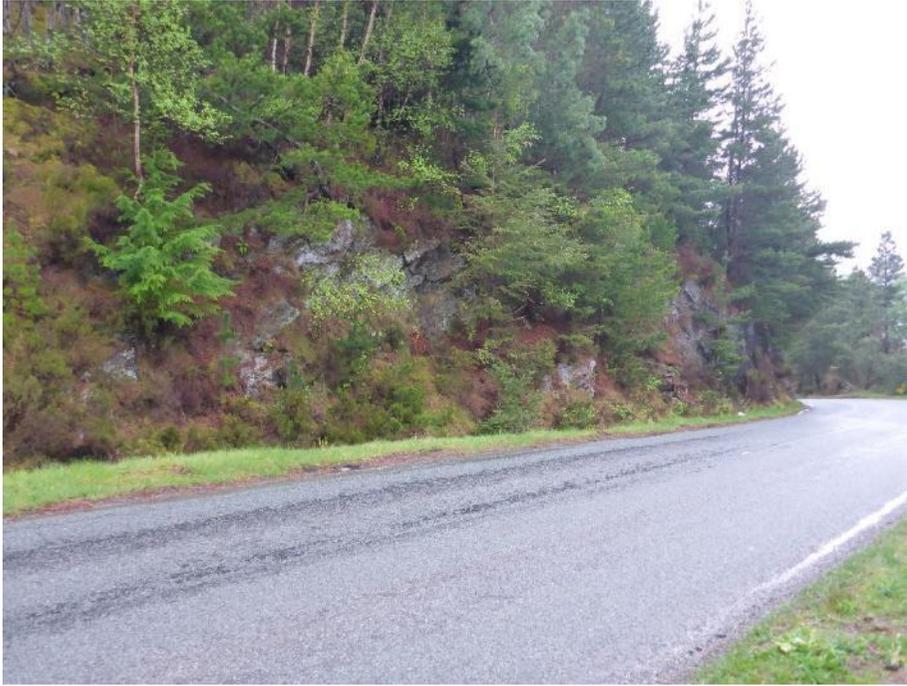
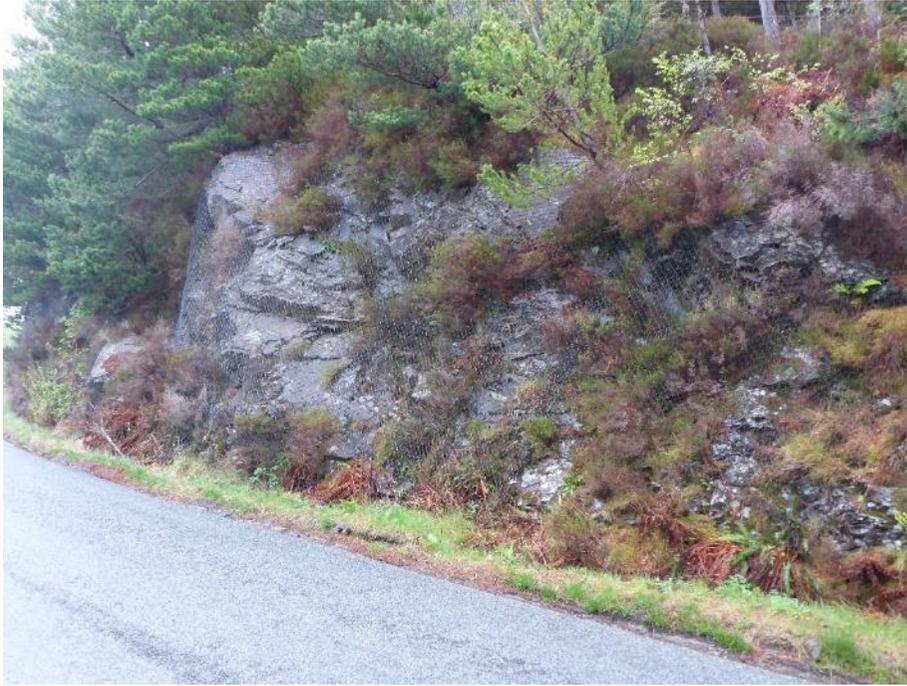
GEOTECHNICAL ASSESSMENT SHEET					
Site: A890 Maman Hill	Slope Ref: M1	Chainage: 015 – 075	Start Grid Ref: NG 92612 39681	End Grid Ref: NG 92572 39636	Elevation: 50 – 55 m AOD

Other Comments
<p>No surface or groundwater flows.</p> <p>Rock mass generally in good condition, although dilated fractures noted locally. Potential for kinematic failure is low.</p> <p>Based on the current condition of the rock slope and the presence of a 0.9 m verge and localised ditch at the toe of the slope, the likelihood of debris from a rock fall landing on the road is considered to be relatively low, excluding between Ch. 040 and 070, where the verge is very narrow.</p>

RISK RATING		Comments
Hazard Rating =	2	Generally limited to small scale raveling although locally potential for larger block fall(s) associated with root jacking. Block size not expected to exceed 1 m ³ .
Pathway Rating =	2	Most rock fall debris likely to land in verge.
Receptor Rating =	1.2	Minimum sightline 45 m.
Risk Value =	4.8	
Risk Level =	Low	Between Ch. 030 and 075 the netting is completed corroded and is considered to be ineffective at retaining falling blocks; between Ch. 040 and 070 there is very little verge for falling blocks to land on. Taking cognisance of these factors, between Ch. 040 and 070, the Pathway Rating could locally be increased to 3 to reflect the increased likelihood of falling blocks reaching the roadside. However, in this slope sub-section the prevailing size of failure material is less than 0.02 m ³ and, as such, the Hazard Rating could be correspondingly reduced to 1. This would equate to an overall Risk Value of 3.6 (Low Risk Level) so no change has been made to the more conservative risk rating determined by consideration of the slope as a whole.

Recommended Remedial Works / Actions					
Large Scale Rock Fall Protection Works (Category 3)		Localised Targeted Rock Fall Protection Works (Category 2)		Ongoing Maintenance (Category 1)	
N/A		<ul style="list-style-type: none"> Consider replacement of existing ineffective drape netting between Ch. 030 and Ch. 075. 		<ul style="list-style-type: none"> Re-inspection by end of April 2026 Felling of trees along crest and de-vegetation of the slope Scaling of loose rock behind netting (between Ch. 030 to 075) 	
Assessed in field by:	MT/PLM/CR/SF	Date:	28/04/2025	Reviewed by:	MT
		Date:		Date:	03/06/2025

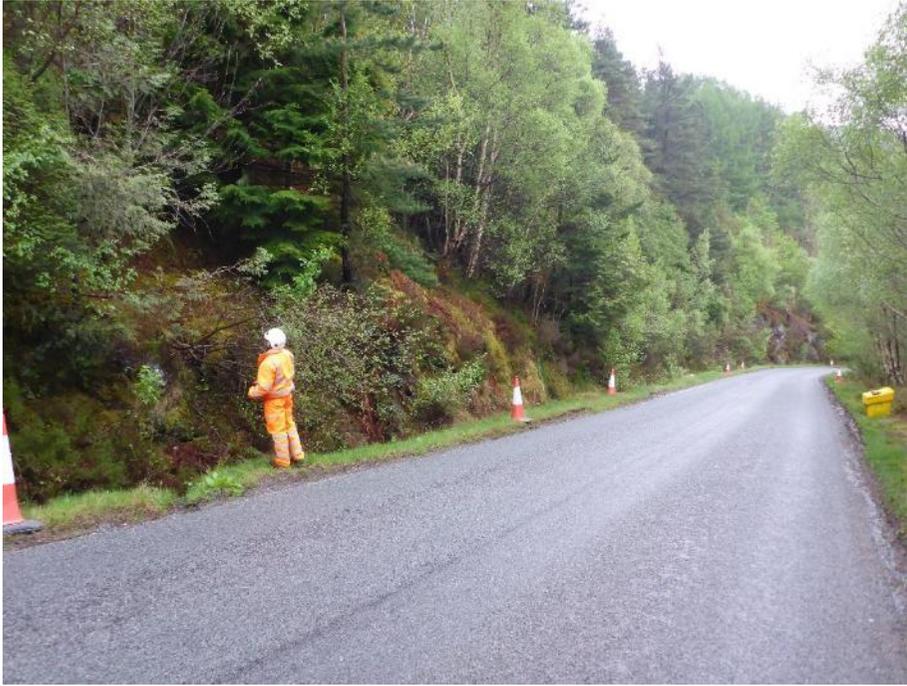
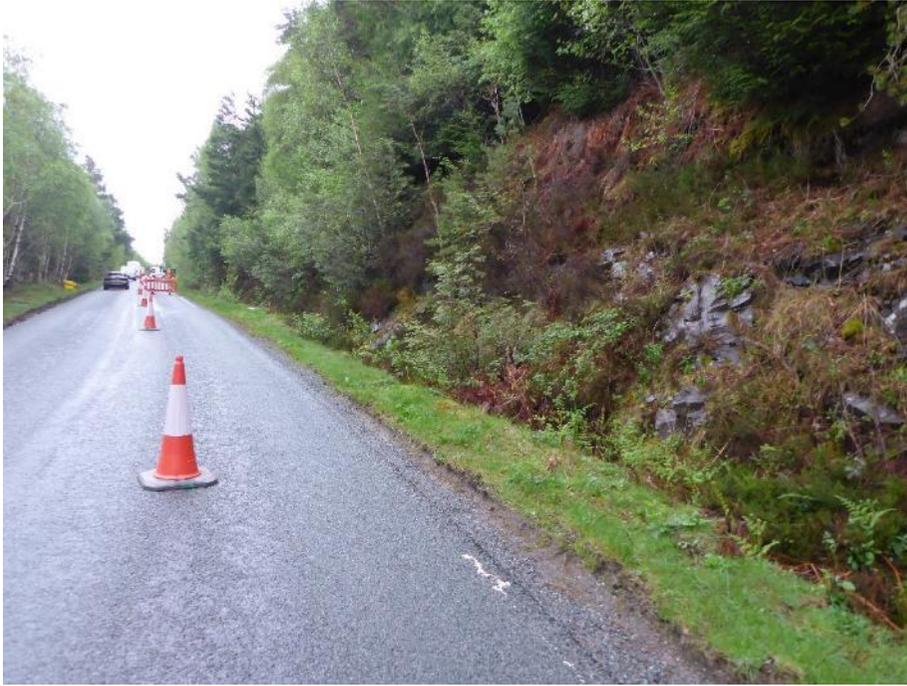
GEOTECHNICAL ASSESSMENT SHEET						
Site: A890 Maman Hill	Slope Ref: M2	Chainage: 200 – 280	Start Grid Ref: NG 92536 39506	End Grid Ref: NG 92513 39431	Elevation: 30 – 35 m AOD

Diversion of existing surface watercourse / water flow observed at Ch. 217; the flow has been diverted upslope, which may signify a blocked channel upslope which may break through in high rainfall conditions. Large verge and ditch should reduce the potential for debris to reach the road.

Isolated low height (2 m max) rock exposures. Rock mass generally in good condition, although dilated fractures noted locally. Potential for kinematic failure is low.

RISK RATING		Comments
Hazard Rating =	1	Generally limited to small scale ravelling.
Pathway Rating =	1	Ditch considered effective.
Receptor Rating =	N/A	Receptor rating only applicable when pathway rating is ≥ 2 .
Risk Value =	1.0	
Risk Level =	Low

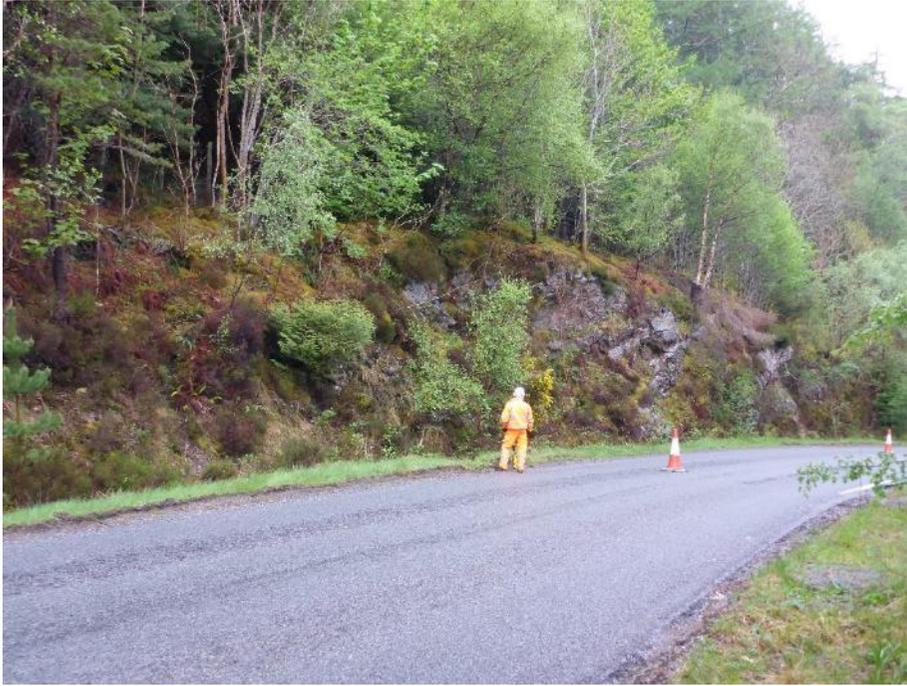
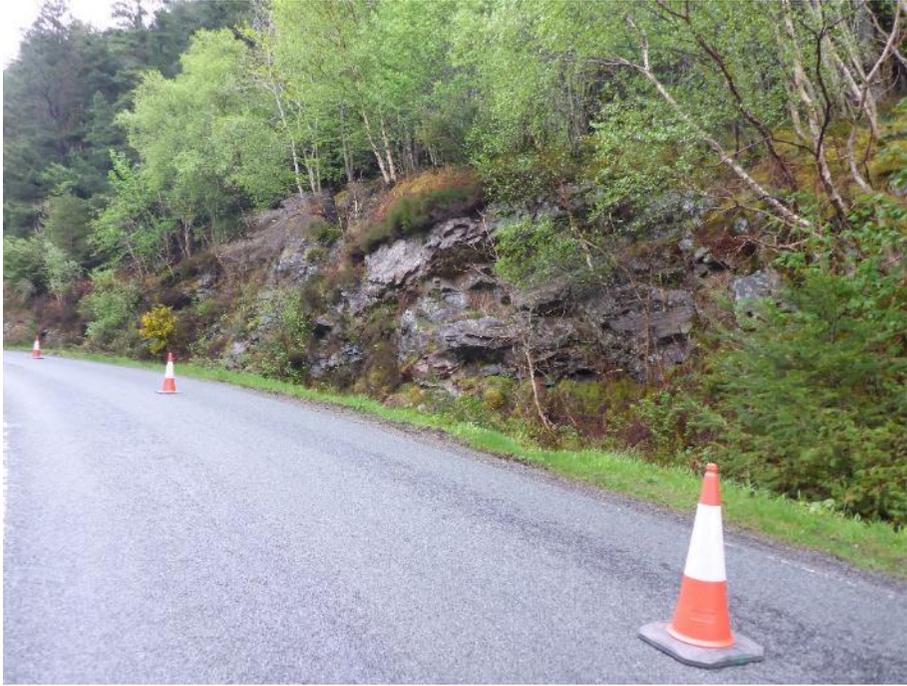
GEOTECHNICAL ASSESSMENT SHEET											
Site:	A890 Maman Hill	Slope Ref:	M3	Chainage:	280 – 330	Start Grid Ref:	NG 92513 39431	End Grid Ref:	NG 92493 39392	Elevation:	25 – 35 m AOD

Existing netting or other remedial work details:				
Year of Works	Description of Works	Comments	2025 Inspection Observations	Photo Reference
December 2020	Tree felled by THC at Ch. 304	There was a large fir tree growing from crest of rock face. Risk of root-jacking and potential rock fall volume up to 0.5 m ³ .	No change noted during the 2025 inspection.	N/A

Hazards Observed:			
Location	Description of Hazard(s) from Previous Inspections	2025 Inspection Observations	Photo Reference
Throughout M3	2019 Inspection: Numerous small scale (<0.02 m ³) ravelling type rock falls observed, some of which were deemed to be imminent (i.e. readily dislodged by hand).	No change noted during the 2025 inspection.	N/A
Throughout M3	2019 Inspection: Localised overhangs with potential for rock fall of unsupported blocks. Individual block size typically <0.1 m ³ (e.g. at Ch. 311)	No change noted during the 2025 inspection.	M3-1
Ch. 280	N/A	Boulder at fence above rock slope (side length 0.50 m). Source unknown.	M3-2
Ch. 304	2023 Inspection: Rock mass beneath tree exhibiting root-jacking potential	No change noted during the 2025 inspection.	N/A
Ch. 311	2024 Inspection: A tree has fallen away from the slope. Possibly due to a vehicle leaving the road and entering the ditch (evidence of disturbed verge and vehicle debris). No significant hazard.	No change noted during the 2025 inspection.	N/A
