A890 Stromeferry Bypass

Annual Slope Inspection 2025

The Highland Council

Project number: 60685712
AECOM Report Ref.: GLRP0010

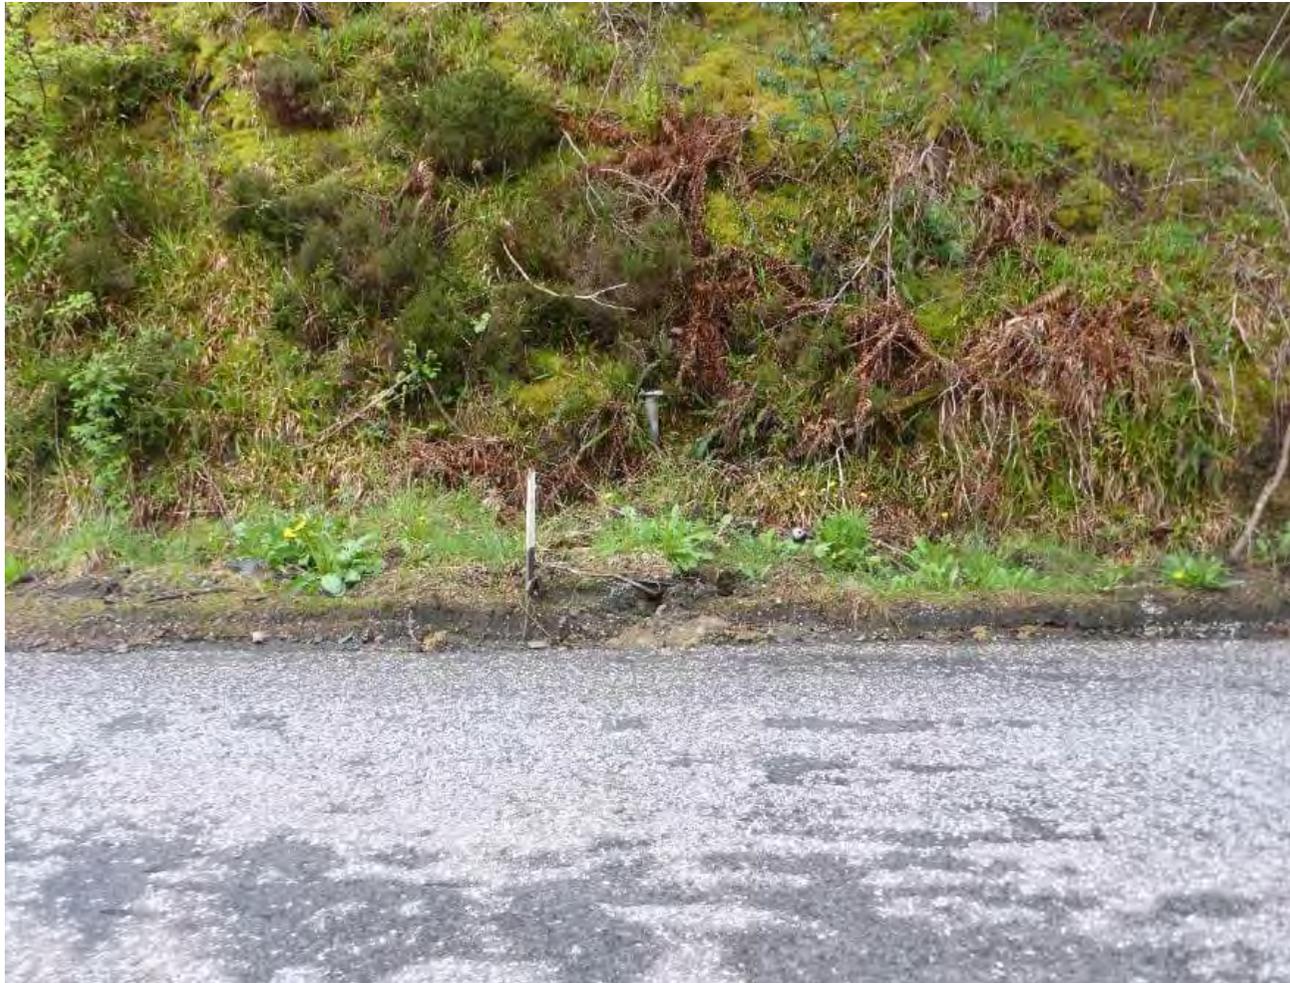
Hazards Observed:			
Location	Description of Hazard(s) from Previous Inspections	2025 Inspection Observations	Photo Reference
Throughout AA1	2012 Inspection: Upper 2 to 3 m of rock face prone to ravelling (block size typically 0.2 x 0.2 x 0.2 m).	No changes observed during 2025 inspection, ditch remains effective.	
Throughout AA1	2018 Inspection: Evidence of ongoing ravelling of small blocks but retained by ditch. Few small blocks retained by TECCO mesh - not currently loading system.	No changes observed during 2025 inspection, ditch remains effective.	
Ch. 0000	2024 Inspection: Road closure gate post has fallen. Possibly been struck by a vehicle. Maintenance required.	Gate post has been removed but not replaced; unable to secure the road closure gate when closed (i.e., cannot effectively close road).	AA1-1

<p>AA1-1</p>	<p>Ch. 0000 2024 observation: Road closure gate post has fallen. Possibly been struck by a vehicle. Maintenance required. 2025 observation: Gate post has been removed but not replaced; unable to secure the road closure gate when required (i.e. cannot effectively close road). Replacement required.</p>	<p>Year First Observed:</p>	<p>2024</p>
--------------	---	-----------------------------	-------------

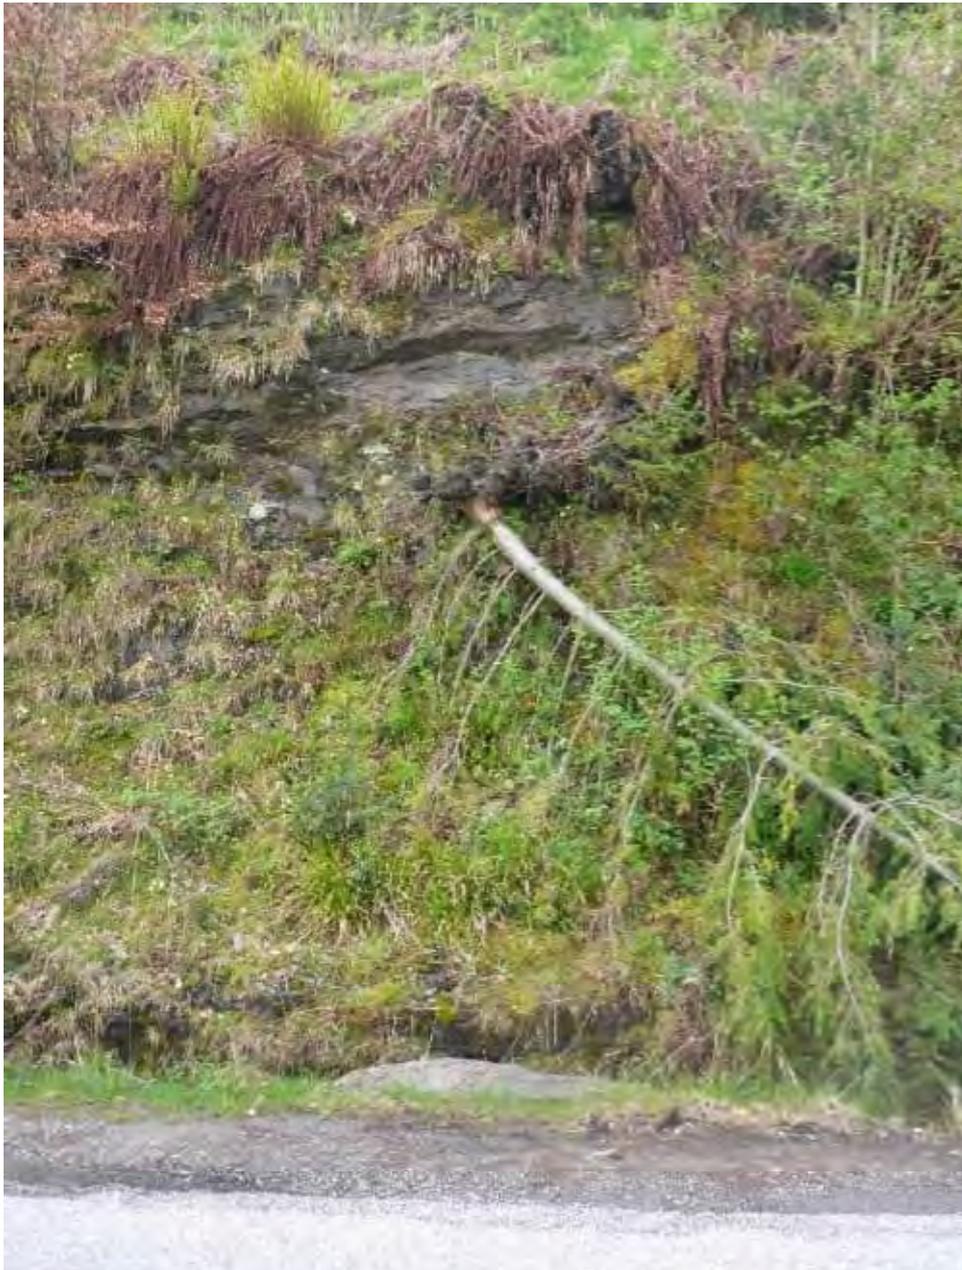
<p>AA1-3</p>	<p>Ch. 0031: 2024 observation: A small tree growing from the rock face, 4 m above the toe, has fallen. At the same location a large block has fallen into the ditch. Dimensions are 1.0 x 0.5 x 0.4 m and the source location was just above the fallen tree. There are no additional hazards on the slope but the ditch capacity is reduced due to the presence of the block. 2025 observation: No changes observed in 2025 inspection.</p>	<p>Year First Observed:</p>	<p>2024</p>
--------------	--	-----------------------------	-------------

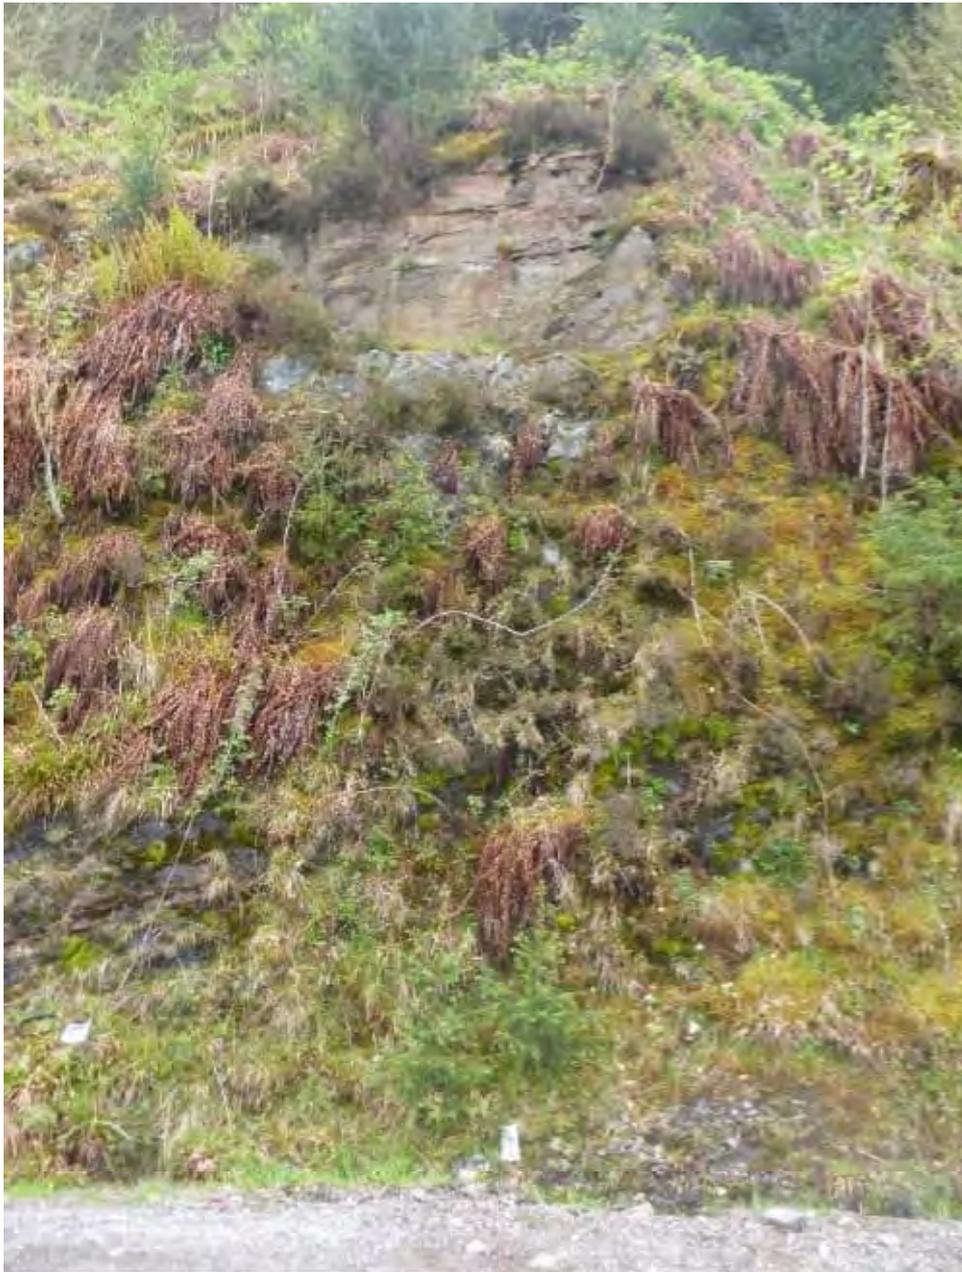
AA1-4	Ch. 0050: 2025 observation: Upper 1 m of rock face fractured and weathered; potential for ravelling-type failures. Ditch below anticipated to trap falling blocks.	Year First Observed:	2025
-------	---	-------------------------	------

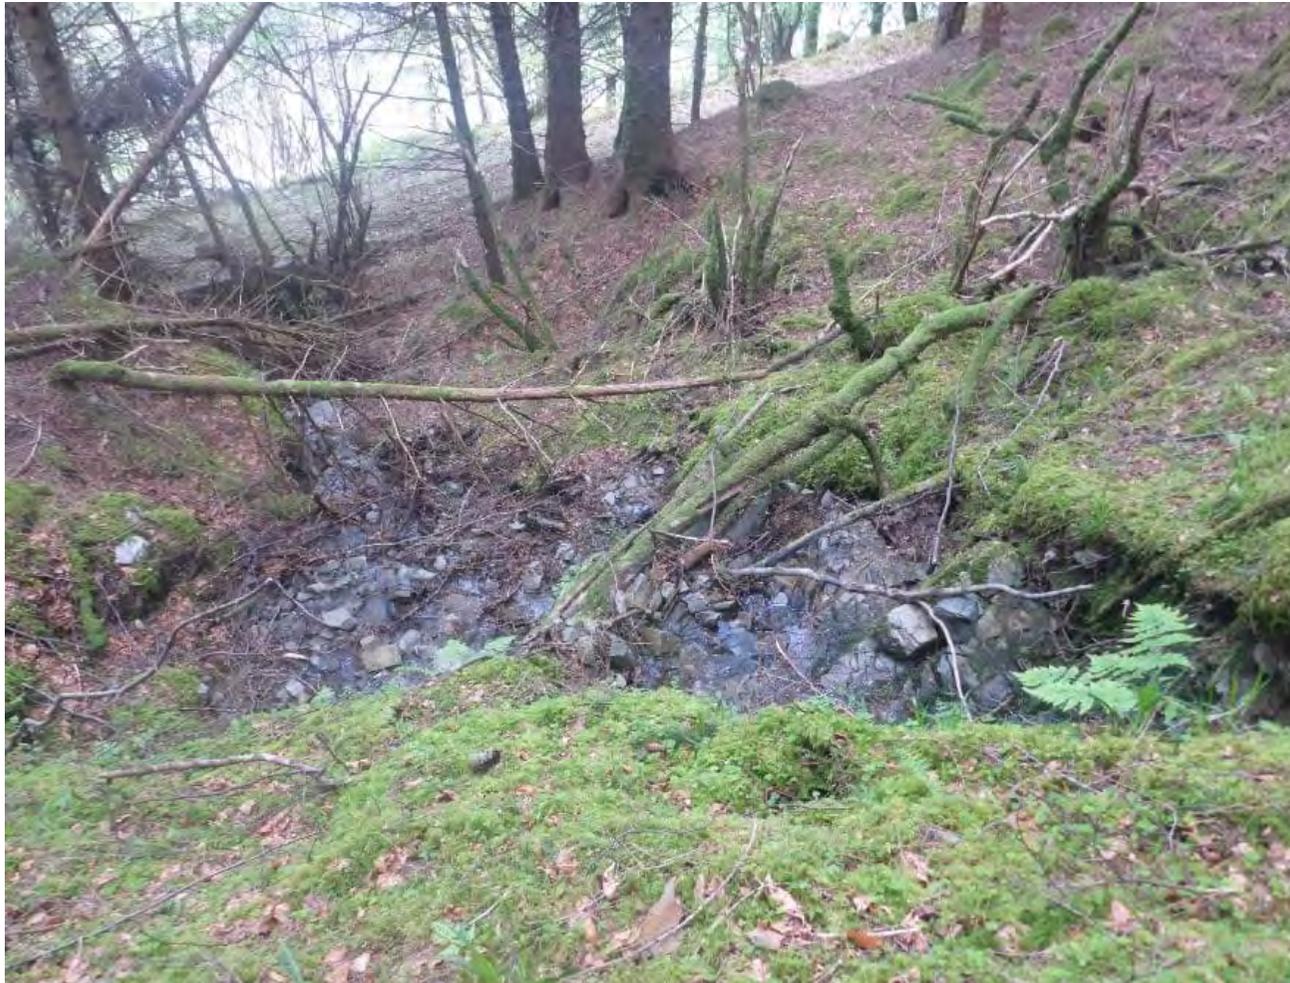
Hazards Observed:				
		<ul style="list-style-type: none"> Upslope box culvert/bridge spanning across small watercourse, slight debris accumulation under bridge (granular cobble/boulder size) at NG 89408 36019. Downslope of forest road is steeply inclined with small waterfalls and localised accumulations of debris against branches and trees forming debris dams. Across slope are branches/fallen trees. 		
Above AA1 (NG 89184 35776, approx. Ch. 0160)	N/A		Bridge and culvert beneath unmaintained forestry track above AA1 are clear of debris. Debris accumulation, including a small debris dam against fallen branches, within the channel between the upper and lower tracks. This unmapped watercourse is flows over the roadside rock slope within area of Tecco netting (location of previous debris flow / rock fall).	AA1-5

<p>AA1-5</p>	<p>Above AA1 (NG 89184 35776, approx. Ch. 160): 2025 observation: Bridge and culvert beneath unmaintained forestry track clear of debris. Debris accumulation, including a small debris dam against fallen branches, within the channel between the upper and lower tracks.</p>	<p>Year First Observed:</p>	<p>2025</p>
--------------	--	-----------------------------	-------------

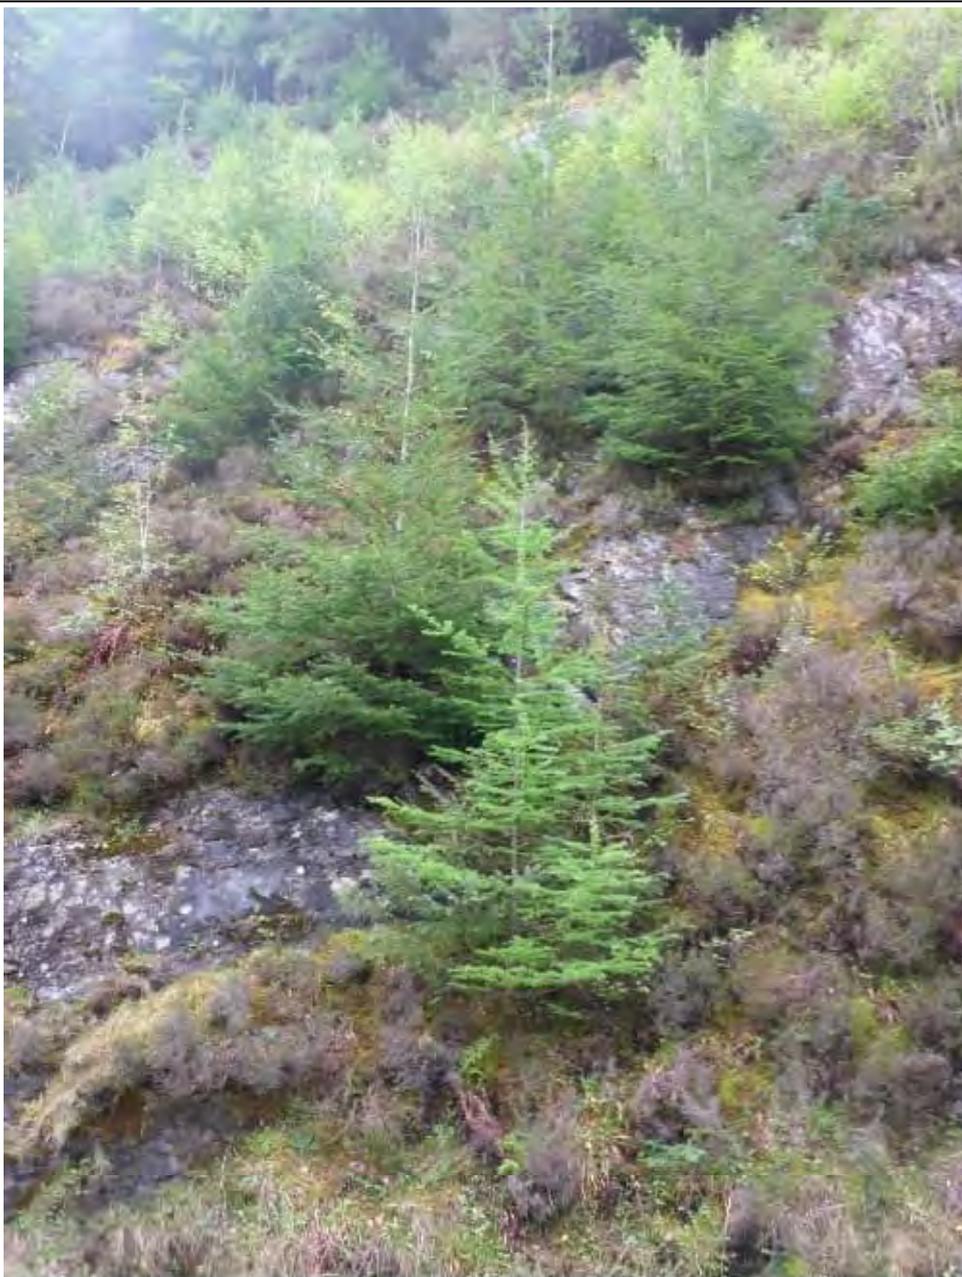
AA2-3	Ch. 0205 to 0230: Limited visibility of the rock face due to significant tree cover. Potential for root jacking.	Year First Observed:	2019
-------	---	----------------------	------

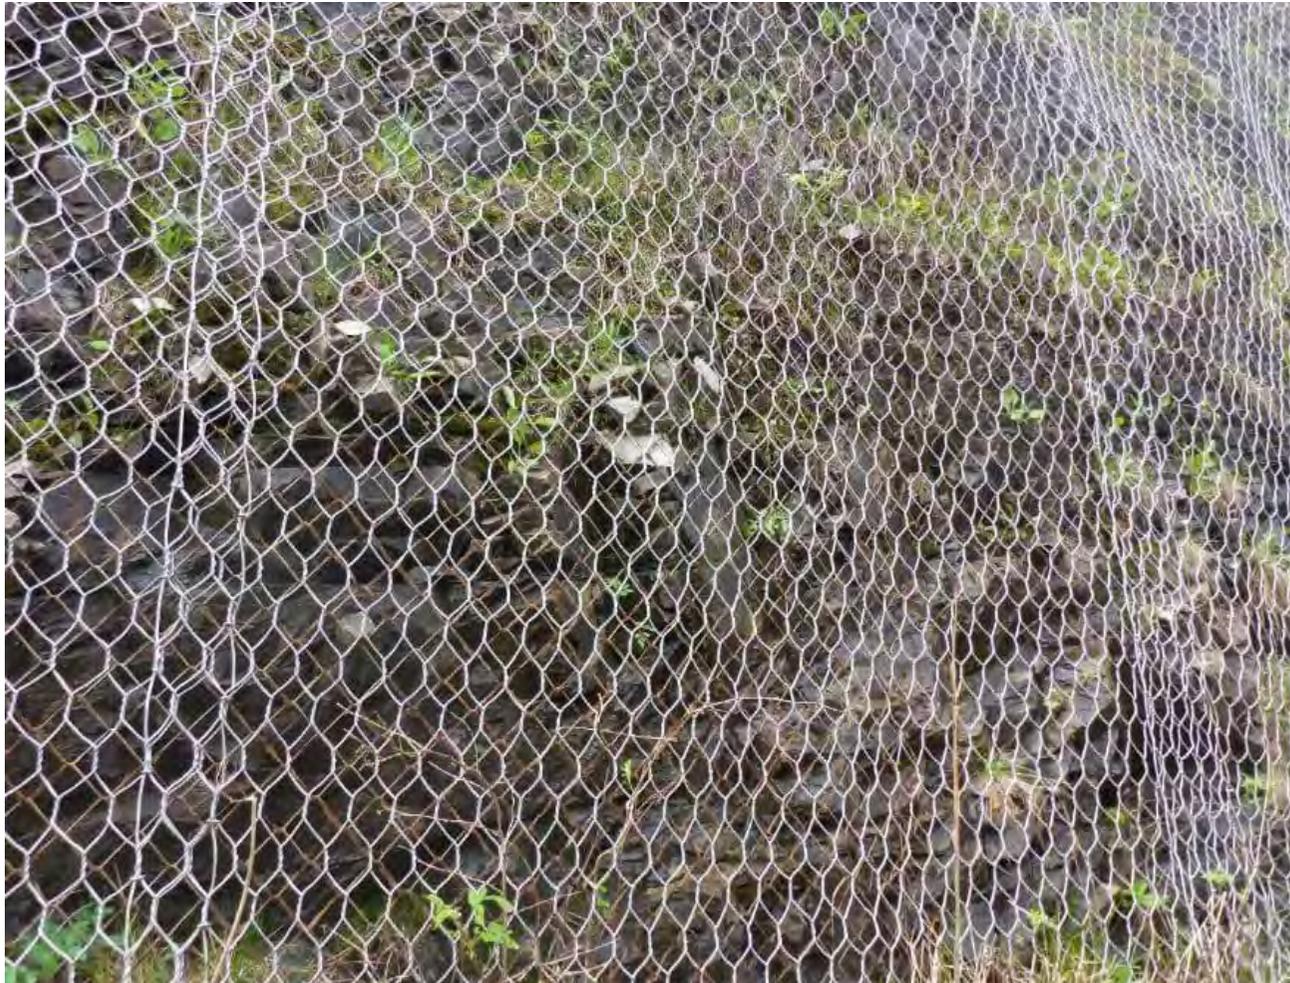
Ch. 0235 to 0250	2019 Inspection: c. 0.3 x 0.3 x 0.3 m debris caught behind drape 1 to 2 m above ditch demonstrating effectiveness of drape netting system.	No changes observed during 2025 inspection.	AA2-4
Ch. 0259	N/A	Small blocks up to 0.25 m ³ retained in netting at slope toe; sources 4 to 5 m above toe from potential wedge failure. Small overhang remaining with the potential for further failure of blocks up to 0.5 m ³ ; Netting anticipated to be sufficient to retain further rock fall material.	
Ch. 0278	2017 Inspection: Debris continues to build up behind netting. Not currently loading system significantly. In 2021, it was noted that some of the material had fallen out of base of netting and into ditch below.	No changes observed during 2025 inspection.	AA2-5
Ch. 0285 to 0315	N/A	Wet surface from water seepage; flow in continuous with build-up of algae; although presence of water can increase potential for rock fall no evidence of slope instability was observed and there is a 1.5 m wide ditch at this location.

AA2-4	<p>Ch. 0235 to 0250: 2019: c. 0.3 x 0.3 x 0.3 m debris caught behind drape 1 to 2 m above ditch demonstrating effectiveness of drape netting system. 2025: No changes observed during 2025 inspection.</p>	Year First Observed:	2019
-------	--	----------------------	------

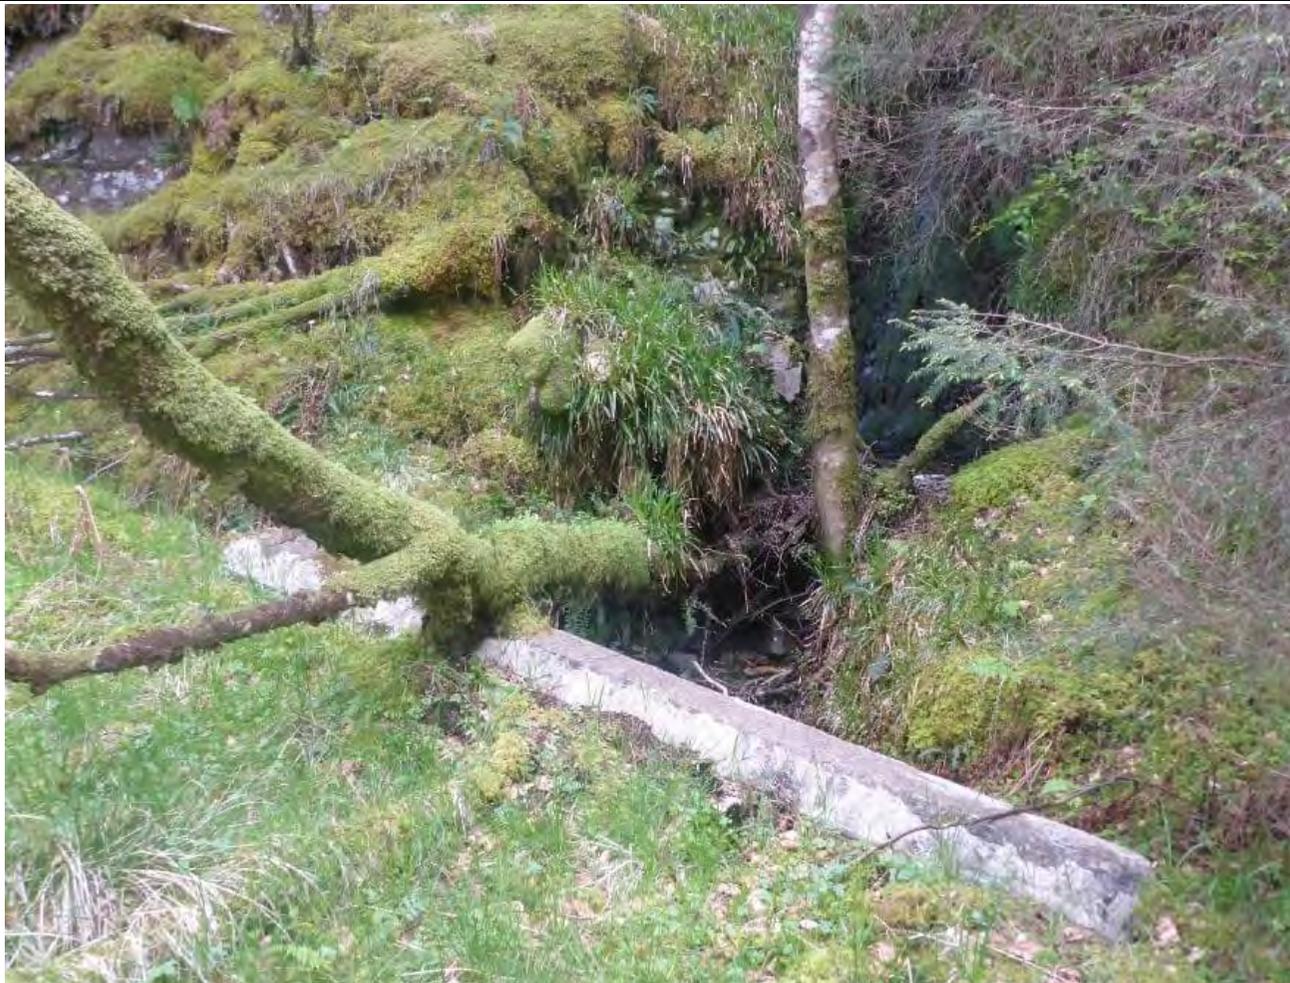
AA2-7	<ul style="list-style-type: none"> Above AA2 NG 89203 35827: Fallen tree blocking channel upstream of bridge. Granular material accumulating beneath the bridge. Channel down-slope towards the road is steep with localised branches and granular debris. 	Year First Observed:	2023
-------	---	----------------------	------

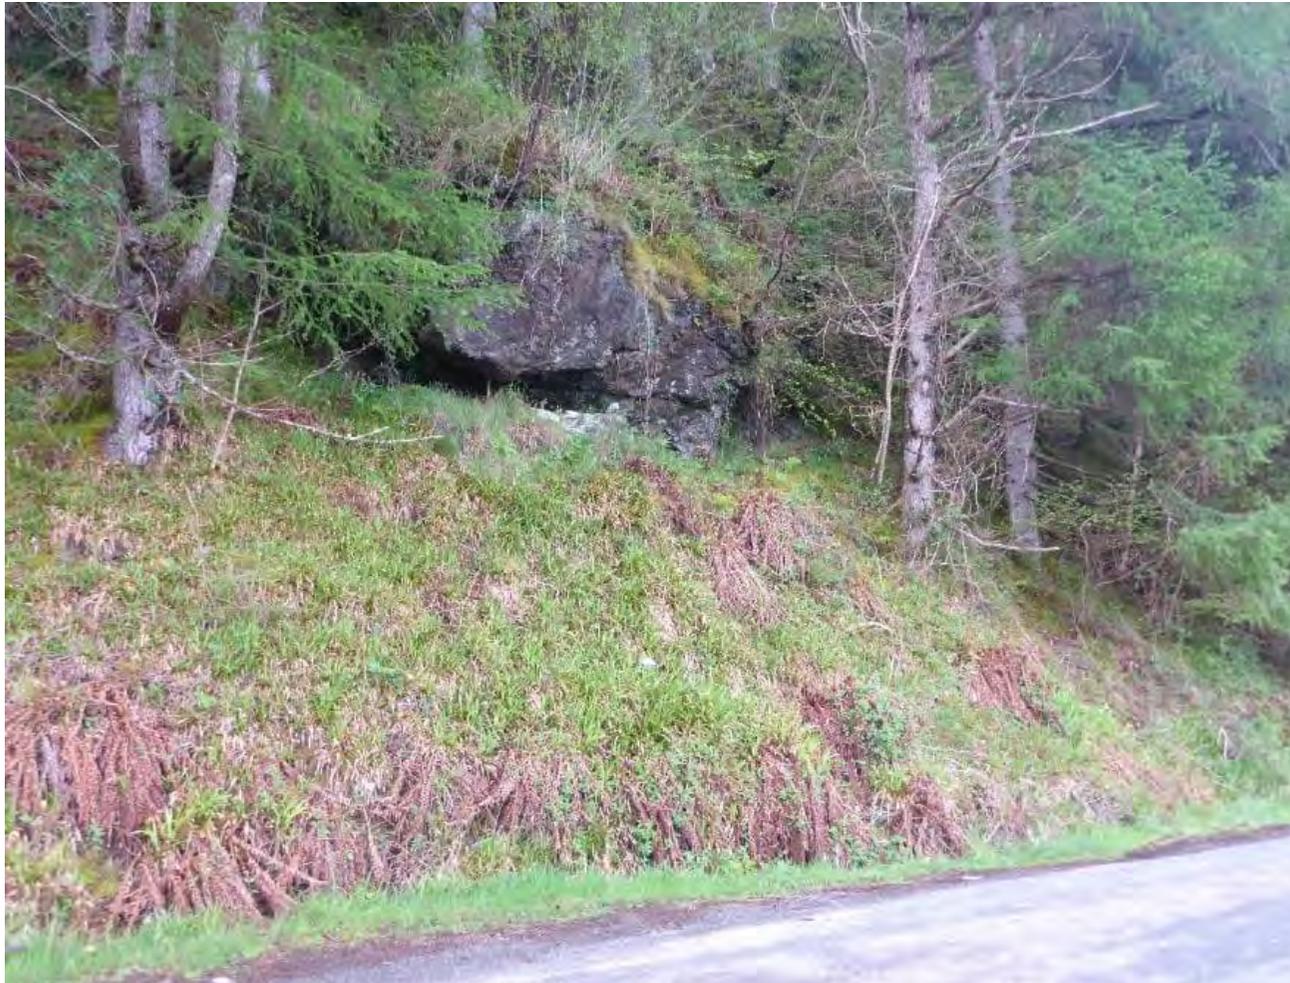
AA2A-1	<p>Ch. 0400: Large boulder above road level at a passing place with a c. 2.5 m overhang. Dilated discontinuities split boulder into two blocks, with the block above the overhang affected by root jacking (coppiced trees regrowing). Historic spalling / ravelling failures noted in 2020 inspection. Should the overhanging block fail, rock fall material would reach the road.</p>	Year First Observed:	2016
--------	--	----------------------	------

Recommended Remedial Works / Actions		
Large Scale Rock Fall Protection Works (Category 3)	Localised Targeted Rock Fall Protection Works (Category 2)	Ongoing Maintenance (Category 1)
N/A	<ul style="list-style-type: none"> Heavy scaling / controlled removal of overhang on boulder at Ch. 0400. Likely to require stitch drilling. 	<ul style="list-style-type: none"> De-vegetate the slope face; Coppice trees within 10 m of road between Ch. 0340 to 0447; The build-up of debris within the ditch should be monitored during monthly and annual inspections and clearance works undertaken as required to maintain its capacity; Monitor build-up of debris (i.e. debris dams) in channels above AA2A and undertake clearance works when required; Ch. 0335 recommend for ditch and culvert to be cleared; Ch. 0428 recommend for ditch and feeder pipe to be cleared; and

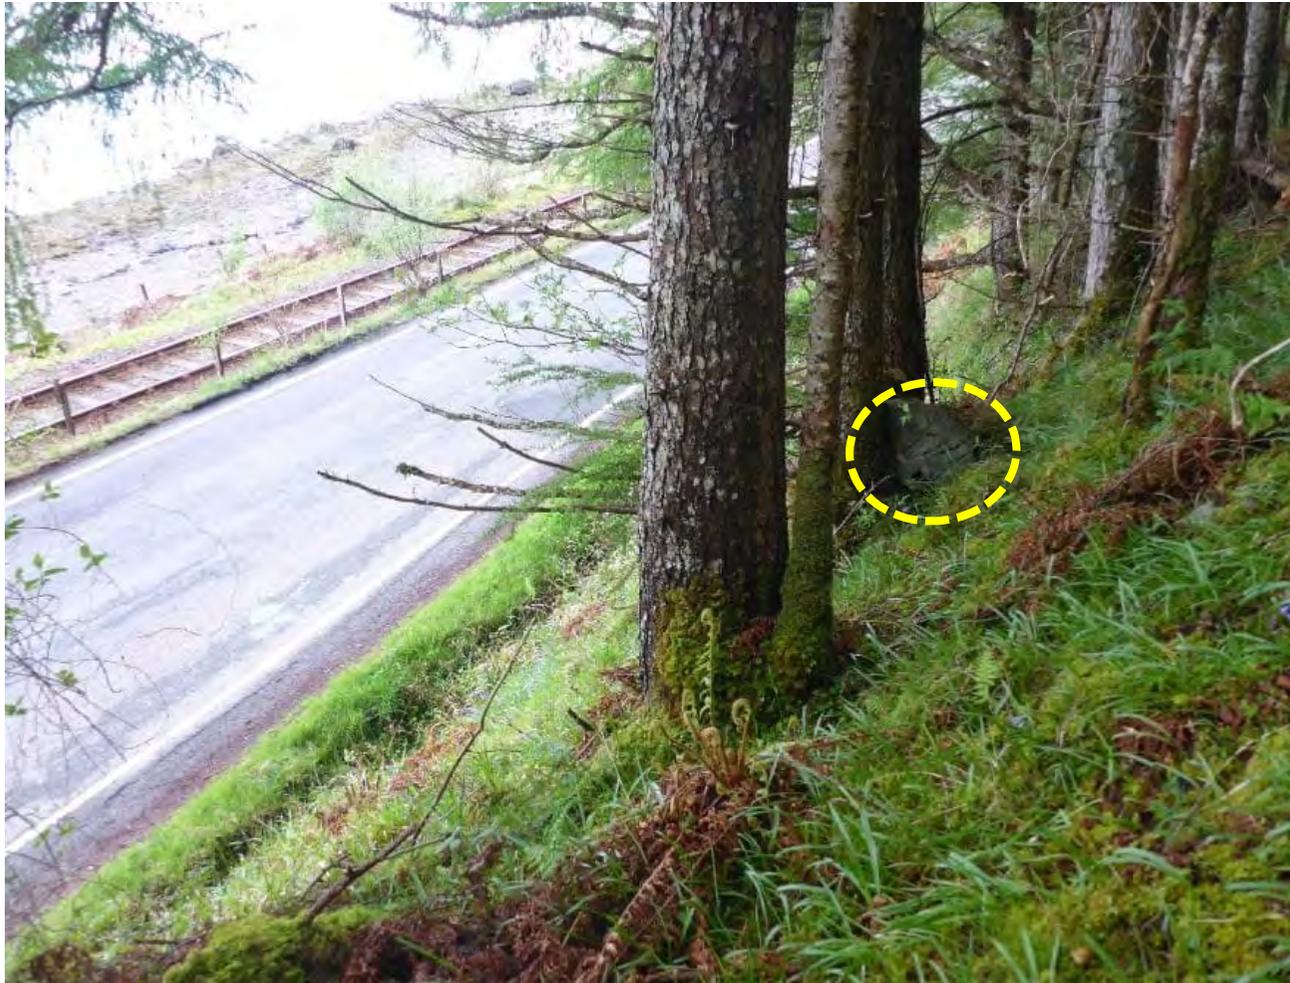
AA2A-4	<p>Ch. 0409: 2025: Boulder resting on / wedged behind a tree ~3 m upslope. Dimensions 0.3 x 0.5 x 0.2 m. Source of rock fall a fallen tree c. 25 m above road level with blocks weathering out of the root ball.</p>	Year First Observed:	2025
--------	---	----------------------	------

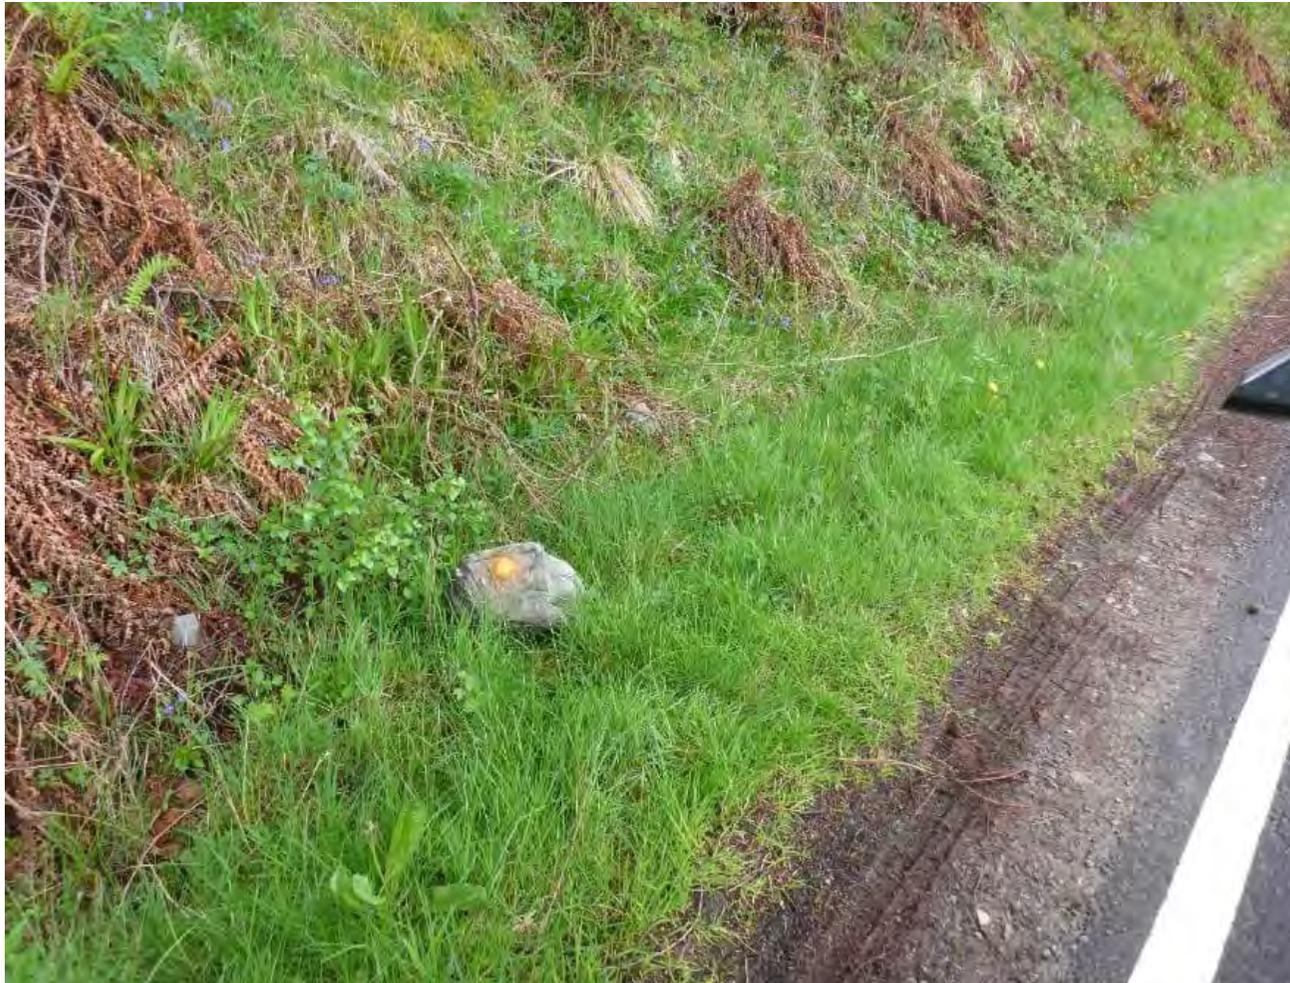
<p>AA2A-5</p>	<p>Ch. 0419: 2021: Two small blocks observed in the roadside ditch. No pre-existing paint marks so assumed to be recent. No obvious upslope source but within area where tree falls / root jacking poses a risk. 2025: No changes observed during 2025 inspection; blocks have been spray-painted.</p>	<p>Year First Observed:</p>	<p>2021</p>
---------------	--	-----------------------------	-------------

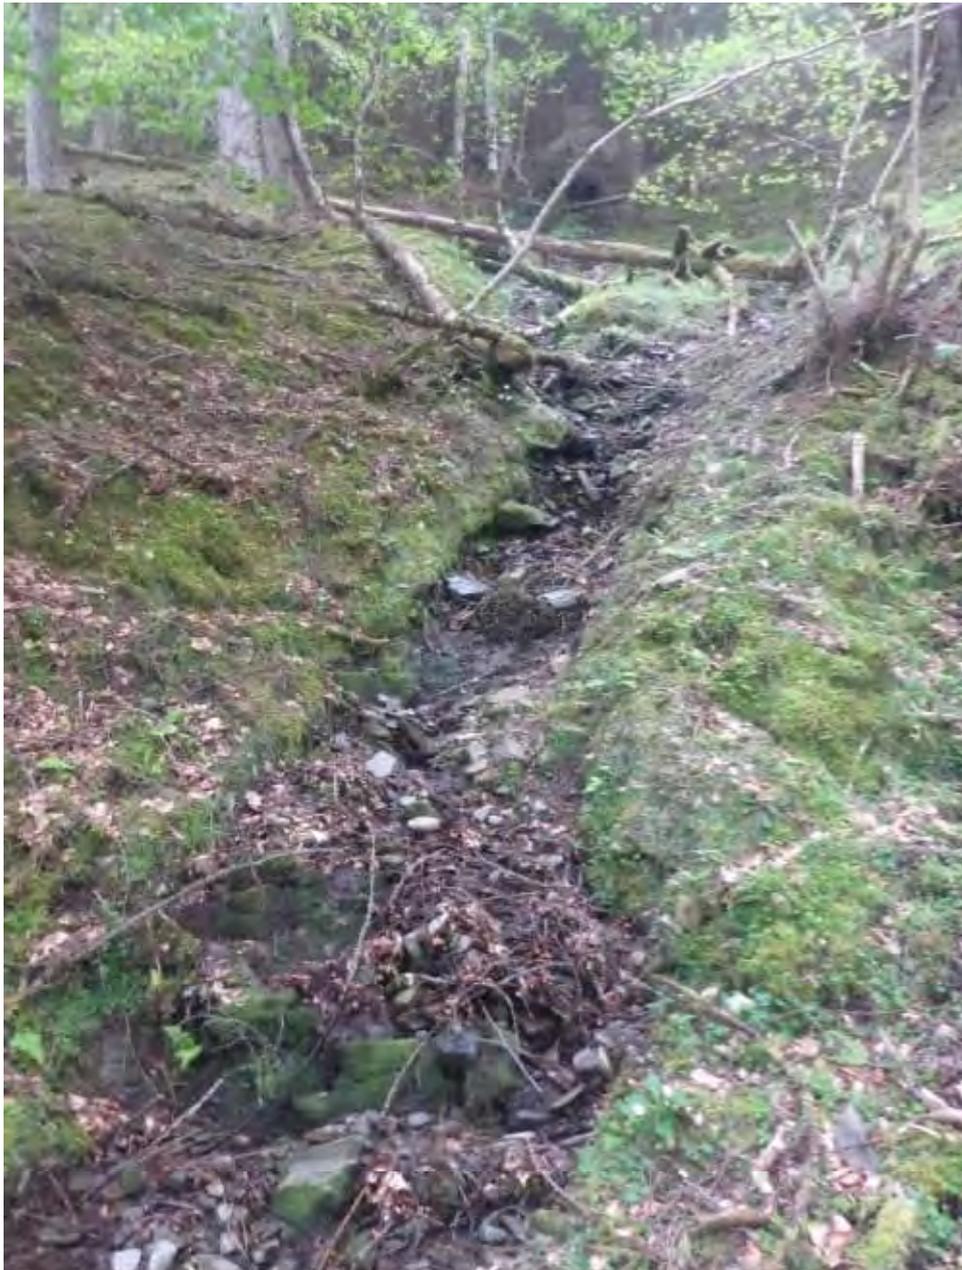
<p>AA2A-6</p>	<p>Above AA2A: 2024: Last watercourse c. 40 m from end of track (upslope of Ch 0476). Loose scree and soil remains in watercourse at track and above that could mobilise in greater flow (NG 89400 35963). Recommend keeping roadside ditch clear as a minimum (NG 89369 35995).</p>	<p>Year First Observed:</p>	<p>2023</p>
---------------	--	-----------------------------	-------------

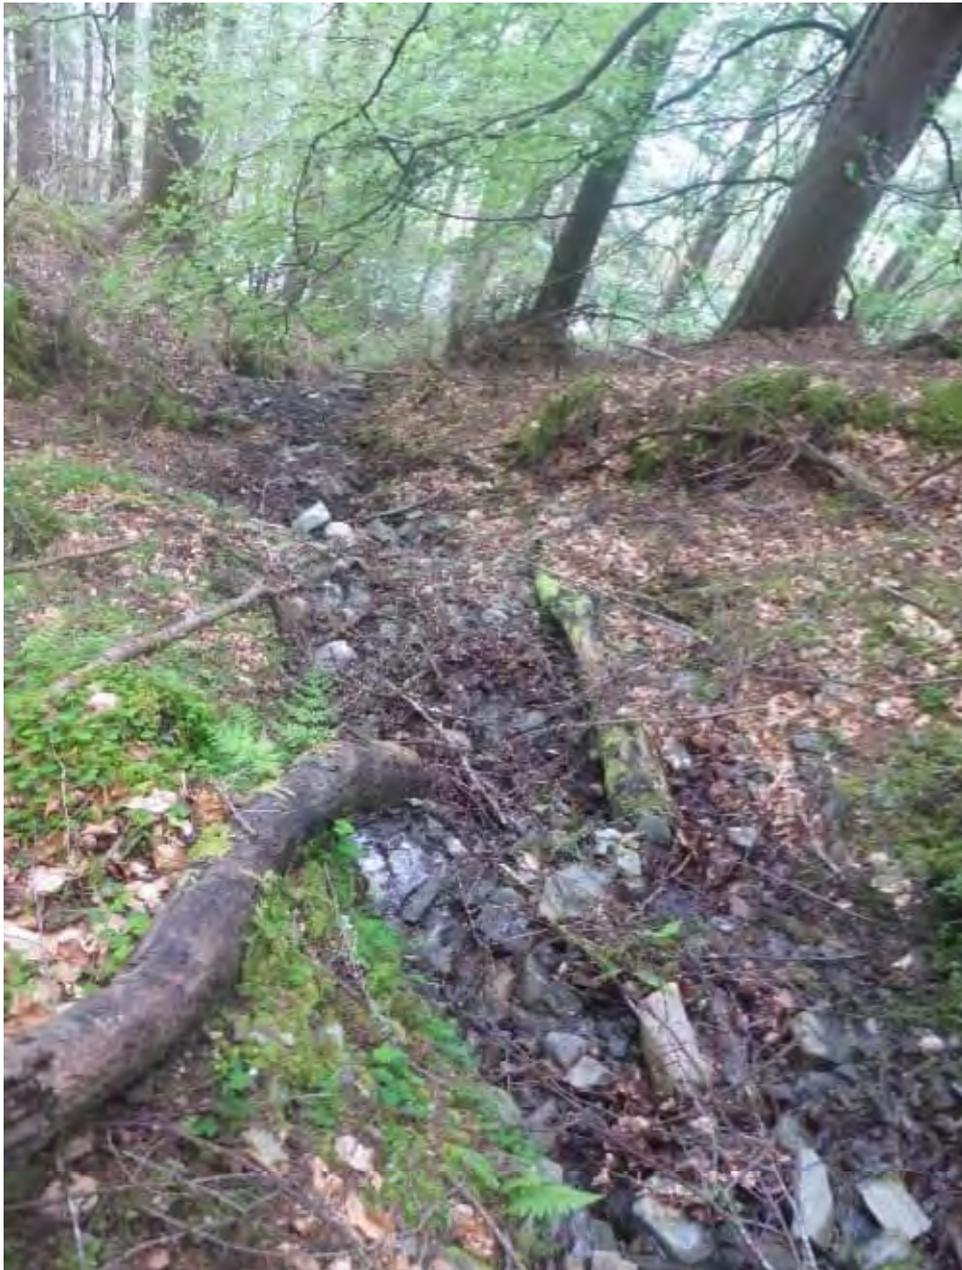
<p>AA2A-7</p>	<p>Above AA2A: 2024: Last watercourse c. 40 m from end of track (upslope of Ch 0476). Debris dams starting to form down slope from the unmaintained forestry track. Keep under observation and ideally clear out channel. Recommend keeping roadside ditch clear as a minimum (NG 89369 35995).</p>	<p>Year First Observed:</p>	<p>2023</p>
---------------	---	-----------------------------	-------------

Recommended Remedial Works / Actions							
					<ul style="list-style-type: none"> Above AA2A it is recommended to clean out watercourse at track and above to mobilise greater flow. Drainage improvements also recommended. 		
Assessed in field by:	SF/MT/PM/CR	Date:	29/04/2025 & 01/05/2025	Reviewed by:	MT	Date:	26/05/2025

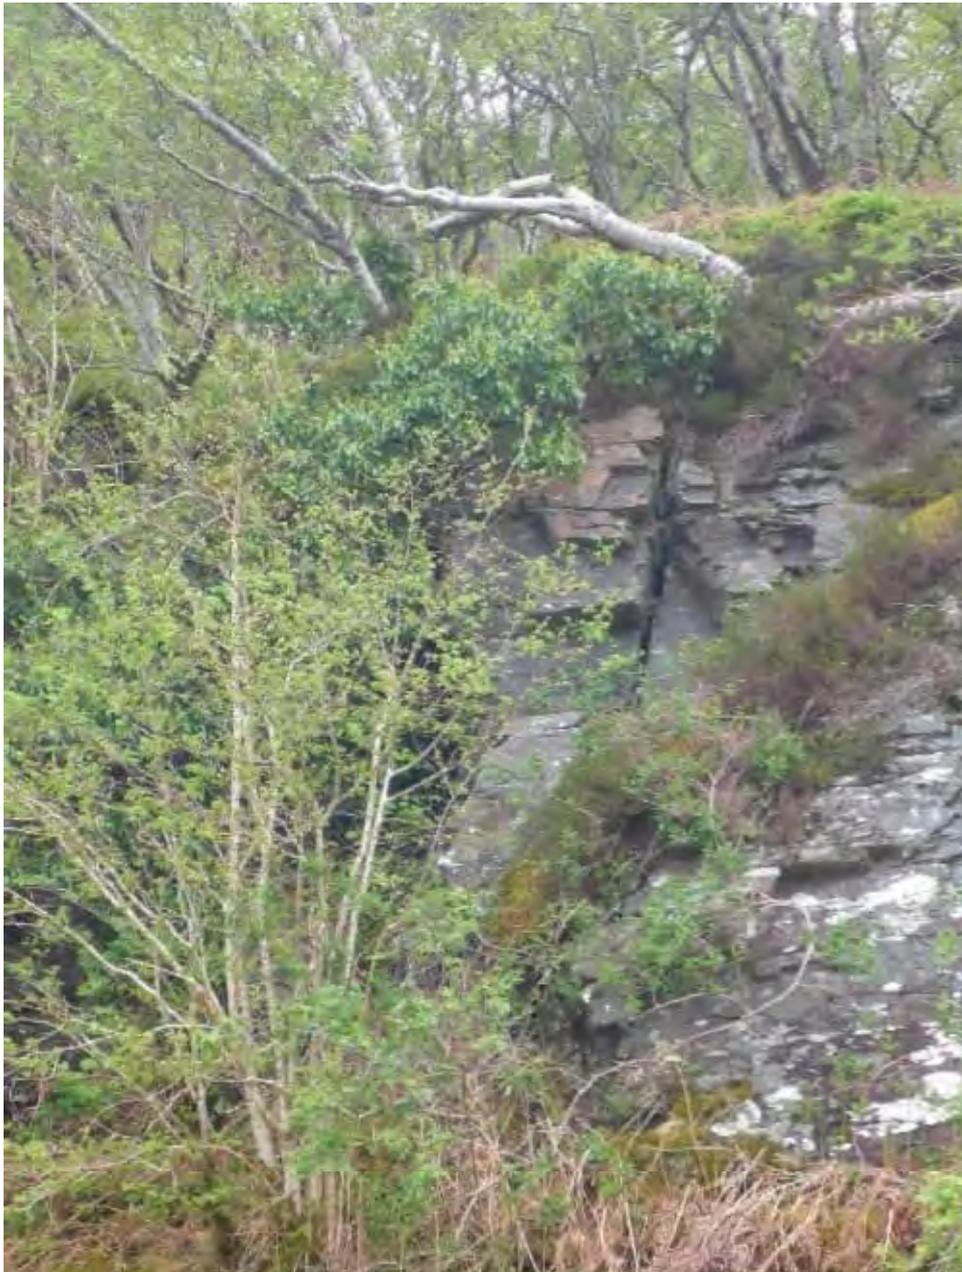
<p>AA3-2</p>	<p>Ch. 0573: Potential for toppling/block fall up to 2 m³ originating from 5 to 8 m above road level. There is a relatively flat 3.5 m wide verge and it is considered unlikely that blocks will reach road in event of a failure.</p>	<p>Year First Observed:</p>	<p>2016</p>
--------------	---	-----------------------------	-------------

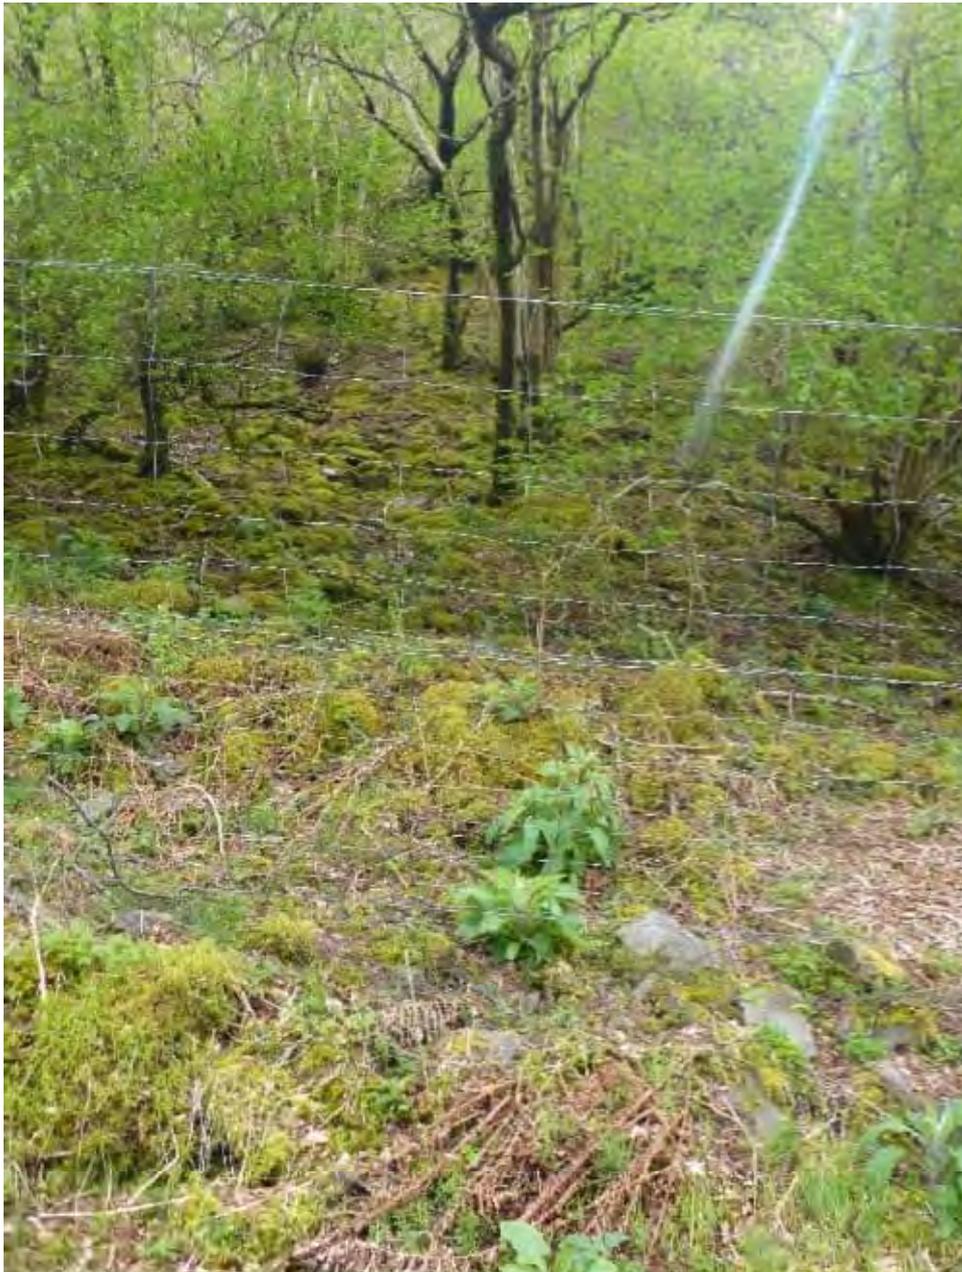
<p>AA3A-1</p>	<p>Ch. 0690: Accumulation of small blocks on the upslope side of the deer fence. Debris not recent but scree present upslope with an isolated rock outcrop ~30 m above road level. Failed blocks a consequence of root jacking. Evidence of roadside deer fence arresting small blocks.</p>	<p>Year First Observed:</p>	<p>2019</p>
---------------	---	-----------------------------	-------------

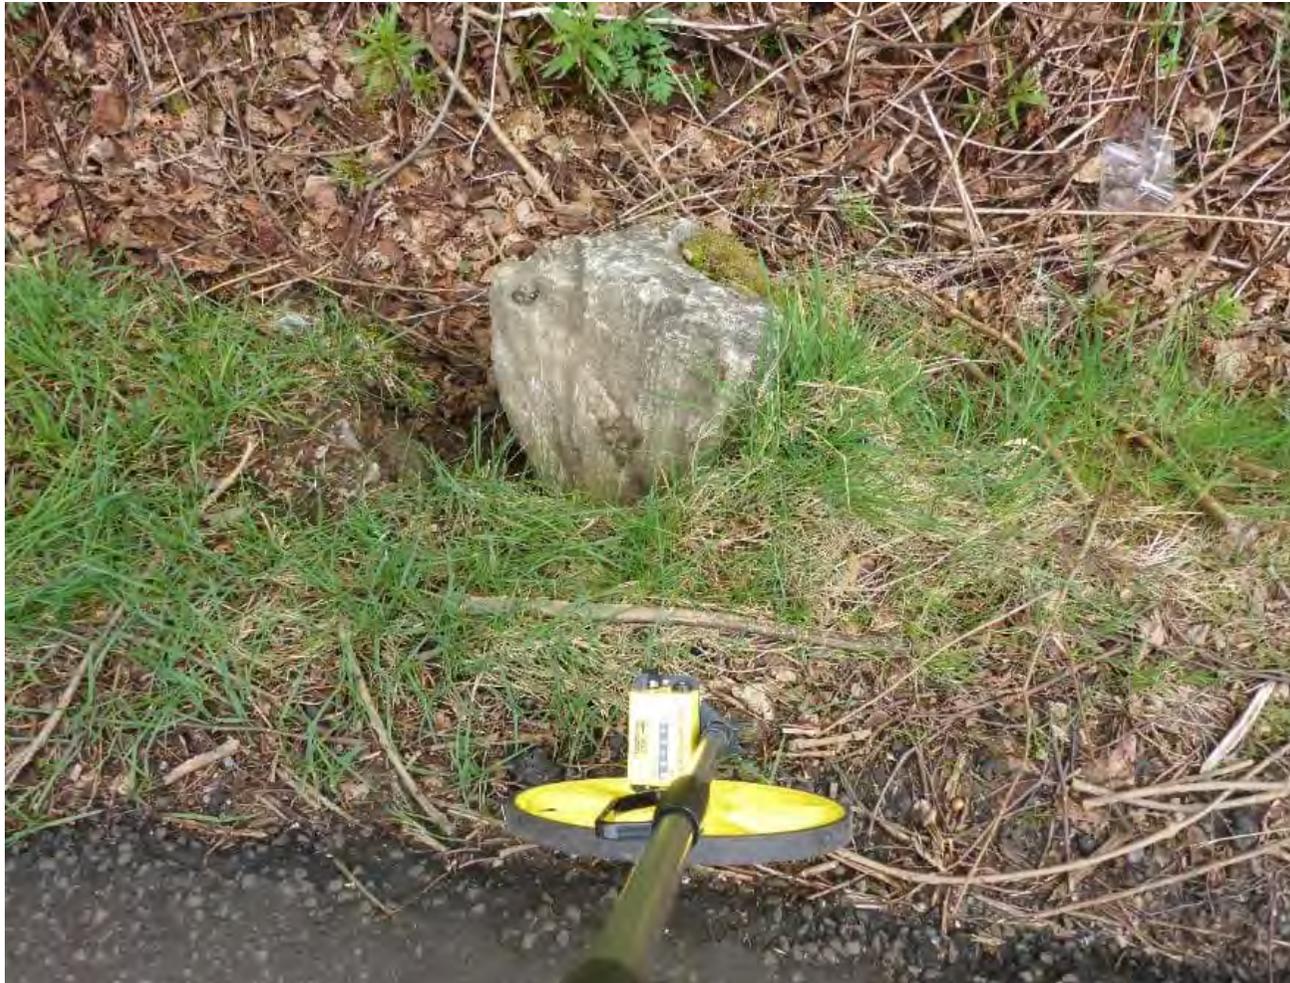
AA3A-3	Ch. 0737: 2025: One c. 0.25 m ³ block in verge; does not appear to be recent and may have been moved by a vehicle strike.	Year First Observed:	2025
--------	---	----------------------	------

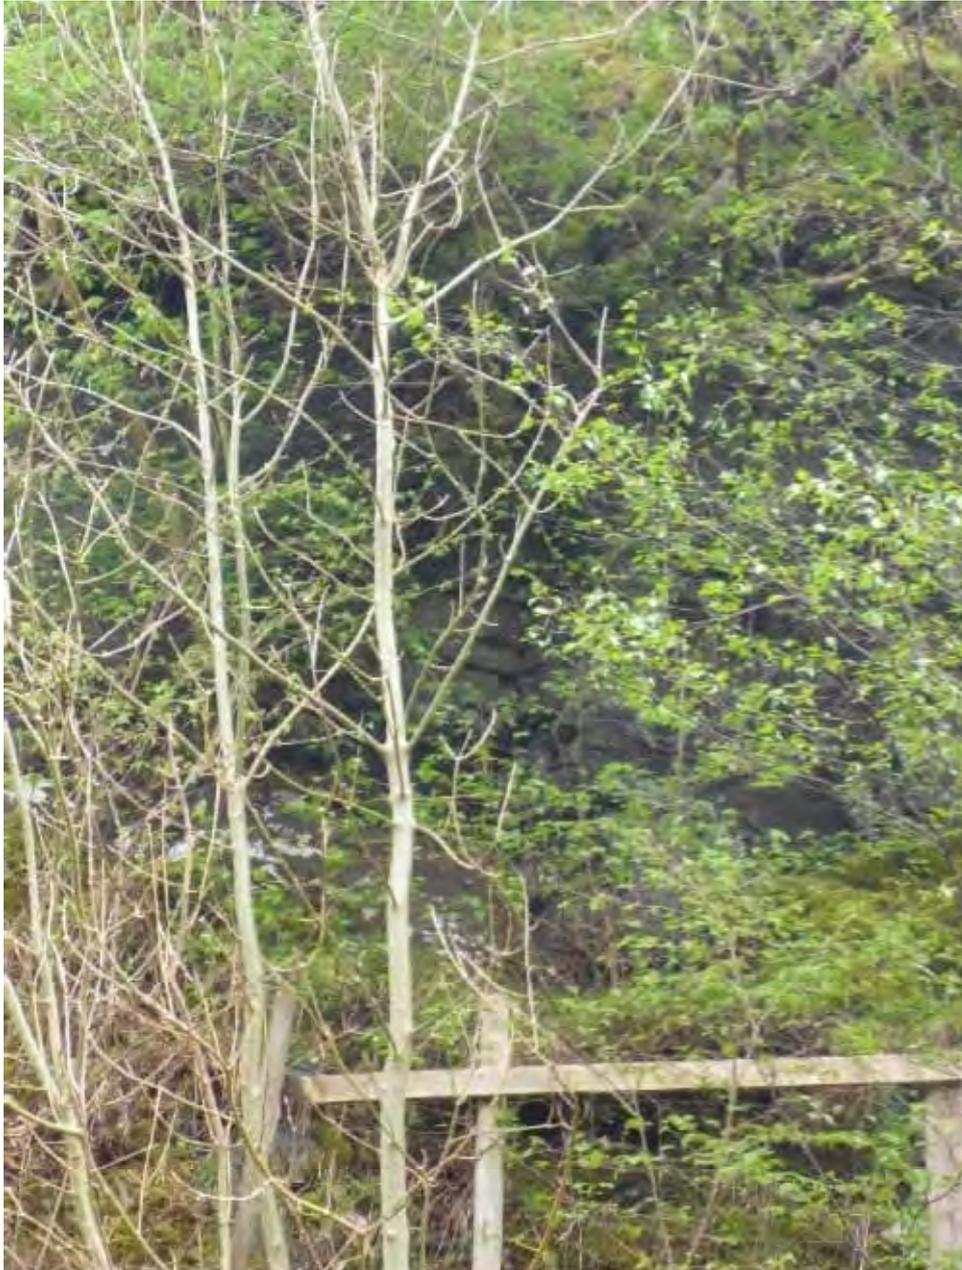
<p>AA4-1</p>	<p>Ch. 0745: Root jacking and fractured rock mass 8 m above road level. Potential failure volume 1 m³. Potential for a small volume to reach the road. Scaling recommended to minimise risk. 2024: Less visible due to vegetation growth.</p>	<p>Year First Observed:</p>	<p>2019</p>
--------------	--	-----------------------------	-------------
