A890 Stromeferry Bypass

Annual Slope Inspection 2025

The Highland Council

Project number: 60685712
AECOM Report Ref.: GLRP0010

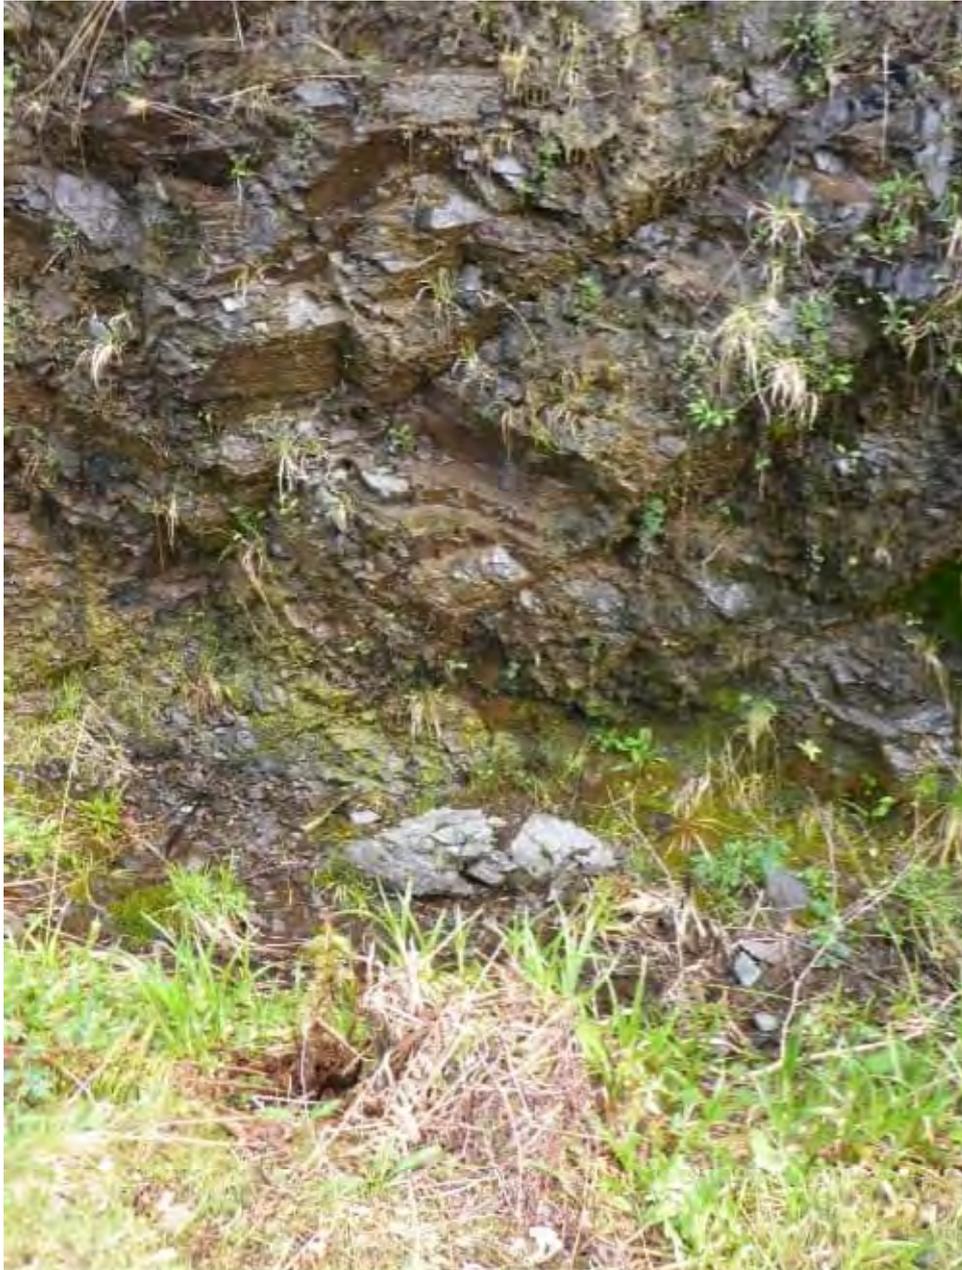
AA4-2	<p>Ch. 0826: 2023: A block 0.5 x 0.3 x 0.2 m in ditch. Fallen from 1 m above toe in area of high-water flow. Ditch effective. 2025: No changes observed during 2025 inspection.</p>	Year First Observed:	2023
-------	---	----------------------	------

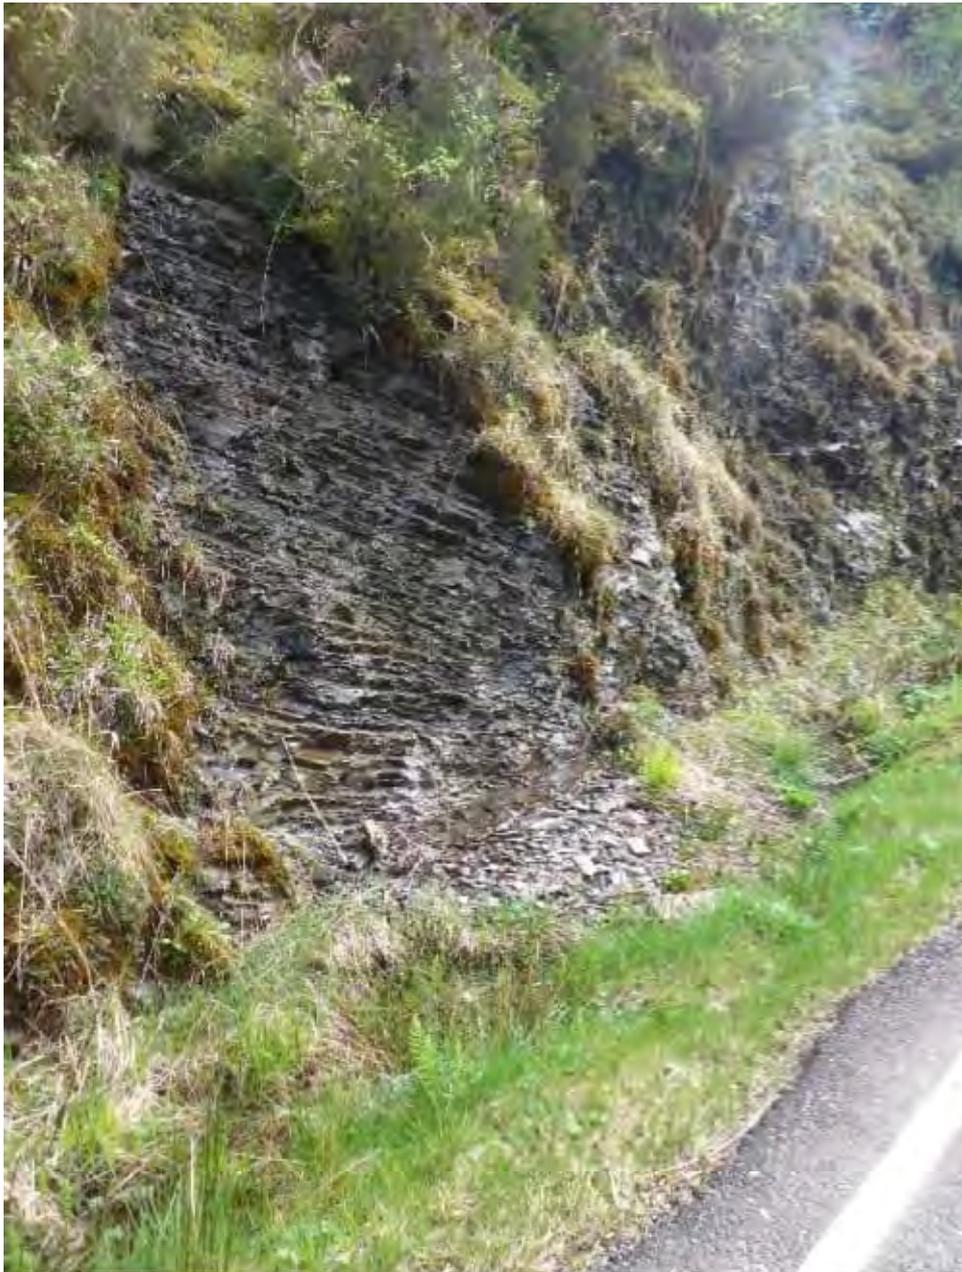
AA4-2	Ch. 0842: 2023: Ditch would benefit from clearance 2025: High water flow. Recommendation from 2023 remains.	Year First Observed:	2023
-------	---	-------------------------	------

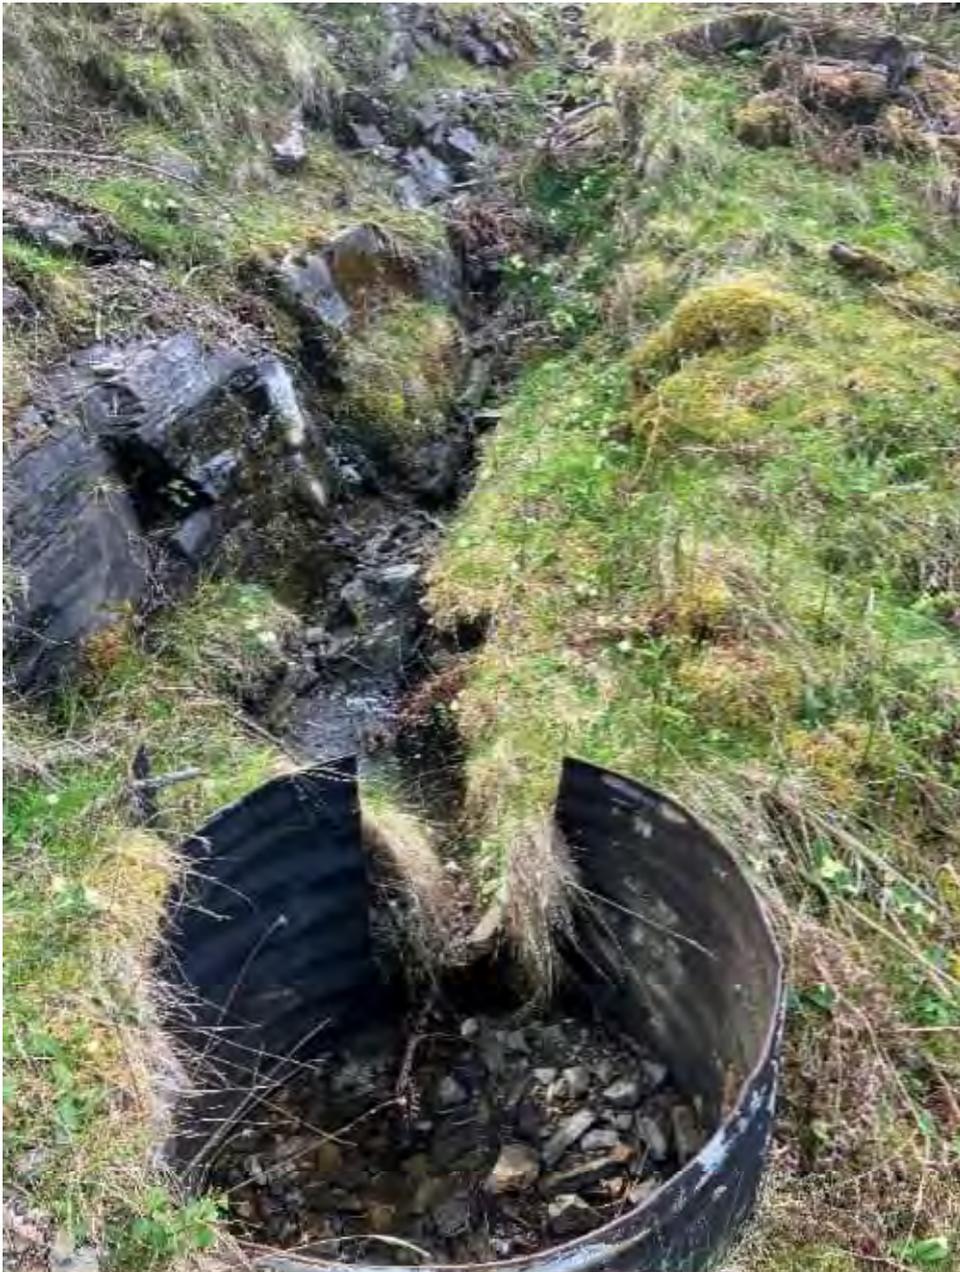
AA5-1-	Ch. 1383: Ditch clear, catch pit clear, pipe in good condition.	Year First Observed:	2021
--------	--	-------------------------	------

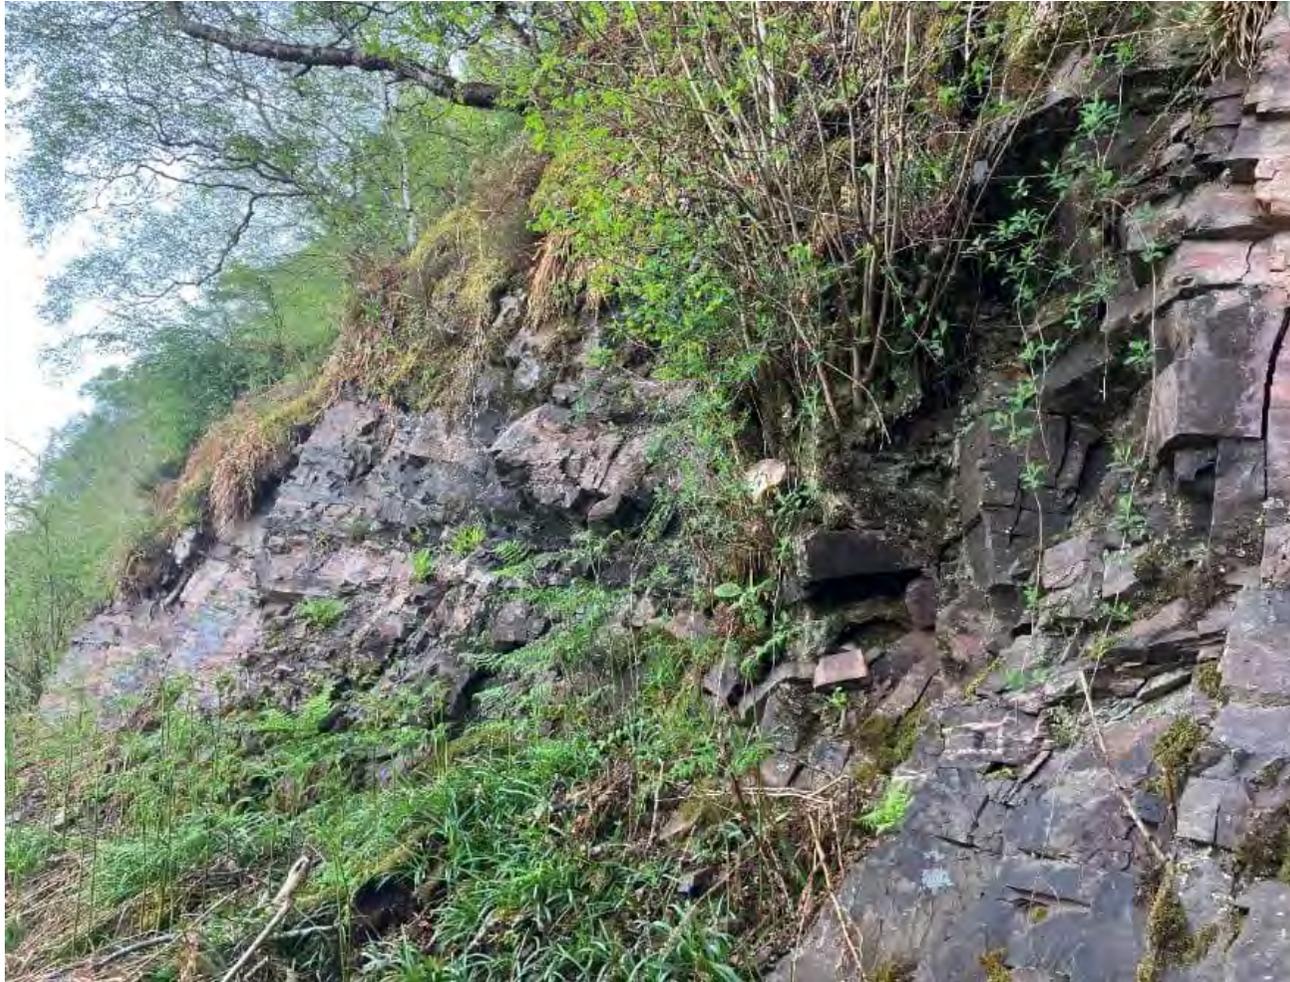
AA5-2	<ul style="list-style-type: none">Scaling works from 2025 (Phase 13) has removed the majority of loose material from the crags upslope of Ch. 1360	Year First Observed:	2025
-------	--	----------------------	------

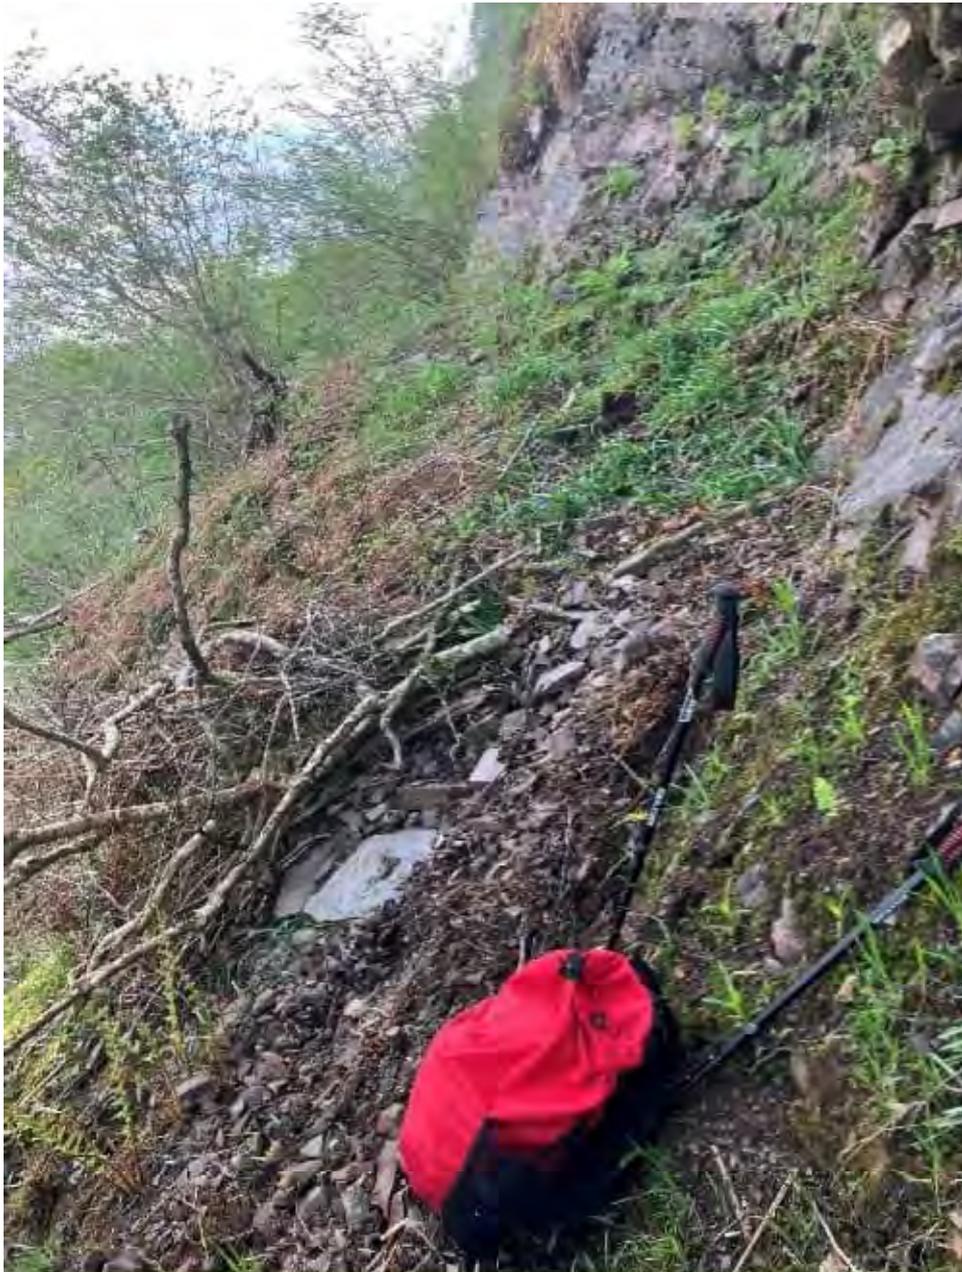
AA5-4	<ul style="list-style-type: none"> • Branches and loose rock debris remains at the toe of the upper slope. This material could be disturbed and move downslope but is considered unlikely to impact road. 	Year First Observed:	2025
-------	--	----------------------	------

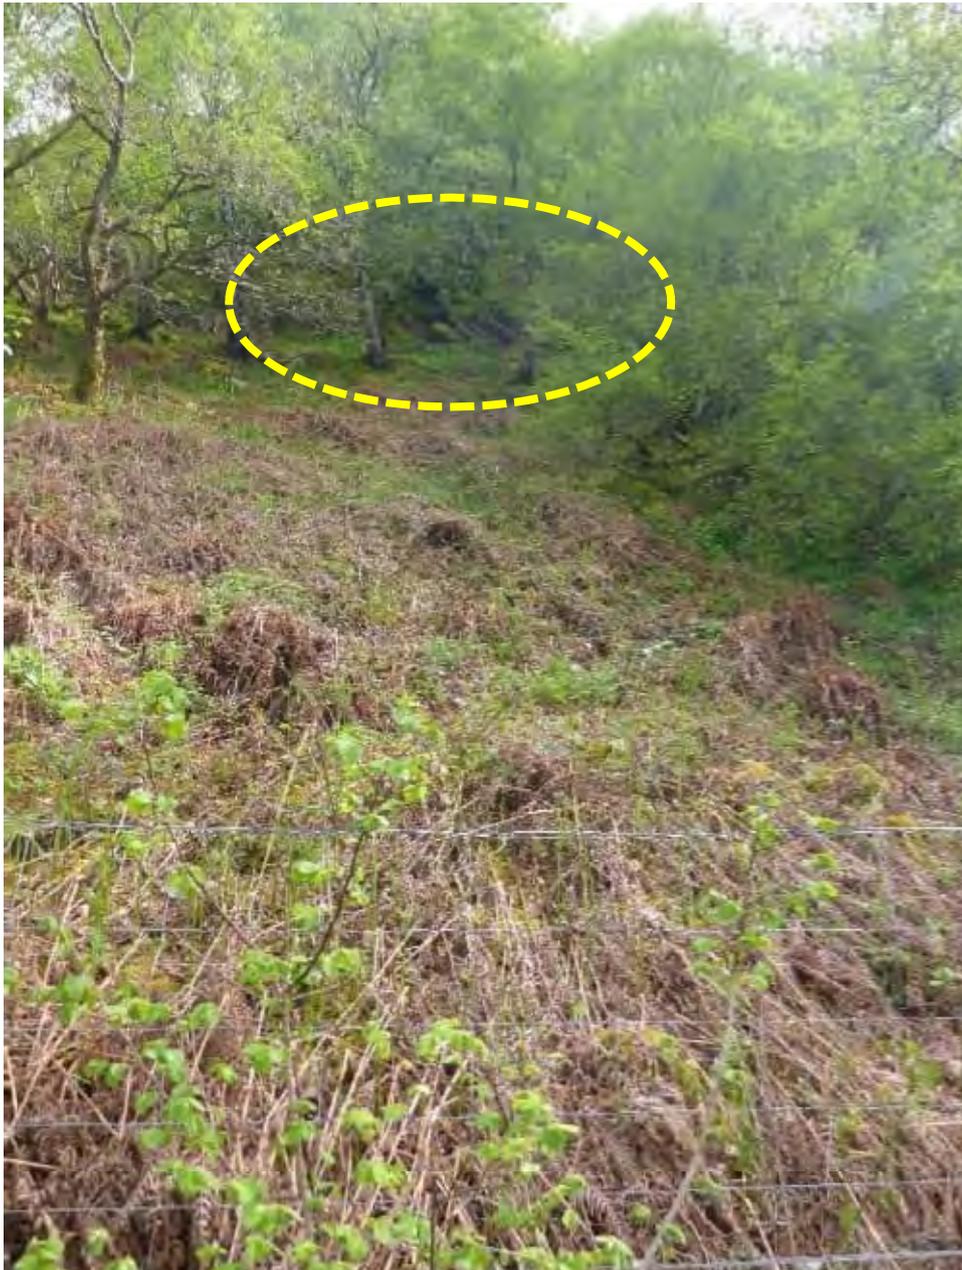
<p>AA5-6</p>	<p>Ch. 1314: 2025: Crags observed c. 20 m vertically up from the toe of the slope; set back from the road by c. 50 m.</p>	<p>Year First Observed:</p>	<p>2025</p>
--------------	---	-----------------------------	-------------

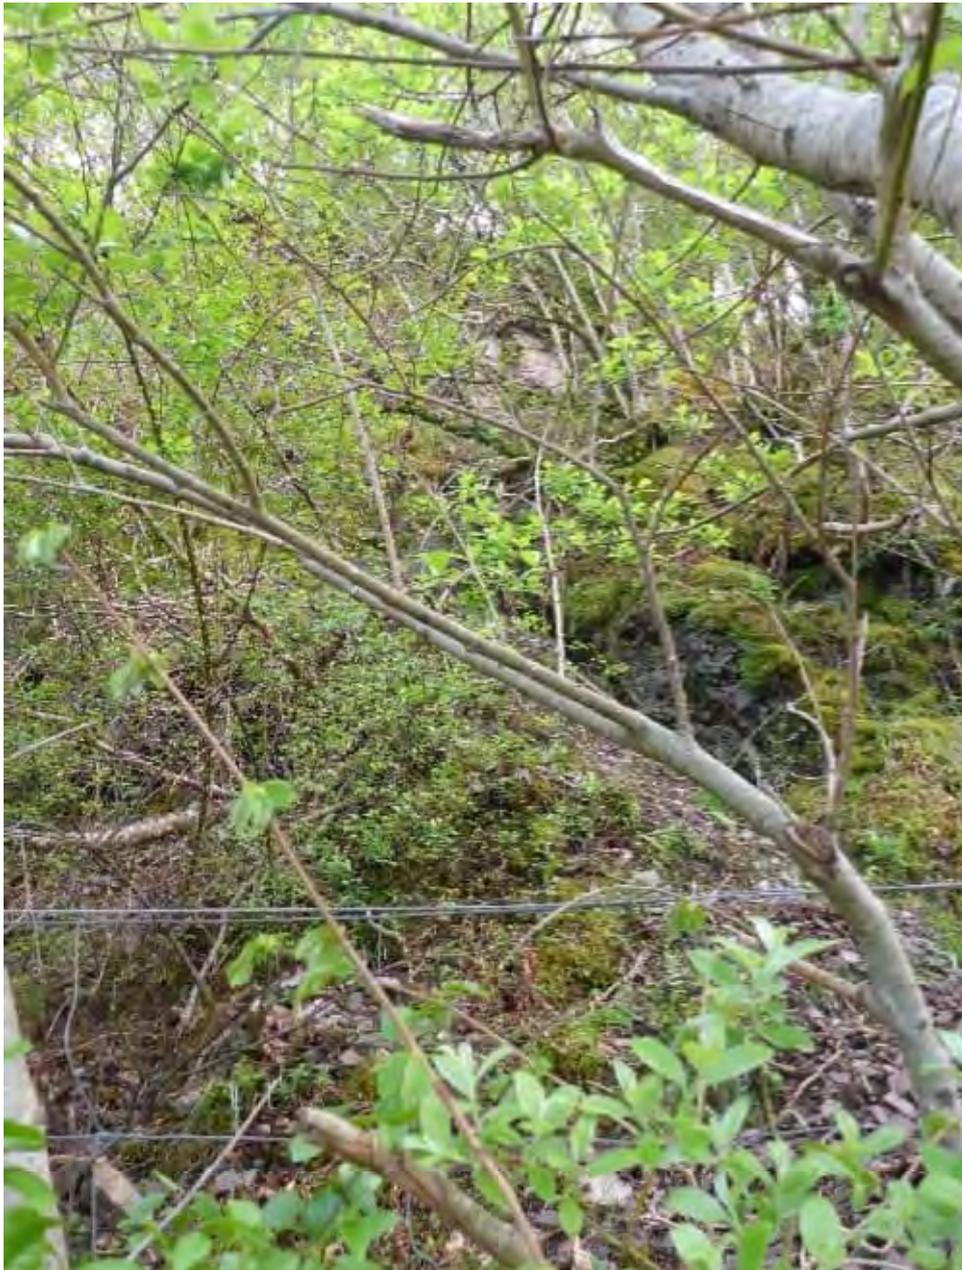
AA5-7	<p>Ch. 1360: Some debris present on the slope and in the ditch at the slope toe, looking upwards towards area of Phase 13 scaling works; source was a soil slip and uprooted tree, bedrock exposed; not considered to represent a significant hazard to the road / road users.</p>	<p>Year First Observed:</p>	<p>2017</p>
-------	---	-----------------------------	-------------

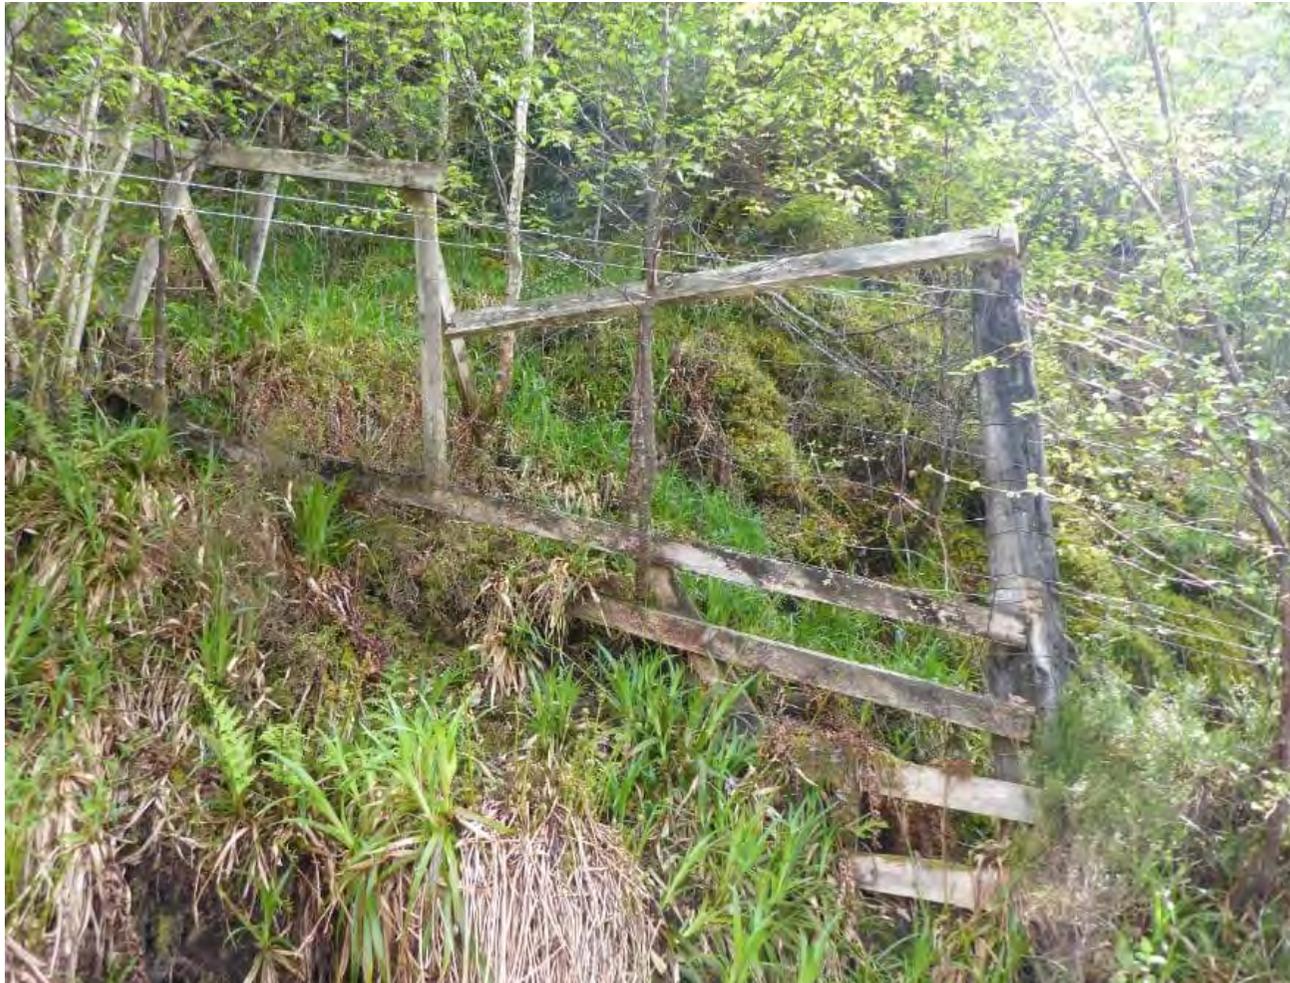
<p>AA5-9</p>	<p>Ch. 1380: Large block (0.7 x 0.3 x 0.2) present in ditch, appearing to have struck the roadside edge of the ditch before rolling/bouncing into the ditch. Deer fence broken by the impact and wiring has snapped. A small hollow with shattered rock and a groundwater flow is present slightly upslope of the block, but is likely unrelated. Source of the rock fall is unclear but the slope is steep and vegetated, i.e., potential for further blocks to be present on the slope but unobserved.</p>	<p>Year First Observed:</p>	<p>2025</p>
--------------	---	-----------------------------	-------------

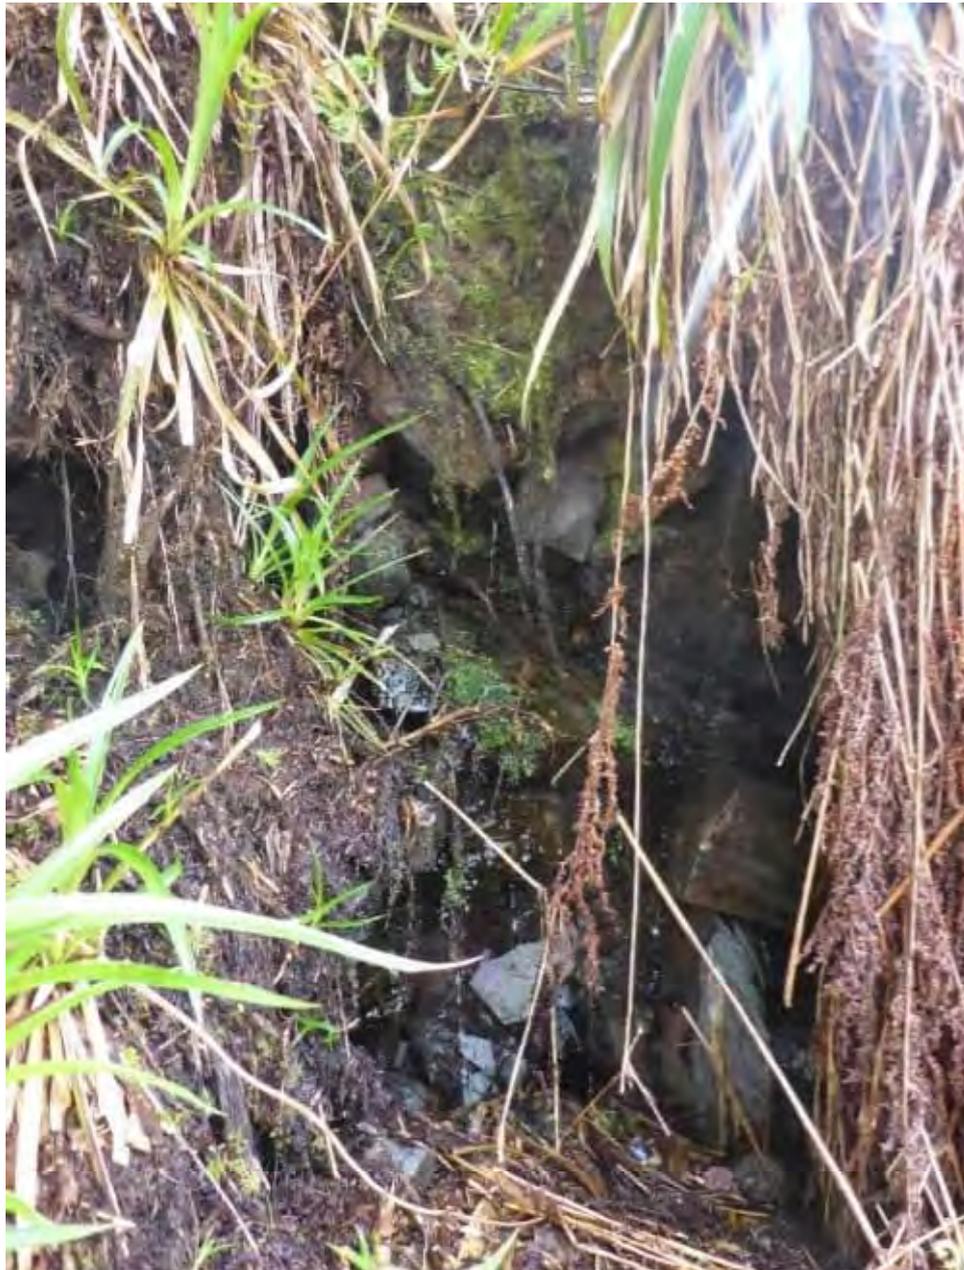
<p>AA5-10</p>	<p>Ch. 1380: Large block (0.7 x 0.3 x 0.2) present in ditch, appearing to have struck the roadside edge of the ditch before rolling/bouncing into the ditch. Deer fence broken by the impact and wiring has snapped. A small hollow with shattered rock and a groundwater flow is present slightly upslope of the block, but is likely unrelated. Source of the rock fall is unclear but the slope is steep and vegetated, i.e., potential for further blocks to be present on the slope but unobserved.</p>	<p>Year First Observed:</p>	<p>2025</p>
---------------	---	-----------------------------	-------------

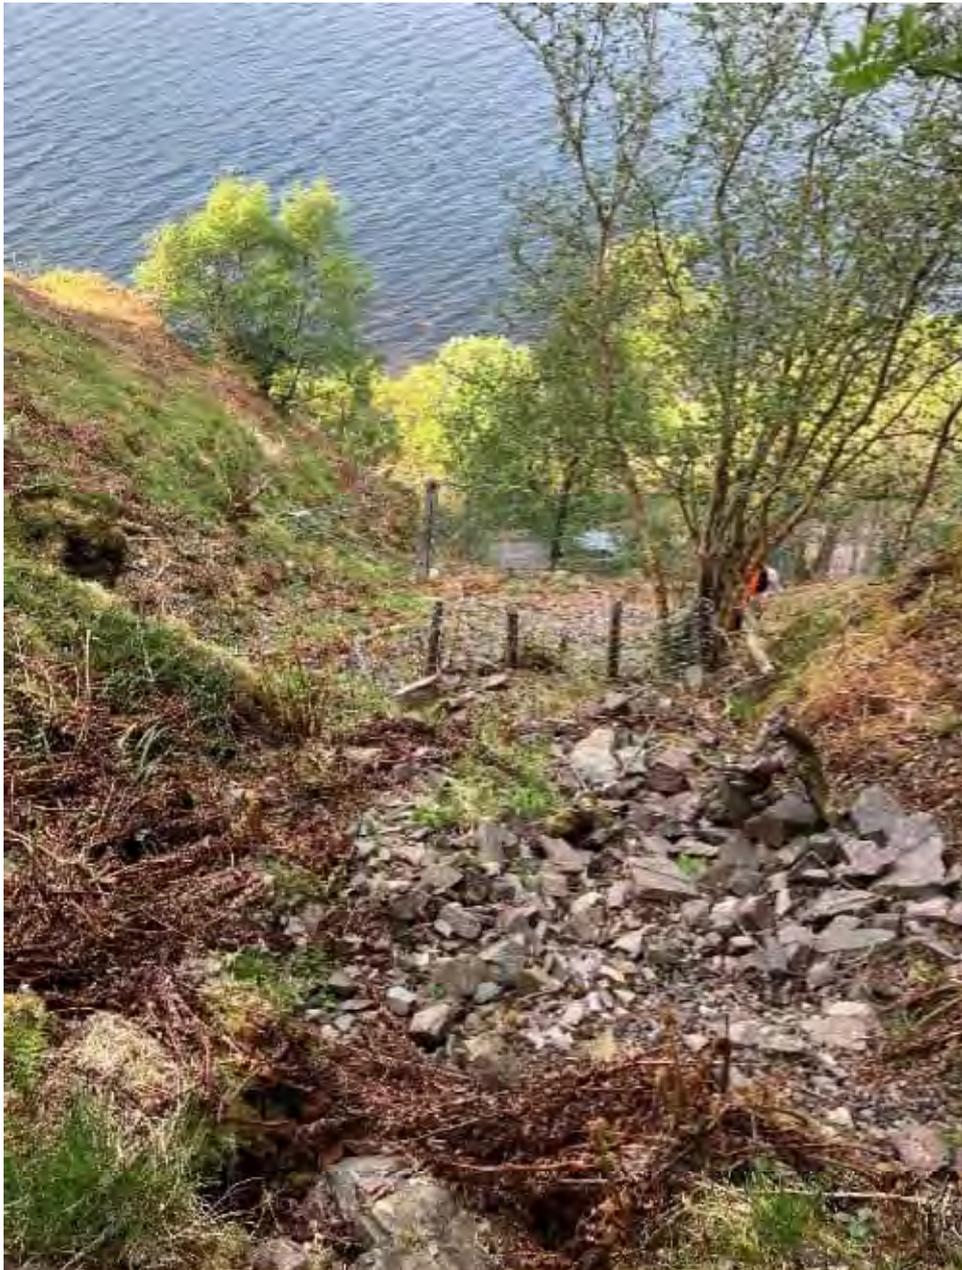
AA6A-3	Ch. 1511: Downslope view from the debris flow barrier towards temporary catch fences and the roadside. Note the high volume of small blocks on the slope.	Year First Observed:	2025
--------	--	----------------------	------

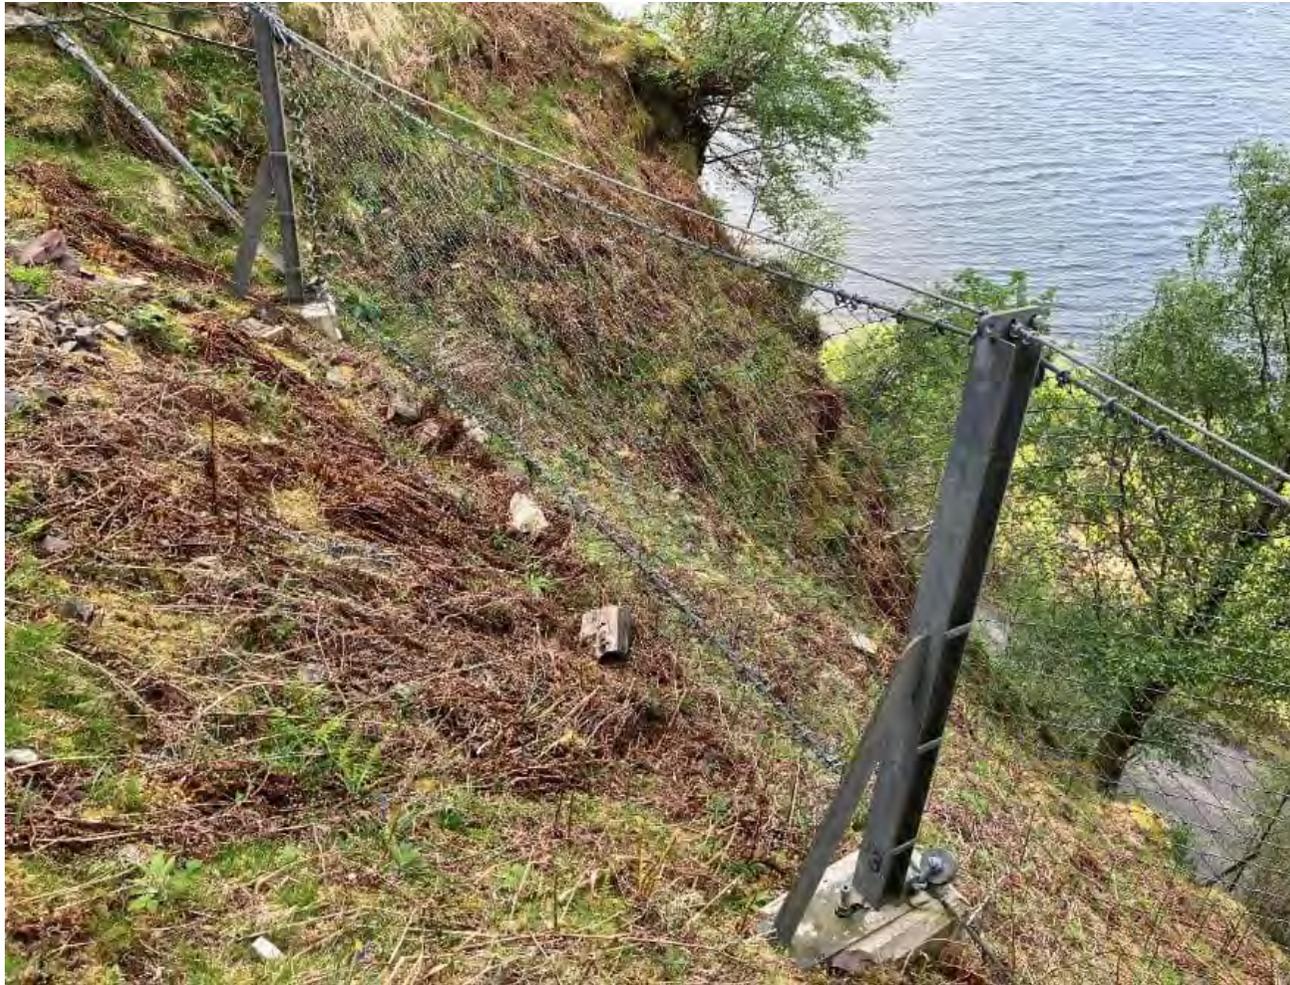
AA6A4

Ch. 1511:
Lower temporary catch fence has caught a small number of small blocks; middle of mesh not interwoven with the top cable and only held on with wire loops.

Rope Access Inspections:			
		Recommendations: <ul style="list-style-type: none"> Remove the tree resting against the debris flow catch fence; and Consider securing the mesh of the lower "temporary" catch fence to the top cable with shackles.

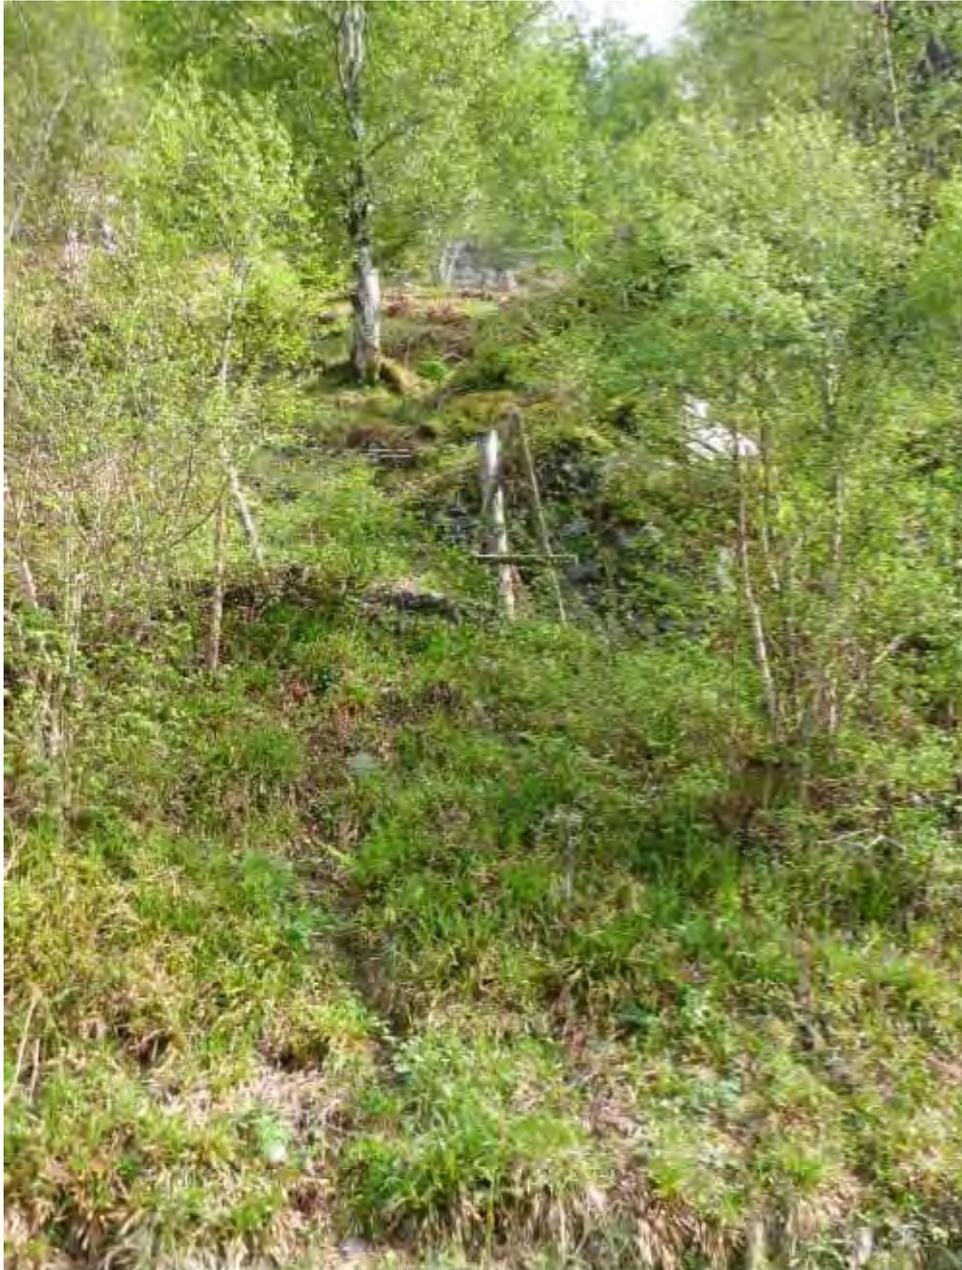
<p>AA6A-5</p>	<p>Ch. 1505: 2023: 0.5 m high accumulation of blocks at deer fence c. 3 m above road. Blocks up to 0.3 x 0.3 x 0.3 m. Source likely scree slope between catch and deer fences. 2025: Accumulation partially cleared.</p>	<p>Year First Observed:</p>	<p>2023</p>
---------------	--	-----------------------------	-------------

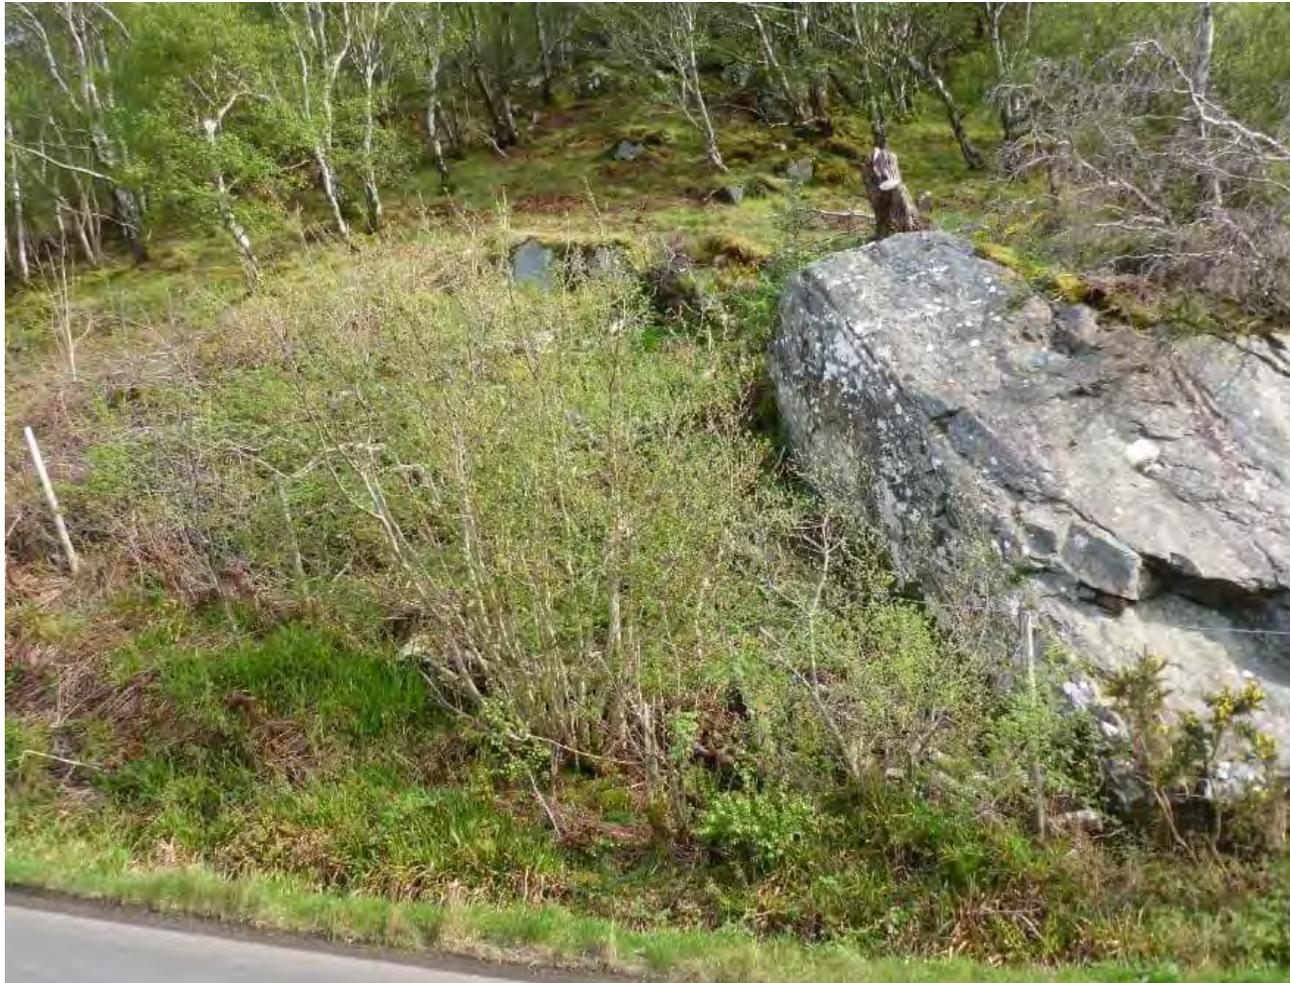
AA6B-1	Ch. 1654: Fallen tree first observed in 2022 and cut back in 2024 has been coppiced.	Year First Observed:	2022
--------	---	----------------------	------

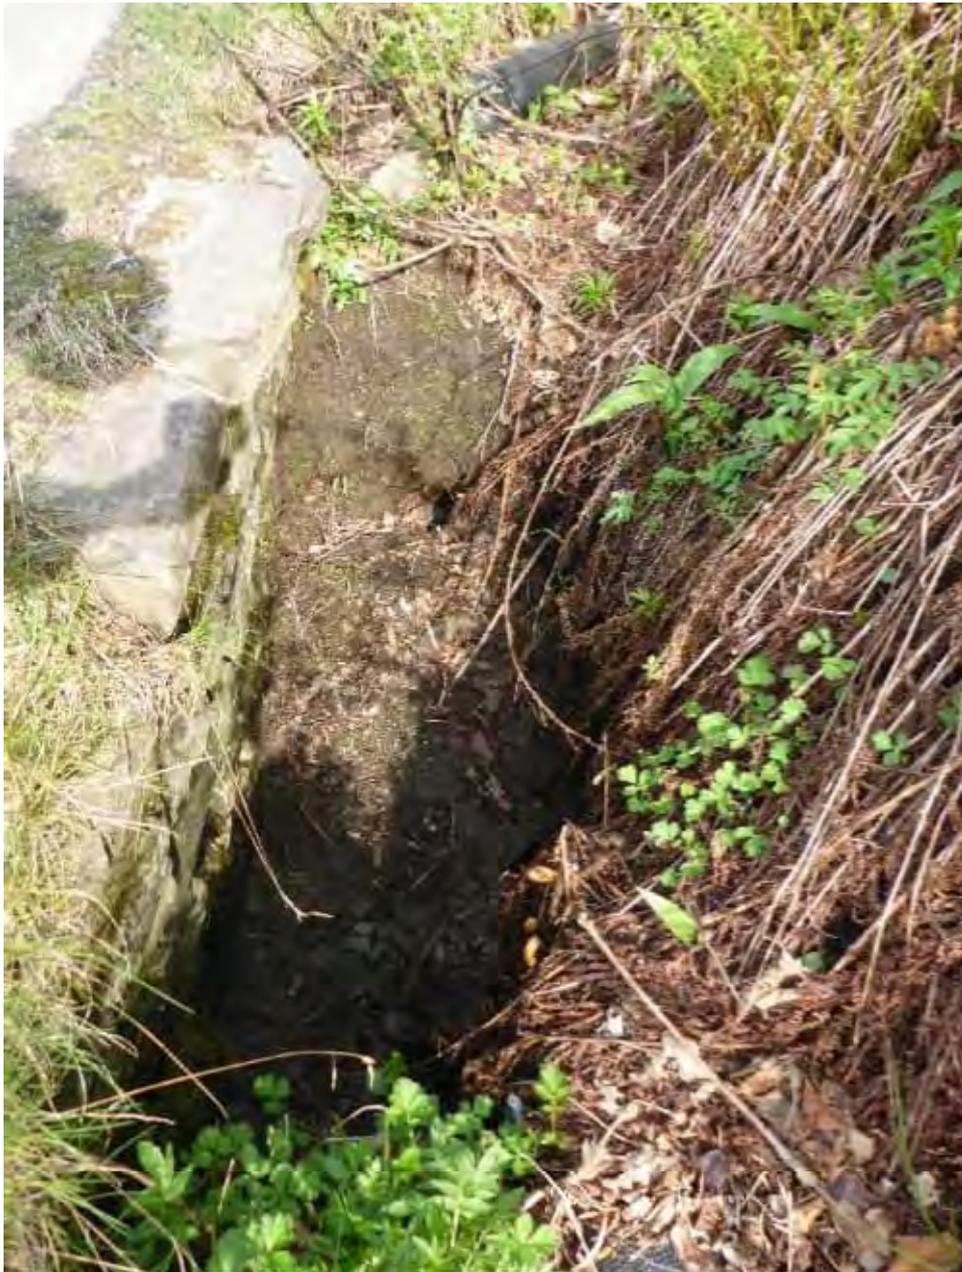
AA7-3	Ch. 1832: Debris in drainage gully is nearly at full capacity and would benefit from being cleared.	Year First Observed:	2024
-------	--	----------------------	------

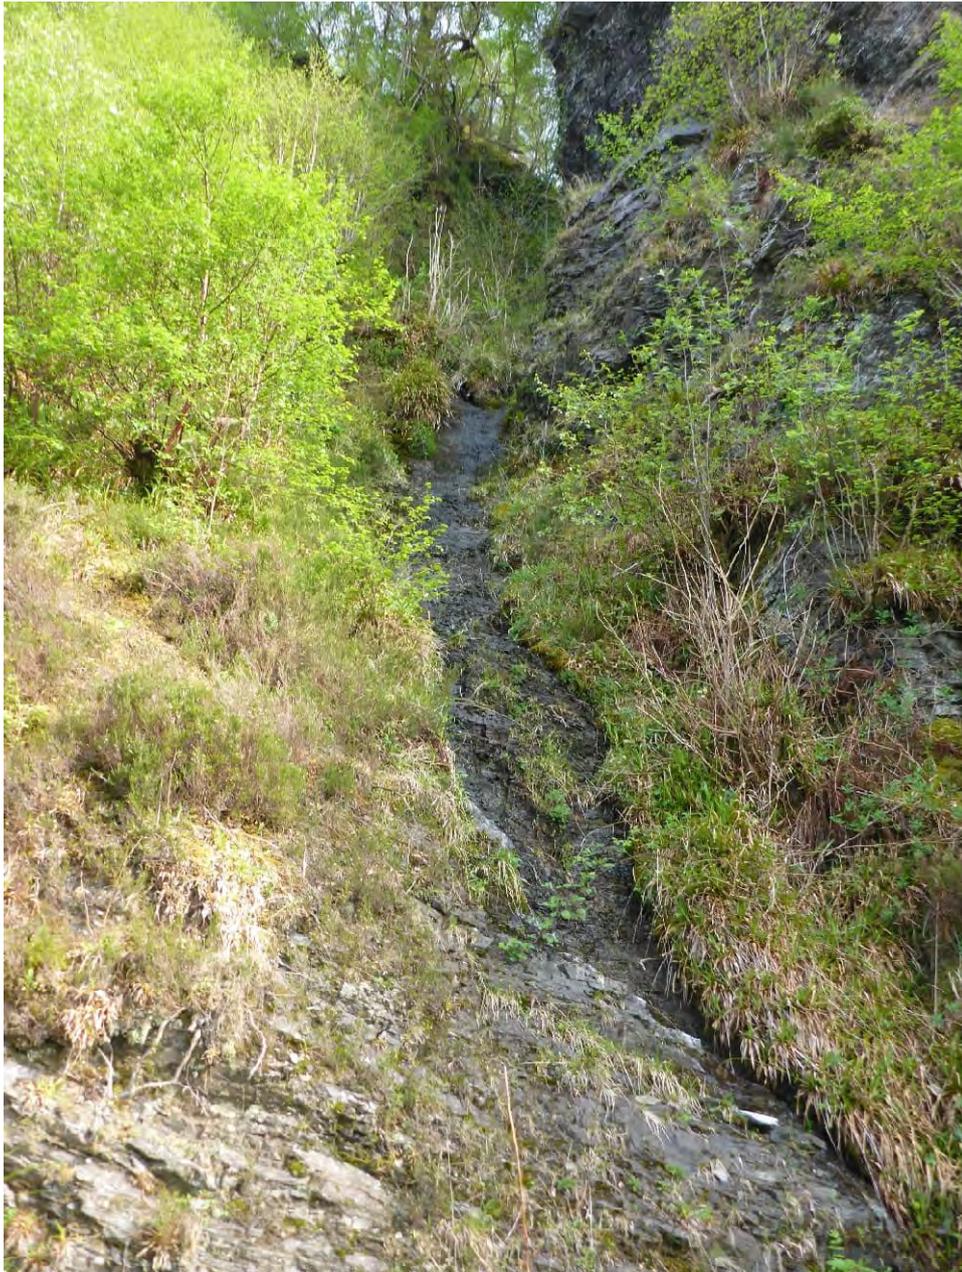
AA8-2	Ch. 1944: Overhangs towards crest with dilated fractures. Accumulation of small blocks at base of watercourse within a 1 to 2 m wide x 1 m deep ditch. Debris beginning to building within the upslope portion of the gully.	Year First Observed:	2021
-------	---	-------------------------	------

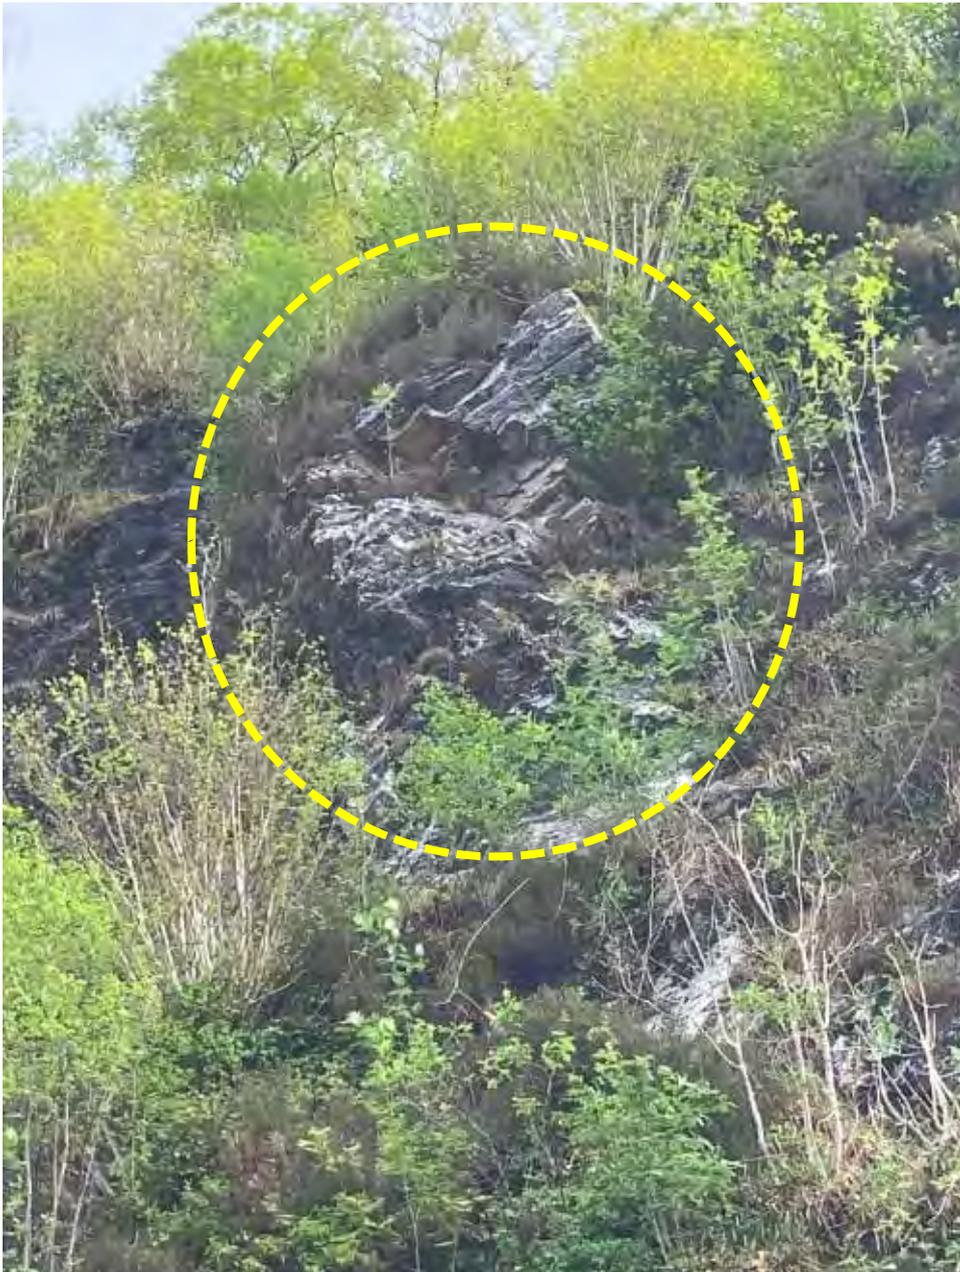
AA9-2	Ch. 1978: Zoomed in copy of circled area of photographic plate AA9-2.	Year First Observed:	2020
-------	--	-------------------------	------

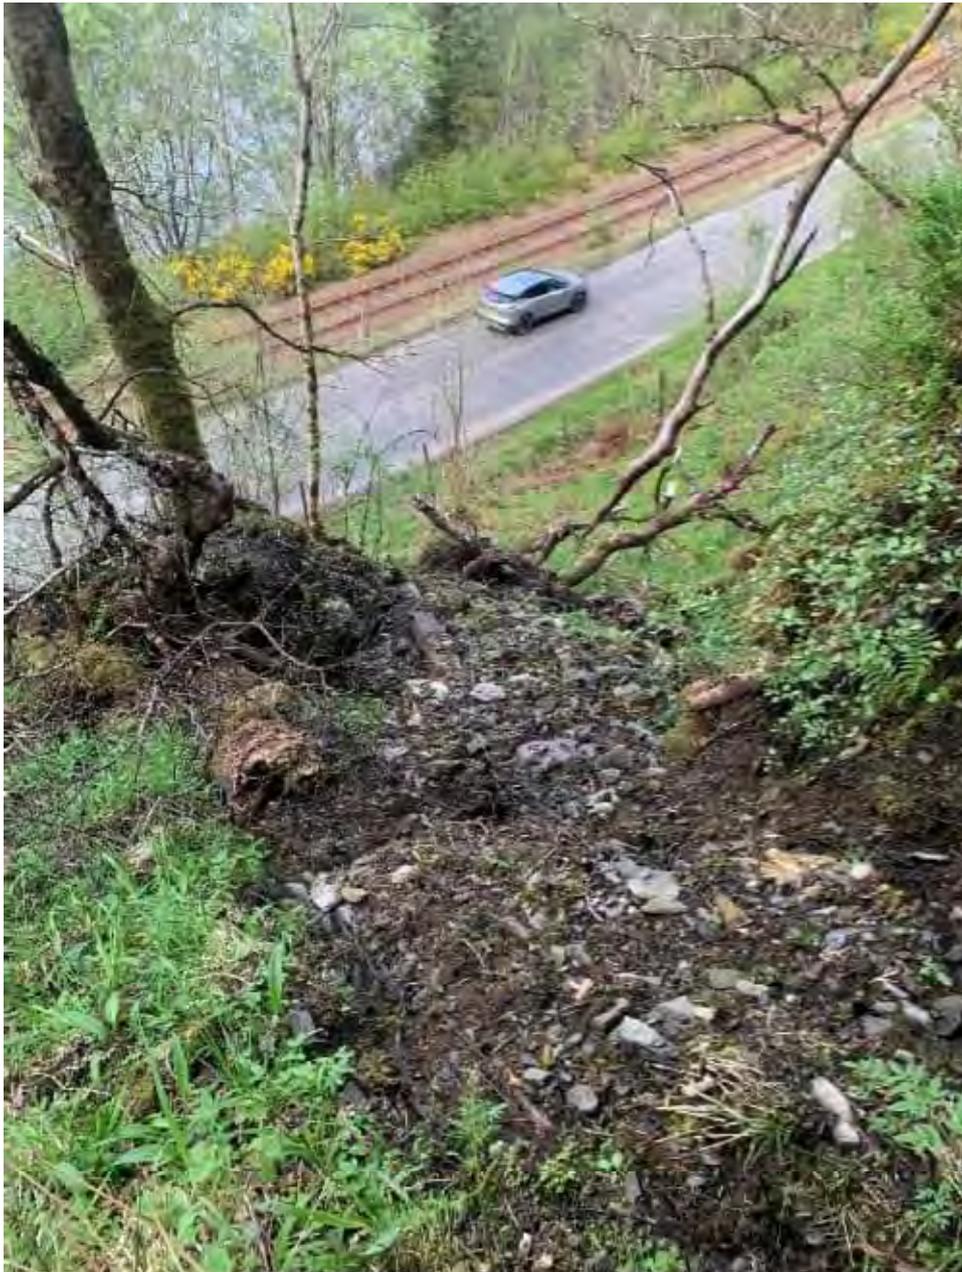
<p>AA10-1</p>	<p>Ch, 2140 to 2163: Debris flow – 20 to 30 m slope length at 35 to 40°; at toe of flow fallen trees have 'locked' into standing trees and created a debris dam; flow stopped c. 10 m from roadside fence, historic debris fan at the toe suggests multiple flow routes; channel has minimal water in, but would have been 4 to 5 m wide during flow; and possible for recurrence.</p>	<p>Year First Observed:</p>	<p>2025</p>
---------------	--	-----------------------------	-------------

Recommended Remedial Works / Actions							
Large Scale Rock Fall Protection Works (Category 3)		Localised Targeted Rock Fall Protection Works (Category 2)			Ongoing Maintenance (Category 1)		
<ul style="list-style-type: none"> Install targeted combination of roadside rock fall / debris flow catch fences and netting, including following specific recommendations centred on approximately Ch. 2150 – <ul style="list-style-type: none"> Long-term solution would encompass a barrier c. 50 m long, 5 m upslope of the deer fence, or Construct the barrier where the channel narrows – 6 to 8 m wide barrier, however, increased build, inspection, and maintenance costs. 		<ul style="list-style-type: none"> Scale potential wedge failure at Ch. 2130. Clearance of upslope debris dam at NG 90495 37112. 			<ul style="list-style-type: none"> Consider a drone survey upslope of the 'amphitheatre' to determine the source of the slip and potential for recurrence Targeted coppicing of trees growing in rock exposures and light scaling of broken/unstable rock.
