A890 Stromeferry Bypass

Annual Slope Inspection 2025

The Highland Council

Project number: 60685712
AECOM Report Ref.: GLRP0010

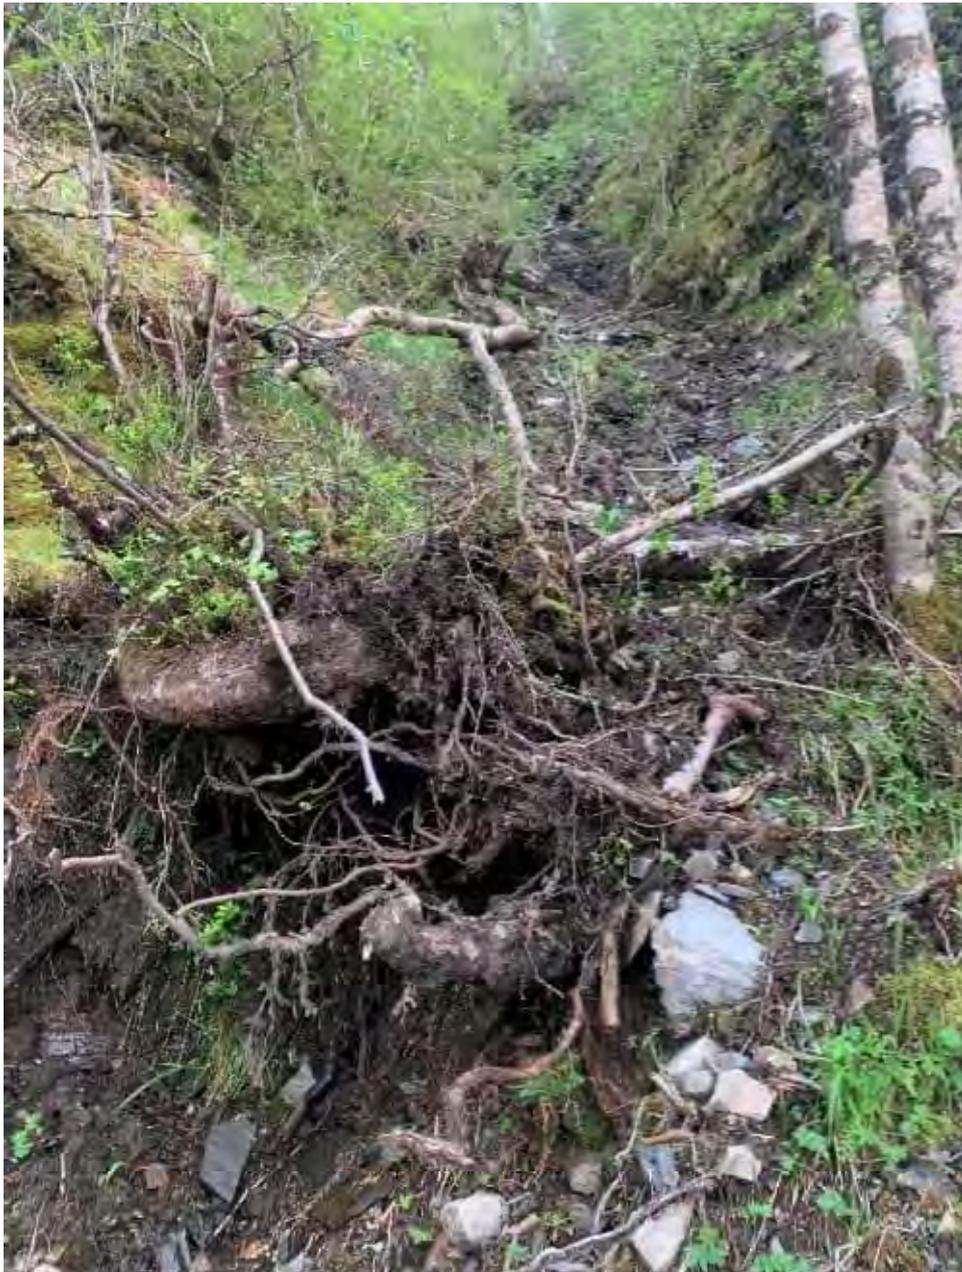
<p>AA10-2</p>	<p>Ch. 2140 to 2163: Debris flow – 20 to 30 m slope length at 35 to 40°; at toe of flow fallen trees have 'locked' into standing trees and created a debris dam; flow stopped c. 10 m from roadside fence, historic debris fan at the toe suggests multiple flow routes; channel has minimal water in, but would have been 4 to 5 m wide during flow; and possible for recurrence.</p>	<p>Year First Observed:</p>	<p>2025</p>
---------------	--	-----------------------------	-------------

Recommended Remedial Works / Actions							
Large Scale Rock Fall Protection Works (Category 3)		Localised Targeted Rock Fall Protection Works (Category 2)			Ongoing Maintenance (Category 1)		
<ul style="list-style-type: none"> Install targeted combination of roadside rock fall / debris flow catch fences and netting, including following specific recommendations centred on approximately Ch. 2150 – <ul style="list-style-type: none"> Long-term solution would encompass a barrier c. 50 m long, 5 m upslope of the deer fence, or Construct the barrier where the channel narrows – 6 to 8 m wide barrier, however, increased build, inspection, and maintenance costs. 		<ul style="list-style-type: none"> Scale potential wedge failure at Ch. 2130. Clearance of upslope debris dam at NG 90495 37112. 			<ul style="list-style-type: none"> Consider a drone survey upslope of the 'amphitheatre' to determine the source of the slip and potential for recurrence Targeted coppicing of trees growing in rock exposures and light scaling of broken/unstable rock.

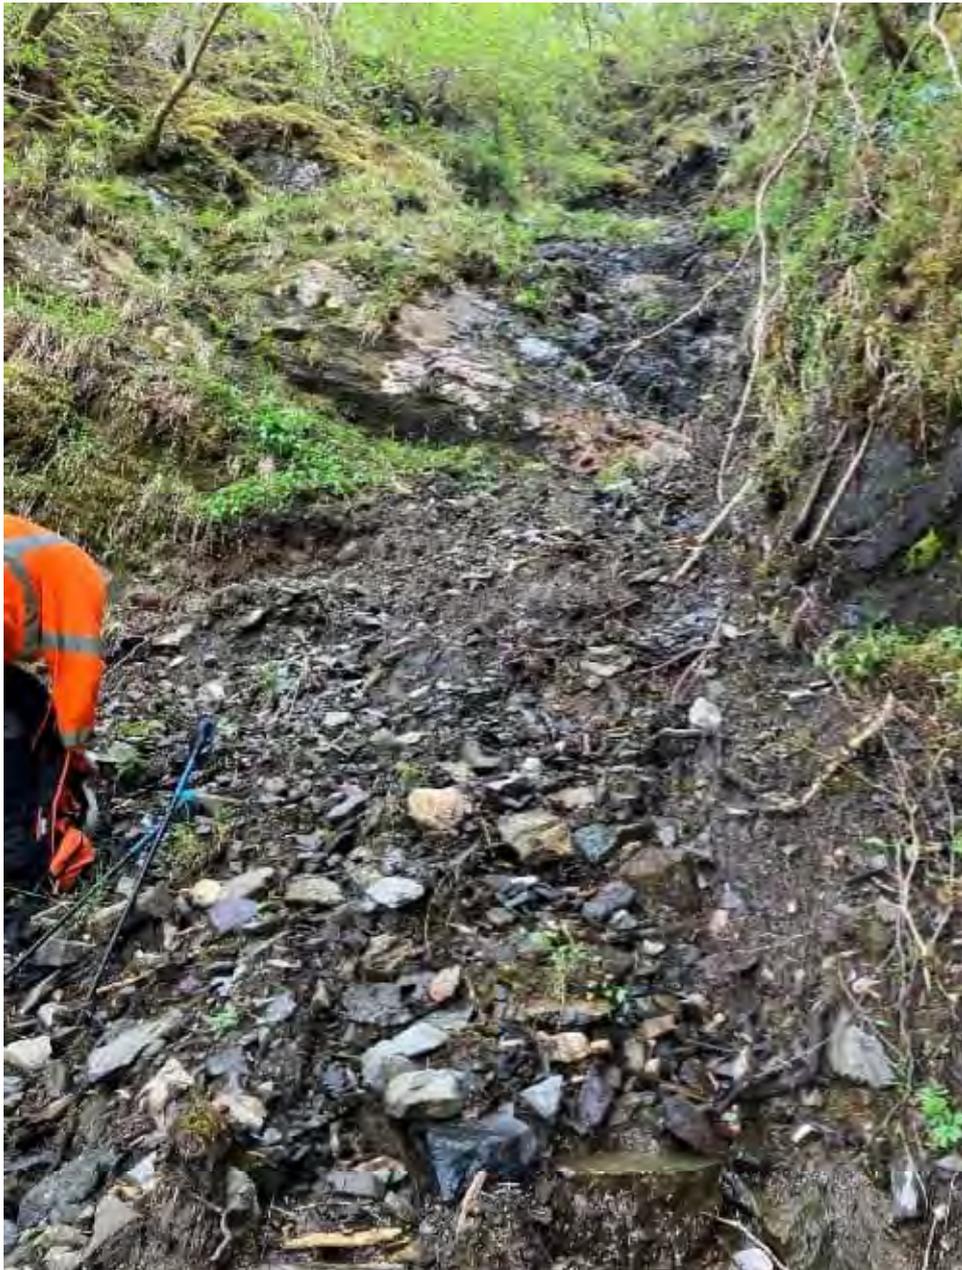
AA10-3	'Amphitheatre' shape of rock at NG 90523 37093. 8 to 10 m scar suggesting water entering from above. Likely material had built up to being washed downslope.	Year First Observed:	2025
--------	--	----------------------	------

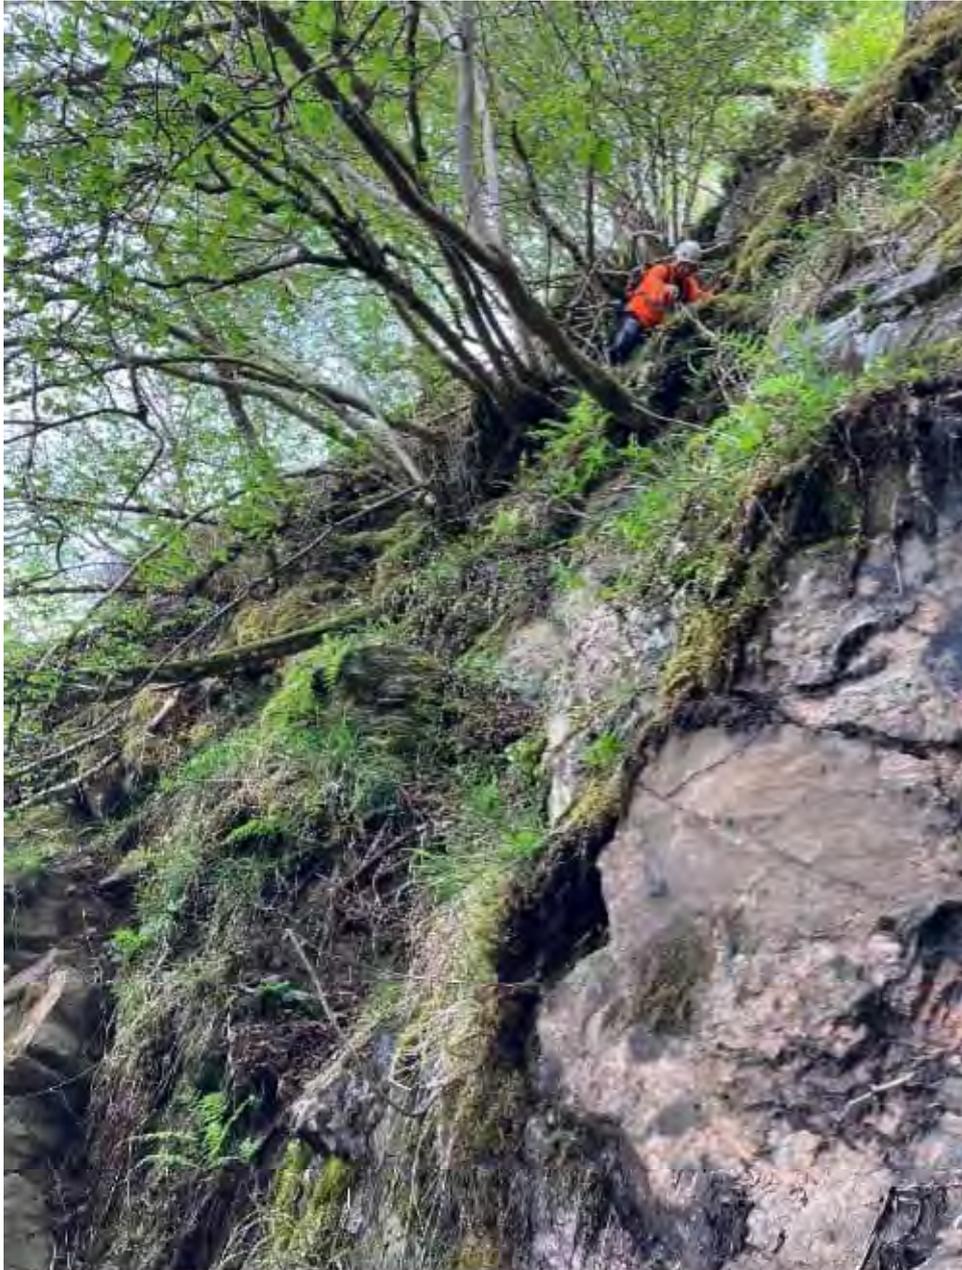
AA10-4	Fractured rock mass and leaning trees at the edge of the 'amphitheatre' at NG 90523 37093.	Year First Observed:	2025
--------	--	----------------------	------

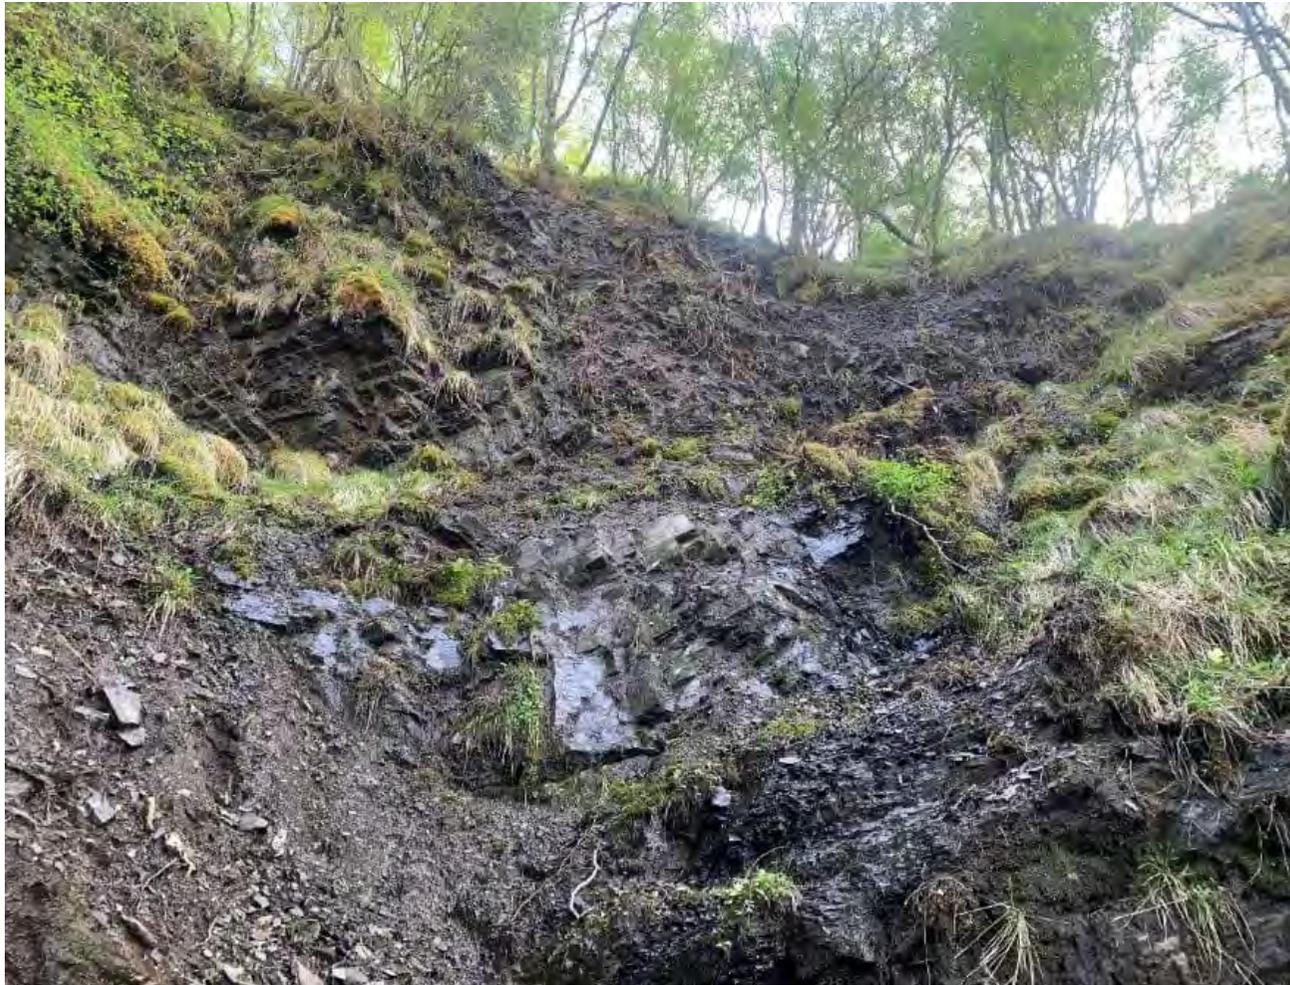
AA10-5

'Amphitheatre' shape of rock at NG 90523 37093. 8 to 10 m scar suggesting water entering from above. Likely material had built up to being washed downslope.

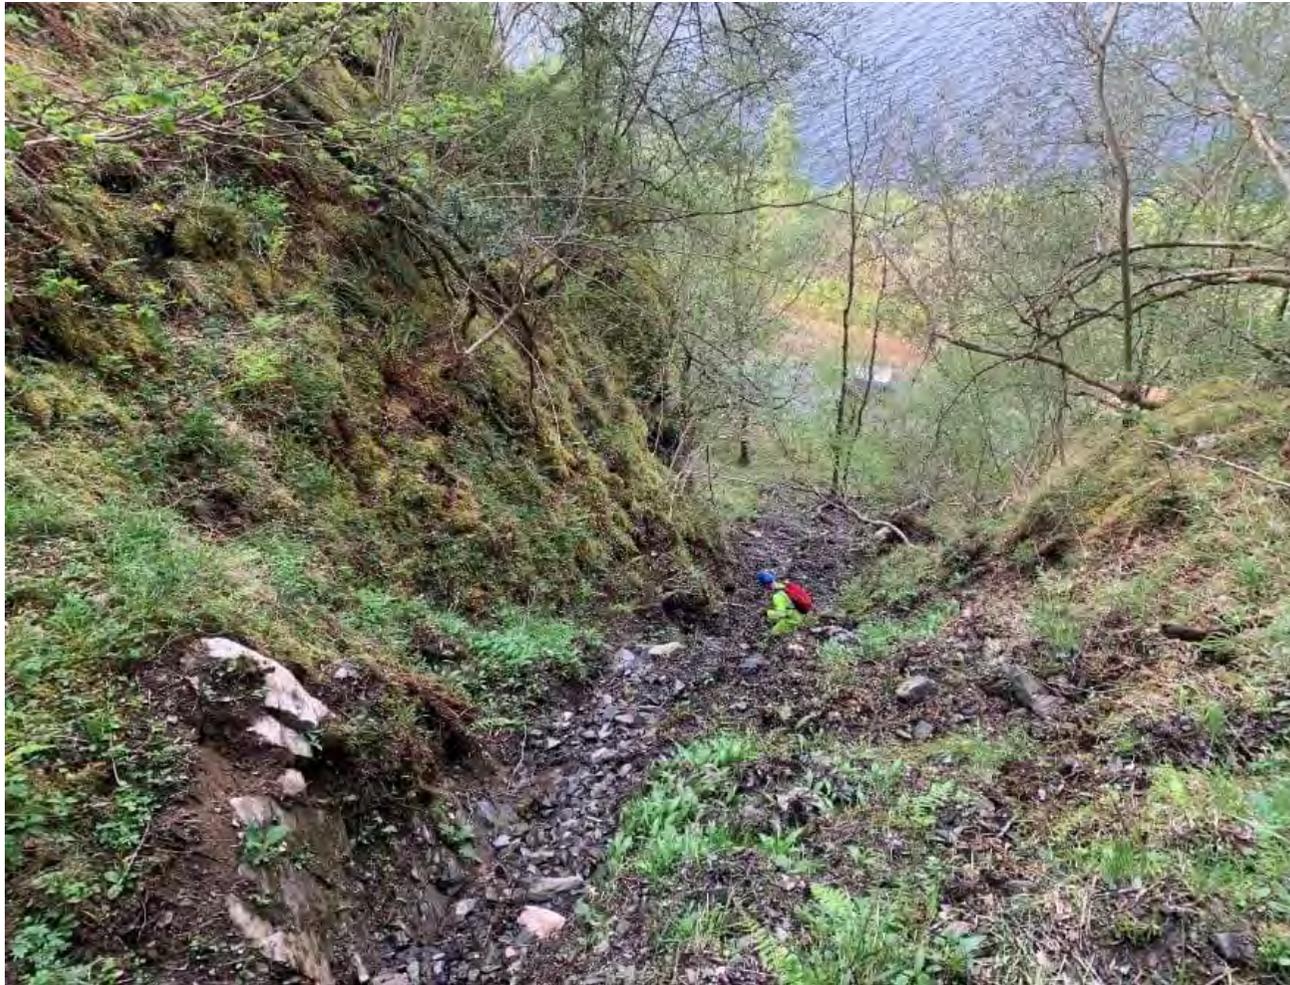
AA10-6

View downslope towards the road from the 'amphitheatre' shape of rock at NG 90523 37093. Loose debris remains in channel and on-slope.

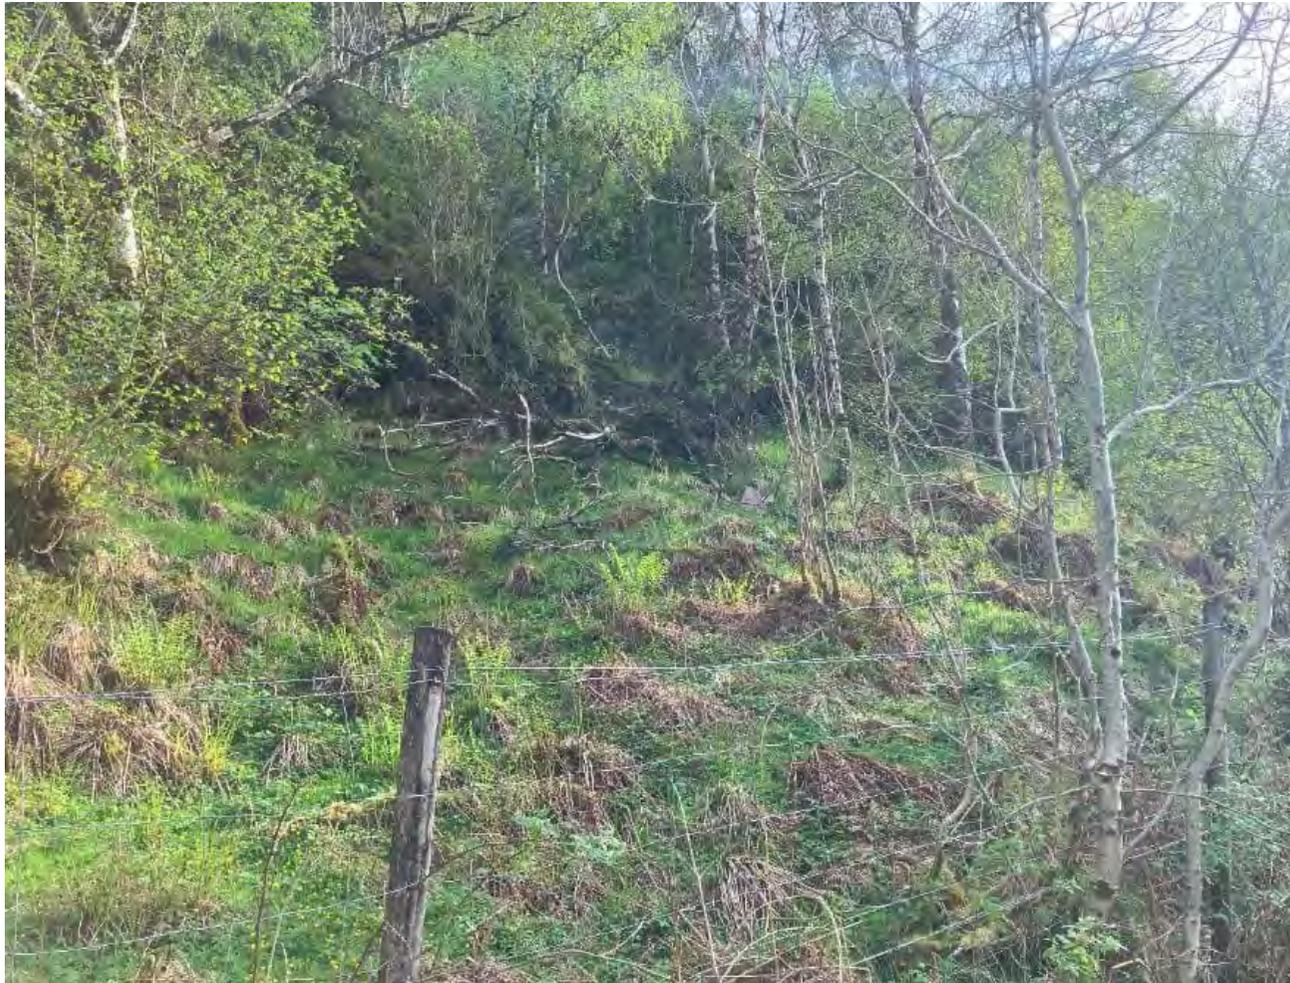
Hazards Observed:			
Ch. 2140 to 2163	N/A	Observation from road level: Small debris flow (in gully) c. 15 m above road level but set back by c. 40 m. Debris on slope, spray paint marker at road level. One block noted at the deer fence (c. 0.4 m) and a fallen tree is present on the slope. Correlates with location of THC observed landslip reported in January 2025. See additional notes under rope access inspection.	AA10-9
Ch. 2185	<p>2021 Inspection: Small accumulation of gravel to cobble sized blocks at fence transported by intermittent waterflow in gully. No rocks past fence and at roadside so risk not considered to be significant</p> <p>2024 Inspection: Accumulation of blocks has slightly increased since 2023.</p>	No changes observed during 2025 inspection.	
Ch. 2188 to 2295	2016 Inspection: Rock face set further back here and it is considered that most failures within this section would be contained by the existing ditch and verge at the toe of the slope.	No changes observed during 2025 inspection.

AA10-9	Ch. 2140 to 2163: 2025: Upslope view from the roadside of a small debris flow (in gully) c. 15 m above road level but set back by c. 40 m. Confirmed during upslope inspection.	Year First Observed:	2025
--------	--	----------------------	------

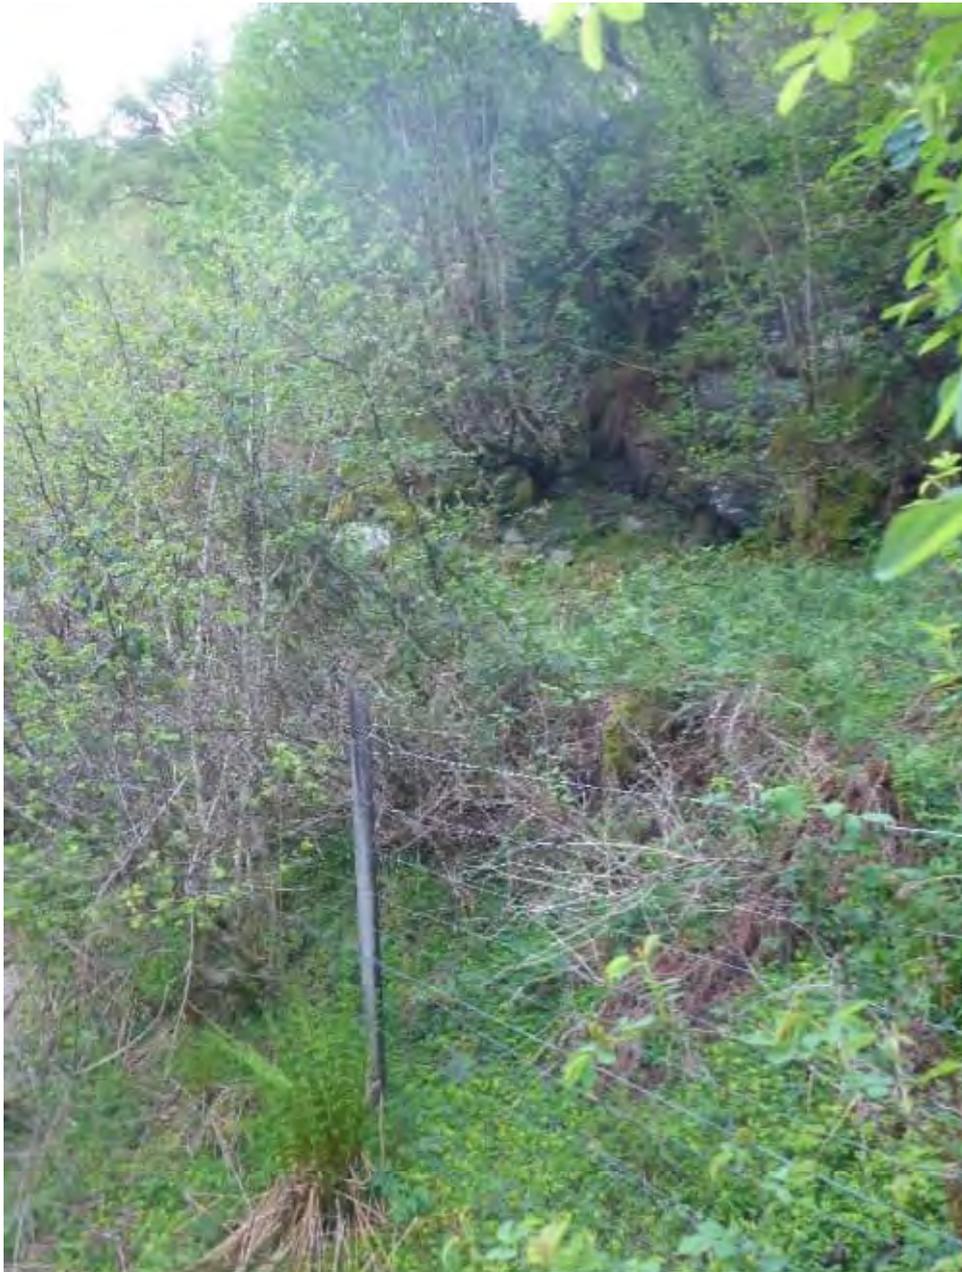
<p>FB-3</p>	<p>Ch. 2340: 2025: Potentially some new blocks present but well set back from the road between Frenchman's Burn and AA11. No significant risk to the road / road users.</p>	<p>Year First Observed:</p>	<p>2025</p>
-------------	---	-----------------------------	-------------

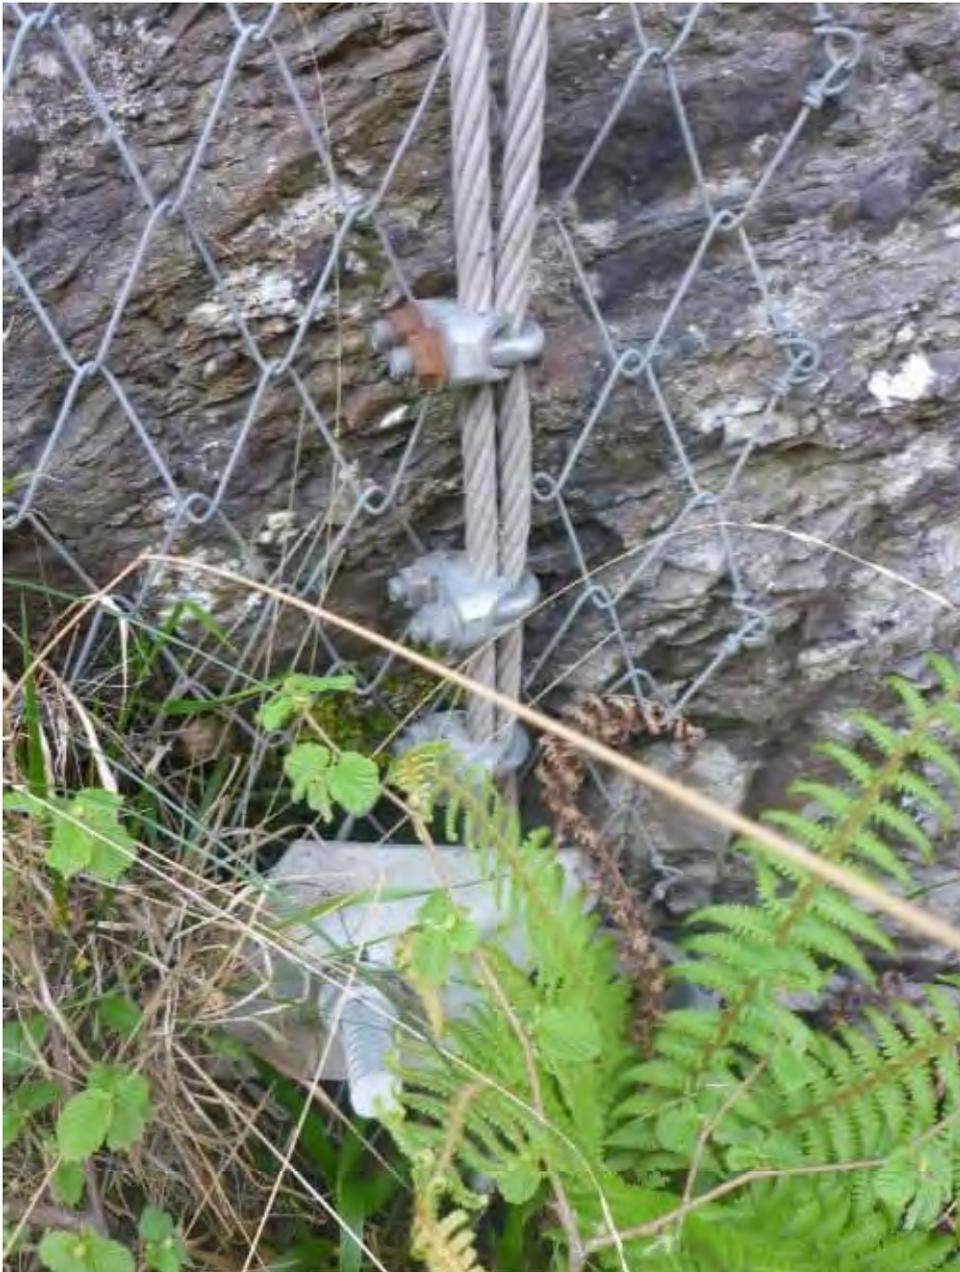
AA12-1	Occasional surface corrosion of nuts and shackles on the cables.	Year First Observed:	201 7
--------	--	-------------------------	----------

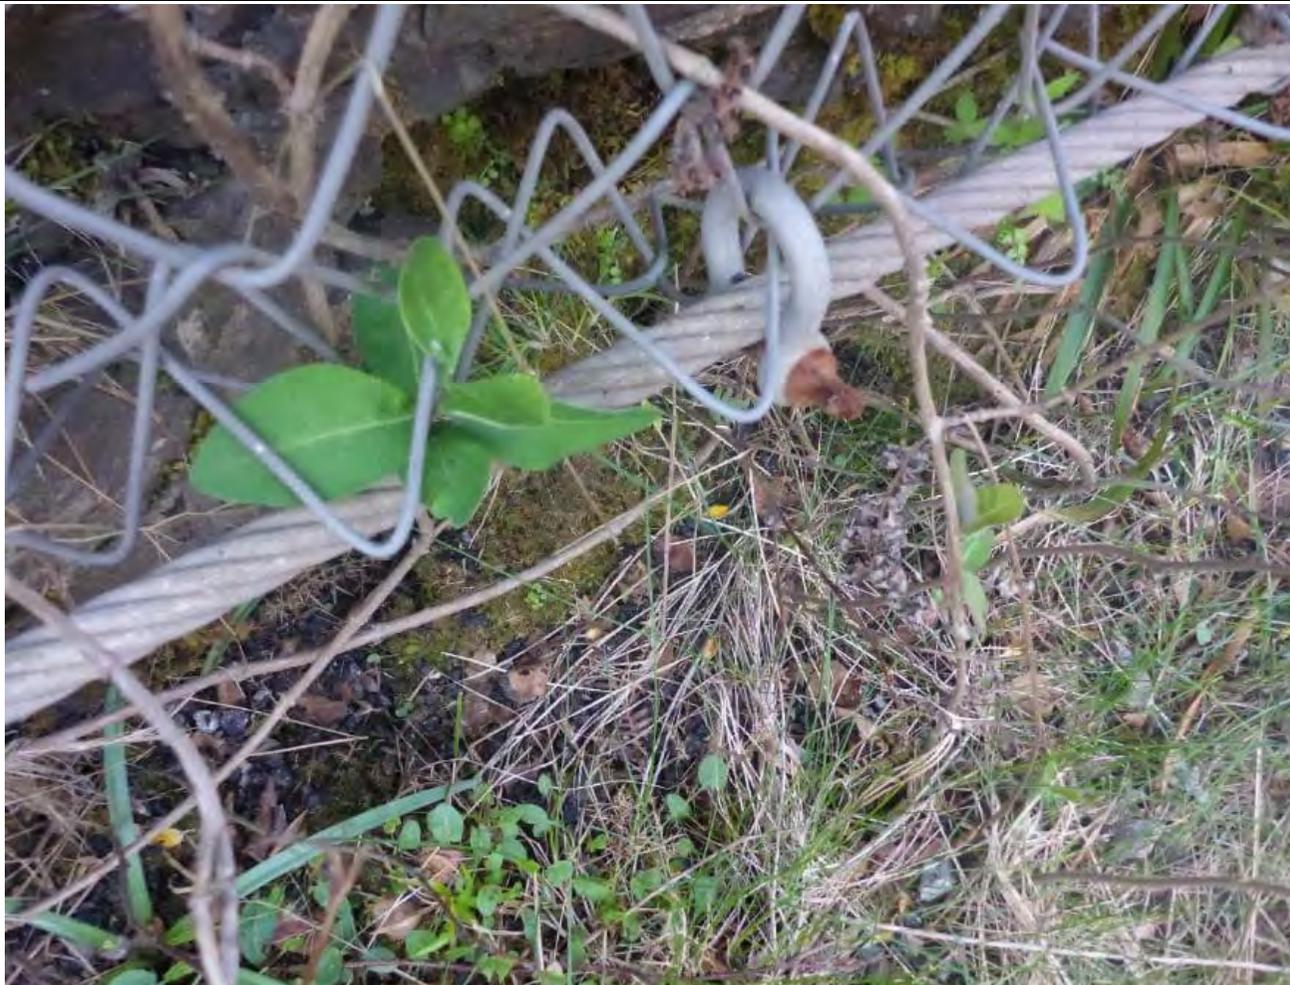
AA12-2

Occasional surface corrosion of nuts and shackles on the cables.

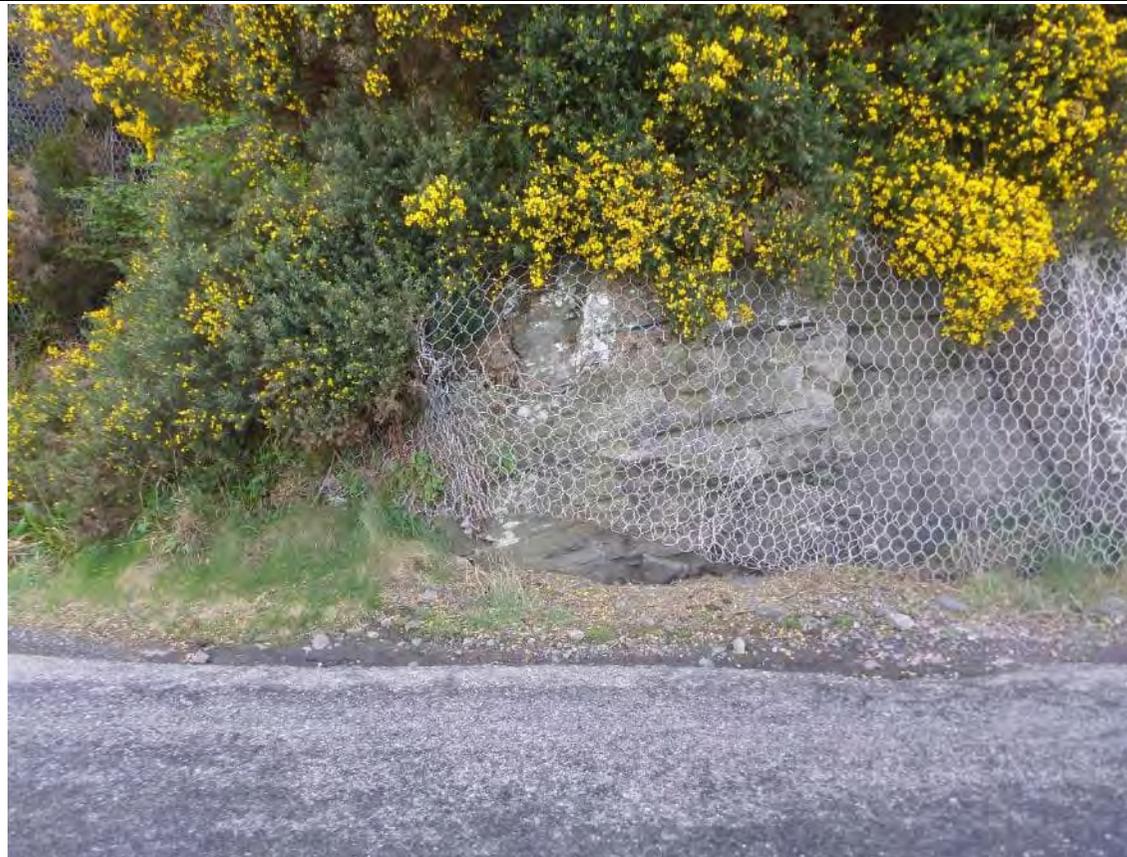
AA13-1	2022: Netting has been torn, potentially by grass cutter at Ch. 2515. 2025: No changes observed during 2025 inspection.	Year First Observed:	2022
--------	--	----------------------	------

Recommended Remedial Works / Actions							
N/A		N/A		<ul style="list-style-type: none"> • Vegetation clearance is recommended across the whole slope. • Replace corroded cable clamps, re-tension and install additional Spenax rings on vertical reinforcing cables between Ch. 2513 and 2528. • Replace missing Ch. 2500 marker post. 			
Assessed in field by:	SF/MT	Date:	30/04/2025	Reviewed by:	MT	Date:	27/06/2025

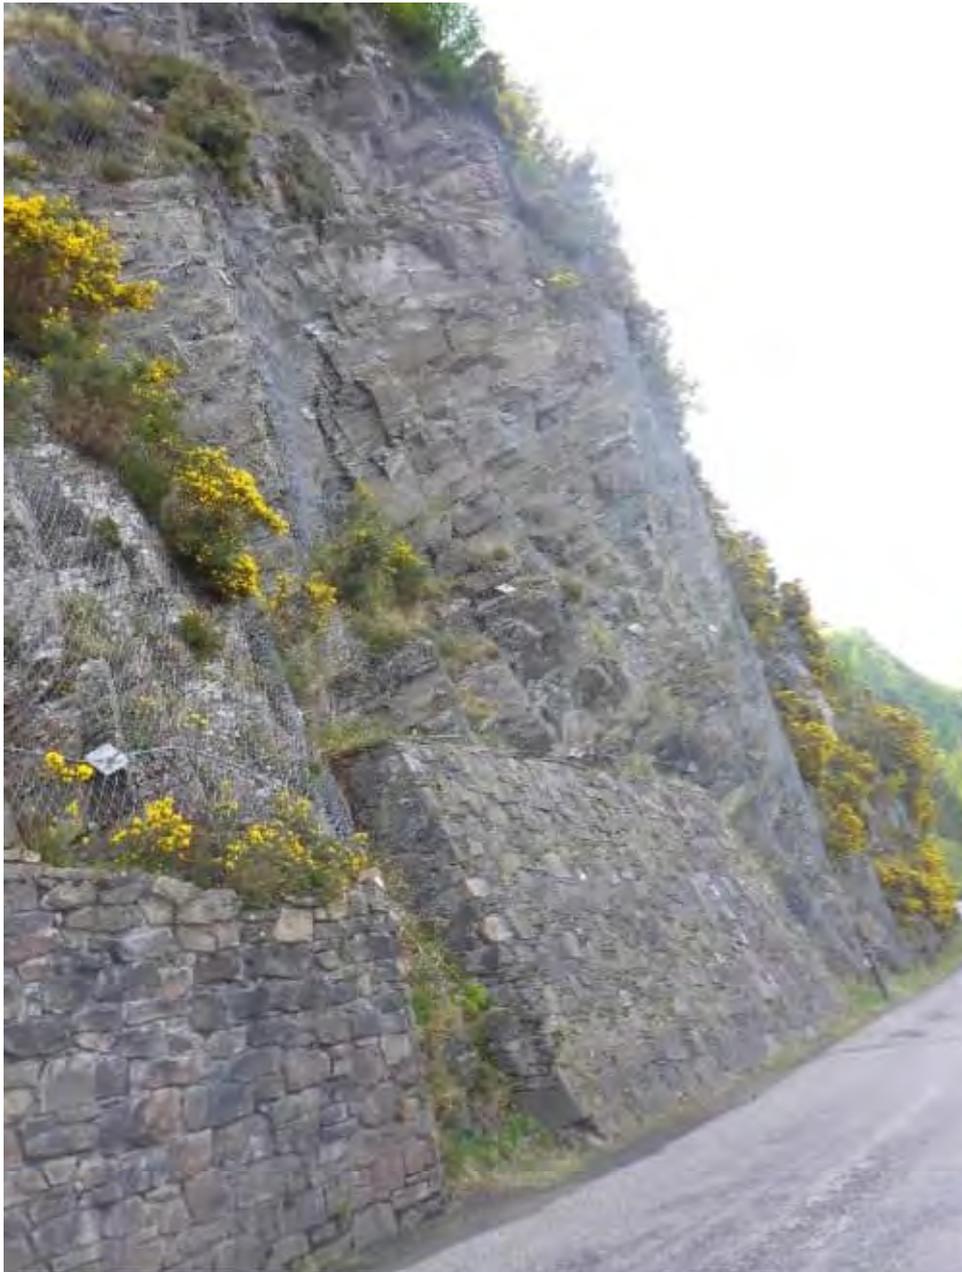
AA14W-1	2023: Localised small blocks (ravelling) behind TECCO c. 15 to 20 m upslope above buttress. 2025: No changes observed during 2025 inspection.	Year First Observed:	2023
---------	--	----------------------	------

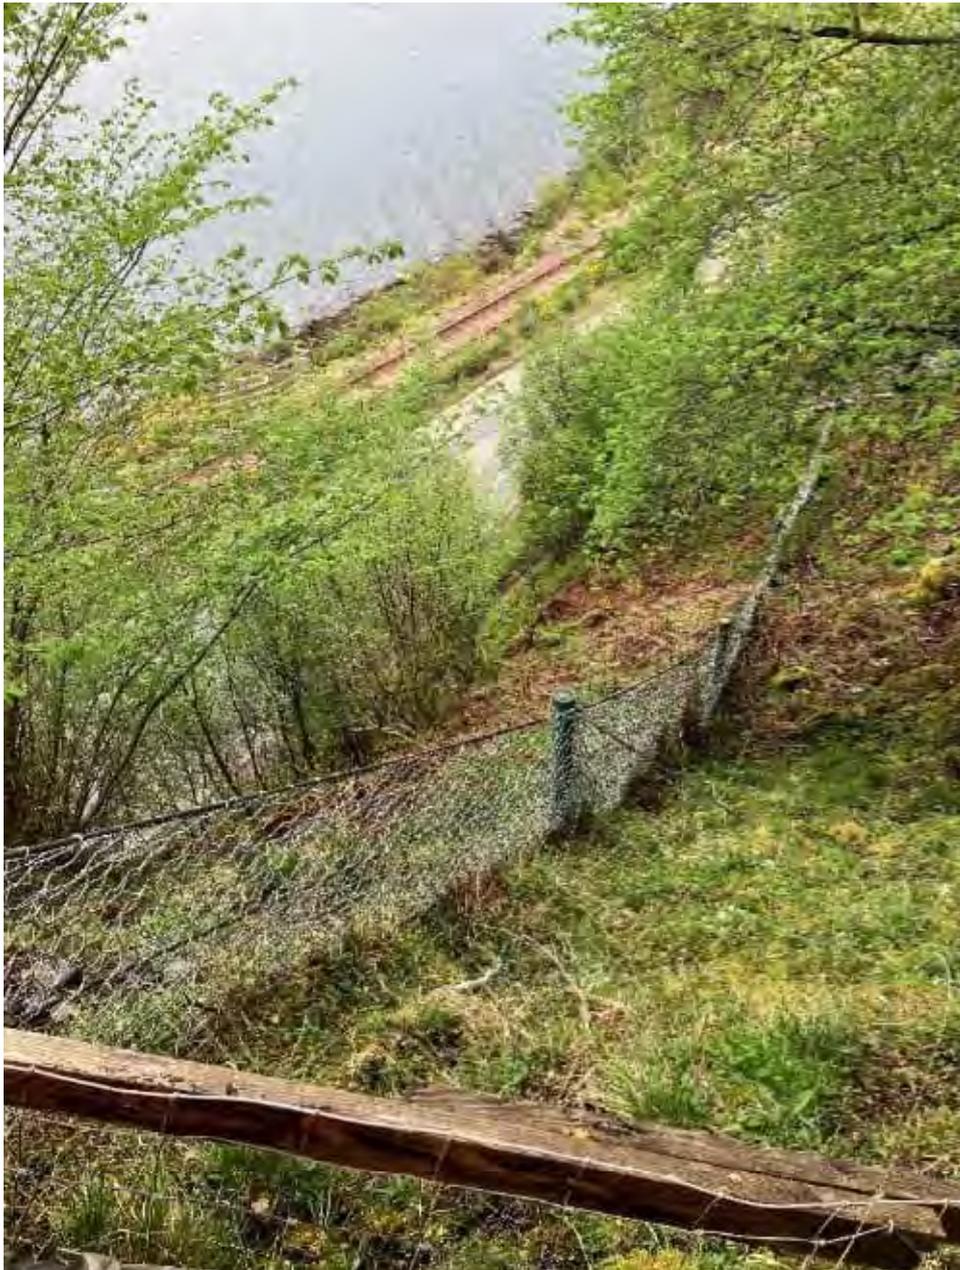
AA14E-3	View along pre-2012 low height catch fence looking down towards road.	Year First Observed:	2012
---------	---	----------------------	------

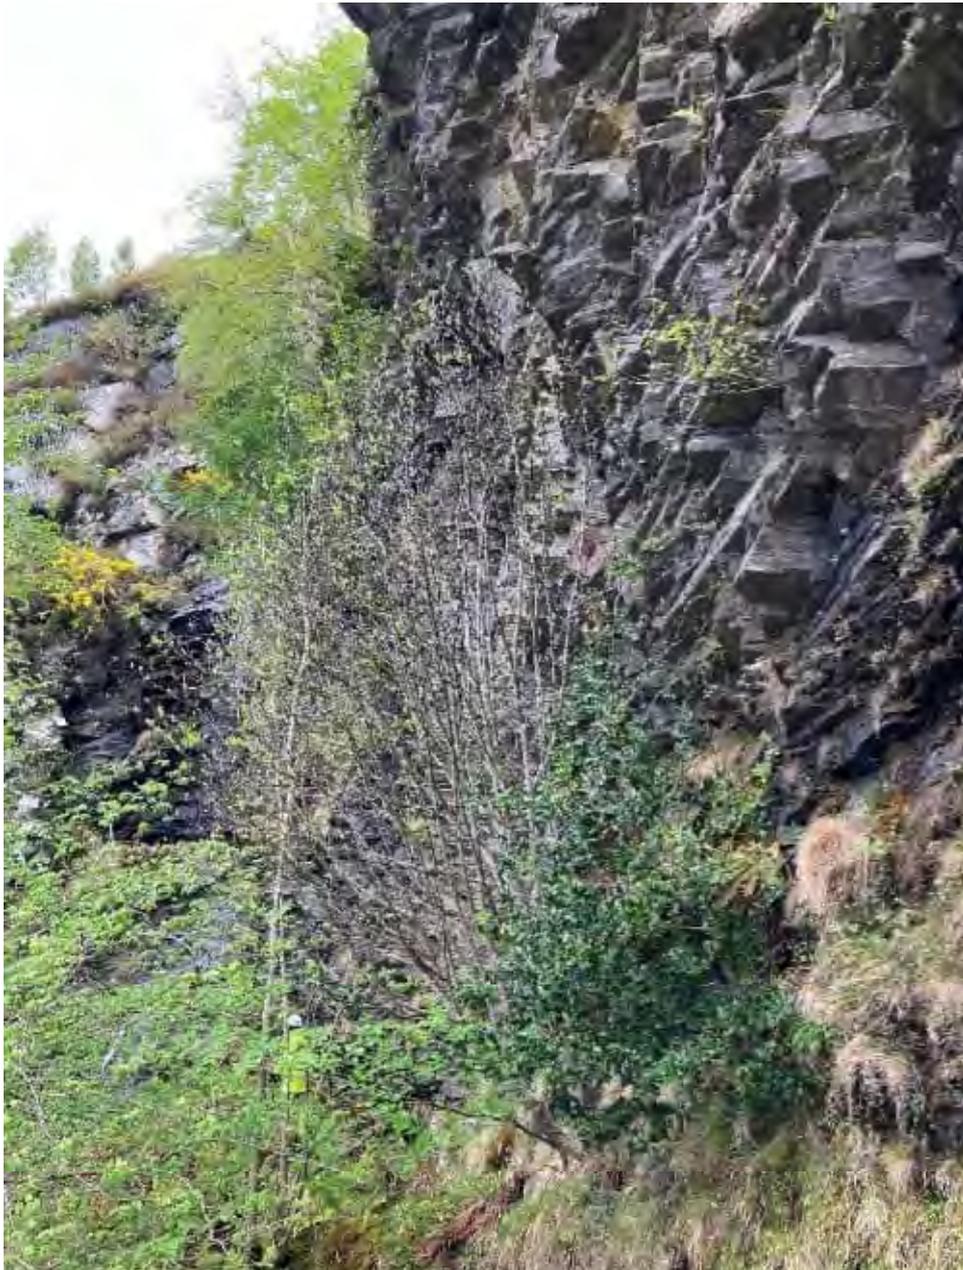
AA14E-4	General view of rock slope above AA14W – blocky overhangs common.	Year First Observed:	2012

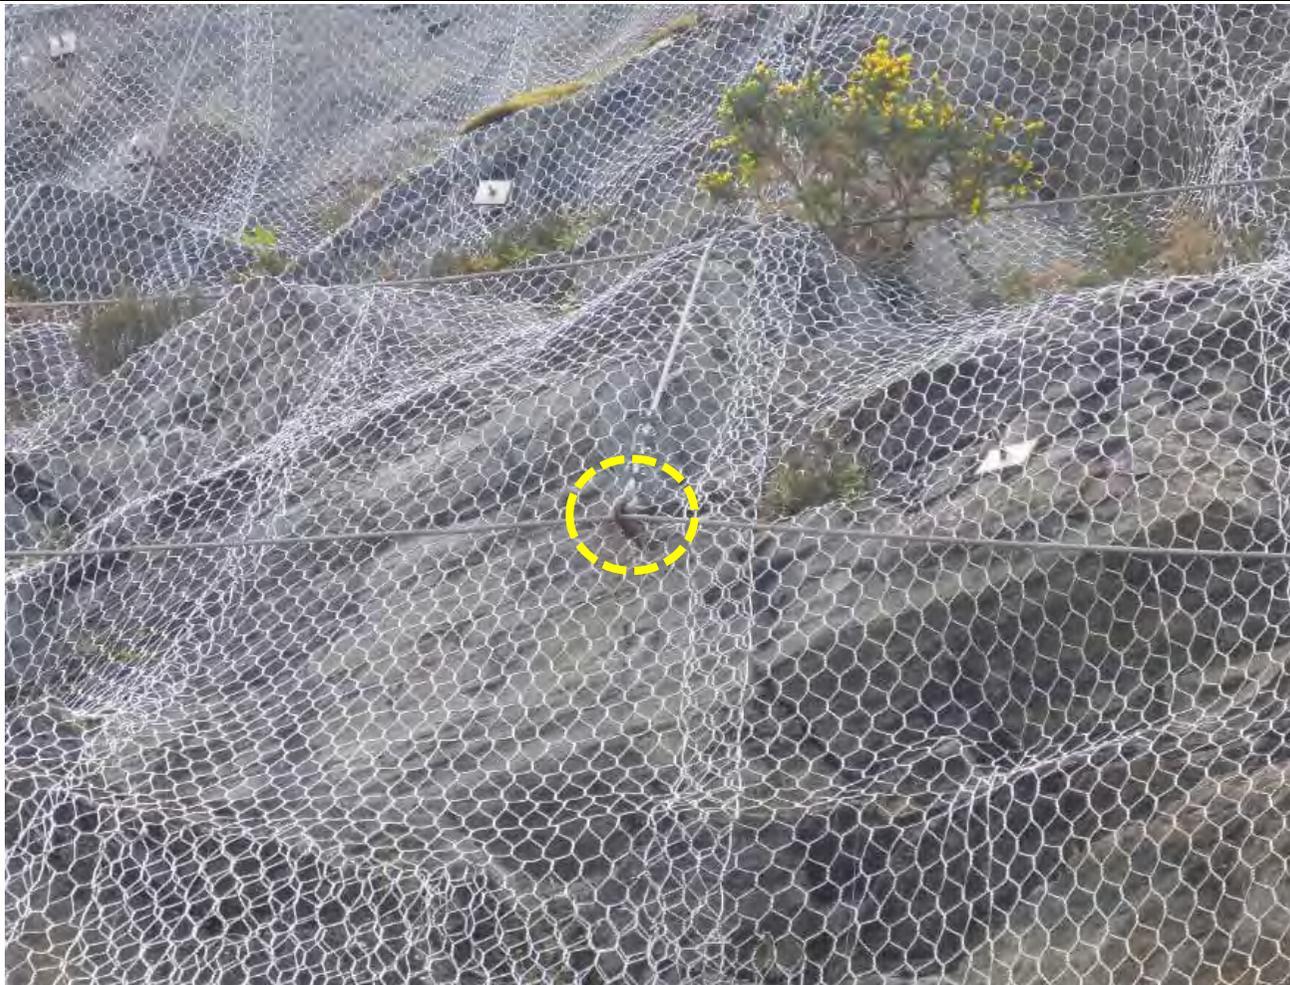
AA17-1

- Almost all of the anchors for the reinforcing cables in the upper portion of the slope are visibly corroded.

Recommended Remedial Works / Actions							
Large Scale Rock Fall Protection Works (Category 3)		Localised Targeted Rock Fall Protection Works (Category 2)			Ongoing Maintenance (Category 1)		
N/A		<ul style="list-style-type: none"> Ch. 2933 to 2946: Open up Maccaferri netting and carry out scaling before re-assessing. Netting to be reinstated on completion. 			<ul style="list-style-type: none"> Vegetation clearance is recommended across the whole slope. Replace corroded anchor points on reinforcing cables. 		
Assessed in field by:	SF/MT	Date:	30/04/2025	Reviewed by:	MT	Date:	27/06/2025

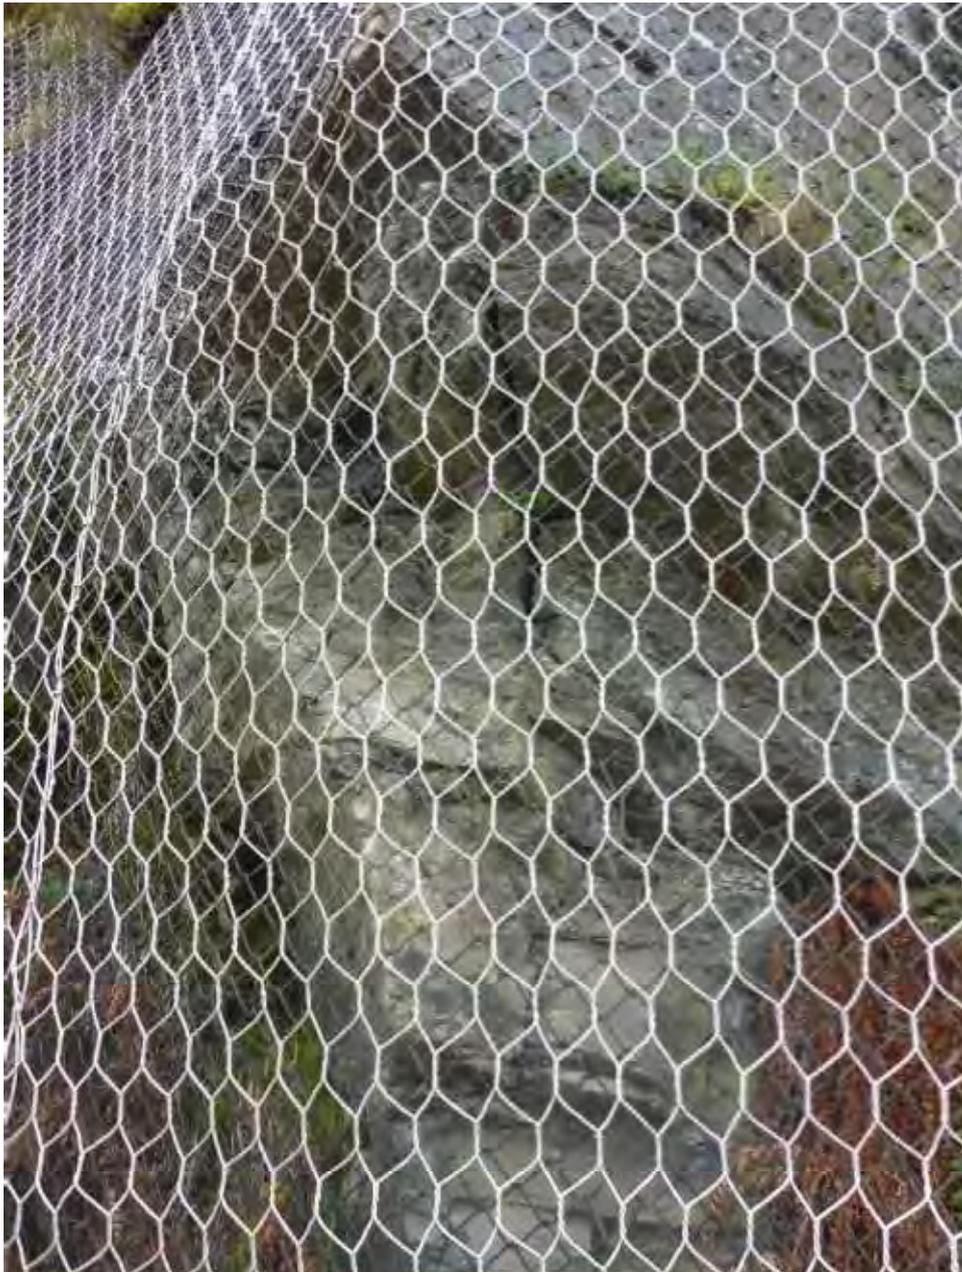
AA17-2	Ch. 2933 to 2946: Large area of blast damaged rock mass with potential to exceed capacity of mesh in event of failure.	Year First Observed:	2017
--------	---	----------------------	------

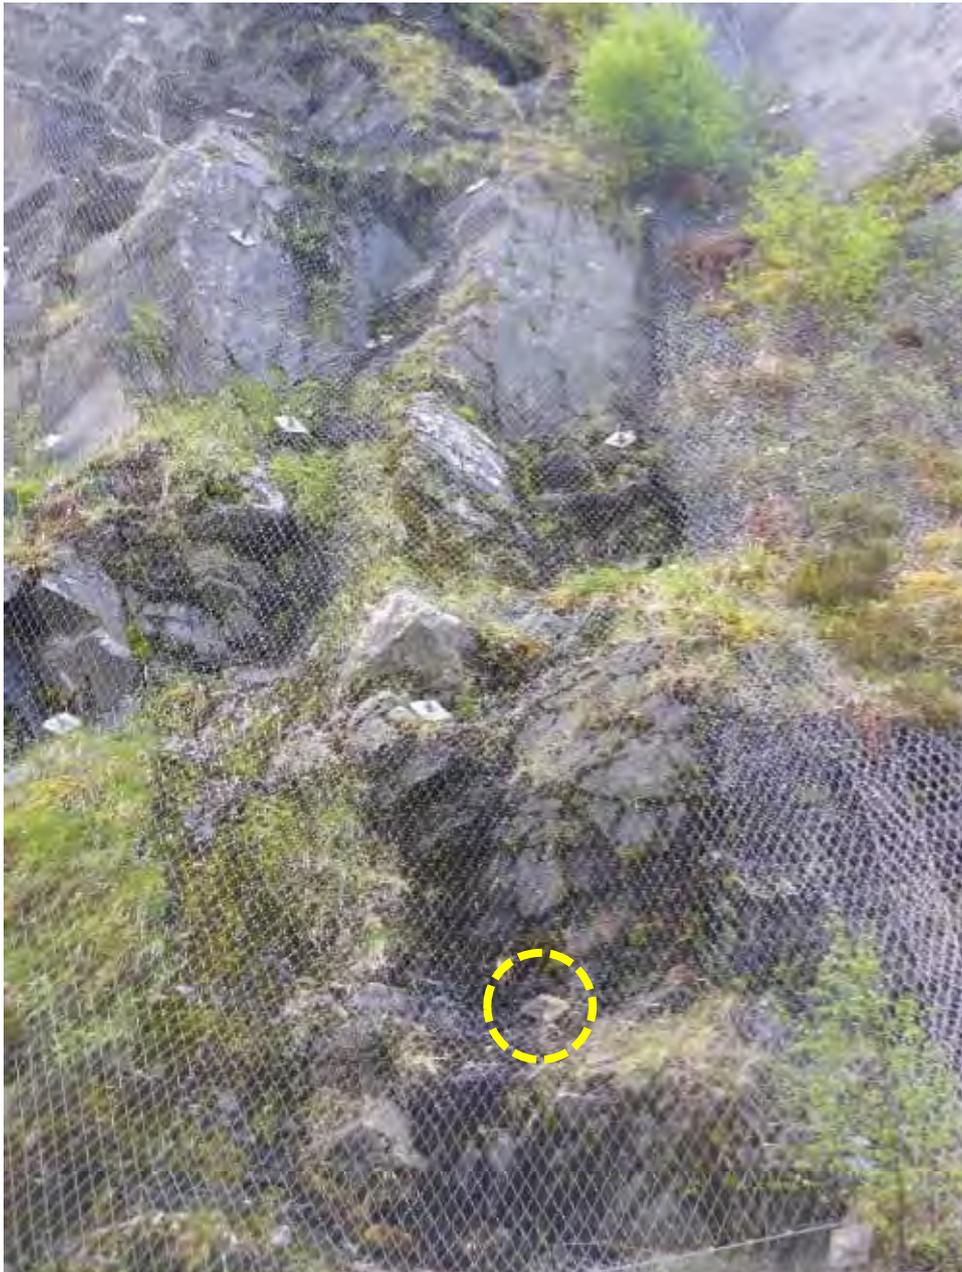
AA18-1	At Ch. 2990 (waterfall area), TECCO showing greenish discolouration. Spike plate discoloured.	Year First Observed:	2018
--------	---	----------------------	------

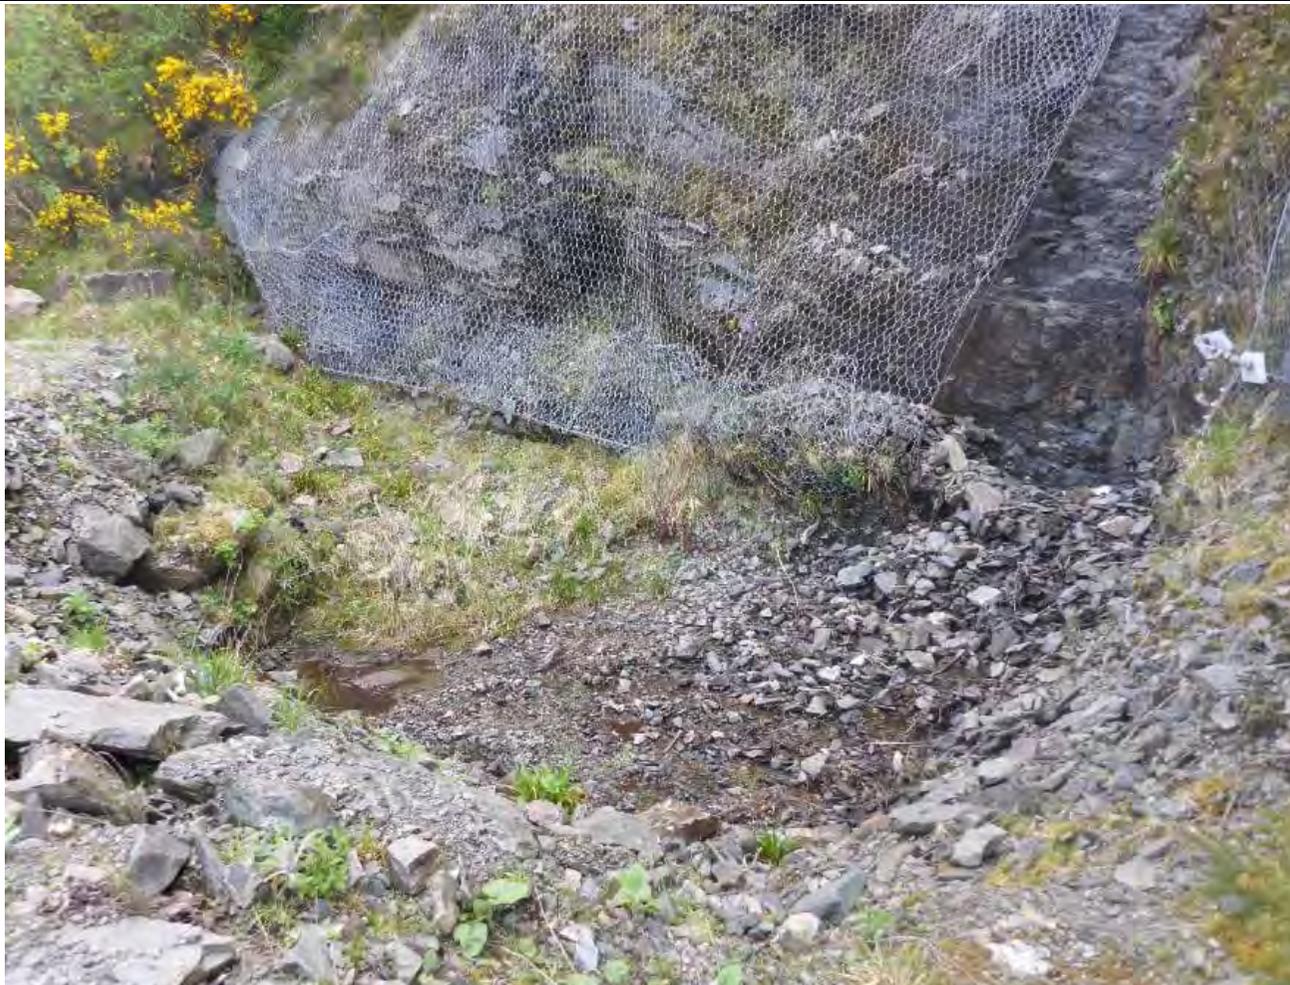
AA18-19-1

Debris accumulation is beginning to load the mesh. Requires clearance.
