A890 Stromeferry Bypass

Annual Slope Inspection 2025

The Highland Council

Project number: 60685712
AECOM Report Ref.: GLRP0010

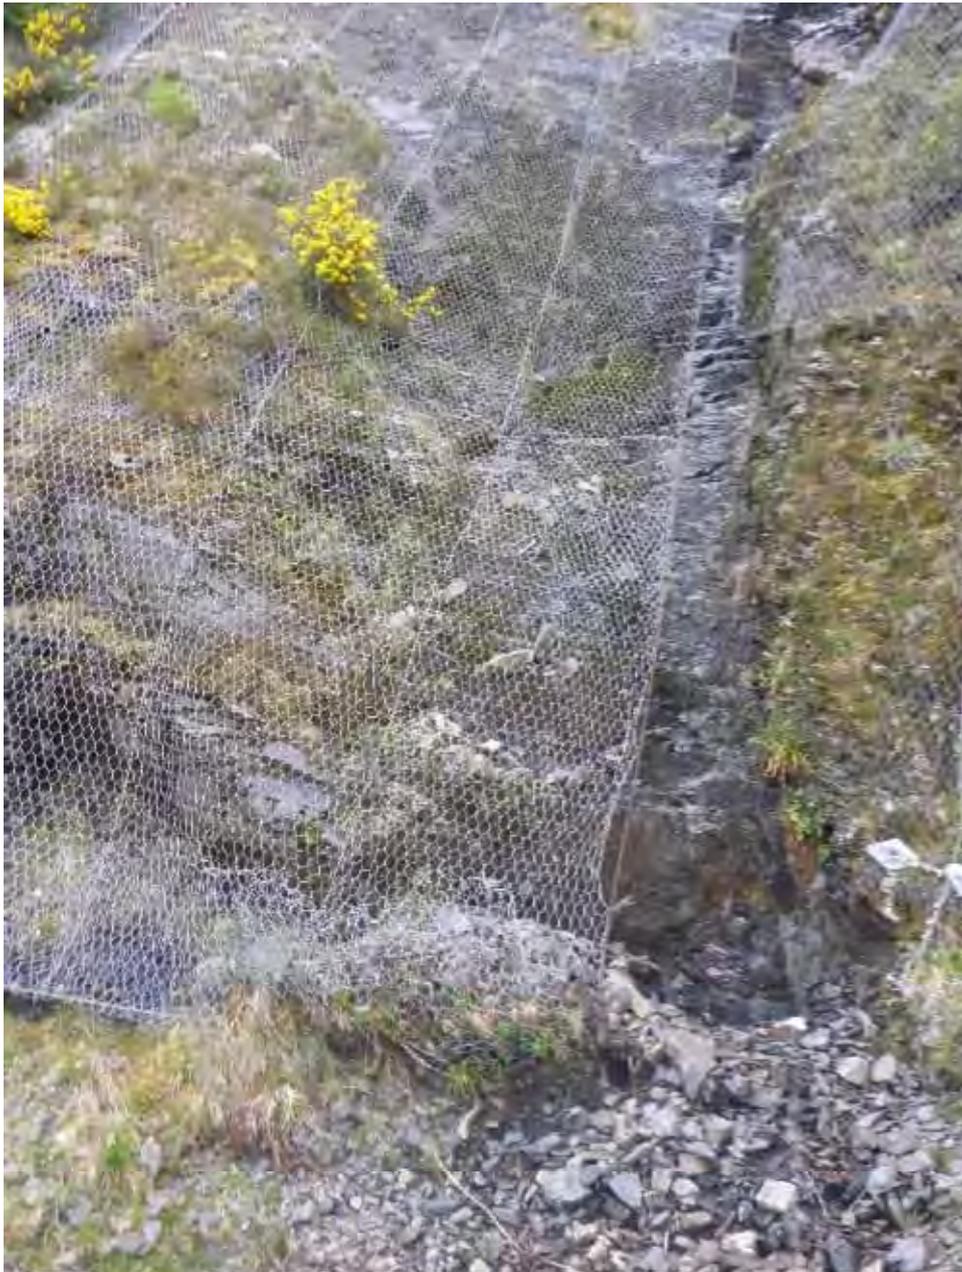
AA18-19-2	Ch. 3052: Debris accumulation is beginning to load the mesh. Requires clearance.	Year First Observed:	2018
-----------	---	-------------------------	------

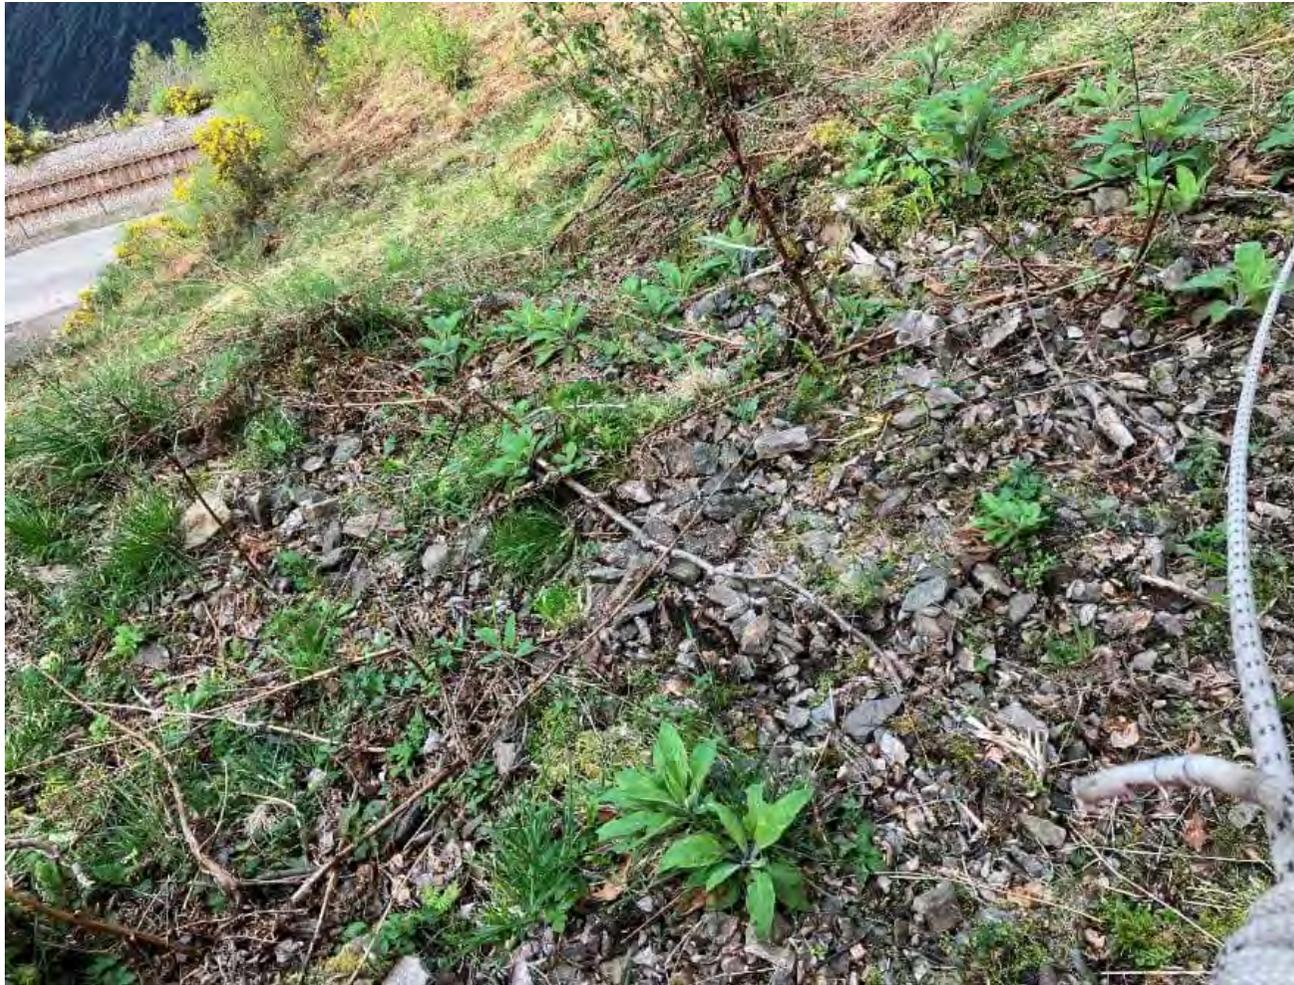
AA19-U-1

Loose blocks / scree remain on the slope between crags and top of AA18-19 netting system.

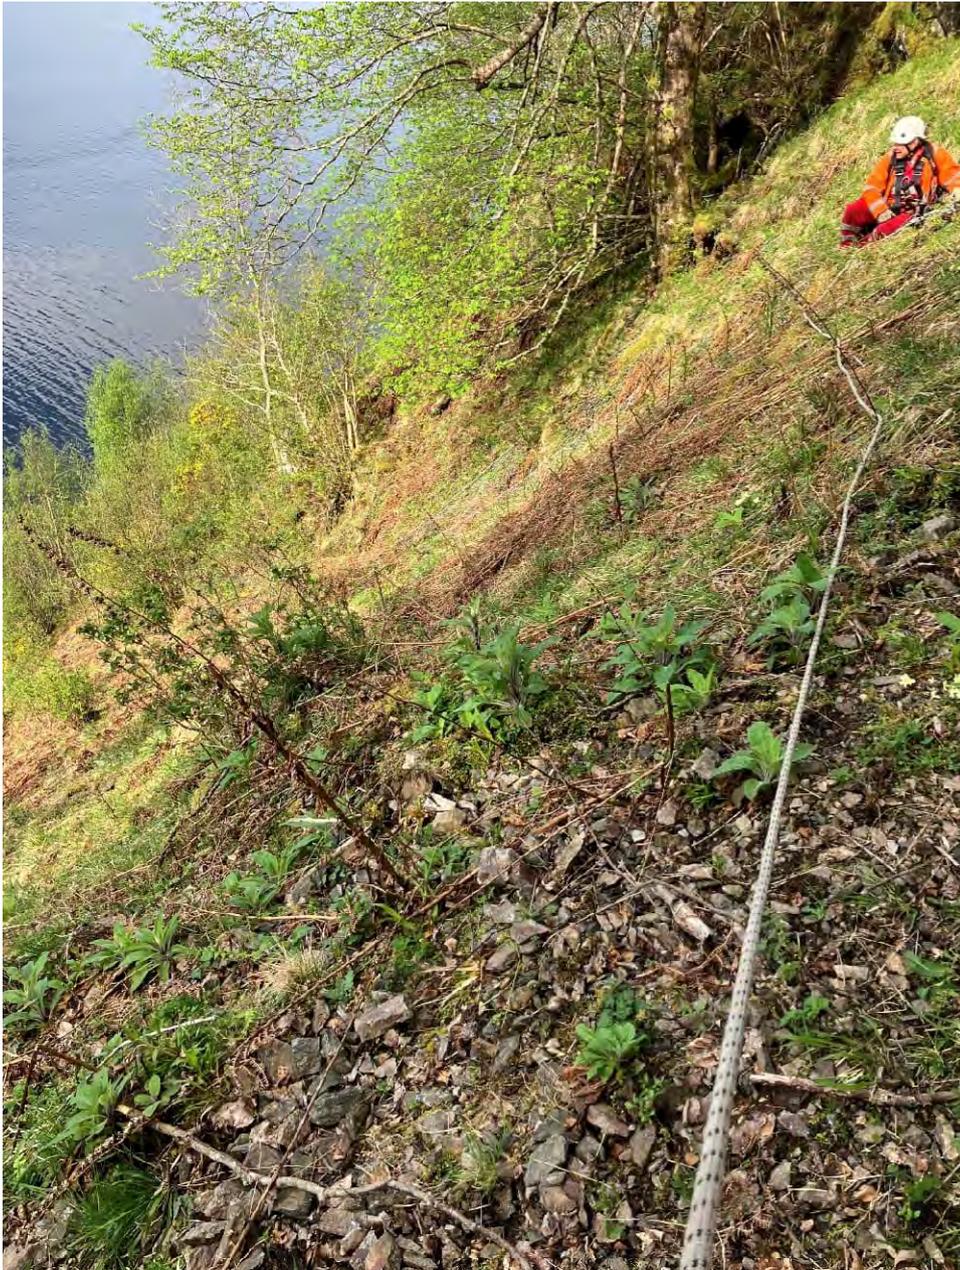
AA19-U-2	Loose blocks / scree remain on the slope between crags and top of AA18-19 netting system.	Year First Observed:	2023
----------	---	----------------------	------

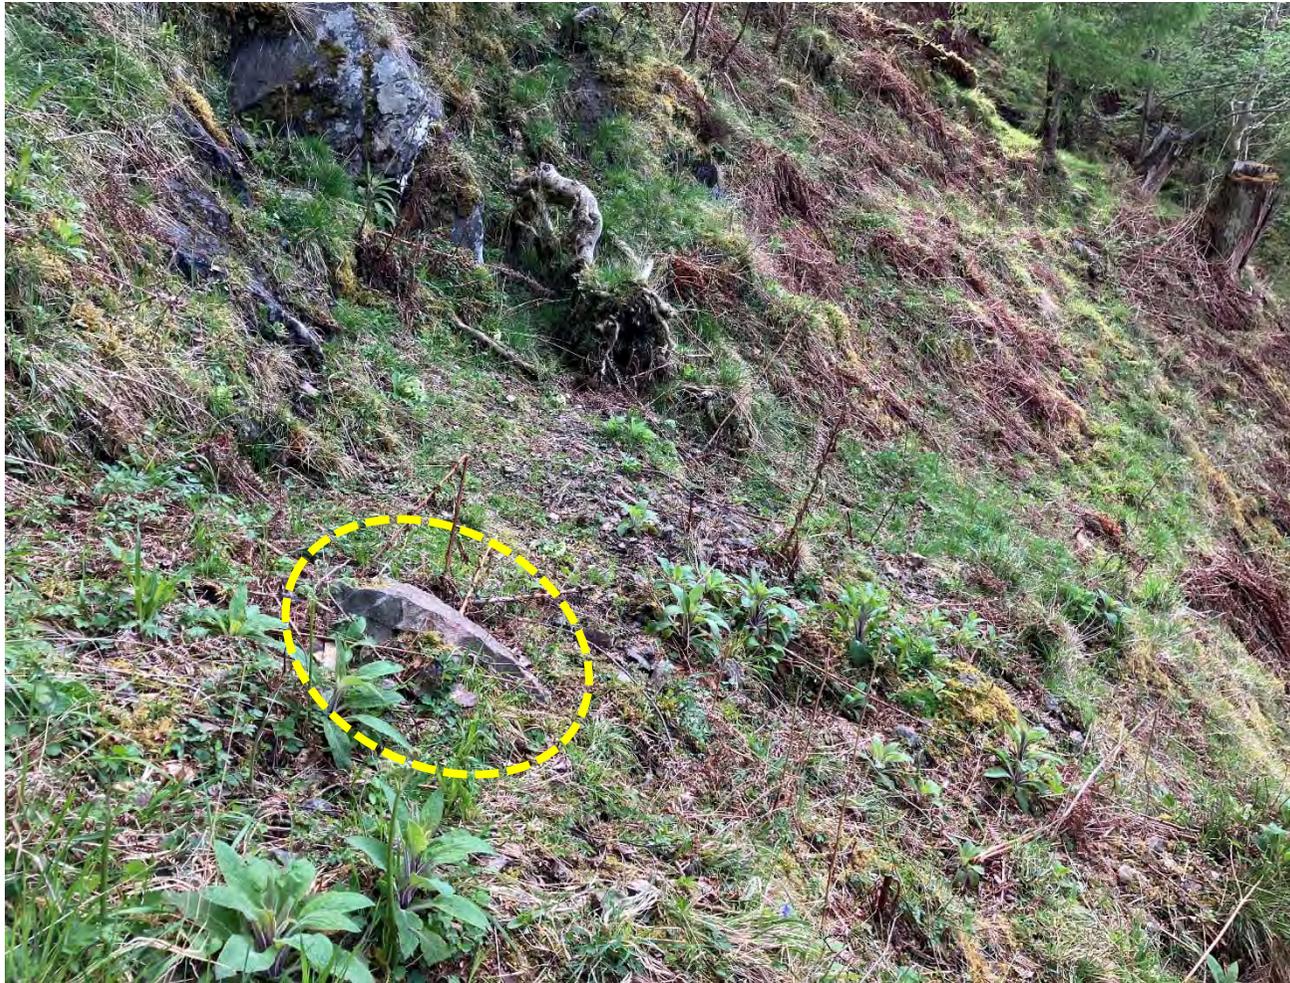
Hazards Observed:			
Location	Description of Hazard(s) from Previous Inspections	2025 Inspection Observations	Photo Reference
General	2012 Inspection: Potential for numerous block falls approximately 60 m above road due to root jacking. Block size up to 1 m ³ .	No changes observed during 2025 inspection.	
NG 91276 37645	2013 Inspection: Developing toppling / root jacking failures (block size up to 1.5 x 2 x 1.5 m) approximately 50 m above road; 4no. blocks (typically 1.5 x m x 0.4 m) prone to toppling failure approximately 20 m above TECCO mesh in slight gully on face (directly above left hand end of the gabions)	No changes observed during 2025 inspection.	
General	2023 Inspection: A number of loose blocks are lying on slope.	No changes observed during 2025 inspection.	AA19-U-3

AA19-U-3	Loose blocks / scree remain on the slope between crags and top of AA18-19 netting system. Larger block (5 m down from the crest) has been present since the 2024 rope access inspection..	Year First Observed:	2023
----------	--	----------------------	------

Recommended Remedial Works / Actions					
Large Scale Rock Fall Protection Works (Category 3)		Localised Targeted Rock Fall Protection Works (Category 2)		Ongoing Maintenance (Category 1)	
<ul style="list-style-type: none"> Install rock fall catch fence above roadside cutting. 		N/A		<ul style="list-style-type: none"> Scree area cleared in September 2022 urgent works is refilling – would benefit from clearance 	
Assessed in field by:	PM/CR	Date:	29/04/2025	Reviewed by:	MT
		Date:		Date:	27/06/2025

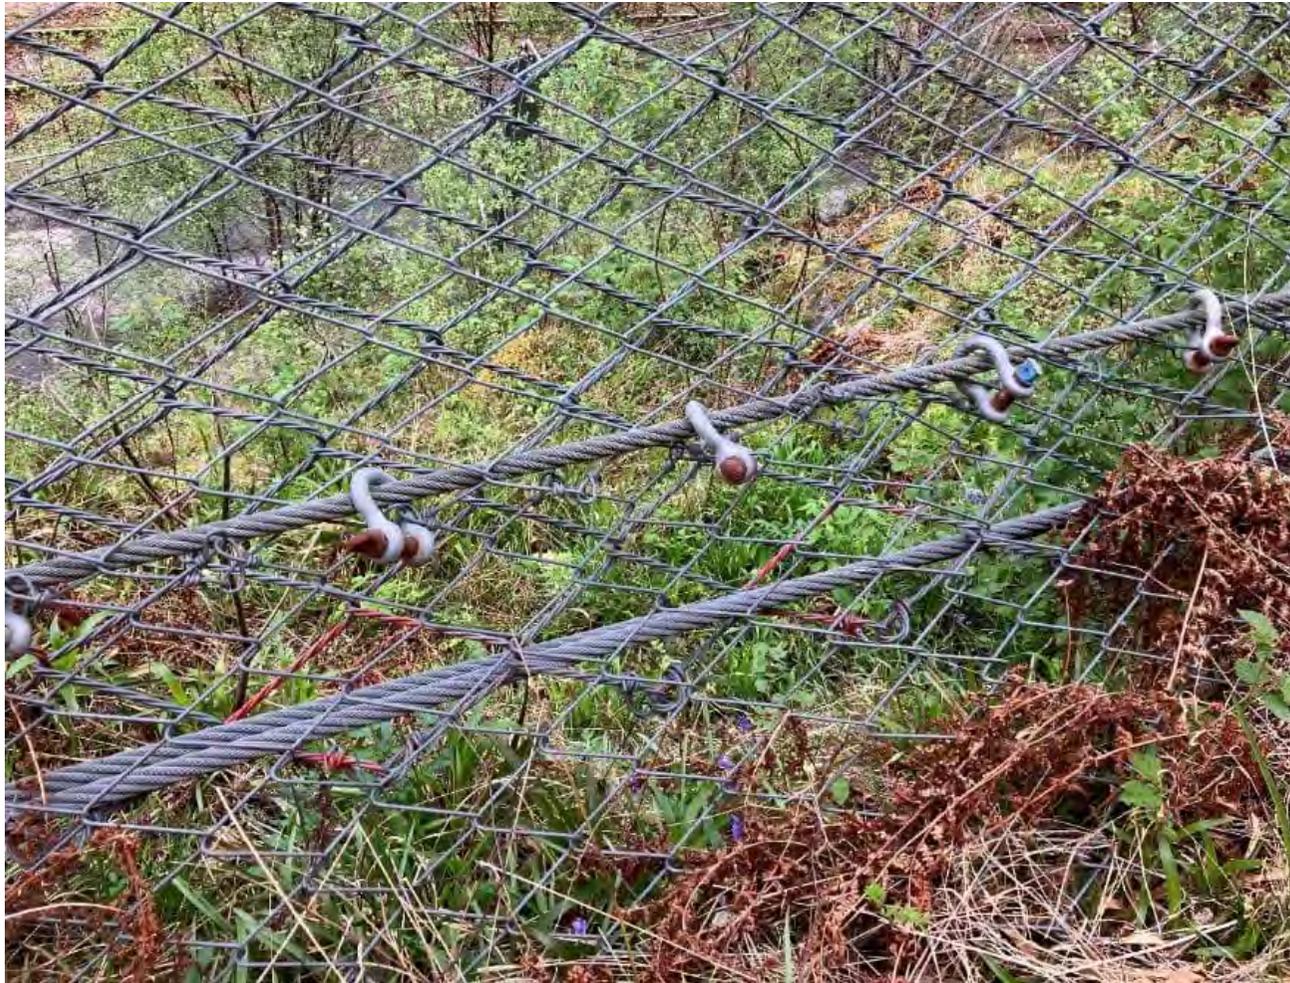
AA20-U-1

Phase 12 works: Rock fall catch fence installed between Ch. 3170 to 3215:
 Catch fence pins in large shackles along bottom rope of catch fence exhibiting surface corrosion.

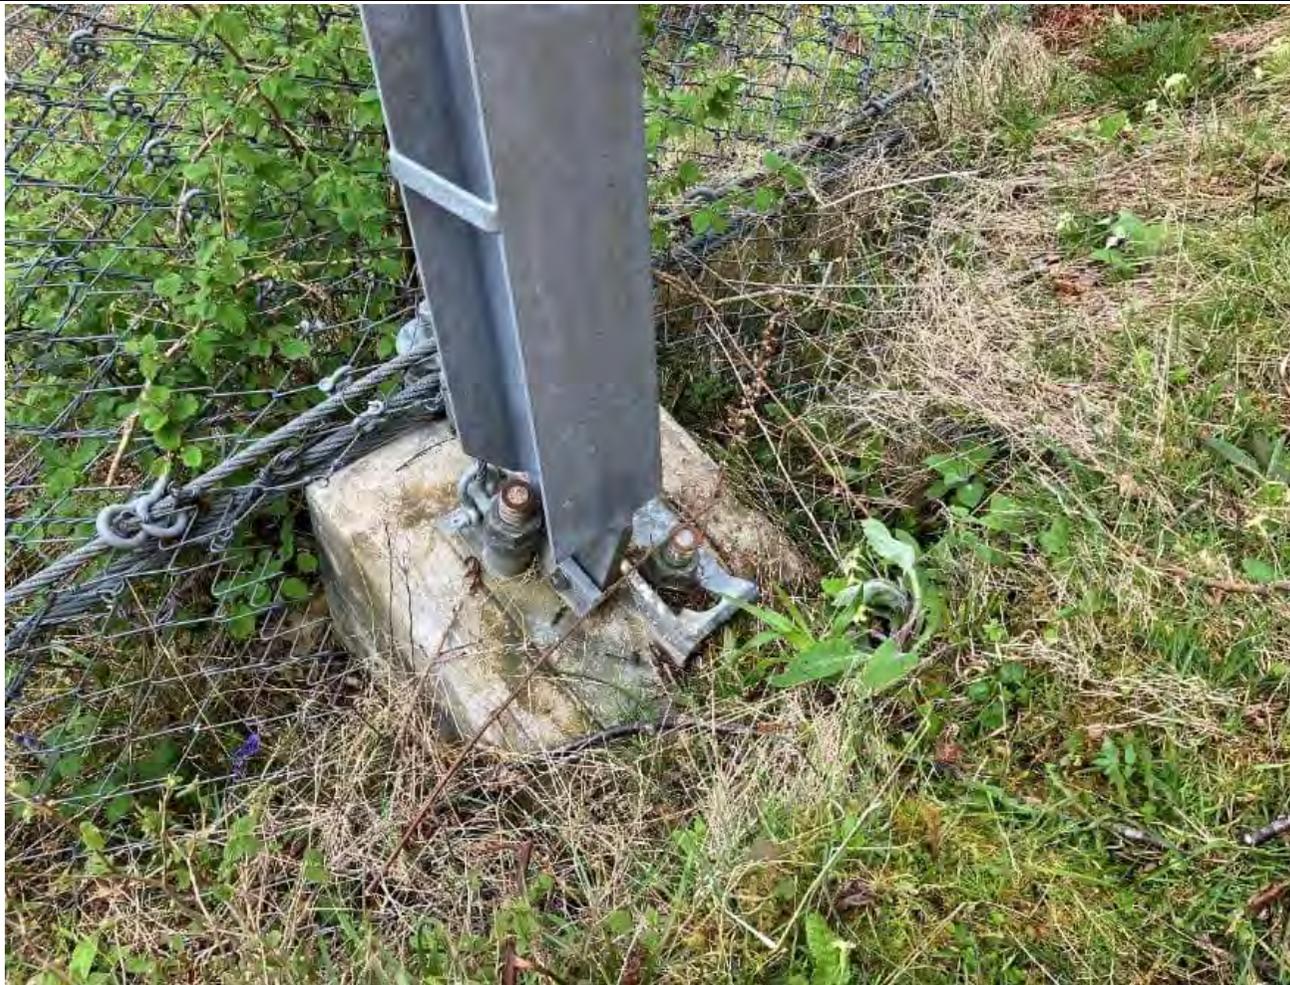
AA20-U-2

Phase 12 works: Rock fall catch fence installed between Ch. 3170 to 3215:
Surface corrosion is evident on exposed cut bar ends on post base foundations.

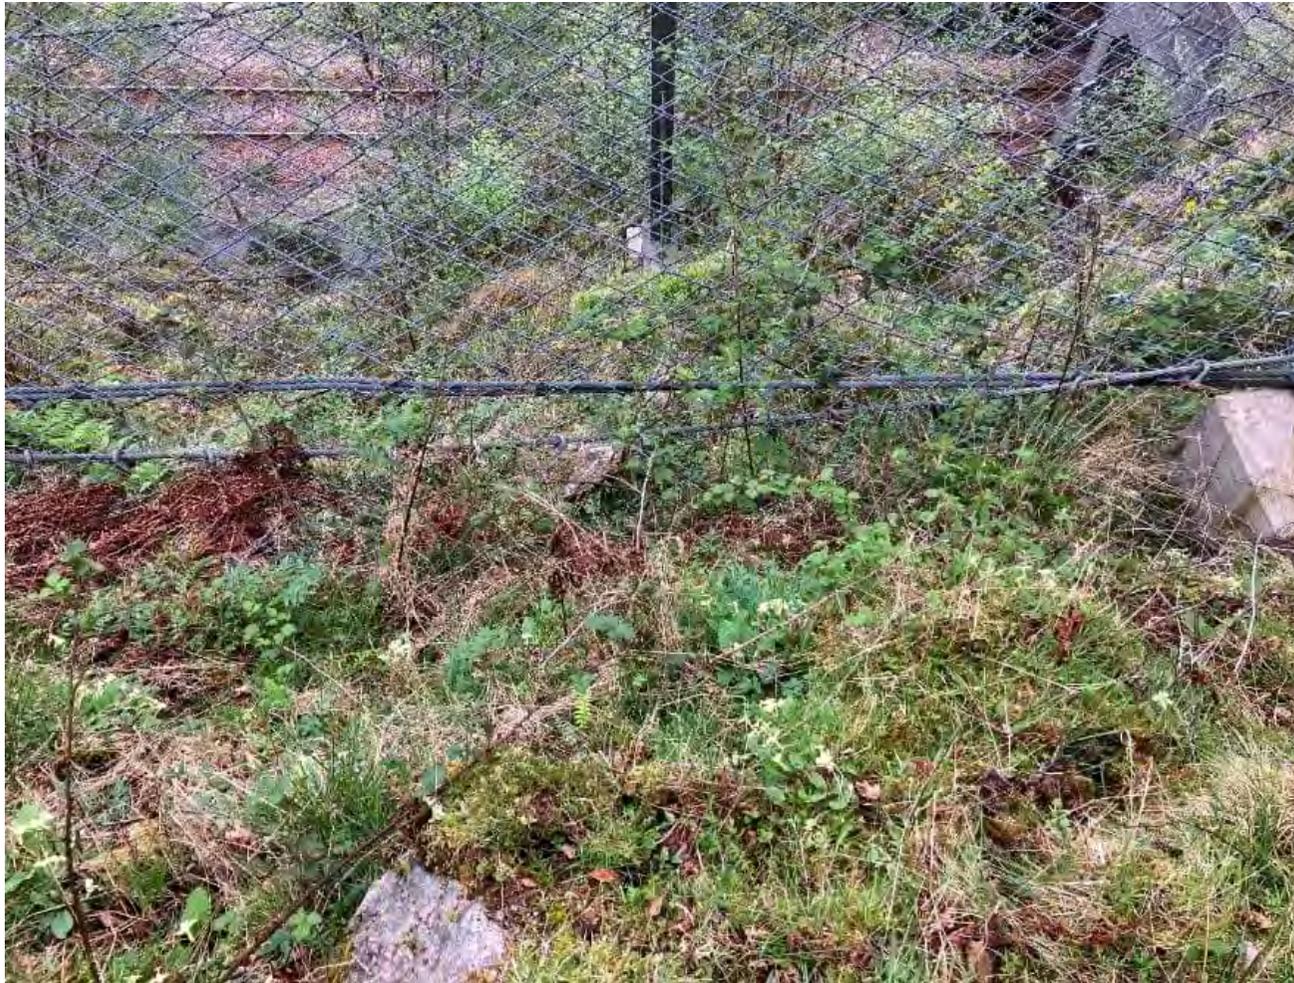
AA20-U-3

Phase 12 works: Rock fall catch fence installed between Ch. 3170 to 3215:
A small number of small blocks have been caught in the base of the fence.

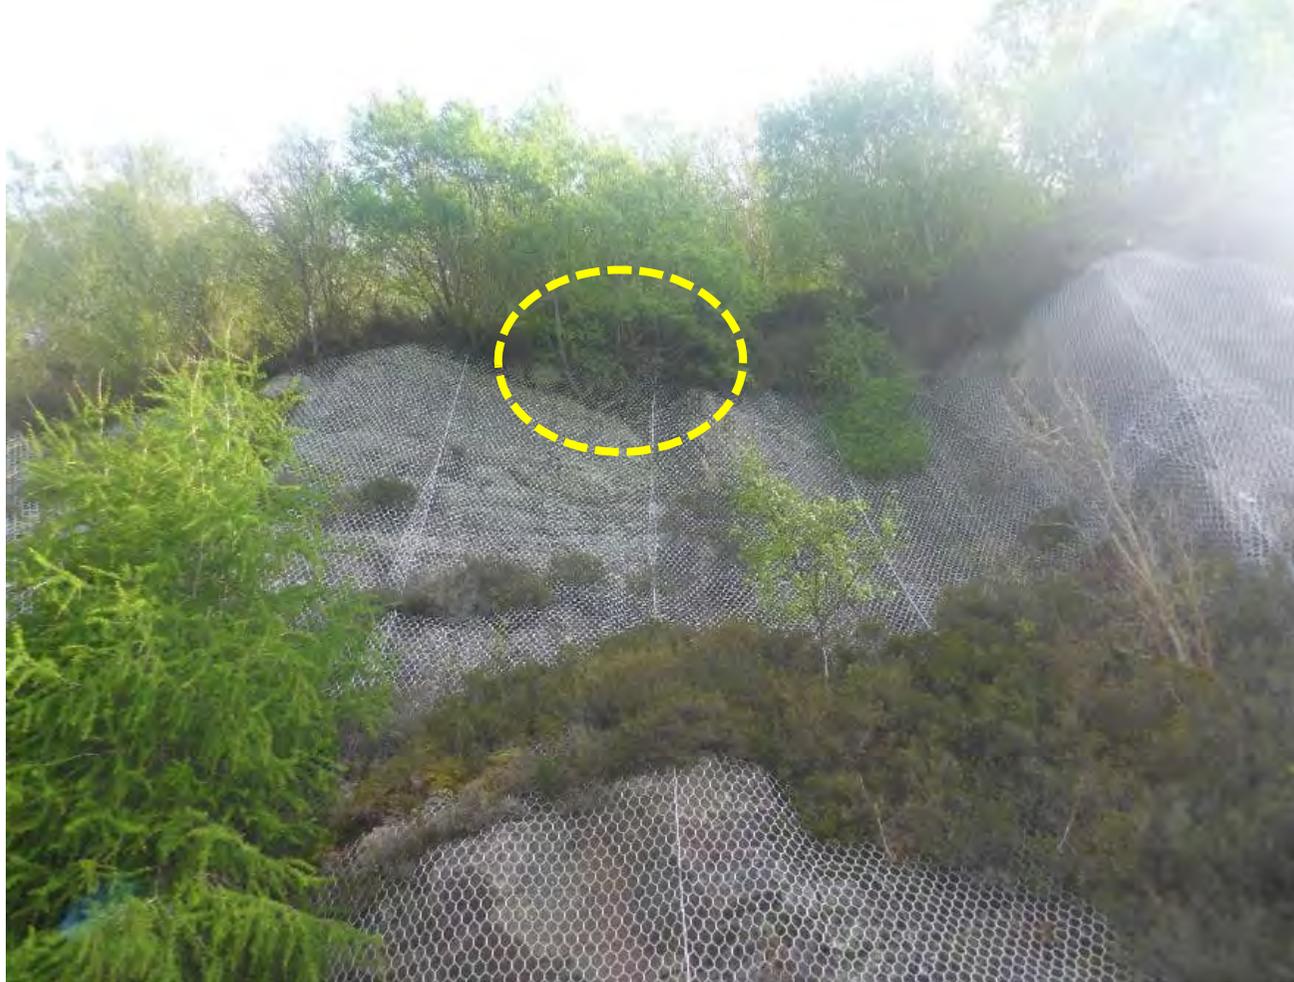
AA21-7	<p>Ch. 3363: Broken rock mass at crest. Root jacking an issue. Potential failure volume around 1 m³ (multiple blocks). Mesh should contain but would benefit from coppicing and light scaling. No change in condition 2025.</p>	Year First Observed:	2016
--------	---	----------------------	------

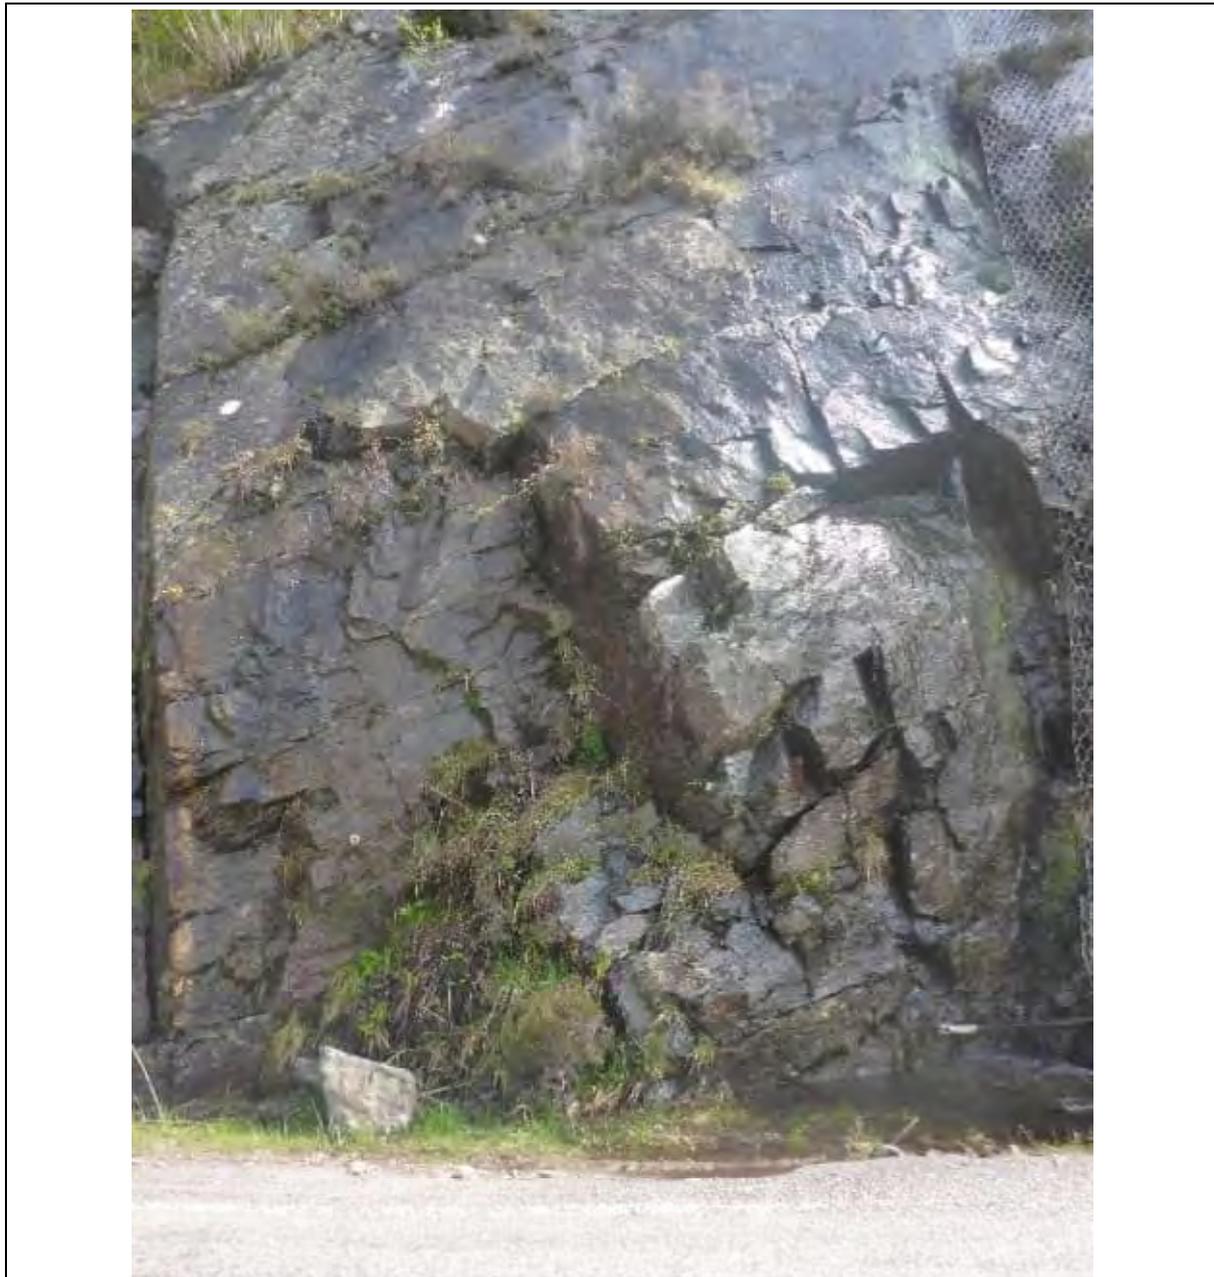
AA21-8	<p>Ch. 3371 to 3374: Dilated fractures on face of rock slope in area of water flow; freeze-thaw could lead to deterioration of some blocks. In 2025 a recent rock fall of 0.3 x 0.3 x 0.2 m block was observed in ditch with a source c. 4 to 5 m above road level. Potential for failure of further material present across lower half of rock slope; most would likely land in the ditch. Long-term, suggest extension of rock netting.</p>	Year First Observed:	2021
--------	--	----------------------	------

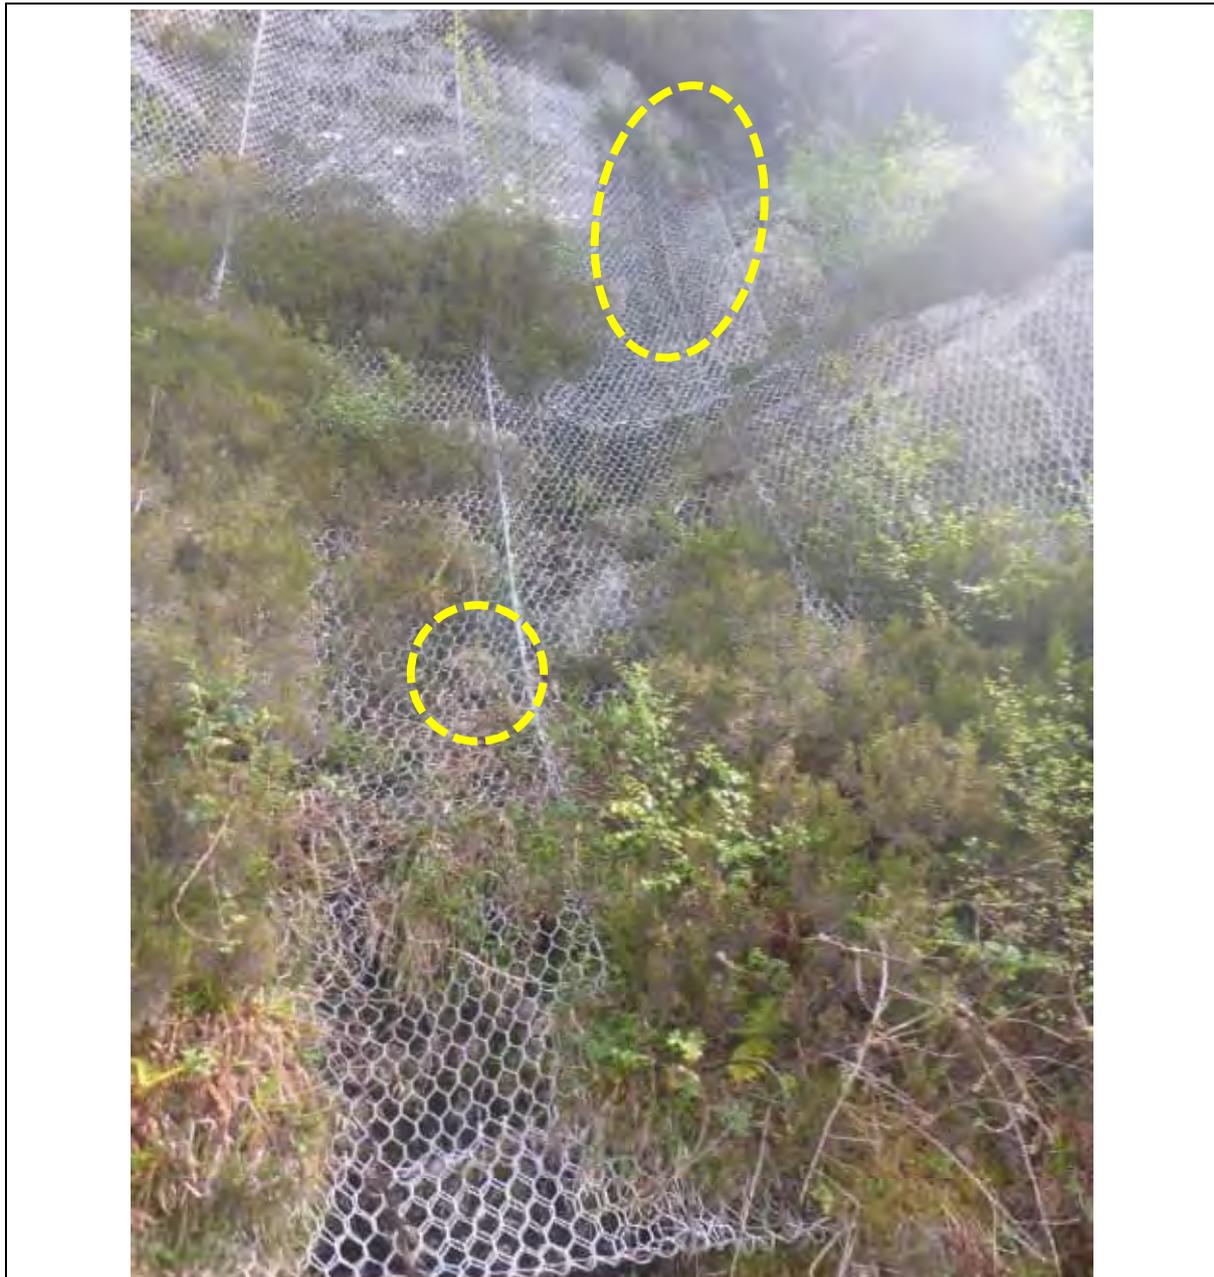
<p>AA22B-1</p>	<p>Ch. 3418: Maccaferri gapping towards top of the slope and not tight to rock face – no specific hazards observed but risk factor as suggest overhang is present and that falling blocks could strike netting with significant momentum. Small blocks present in the gully at 3 and at 8 m height. Netting undamaged.</p>	<p>Year First Observed:</p>	<p>2025</p>
----------------	--	-----------------------------	-------------

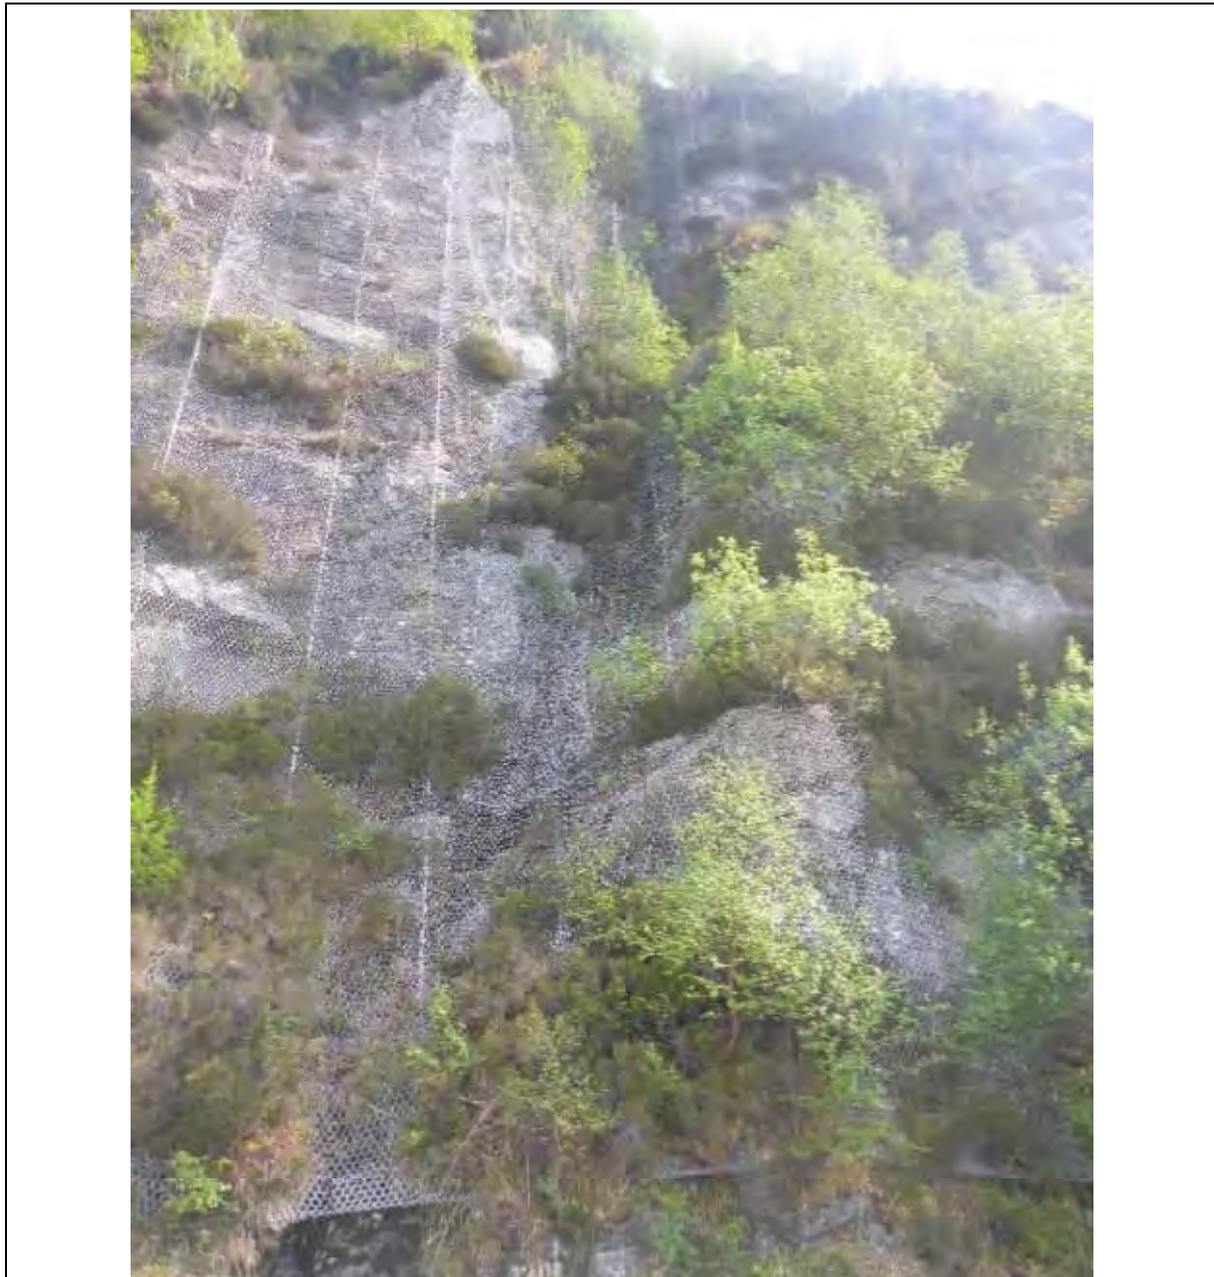
<p>AA22B-2</p>	<p>Ch. 3418: Maccaferri gaping towards top of the slope and not tight to rock face – no specific hazards observed but risk factor as suggest overhang is present and that falling blocks could strike netting with significant momentum. Small blocks present in the gully feature at 3 and at 8 m height. Netting undamaged. Cable in gully (dry at time of inspection) corroded; possibly an ephemeral watercourse.</p>	<p>Year First Observed:</p>	<p>2025</p>
----------------	--	-----------------------------	-------------

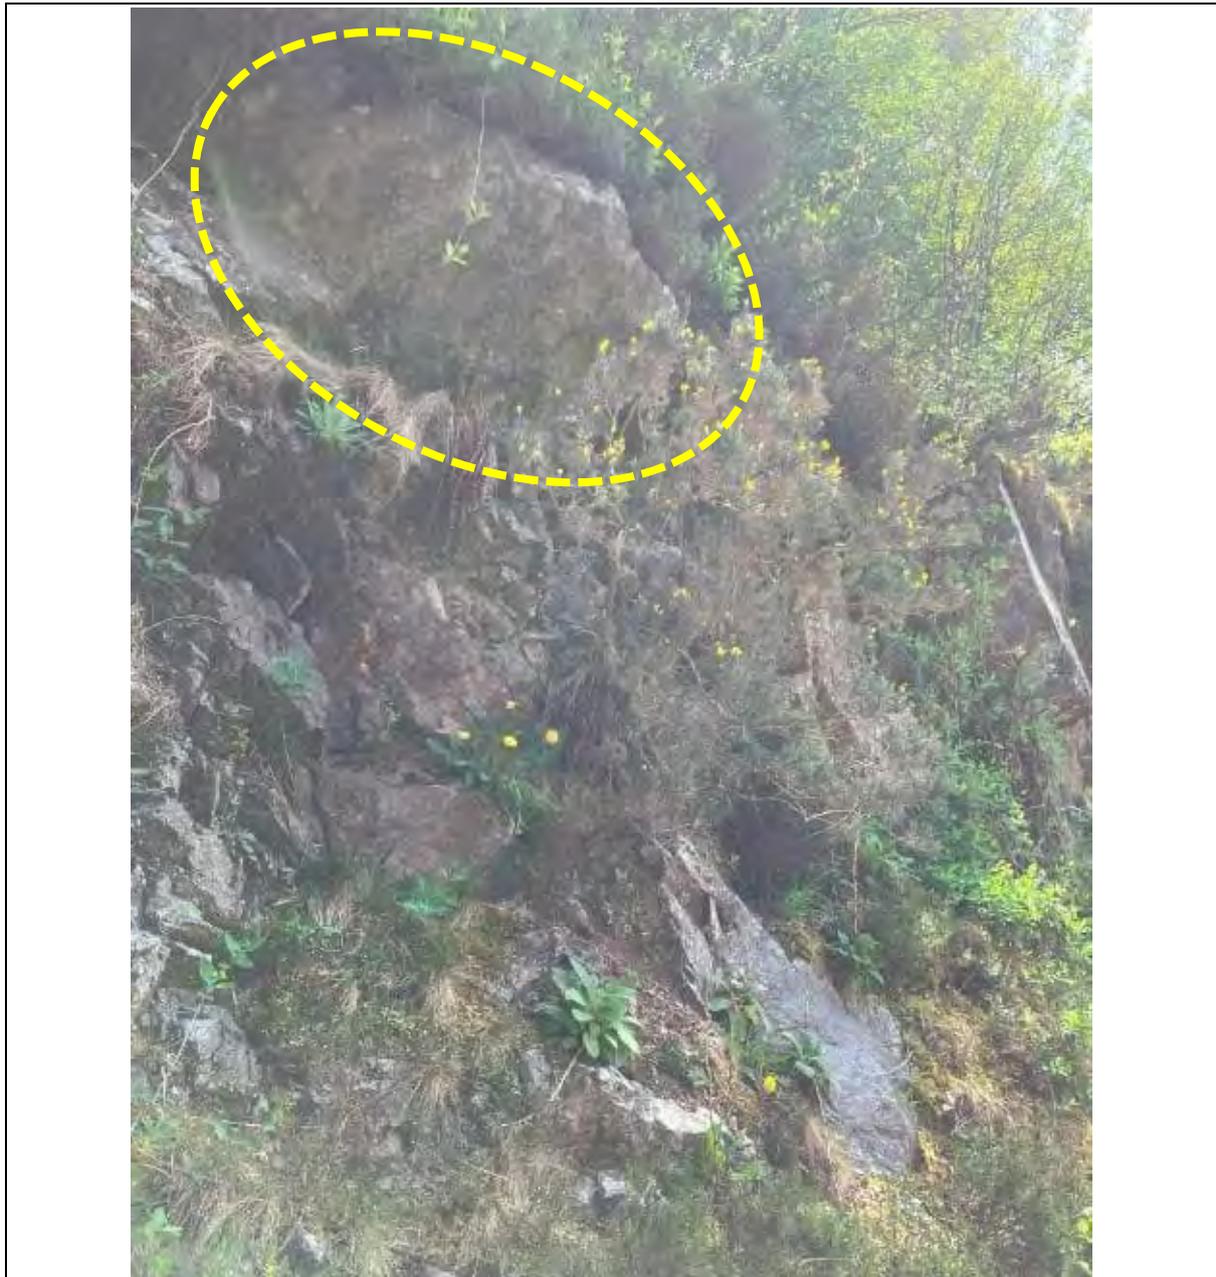
AA23S-1	Ch. 3655: Overhanging block (0.5 x 0.75 x 0.4 m) at 3 to 4 m above road level. Separated from face by blast induced fractures. If it were to fall it would most likely land on the verge.	Year First Observed:	2025
---------	--	----------------------	------

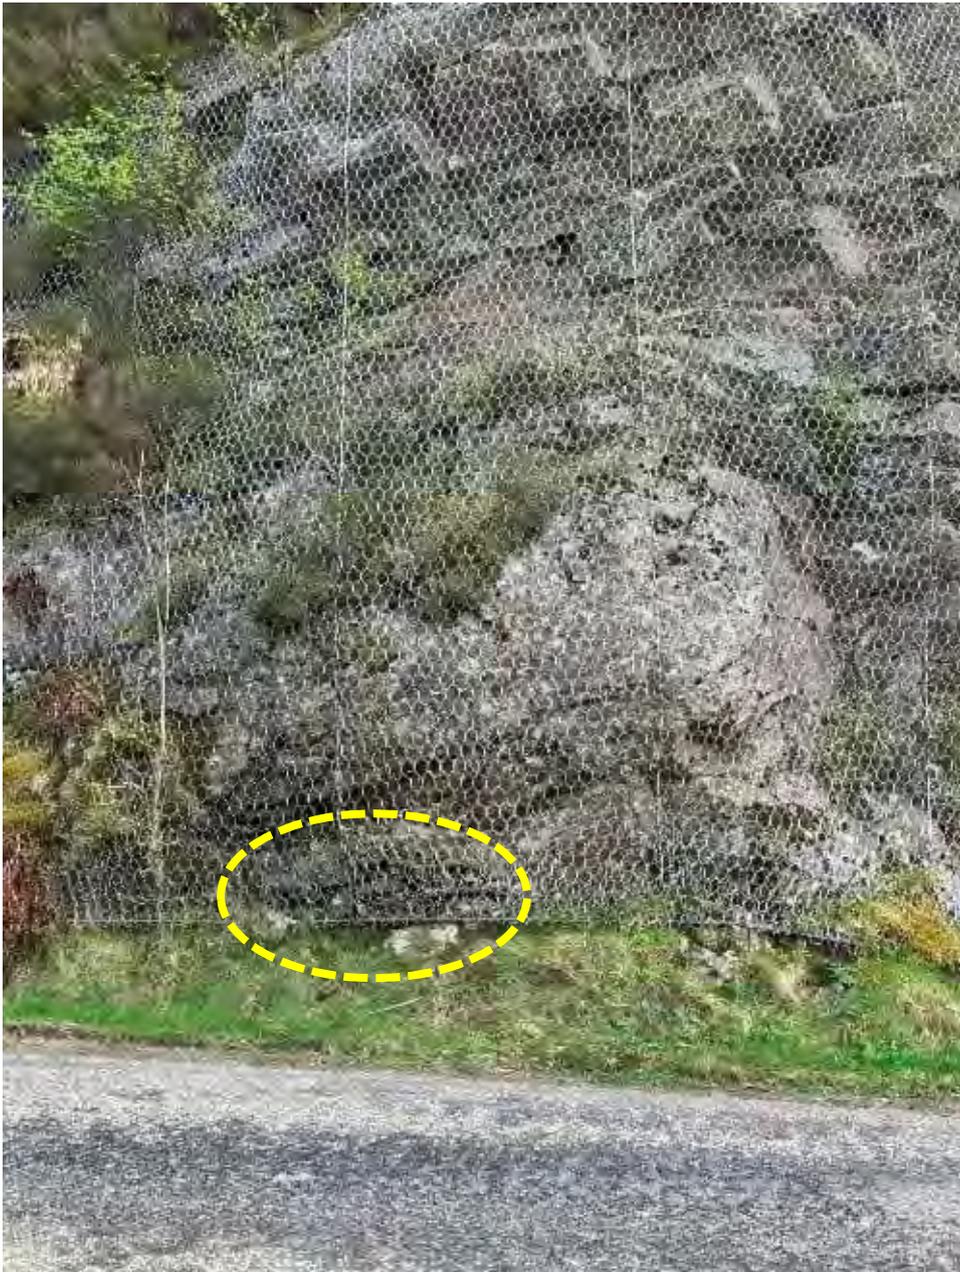
Ch. 3745	2024 Inspection: A rock fall has occurred which has been caught by the netting. Netting is now under tension but there is no damage to netting. Debris dimensions are 2 x 0.7 x 0.7 m. The source of the rock fall is c. 5 to 6 m above the toe of the slope from the base and side of an overhang. Recommend for light scaling to take place at the source and for the debris to be cleared.	No changes observed during 2025 inspection.	
Ch. 3745 to 3755	2024 Inspection: The Maccaferri netting does not extend to the crest of the slope but stops at a small ledge c. 3 to 4 m down from the crest. Rock exposures above netting inspected and no concerns over stability.	No changes observed during 2025 inspection.	
Ch. 3753	2021 Inspection: Small accumulation of debris at toe of slope behind netting c. 1 x 0.4 x 0.2 m. Source c. 4 m above toe. Material not loading net. Keep under observation.	No changes observed during 2025 inspection.	AA24-1

AA24-1	Ch. 3753: Small accumulation of debris at toe of slope behind netting c. 1 x 0.4 x 0.2 m. Source c. 4 m above toe. First observed 2021 and no significant change since.	Year First Observed:	2021
--------	--	----------------------	------

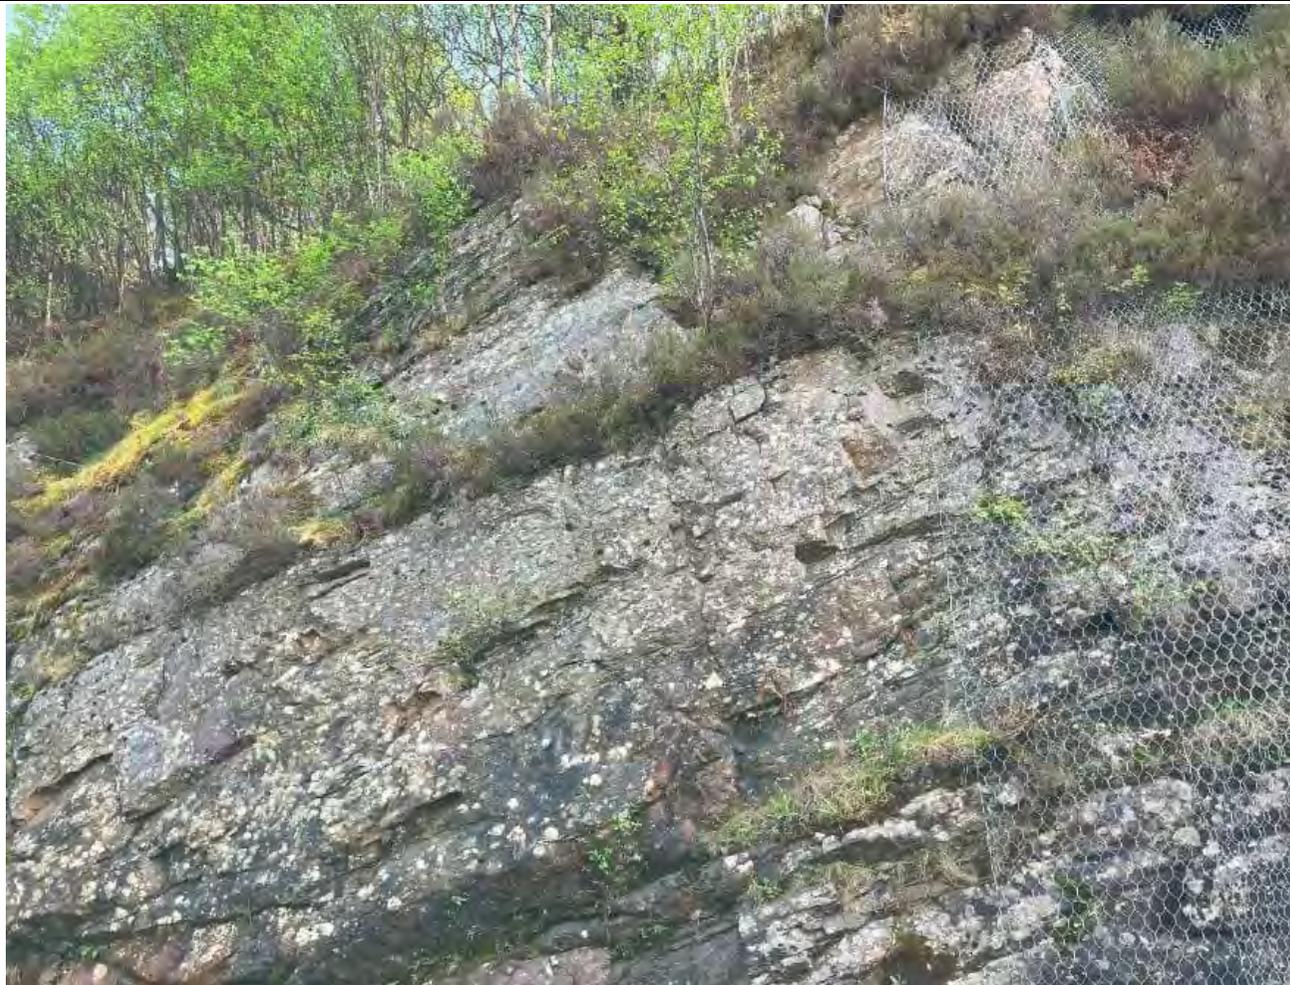
Ch. 3762 to 3800	2016 Inspection: Trees at crest of slope could cause block fall associated with root jacking / uprooted trees.	Active root jacking noted across the slope; failing blocks would likely land in the ditch.	AA24-2
Ch. 3783 to 3792	2016 Inspection: Exposed soil slope 4 m above road level with boulders in back scar of previous failure which could weather out and reach road. Slumping is also noted upslope from back scar.	No changes observed during 2025 inspection.	AA24-3
Ch. 3783 to 3892	2017 Inspection: Potential for ravelling of small blocks, however, ditch below sufficiently wide/deep to retain.	No changes observed during 2025 inspection.	
Ch. 3790	2017 Inspection: Broken rock at crest of slope. Likely to be caught by ditch but should remain under inspection.	Evidence of root jacking.	
Ch. 3810	2019 Inspection: 0.4 x 0.3 x 0.2 m block in ditch. Source not obvious but recent (no paint).	No changes observed during 2025 inspection.

AA24-2	<p>Ch. 3762 to 3800: In 2016 trees at crest of slope were highlighted as having potential to cause block fall associated with root jacking / uprooted trees. In 2025 root jacking was observed locally; failing blocks would likely land in the ditch.</p>	Year First Observed:	2016
--------	---	----------------------	------

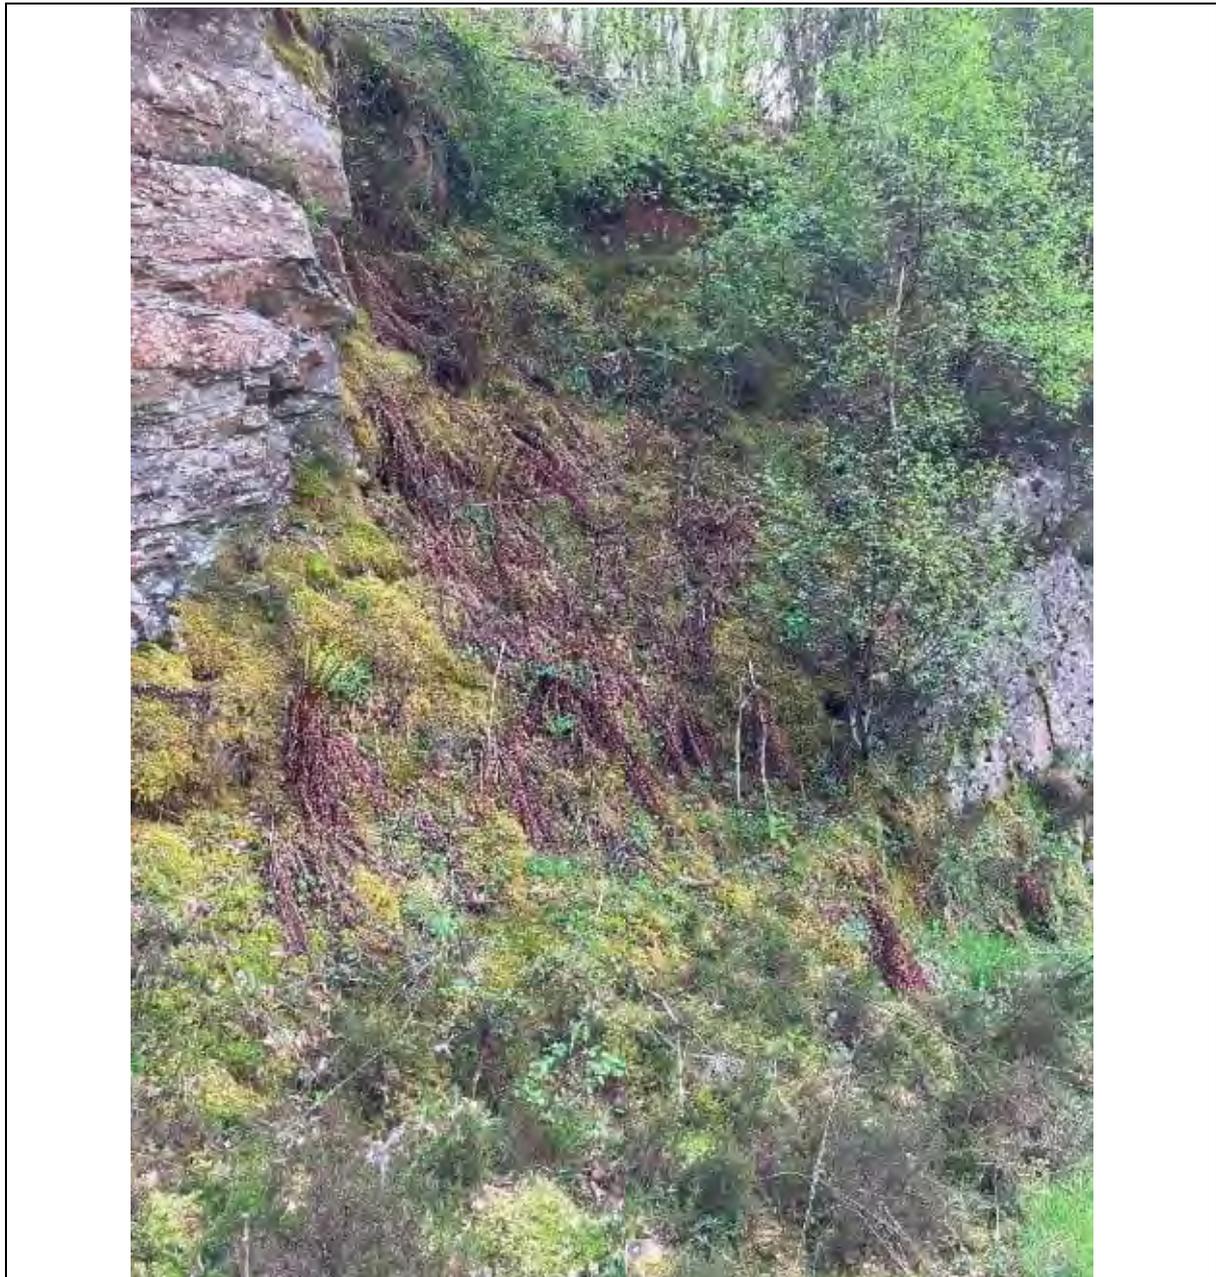
<p>AA24-3</p>	<p>Ch. 3783 to 3792: Exposed soil slope 4 m above road level with boulders in back scar of previous failure which could weather out and reach road. Slumping is also noted upslope from back scar. First observed 2016. No significant change 2025.</p>	<p>Year First Observed:</p>	<p>2016</p>
---------------	---	-----------------------------	-------------

Recommended Remedial Works / Actions					
Large Scale Rock Fall Protection Works (Category 3)		Localised Targeted Rock Fall Protection Works (Category 2)		Ongoing Maintenance (Category 1)	
N//A		<ul style="list-style-type: none"> Ch.3783 to 3790: Re-profile vertical soil slope and install erosion control matting. 		<ul style="list-style-type: none"> Coppice trees within 5 m of crest of rock face between Ch. 3762 and 3800. Build-up of debris in ditch should be monitored and clearance works undertaken as required to maintain its capacity. At Ch. 3745 light scaling and debris clearance from rock fall recorded in 2024 inspection. Ch. 3892 – consider replacing the sign with phone number to call in case of a rock fall before it becomes illegible. 	
Assessed in field by:	SF/MT	Date:	30/05/2025	Reviewed by:	MT
		Date:			Date: 27/06/2025
