A890 Stromeferry Bypass

Annual Slope Inspection 2025

The Highland Council

Project number: 60685712
AECOM Report Ref.: GLRP0010

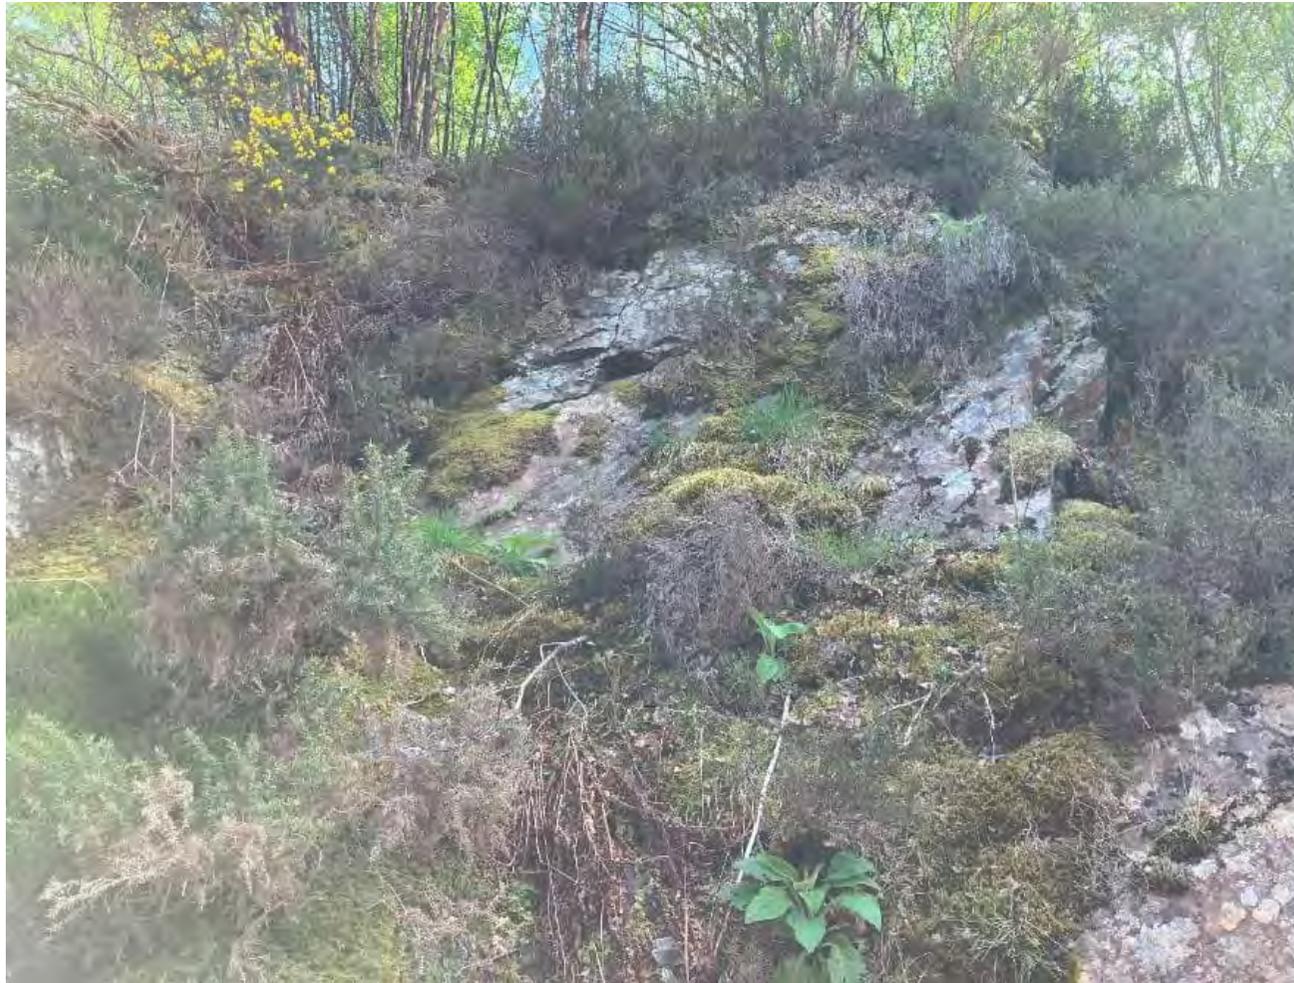
Ch. 3870	2017 Inspection: Potential planar failure 3 m above road. Small tabular blocks likely to be contained by ditch below. 2023 Inspection: A new block has landed in the ditch, confirming this ongoing planar failure mechanism.	No changes observed during 2025 inspection.	AA24-4
Ch. 3892	2024 Inspection: Phone number on the sign by the road closure gates is starting to weather off.	Phone number has deteriorated further. Consider replacing before number become illegible.	AA24-5

<p>AA24-4</p>	<p>Ch. 3870: Potential for planar failure of rock first noted in 2017 3 m above the road, with small tabular blocks likely to be contained within the ditch below. A small block was noted in the ditch during the 2023 annual inspection, with the size and shape confirming failure was planar. No change in condition was recorded in 2025.</p>	<p>Year First Observed:</p>	<p>2017</p>
---------------	---	-----------------------------	-------------

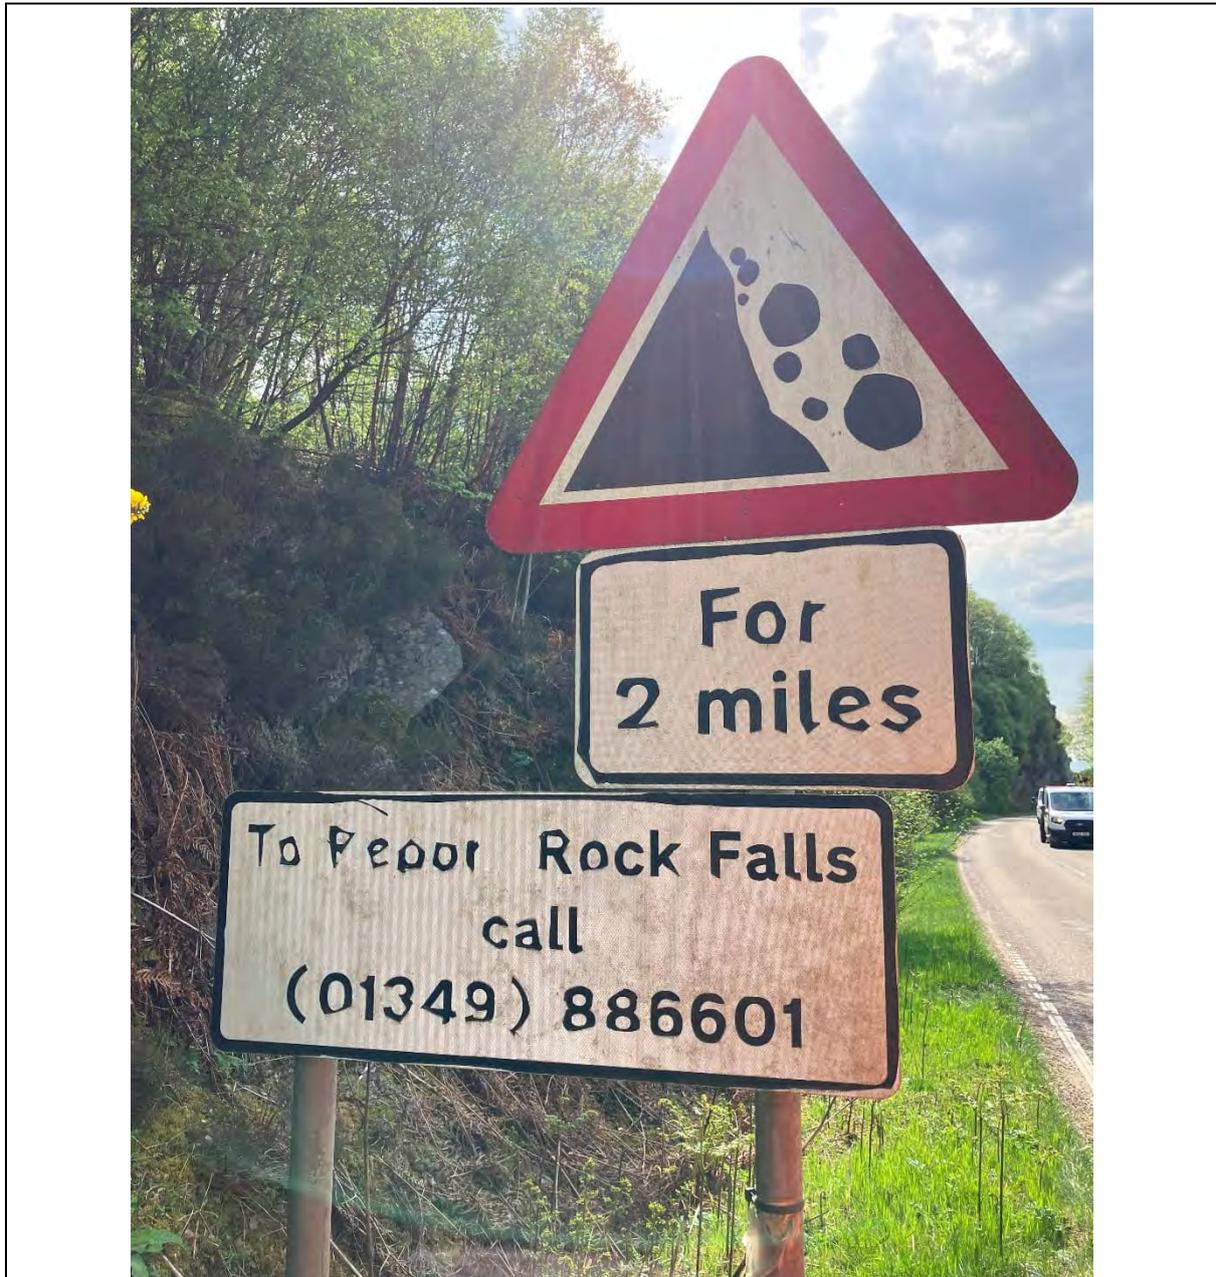
<p>AA24-5</p>	<p>Ch. 3892: Phone number on the sign by the road closure gates is starting to weather off and has deteriorated since the previous (2024) inspection. Consider replacing before number become illegible.</p>	<p>Year First Observed:</p>	<p>2024</p>
---------------	--	-----------------------------	-------------

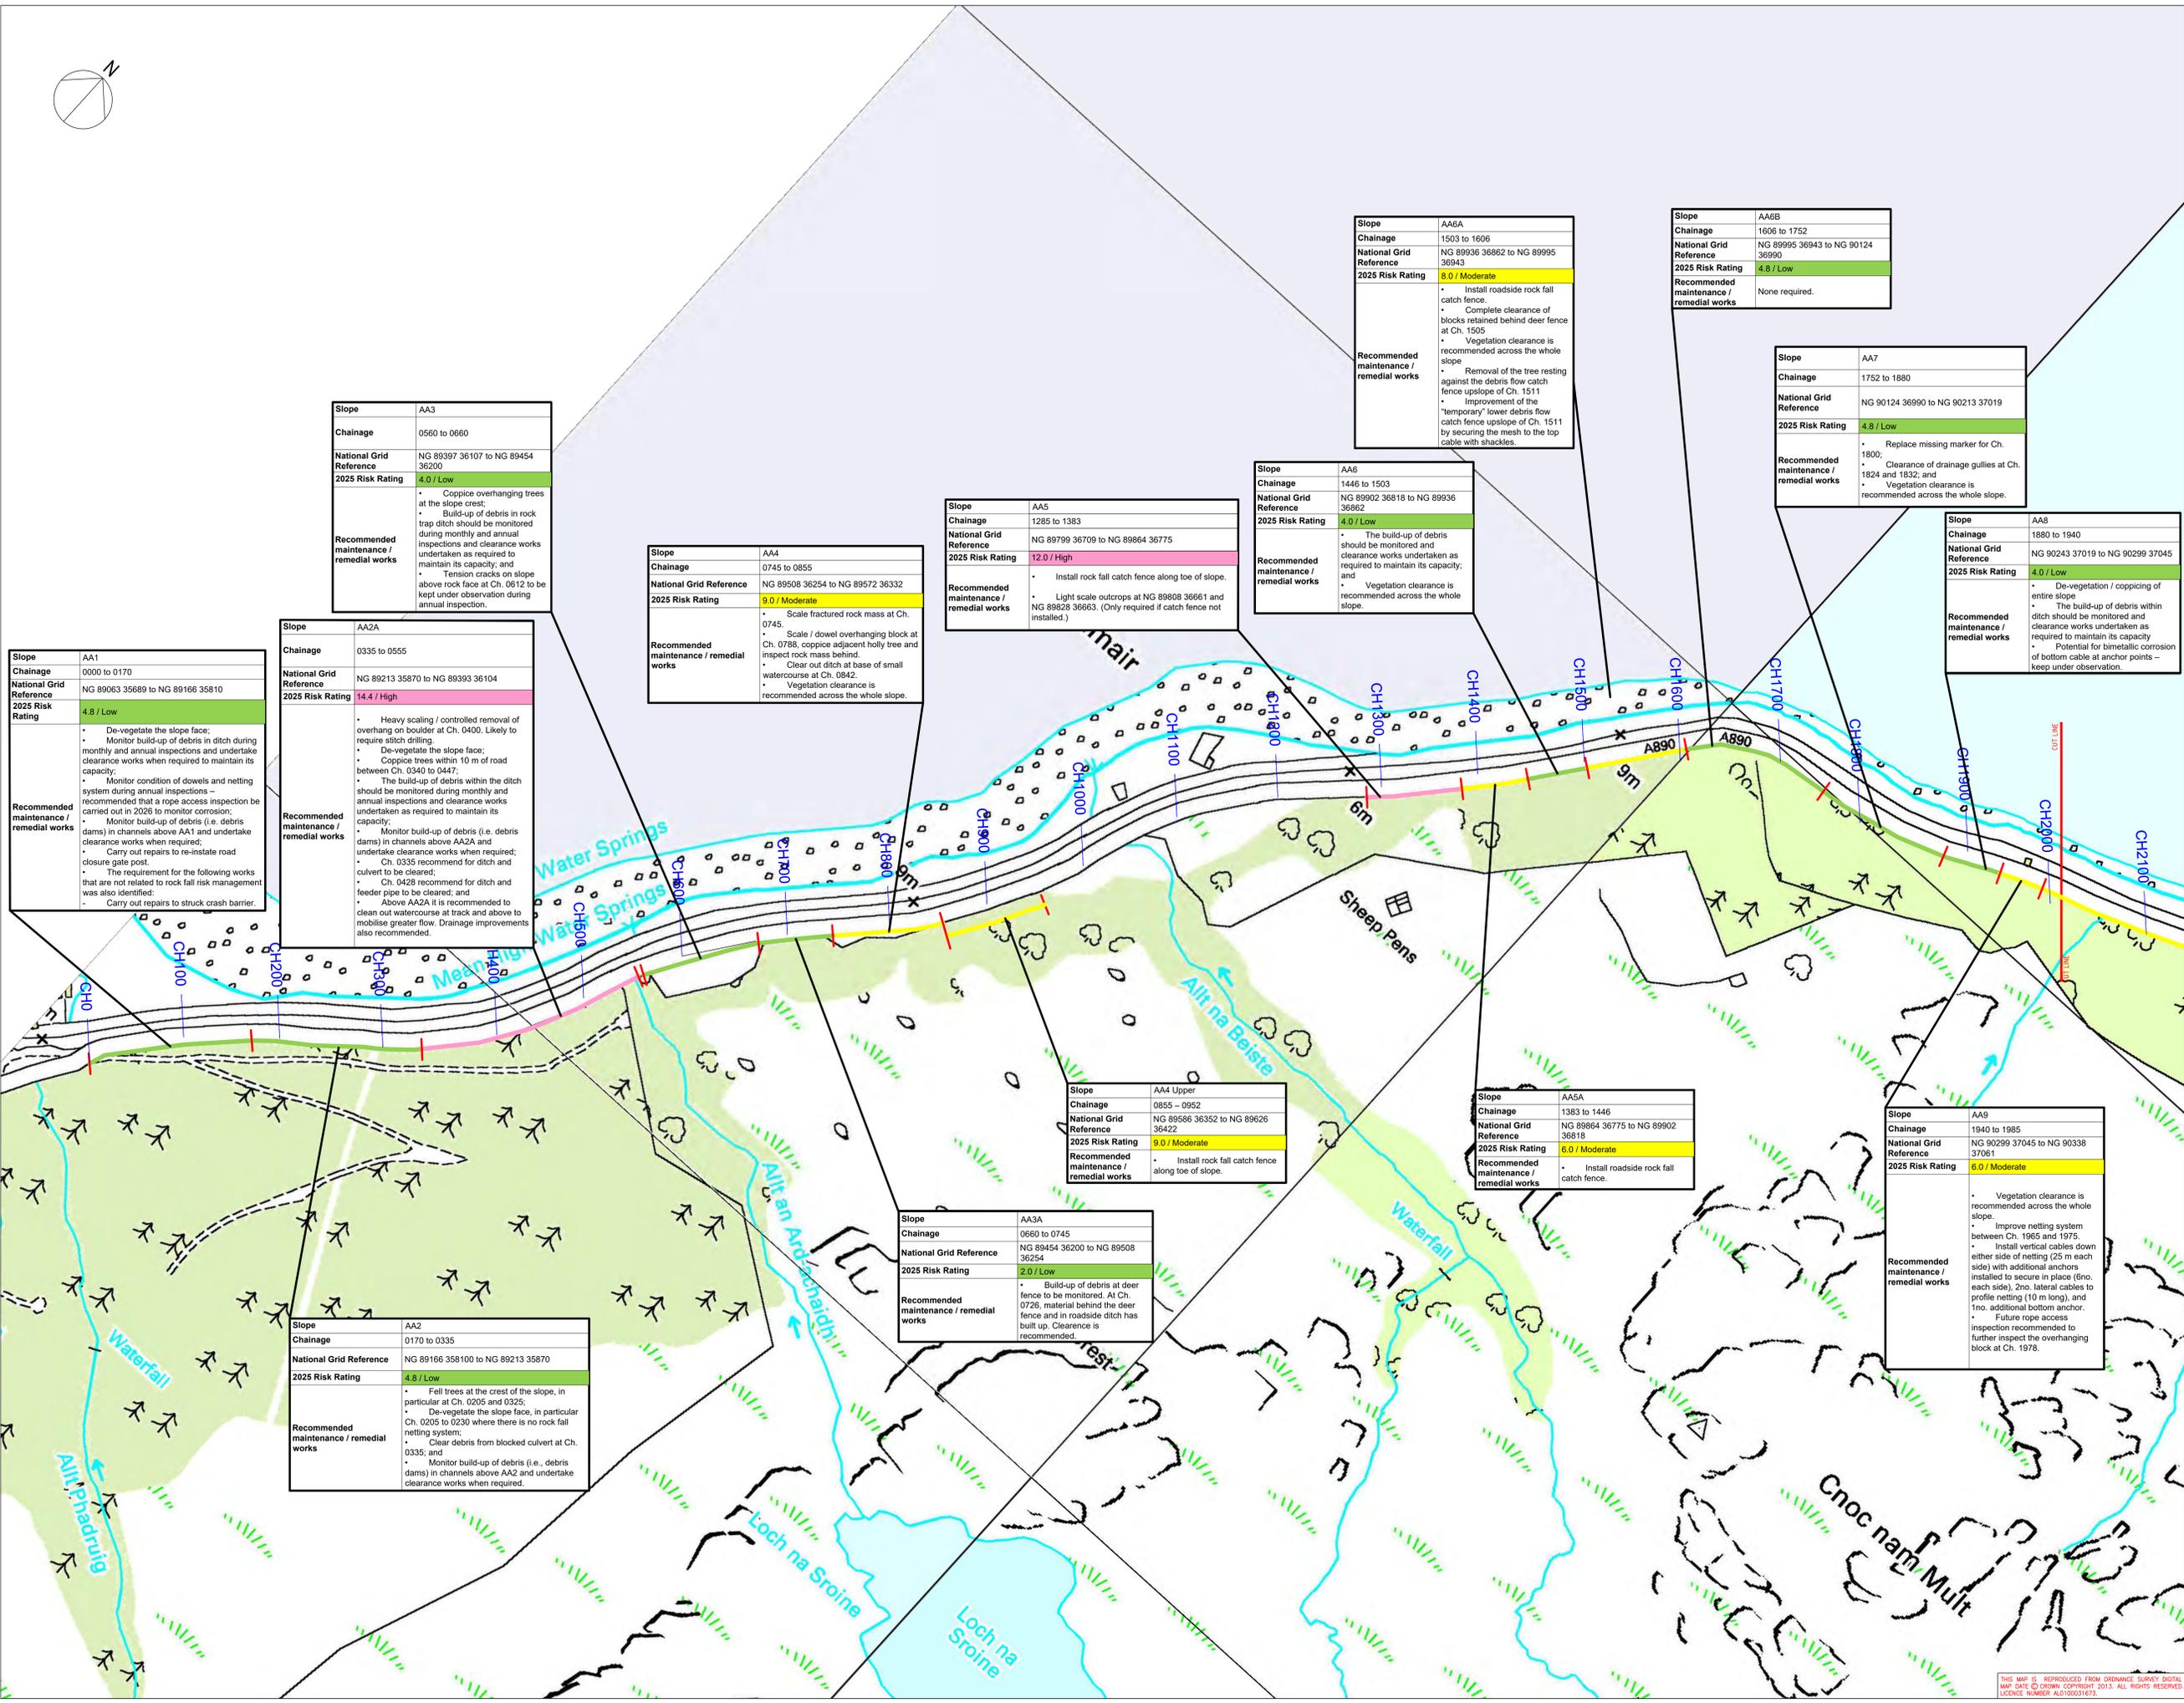
Slope AA3 data table: Chainage 0560 to 0660, National Grid Reference NG 89397 36107 to NG 89454 36200, 2025 Risk Rating 4.0 / Low. Remedial works include coppicing trees and debris removal.

Slope AA2A data table: Chainage 0335 to 0555, National Grid Reference NG 89213 35870 to NG 89393 36104, 2025 Risk Rating 14.4 / High. Remedial works include heavy scaling and controlled removal of overhangs.
