# A890 Strome ferry Bypass

Annual Slope Inspection 2026

The Highland Council

Project number: 60685712  
AECOM Report Ref.: GLRP0013

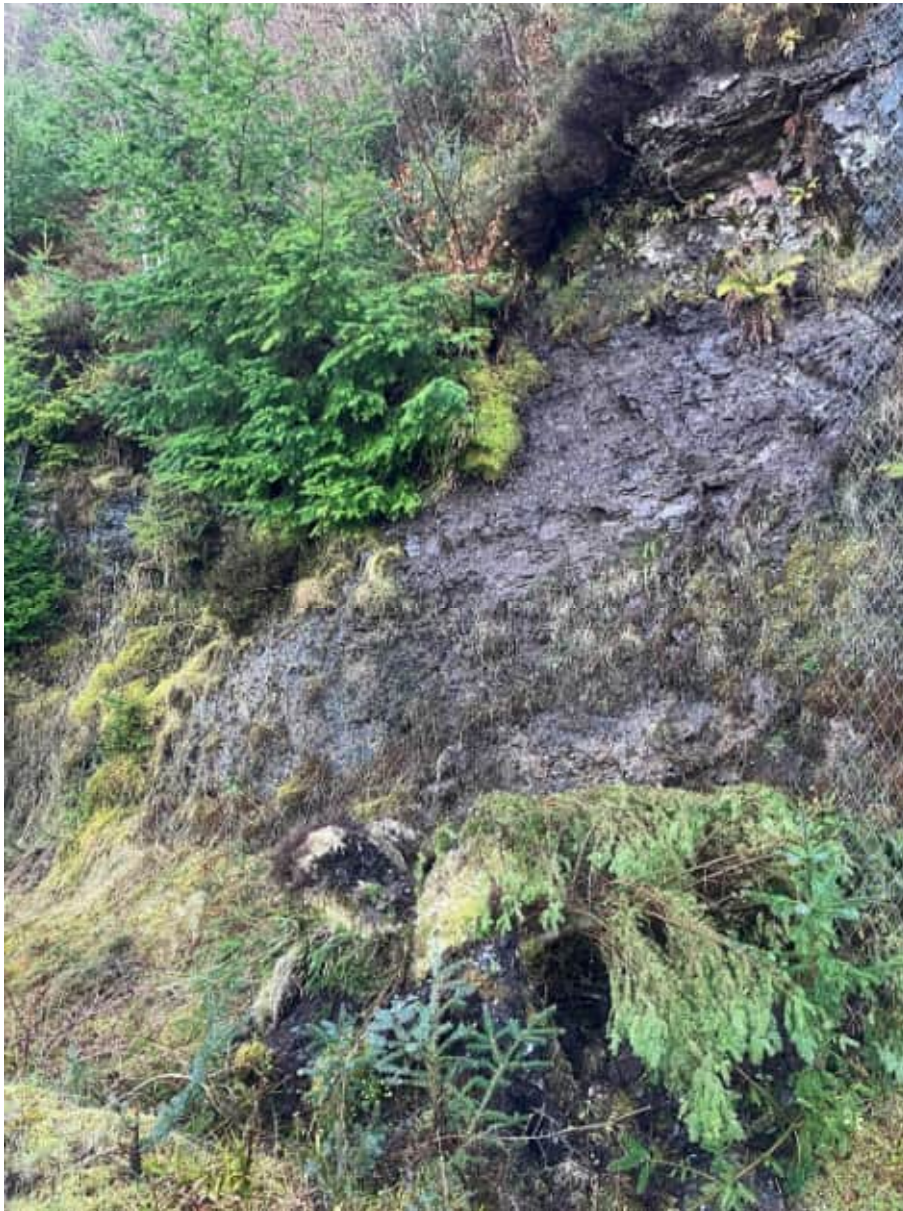
| AA1-2 | <p>Ch. 0166:</p> <p>2026: A small tree fall approx. 3 to 5 m above road level has resulted in a small soil slip / slump, creating an overhang on the exposed rock face. Overhang would most likely drop into the ditch and is not considered to pose a risk to the road. A second tree appears likely to fall in the short-term.</p> | <p>Year First Observed:</p> | 2026 |

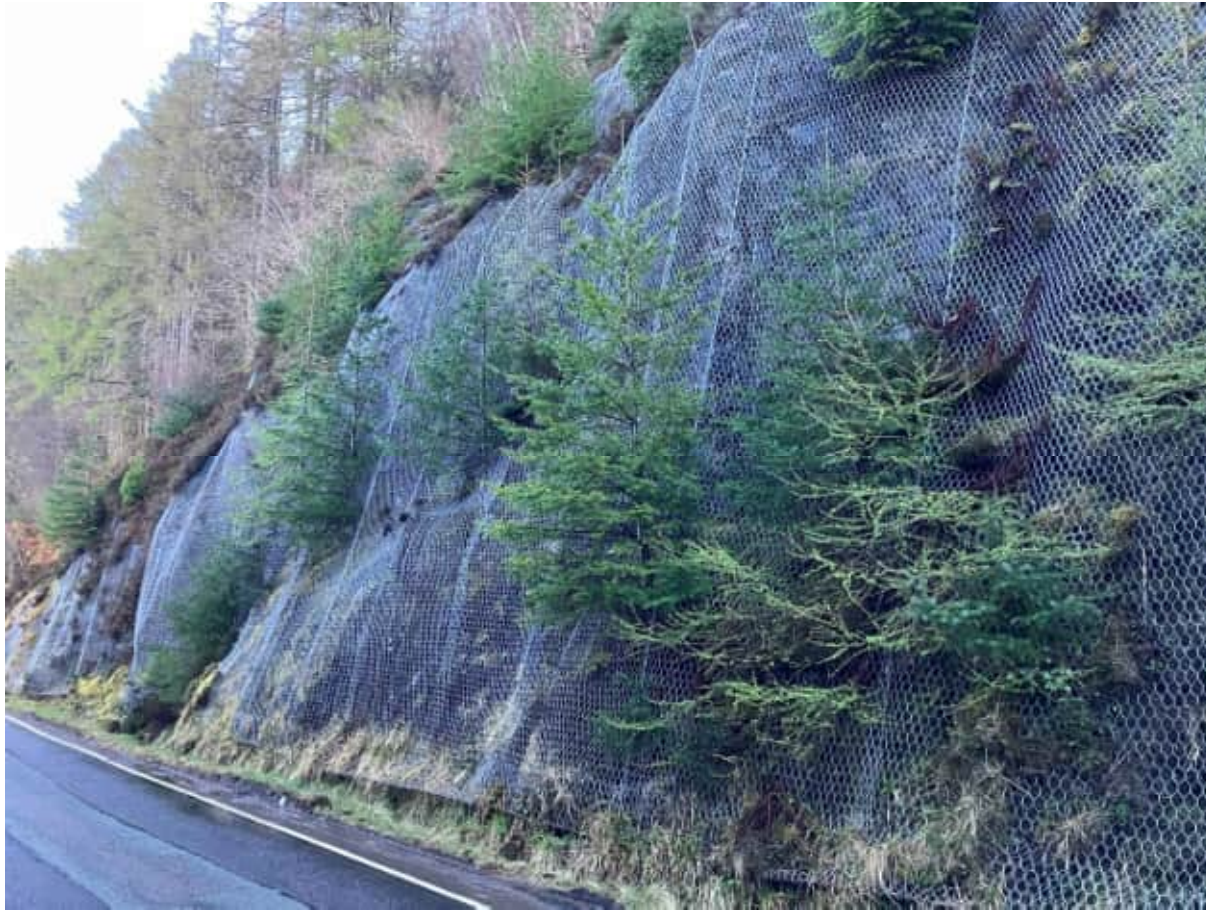
AA2-1

Netting system from Ch. 0170 to 0202 and Ch. 0230 to 0292 installed before AECOM involvement (i.e., pre-2012). Generally, in good condition, although the bottom cable is corroded around Ch. 0273. Vegetation regrowth increases the potential for rock falls due to root jacking.

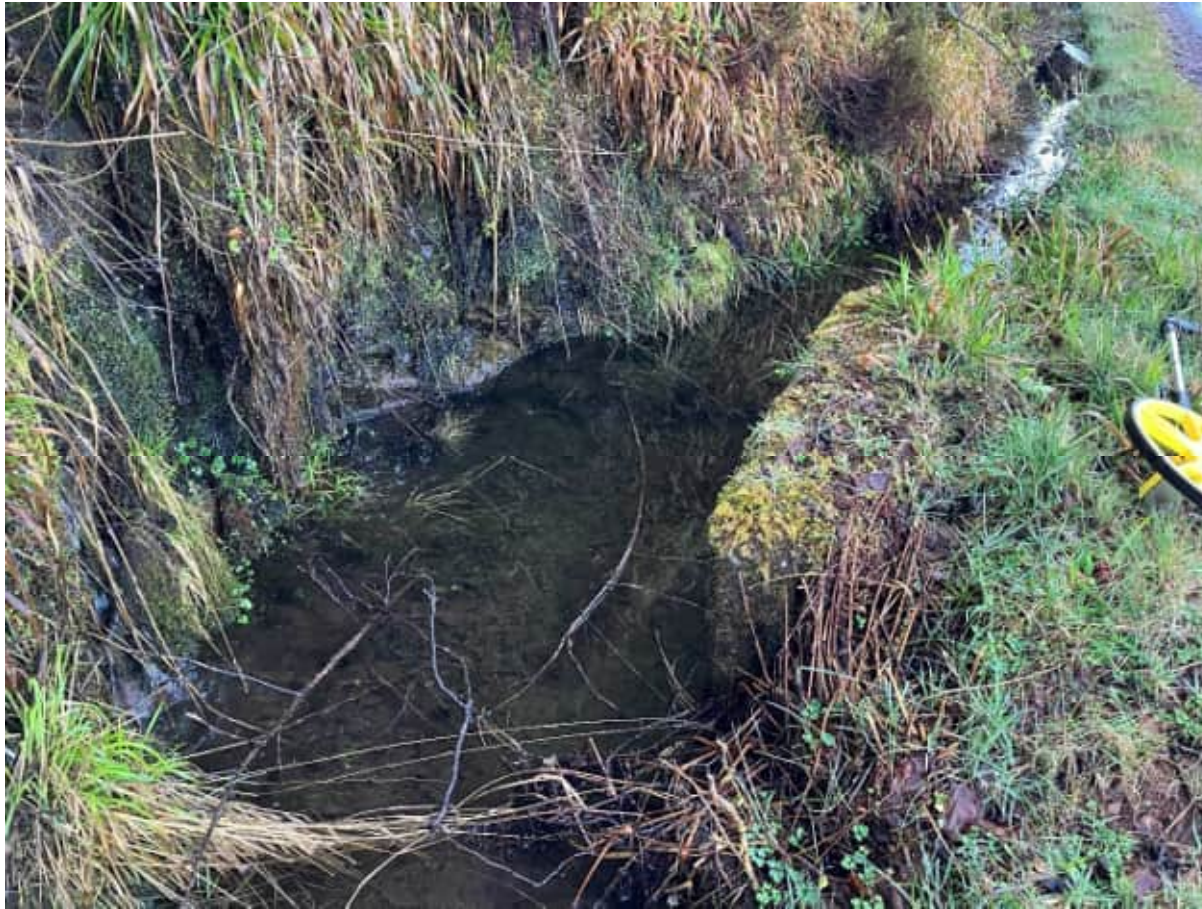
| AA2-2 | <p>2021 – Phase 12 works: Clearance of roadside ditch from Ch. 0310 to 0335 and drainage gully at Ch. 0335 cleaned out at roadside.</p> <p>2022: Culvert at Ch. 0335 would benefit from clearance again.</p> <p>2023: Culvert at Ch. 0335 is c. 50% full.</p> <p>2024: No changes observed during 2024 inspection. Culvert was clear.</p> <p>2025: Culvert at Ch. 0335 is completely blocked by organic debris. Required to be cleared.</p> <p>2026: Culvert remains blocked. Ditch is backfilling with water.</p> | Year First Observed: | 2021 |

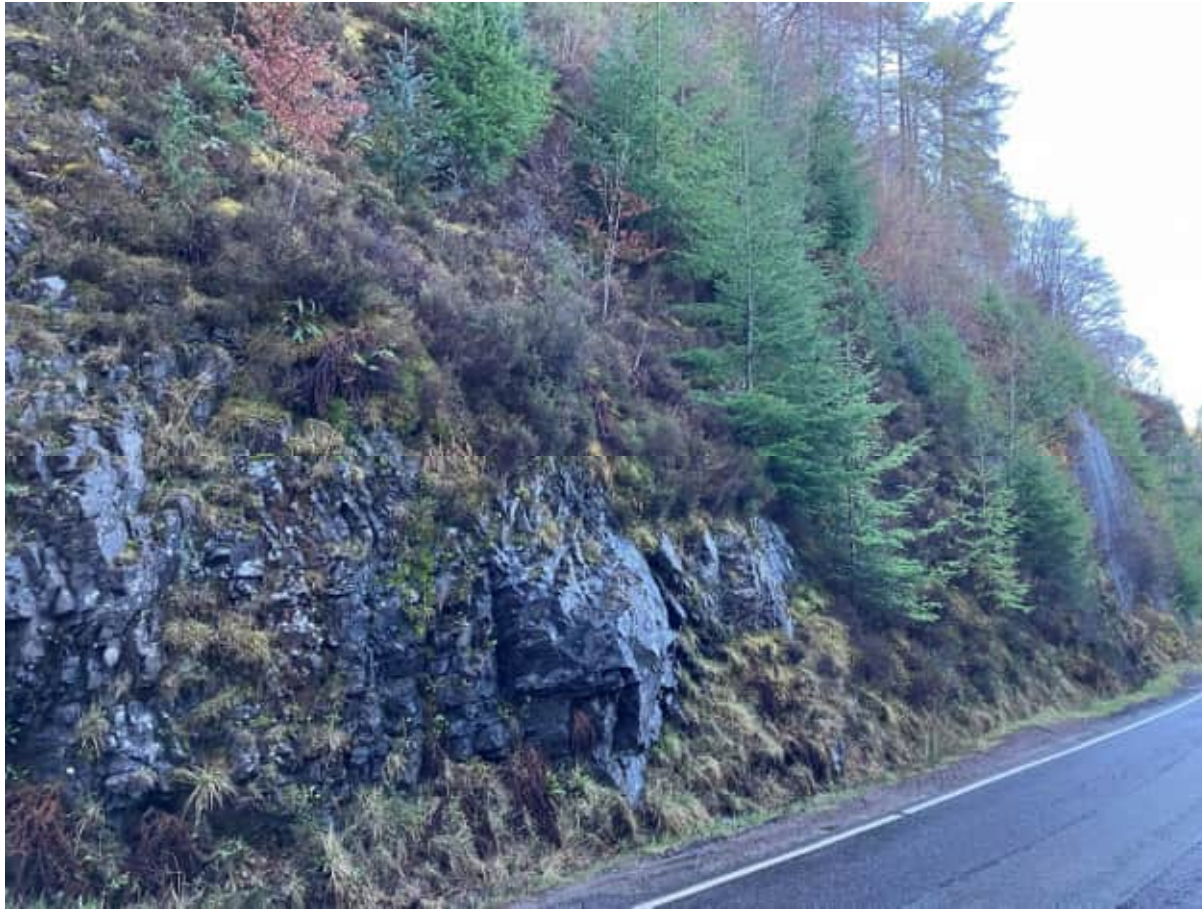
| AA2-3 | <p>Ch. 0205 to 0230:</p> <p>2019: No remedial measures over rock face in this area. Almost 70% vegetation cover including small coniferous saplings. Root jacking may become an issue - potential for small block fall &lt;0.1 m3. Keep under observation.</p> <p>2025: Almost no visibility of the rock face due to significant immature tree cover. Potential for root jacking. De-vegetation recommended.</p> <p>2026: No changes observed during 2026 inspection.</p> | Year First Observed: | 2019 |

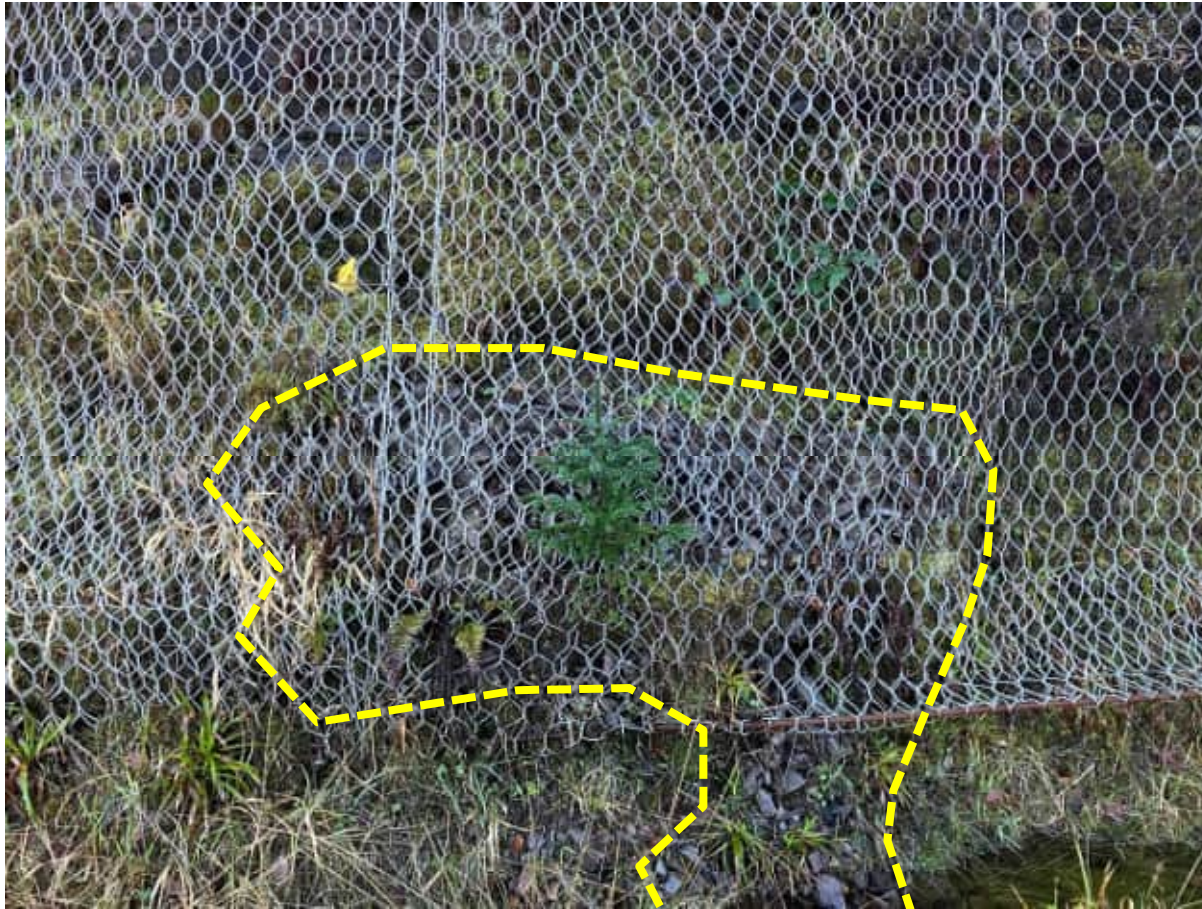
| AA2-4 | <p>Ch. 0278:</p> <p>2017: Debris continues to build up behind netting. Not currently loading system significantly. In 2021, it was noted that some of the material had fallen out of base of netting and into ditch below.</p> <p>2026: No changes observed during 2026 inspection.</p> | Year First Observed: | 2017 |

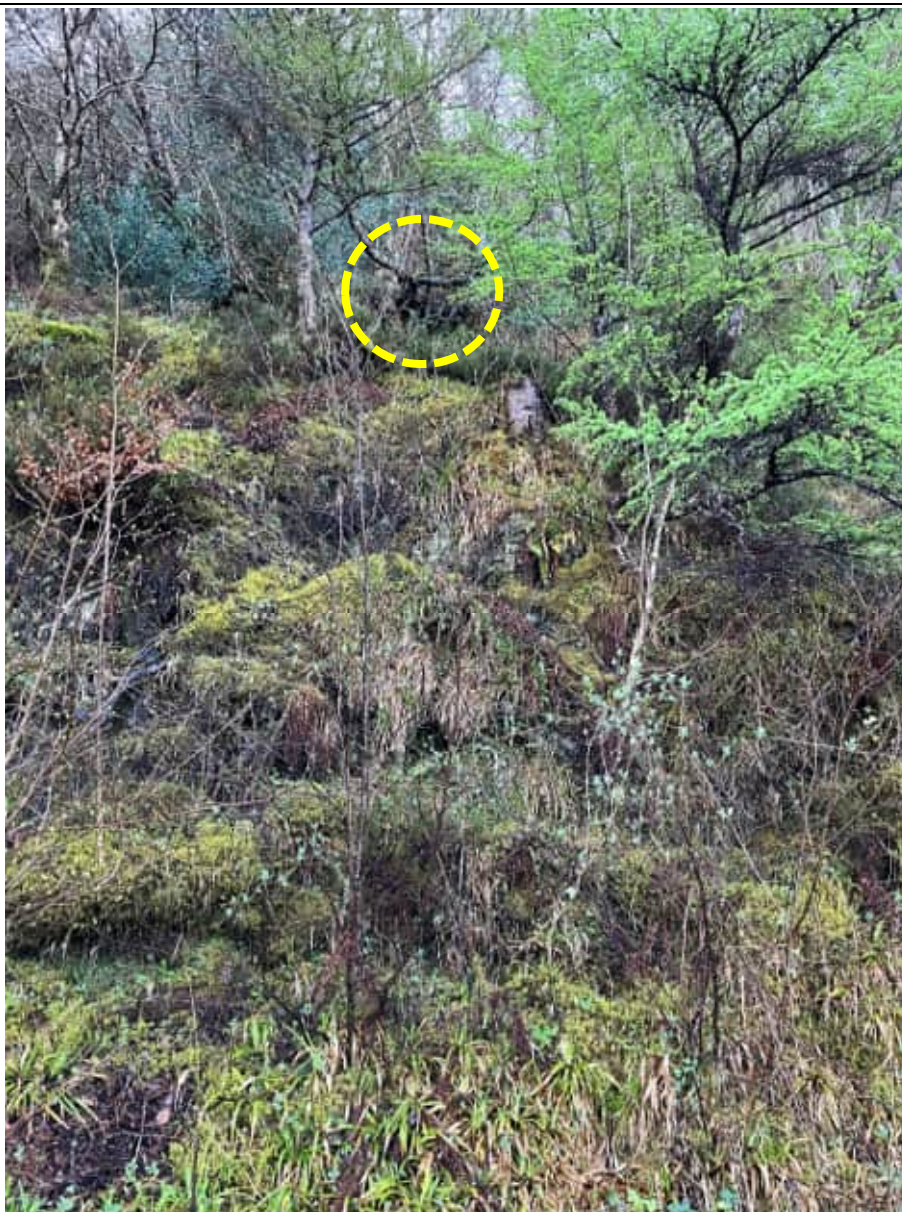
| AA2-5 | <p>Ch. 0328:</p> <p>2026: Two blocks present in the base of the ditch, the largest block is approx. 0.3 x 0.3 x 0.3 m. Origin of blocks is unclear as the slope is too heavily vegetated to fully assess the source, possibly ravelled out of a root ball approx. 8 m above road level.</p> | Year First Observed: | 2026 |

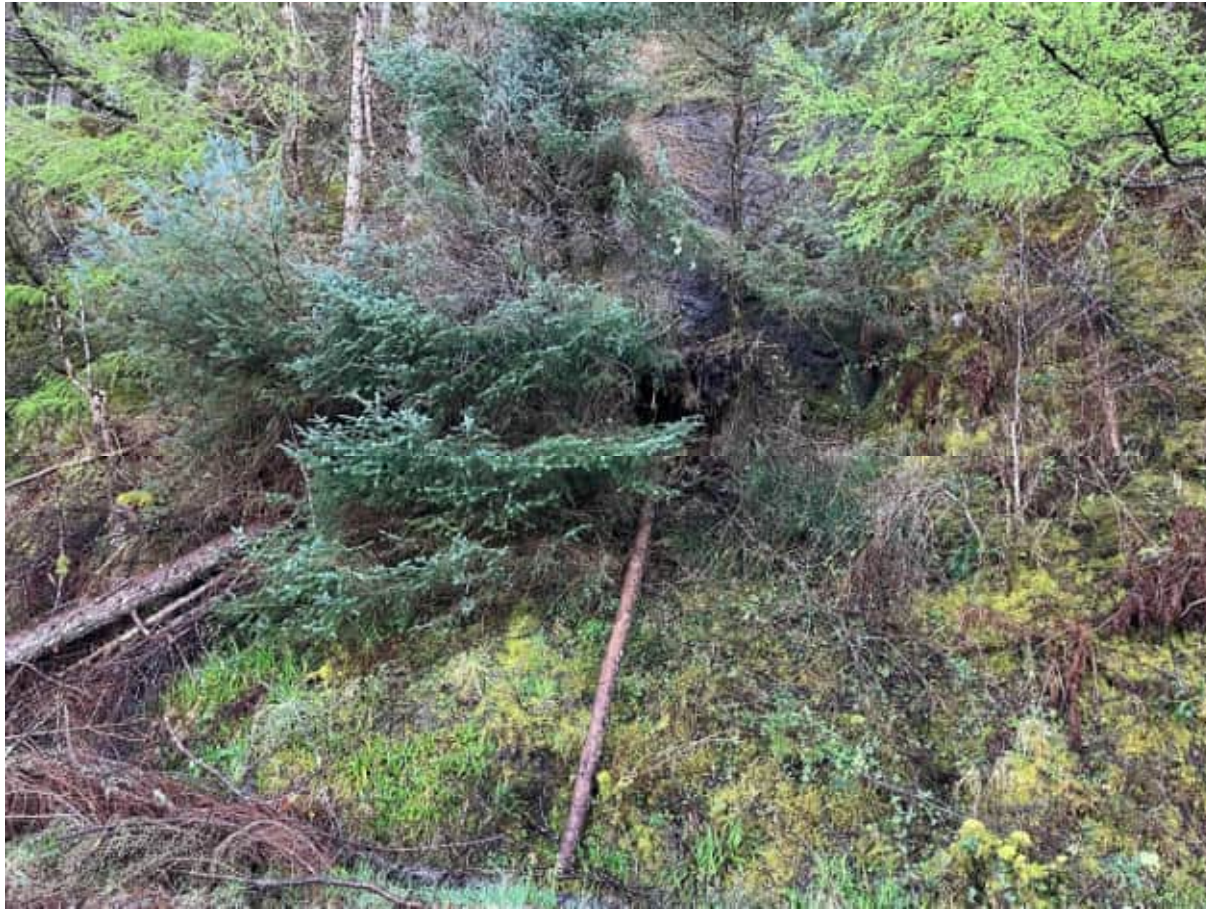
| AA2A-1 | <p>Ch. 0350 to 0356:</p> <p>2026: Three/four trees have fallen from the slope. Deadwood material has been trimmed back and waste left in the roadside ditch, which is completely blocked and requires clearance. Exposed rock scar, between 6 and 12 m above road level, appears reasonably competent and does not represent a significant ongoing risk of rockfall.</p> | Year First Observed: | 2026 |

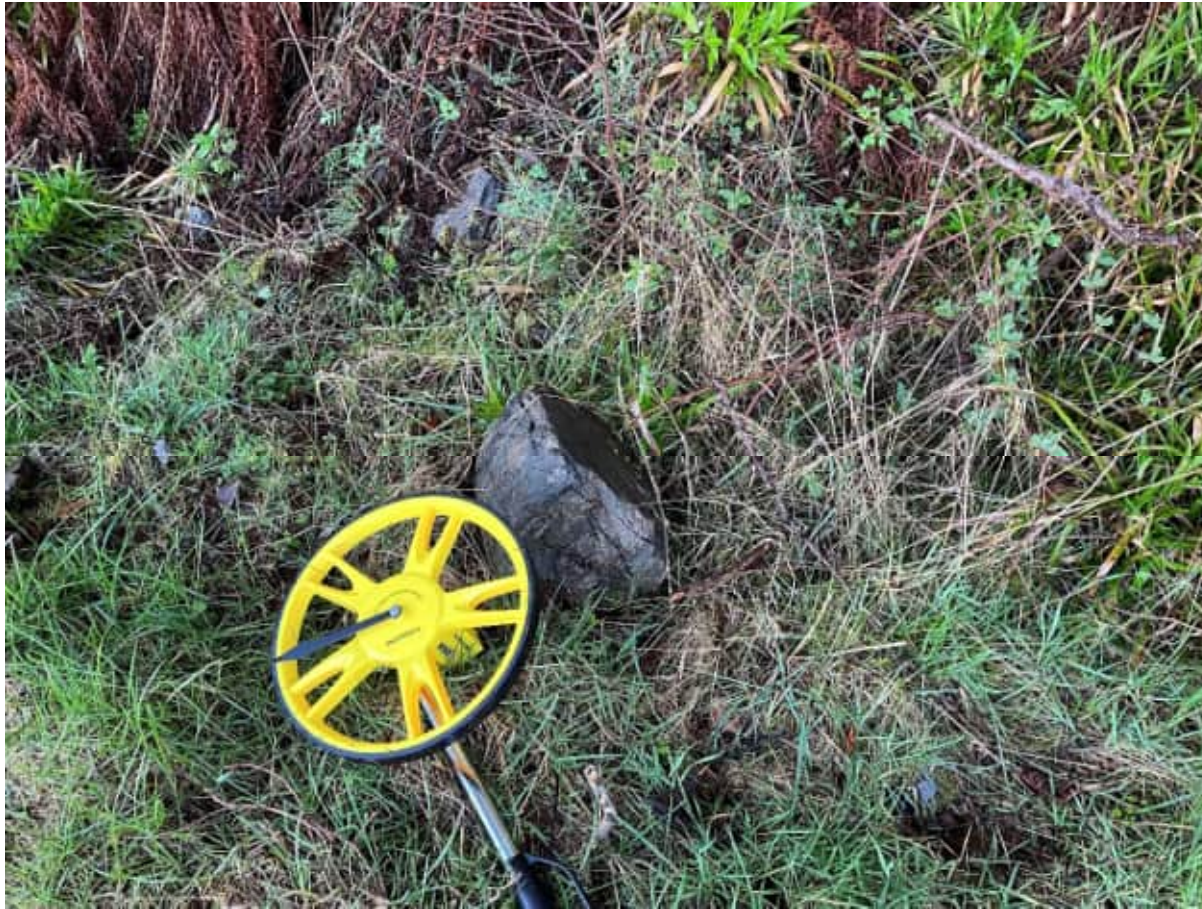
| AA2A-5 | <p>Ch. 0419:</p> <p>2021: Two small blocks observed in the roadside ditch. No pre-existing paint marks so assumed to be recent. No obvious upslope source but within area where tree falls / root jacking poses a risk.</p> <p>2026: One block present in the ditch, suspected to be a recent rockfall but unclear. Evidence that the ditch remains an effective rock trap.</p> | Year First Observed: | 2021 |

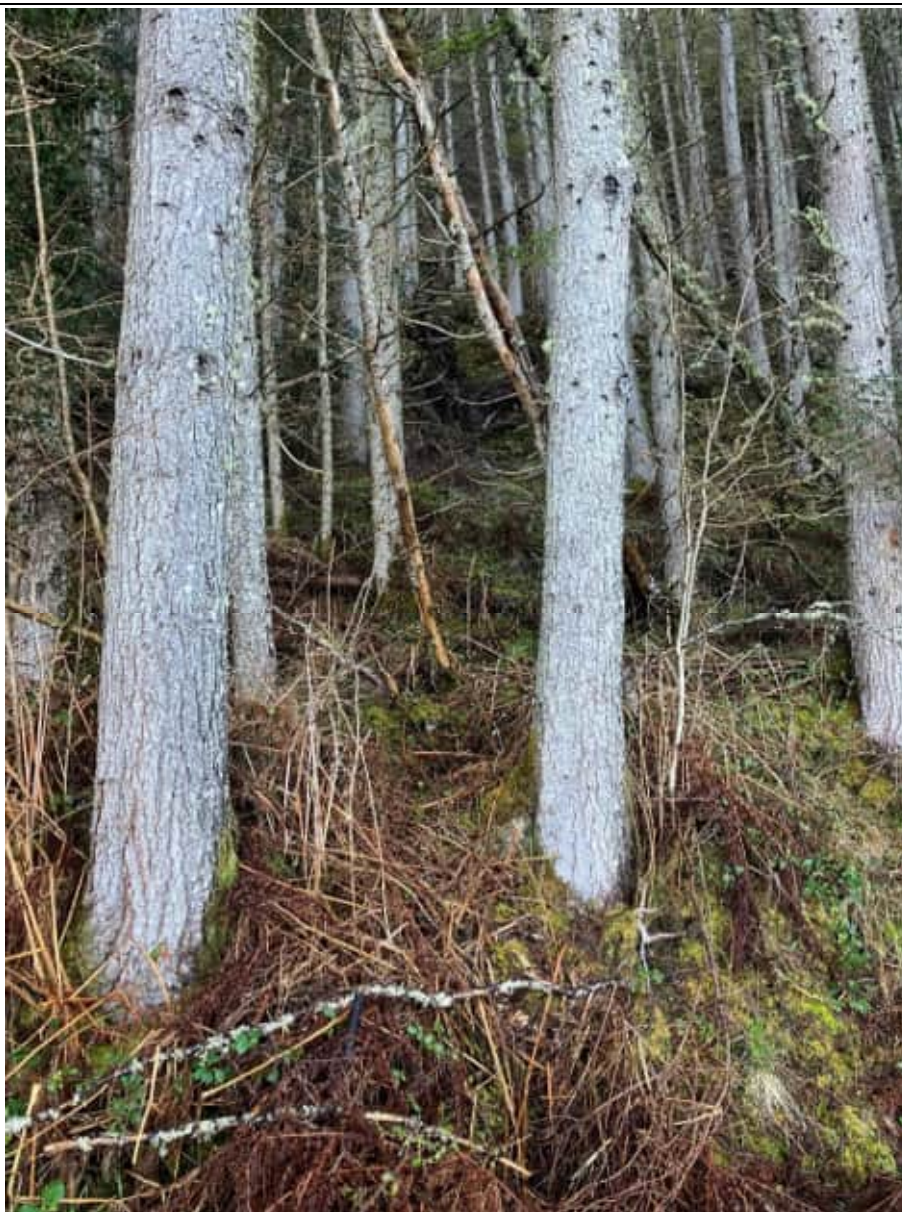
| AA2A-7 | <p>Ch. 0434:</p> <p>2026: One new block (approx. 0.5 x 0.4 x 0.3 m) present in the ditch. Likely dislodged from tree fall further upslope (see comments at Ch. 0429). Evidence that the ditch remains an effective rock trap.</p> | <p>Year First Observed:</p> | 2026 |

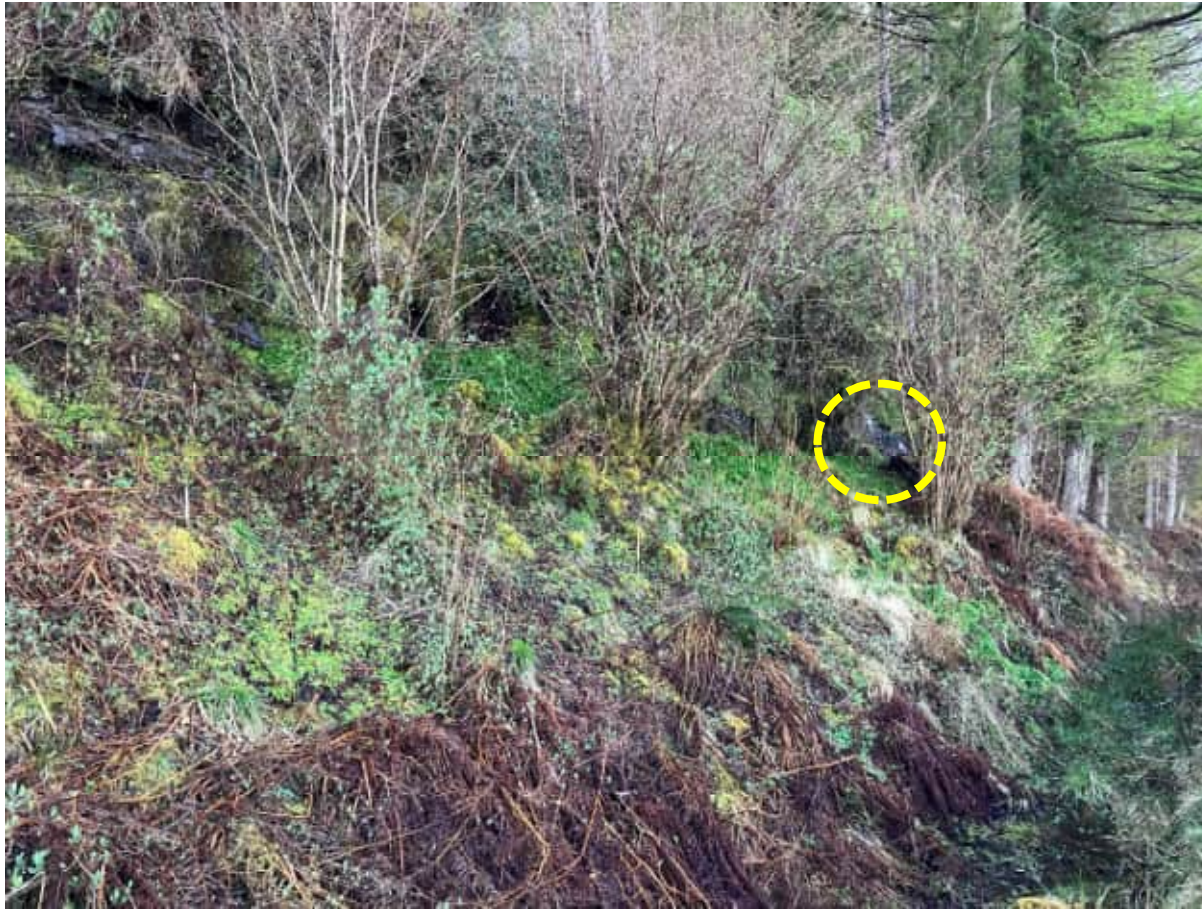
| AA2A-9 | <p>Ch. 500:</p> <p>2026: One new block (approx. 0.5 x 0.3 x 0.1 m) present on the slope, set well back from the road with the ditch between the slope and the roadside. Not considered to represent a risk to the road.</p> | Year First Observed: | 2026 |

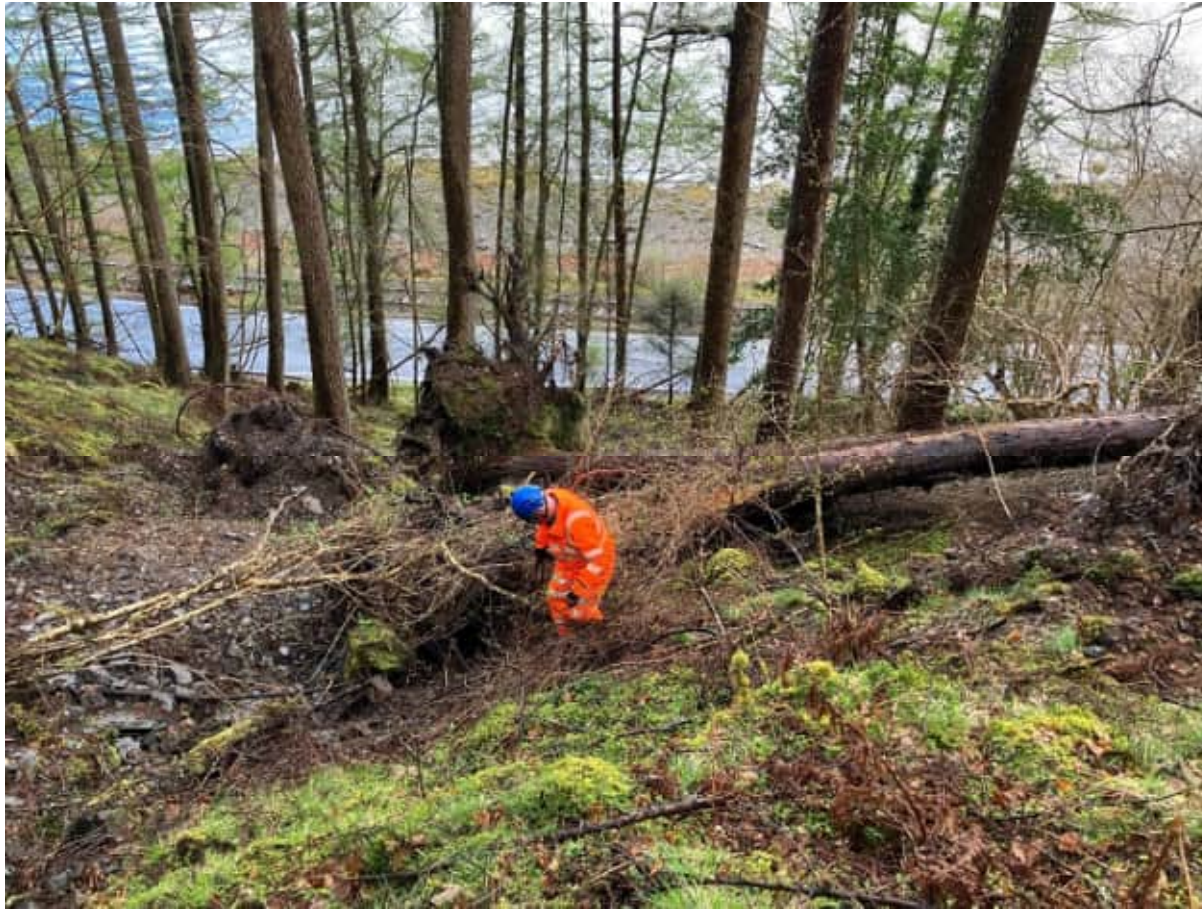
| AA2A-10 | <p>Above AA2A:</p> <p>2026: Forest access track wetter than in 2025 but no other significant changes. On-slope inspection of fallen trees coinciding with debris flow channel circa 20m above road level: the watercourse channel is blocked by three fallen trees, with the root balls in the channel and the trunks lying / wedged against standing trees along the slope; soil, gravel, cobble, and small boulder sized debris accumulating behind trees in channel (approx. 20 m3 of material) but expected to increase over time; will pose an increased risk of debris flow due to presence of debris dam.; and once root balls have rotted debris flow could also involve mobilisation of these with risk to road and possibly railway.</p> | Year First Observed: | 2026 |

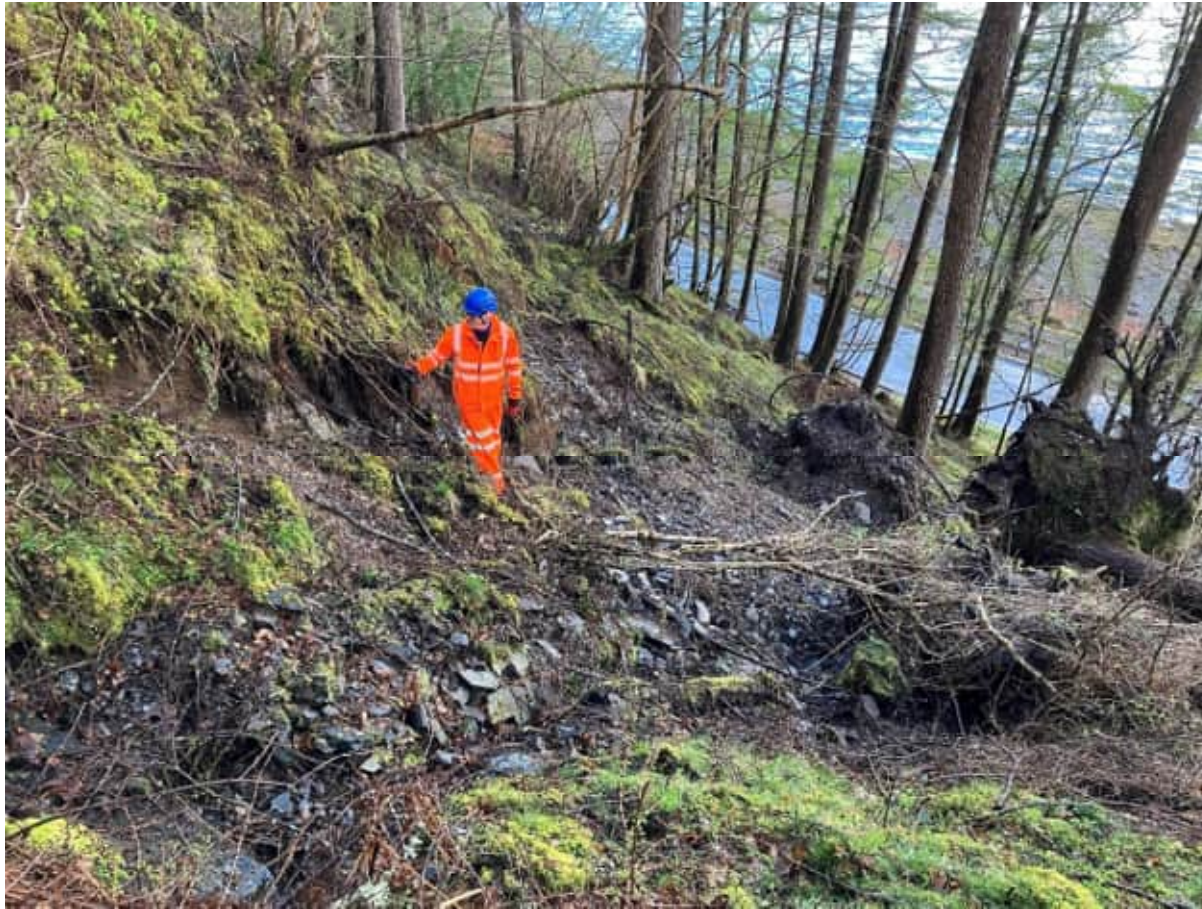
| AA2A-11 | <p>Above AA2A:</p> <p>2026: Forest access track wetter than in 2025 but no other significant changes. On-slope inspection of fallen trees coinciding with debris flow channel circa 20m above road level: the watercourse channel is blocked by three fallen trees, with the root balls in the channel and the trunks lying / wedged against standing trees along the slope; soil, gravel, cobble, and small boulder sized debris accumulating behind trees in channel (approx. 20 m3 of material) but expected to increase over time; will pose an increased risk of debris flow due to presence of debris dam.; and once root balls have rotted debris flow could also involve mobilisation of these with risk to road and possibly railway.</p> | Year First Observed: | 2026 |

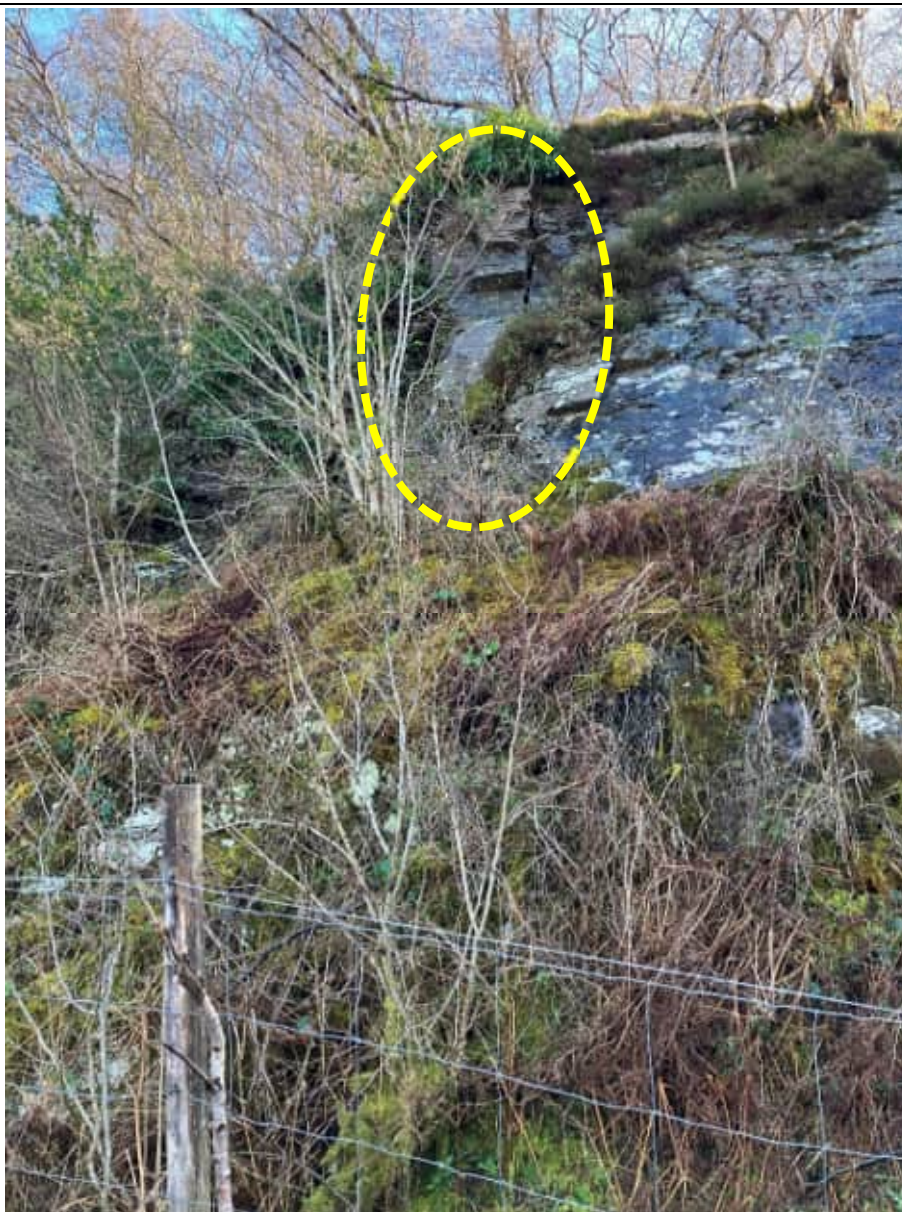
| AA3-1 | <p>Ch. 0573:</p> <p>2016: Potential for toppling/block fall up to 2 m<sup>3</sup> originating from 5 to 8 m above road level. There is a relatively flat 3.5 m wide verge, and it is considered unlikely that blocks will reach road in event of a failure.</p> <p>2026: No changes observed during 2026 inspection.</p> | Year First<br>Observed: | 2016 |

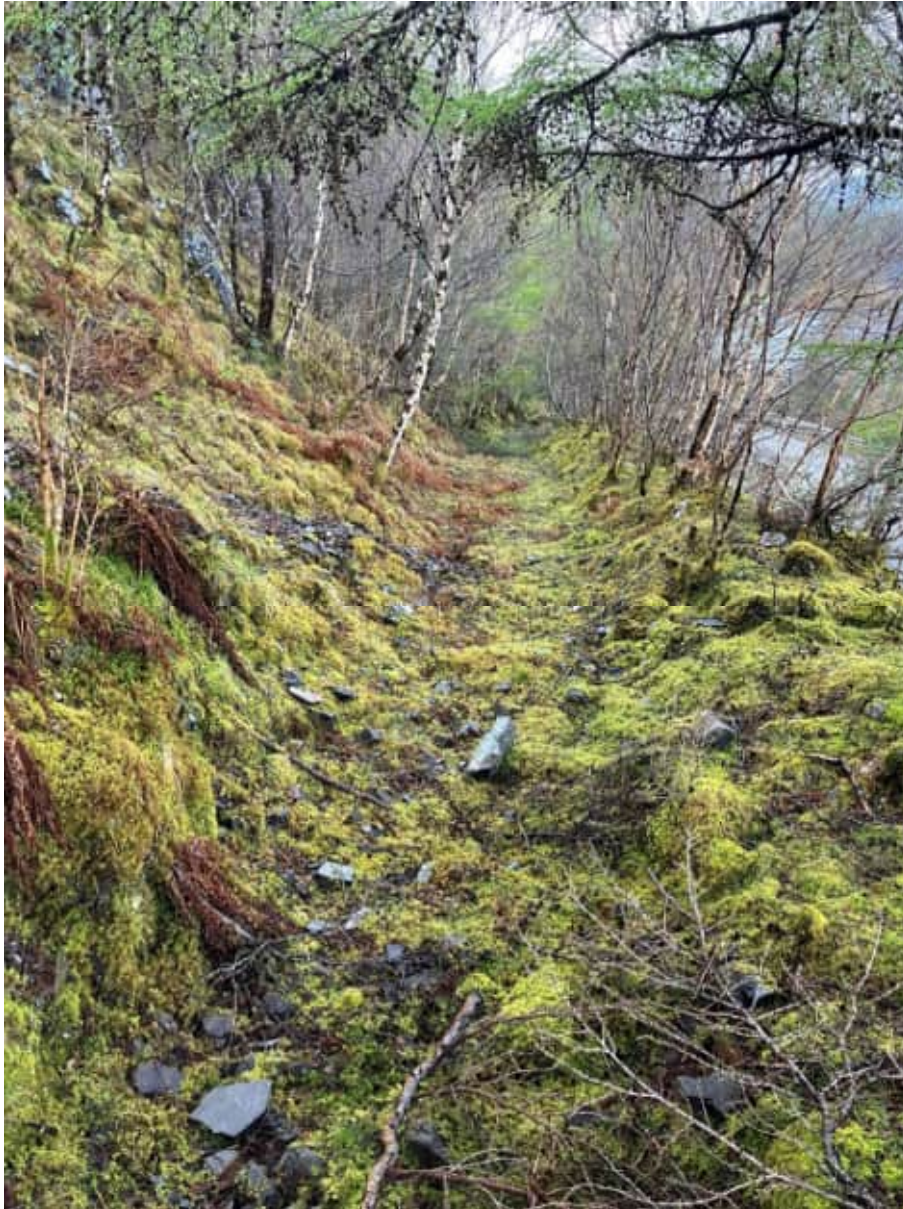
| AA3-4 | <p>Ch. 0622:</p> <p>2025: Potential toppling failure with dilated fracture at crest of slope. View of feature largely obscured by vegetation.</p> <p>2026: Possible further rockfall and presence of 'fresh' surfaces at height, although vegetation growth inhibits the assessment from road level.</p> | Year First Observed: | 2025 |

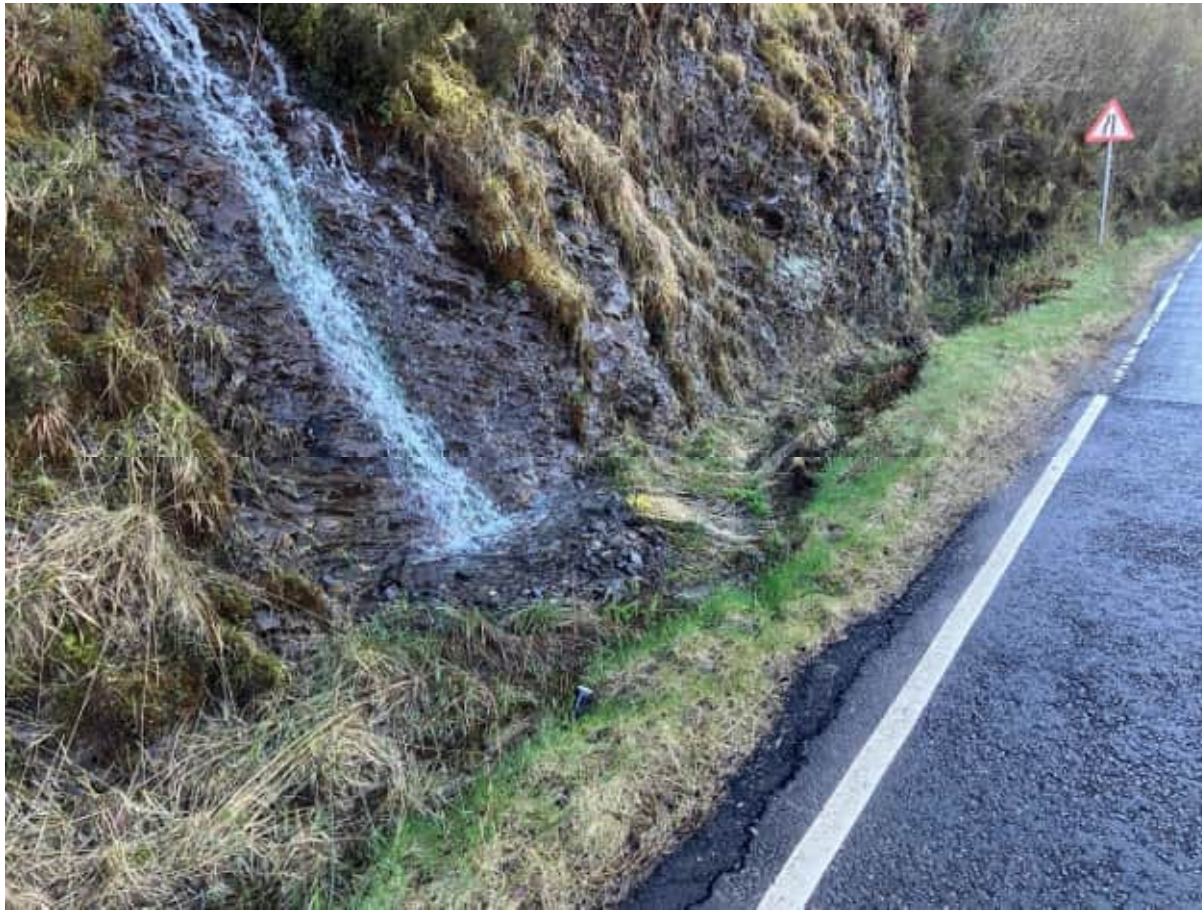
| AA4-1 | <p>Ch. 0842:</p> <p>2023: Ditch would benefit from clearance.</p> <p>2025: High water flow.</p> <p>2026: Significant volume of water flowing down over the rockface. Aggregation of blocks at the base of the waterfall and partially infilling the ditch. Recommendation from 2023 remains.</p> | Year First Observed: | 2023 |

| Recommended Remedial Works / Actions | | | | | | | |
|---|---|---|---|---|---|---|---|
| N/A | | <ul style="list-style-type: none"> <li>Scale fractured rock mass at Ch. 0745.</li> <li>Scale / dowel overhanging block at Ch. 0788, coppice adjacent holly tree and inspect rock mass behind.</li> </ul> | | | <ul style="list-style-type: none"> <li>Clear out ditch at base of small watercourse at Ch. 0842.</li> <li>Vegetation clearance is recommended across the whole slope.</li> </ul> | | |

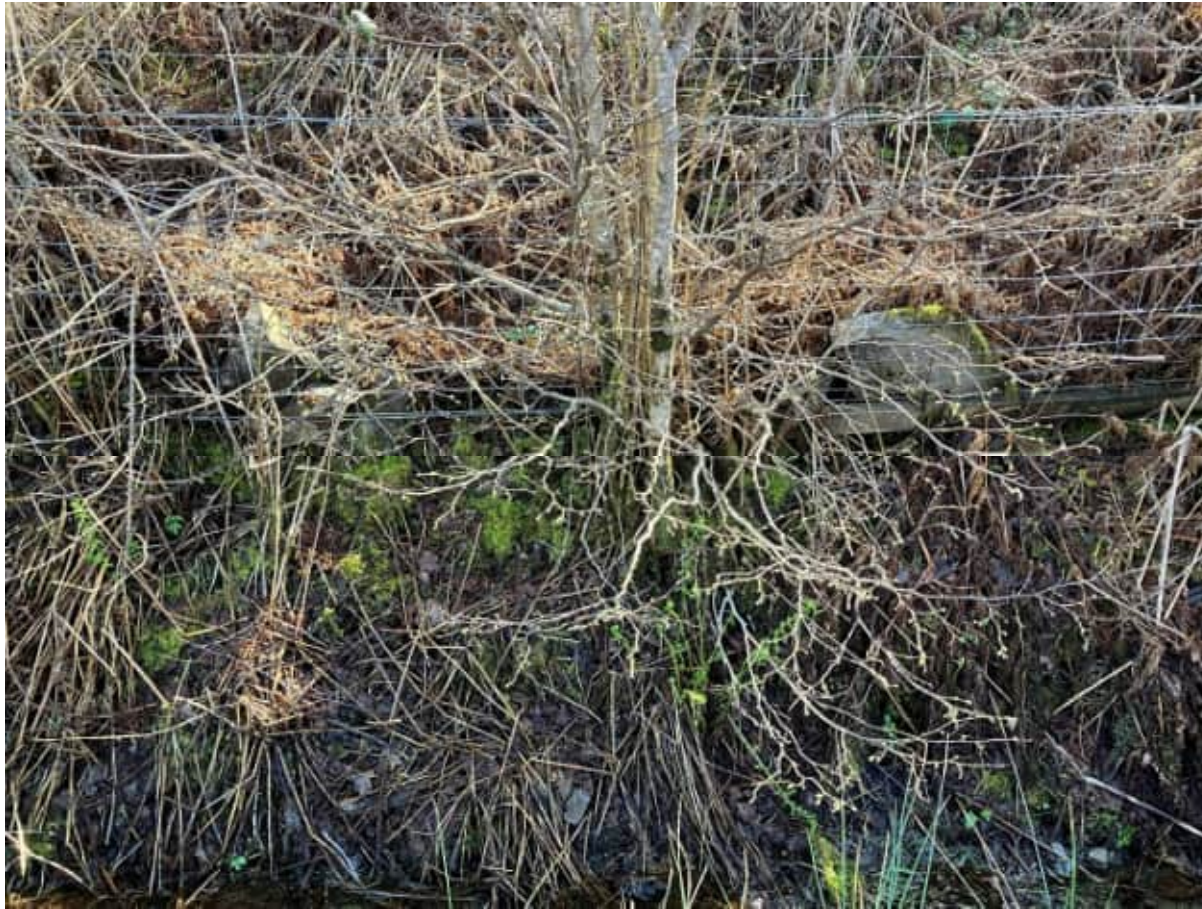
| AA5-1 | <p>Ch. 1253 (between section AA4 Upper and section AA5):</p> <p>2026: One large block present resting on the slope, upslope of the deer fence. Dimensions approx. 1.0 x 0.5 x 0.4 m. Likely fallen from upper crags approx. 25 m upslope. Unlikely to become mobilised in future and, therefore, represents a low risk to the road; however, there remains the potential for future rockfall from the upper crags.</p> | Year First Observed: | 2026 |

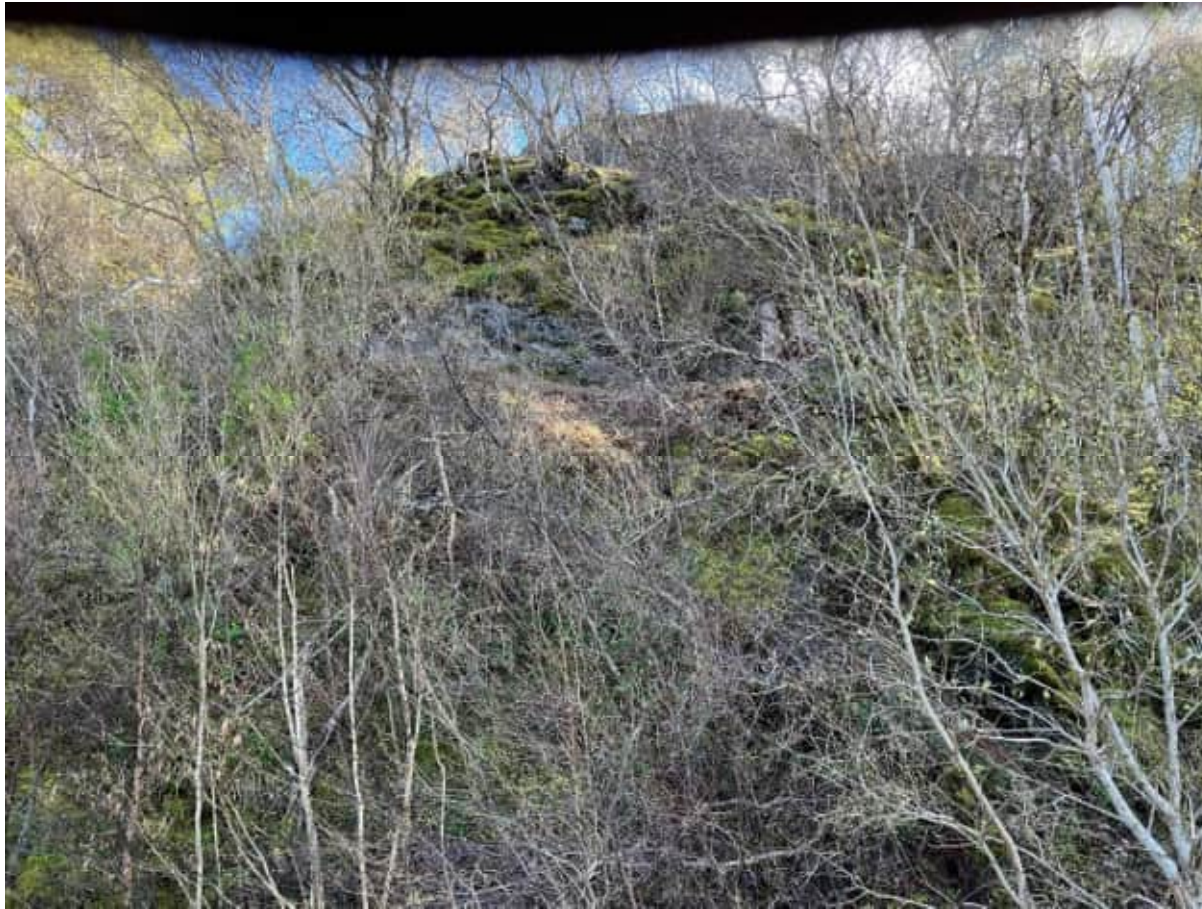
AA5-2

Ch. 1309:

2026: No changes observed during 2026 inspection.

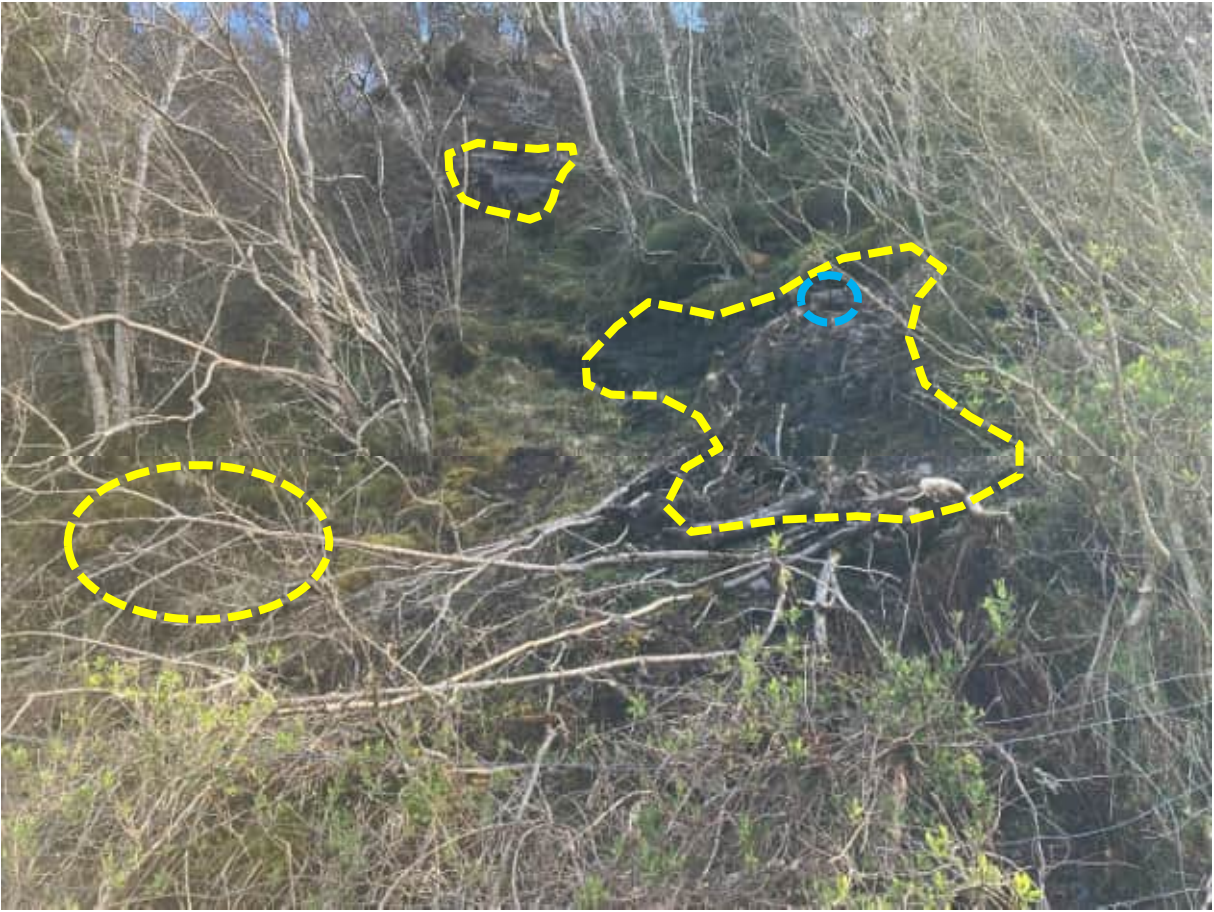
| AA5A-2 | <p>Ch. 1420 to 1431:</p> <p>2026: Three fallen trees at circa 6, 8, and 15 m above road level (yellow). All three trees appear to have 'peeled' off the slope face, leaving large areas of exposed rock at surface and dislodging a large amount of soil and rock, with debris completely filling the ditch. A fourth tree has also fallen (immediately below tree fall at 15 m height) and is completely detached but is propped up by other trees. Further tree falls in future highly likely. Exposed rock is blocky, however, the metamorphic foliation/fabric dip into the slope and there does not appear to be a release joint. Tree fall at 6 m – Small number of blocks present downslope of the tree fall (Ch. 1432). Tree fall at 8 m – Tree fall has left a vegetated overhang over the slip scar. One boulder (0.35 x 0.25 x 0.15 m) (blue) is completely detached from the exposed rockface and is held at height resting against a rotten, large diameter tree root. Loose gravel to cobble sized fragments of rock held in vegetation of overhang.</p> | Year First Observed: | 2026 |
