# A890 Strome ferry Bypass

Annual Slope Inspection 2026

The Highland Council

Project number: 60685712  
AECOM Report Ref.: GLRP0013

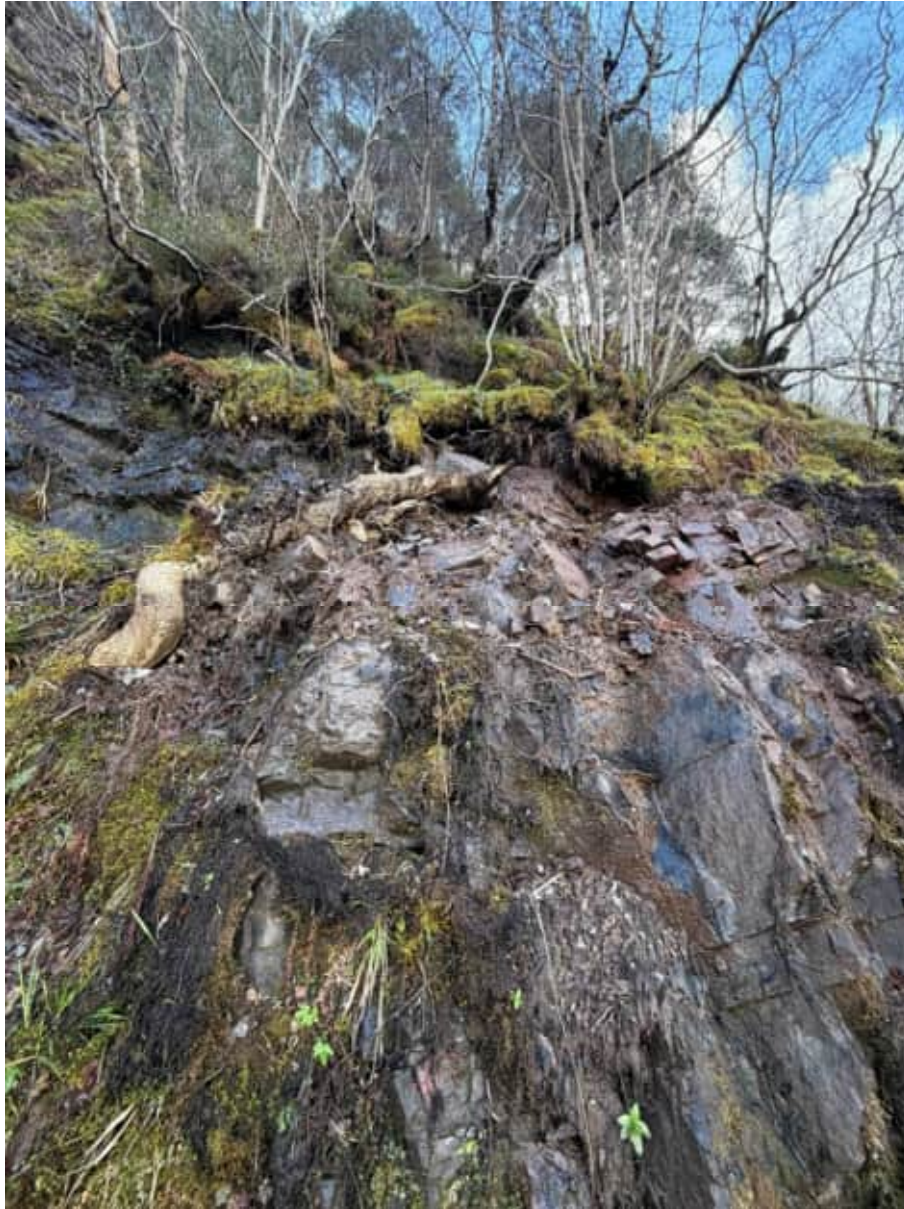
| AA5A-3 | <p>Ch. 1420 to 1431:</p> <p>2026: Three fallen trees at circa 6, 8, and 15 m above road level. All three trees appear to have 'peeled' off the slope face, leaving large areas of exposed rock at surface and dislodging a large amount of soil and rock, with debris completely filling the ditch. A fourth tree has also fallen (immediately below tree fall at 15 m height) and is completely detached but is propped up by other trees. Further tree falls in future highly likely. Exposed rock is blocky, however, the metamorphic foliation/fabric dip into the slope and there does not appear to be a release joint. Tree fall at 8 m – Tree fall has left a vegetated overhang over the slip scar. One boulder (0.35 x 0.25 x 0.15 m) is completely detached from the exposed rockface and is held at height resting against a rotten, large diameter tree root (Photo AA5A-4). Loose gravel to cobble sized fragments of rock held in vegetation of overhang.</p> | Year First Observed: | 2026 |

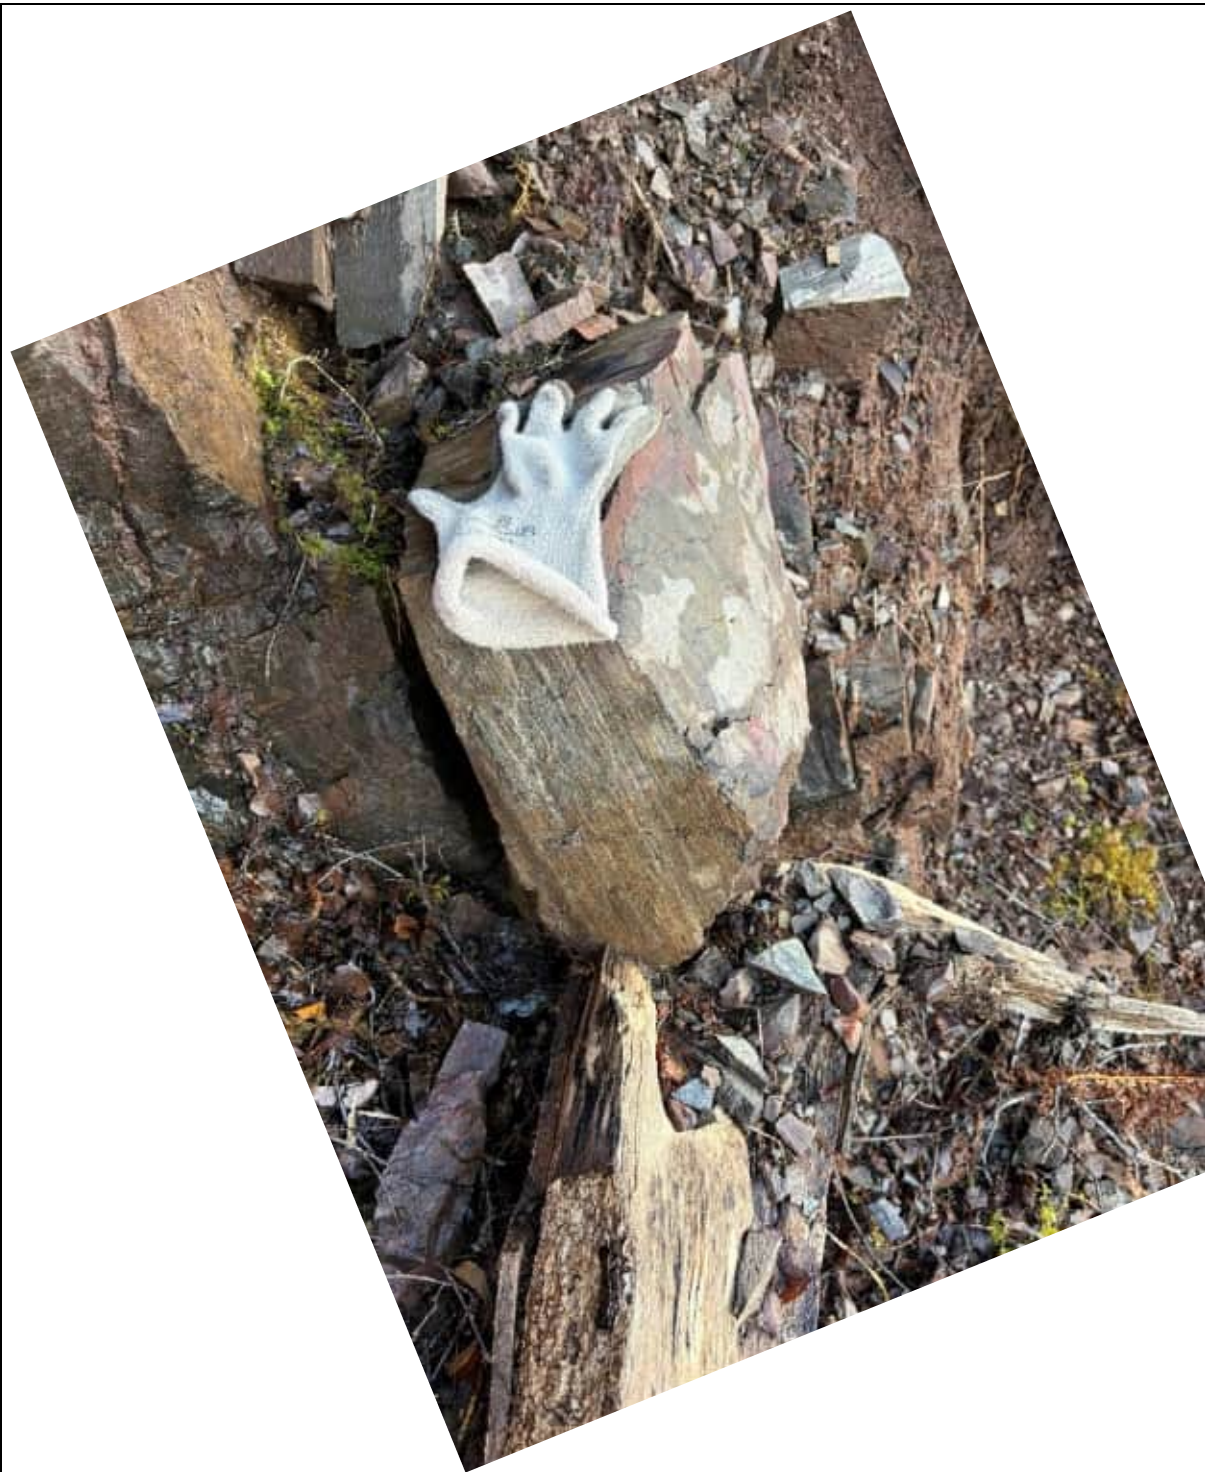
| AA5A-4 | <p>Ch. 1420 to 1431:</p> <p>2026: Three fallen trees at circa 6, 8, and 15 m above road level. All three trees appear to have 'peeled' off the slope face, leaving large areas of exposed rock at surface and dislodging a large amount of soil and rock, with debris completely filling the ditch. Exposed rock is blocky, however, the metamorphic foliation/fabric dip into the slope and there does not appear to be a release joint. Tree fall at 8 m –One boulder (0.35 x 0.25 x 0.15 m) is completely detached from the exposed rockface and is held at height resting against a rotten, large diameter tree root. Loose gravel to cobble sized fragments of rock held in vegetation of overhang.</p> | Year First Observed: | 2026 |

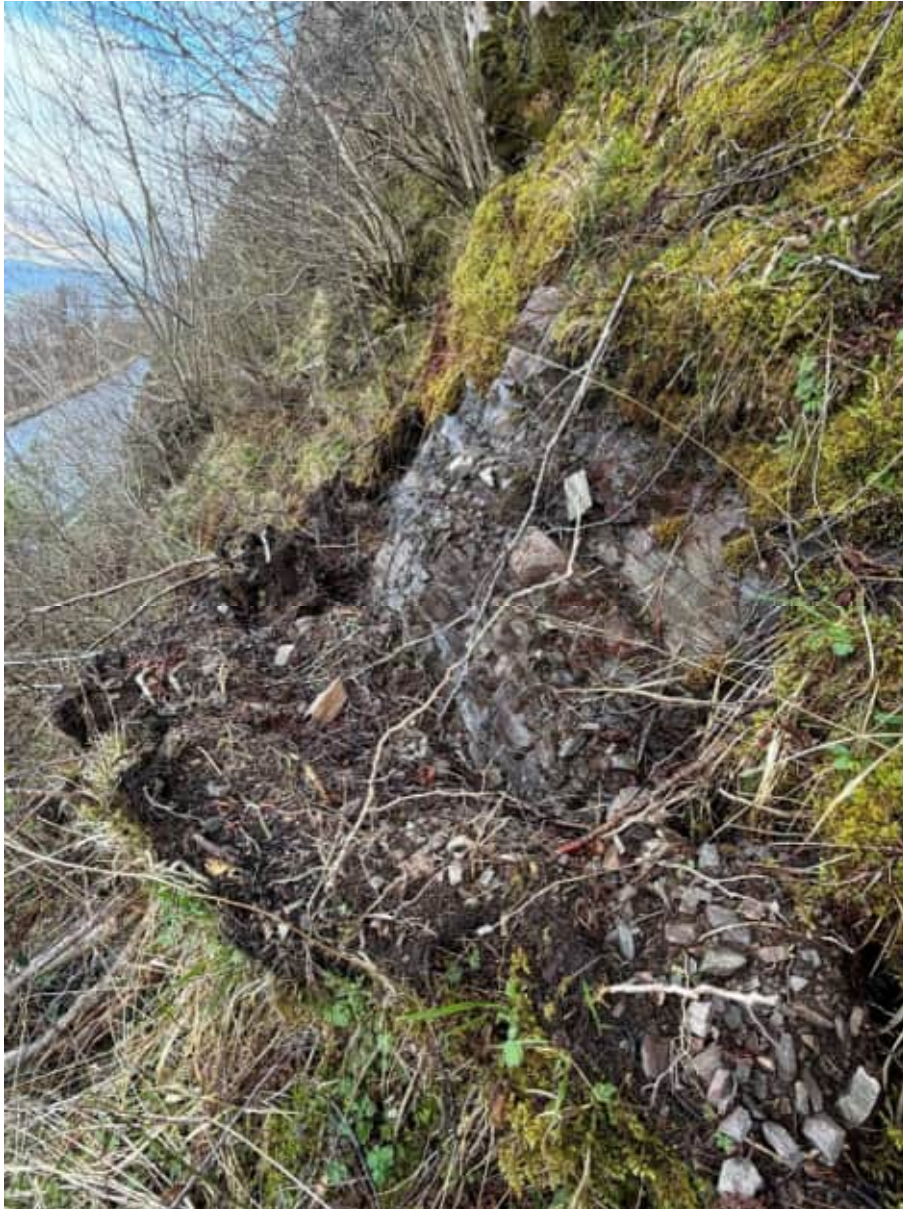
| AA5A-5 | <p>Ch. 1420 to 1431:</p> <p>2026: Three fallen trees at circa 6, 8, and 15 m above road level. All three trees appear to have 'peeled' off the slope face, leaving large areas of exposed rock at surface and dislodging a large amount of soil and rock, with debris completely filling the ditch. A fourth tree has also fallen (immediately below tree fall at 15 m height) and is completely detached but is propped up by other trees. Further tree falls in future highly likely. Exposed rock is blocky, however, the metamorphic foliation/fabric dip into the slope and there does not appear to be a release joint.</p> | Year First Observed: | 2026 |

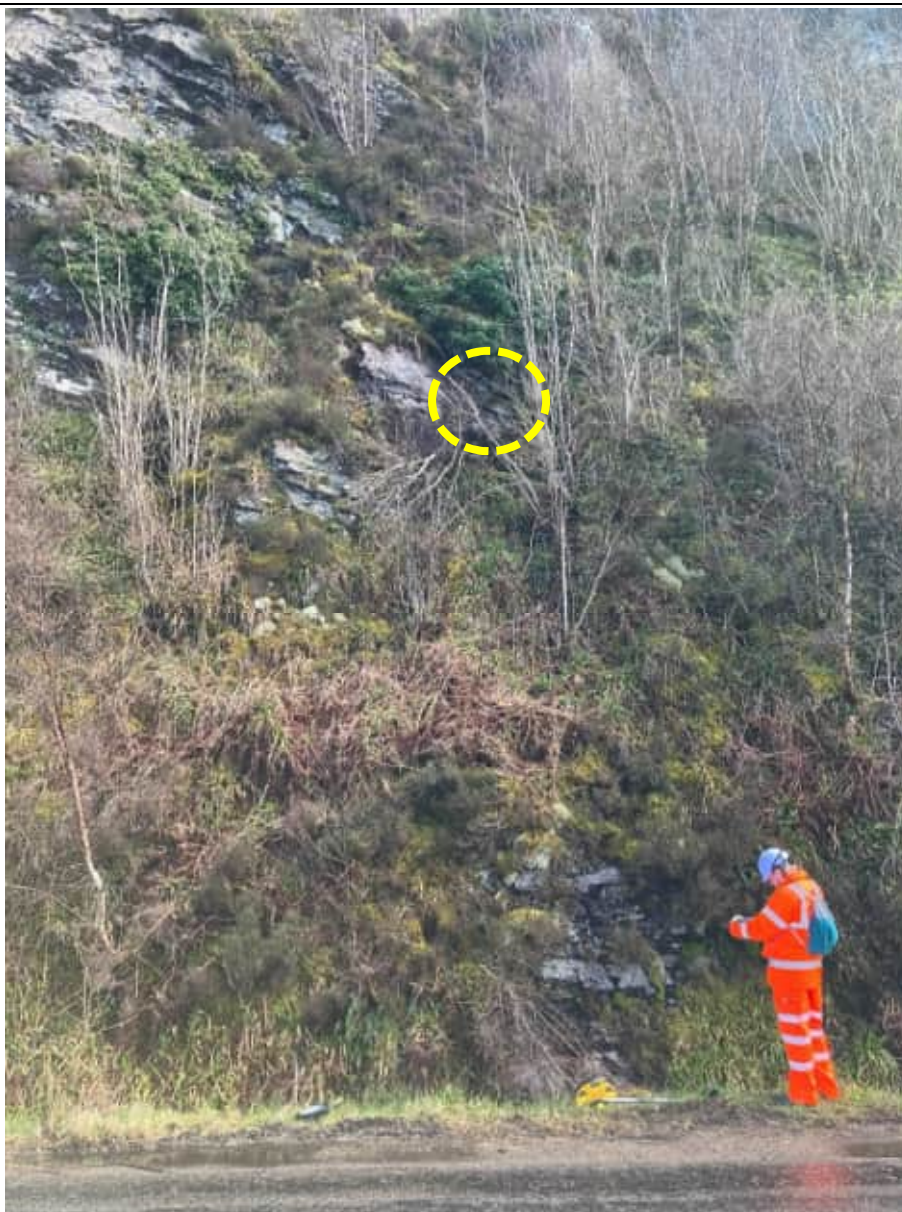
| AA6-1 | <p>Ch. 1478:</p> <p>2026: One fallen tree; appears to have 'peeled' off the slope face, leaving an area of exposed rock at surface level. Two blocks are present in the ditch (0.4 x 0.2 x 0.2 and 0.2 x 0.2 x 0.2 m); a 1.2 x 0.5 m area of loose material remains on the slope to the south of the tree fall site which could slip in future, although it is expected that future rockfalls would land in the ditch and represent a low risk to the road. Overhanging block may not be unsupported.</p> | Year First Observed: | 2026 |

| Recommended Remedial Works / Actions | | | | | | | |
|---|---|--|---|---|---|---|---|
| N/A | | | N/A | | | <ul style="list-style-type: none"> <li>The build-up of debris should be monitored and clearance works undertaken as required to maintain its capacity;</li> <li>(Light) scaling of loose material associated with the tree fall at Ch. 1478; and</li> <li>Vegetation clearance is recommended across the whole slope, in particular between Ch. 1465 and 1480.</li> </ul> | |

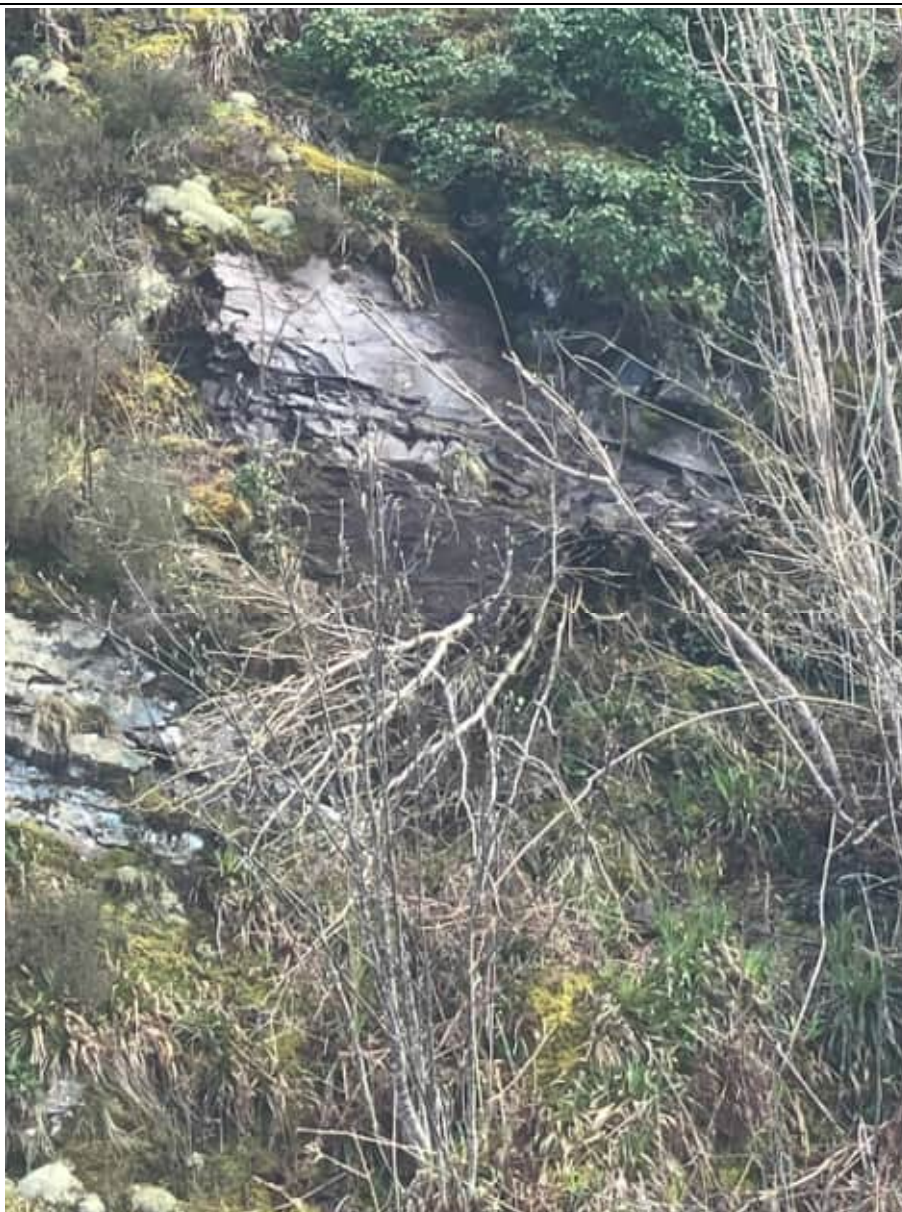
| AA6-2 | <p>Ch. 1478:</p> <p>2026: One fallen tree; appears to have 'peeled' off the slope face, leaving an area of exposed rock at surface level. Two blocks are present in the ditch (0.4 x 0.2 x 0.2 and 0.2 x 0.2 x 0.2 m); a 1.2 x 0.5 m area of loose material remains on the slope to the south of the tree fall site which could slip in future, although it is expected that future rockfalls would land in the ditch and represent a low risk to the road. Overhanging block may not be unsupported.</p> | Year First Observed: | 2026 |

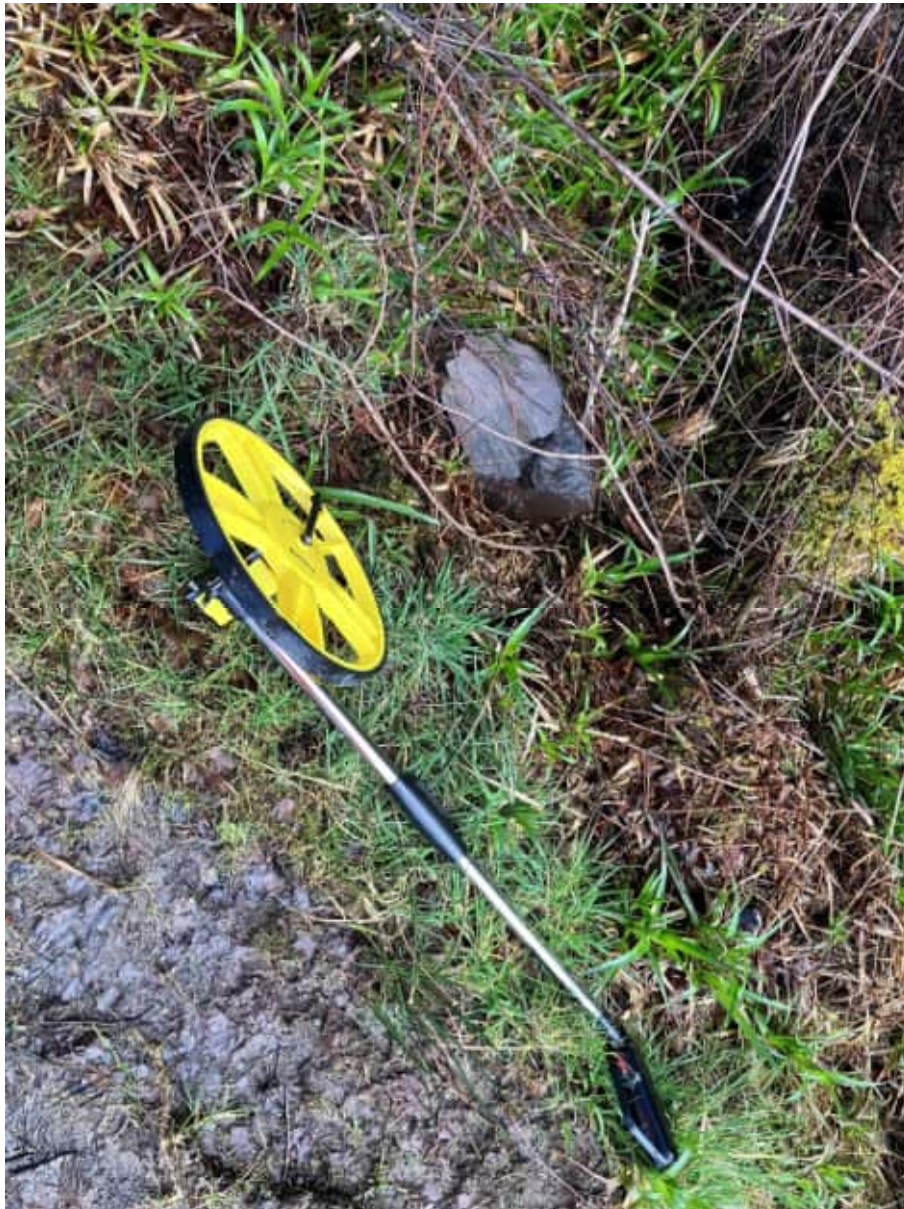
| AA6-3 | <p>Ch. 1478:</p> <p>2026: One fallen tree; appears to have 'peeled' off the slope face, leaving an area of exposed rock at surface level. Two blocks are present in the ditch (0.4 x 0.2 x 0.2 and 0.2 x 0.2 x 0.2 m); a 1.2 x 0.5 m area of loose material remains on the slope to the south of the tree fall site which could slip in future, although it is expected that future rockfalls would land in the ditch and represent a low risk to the road. Overhanging block may not be unsupported.</p> | Year First Observed: | 2026 |

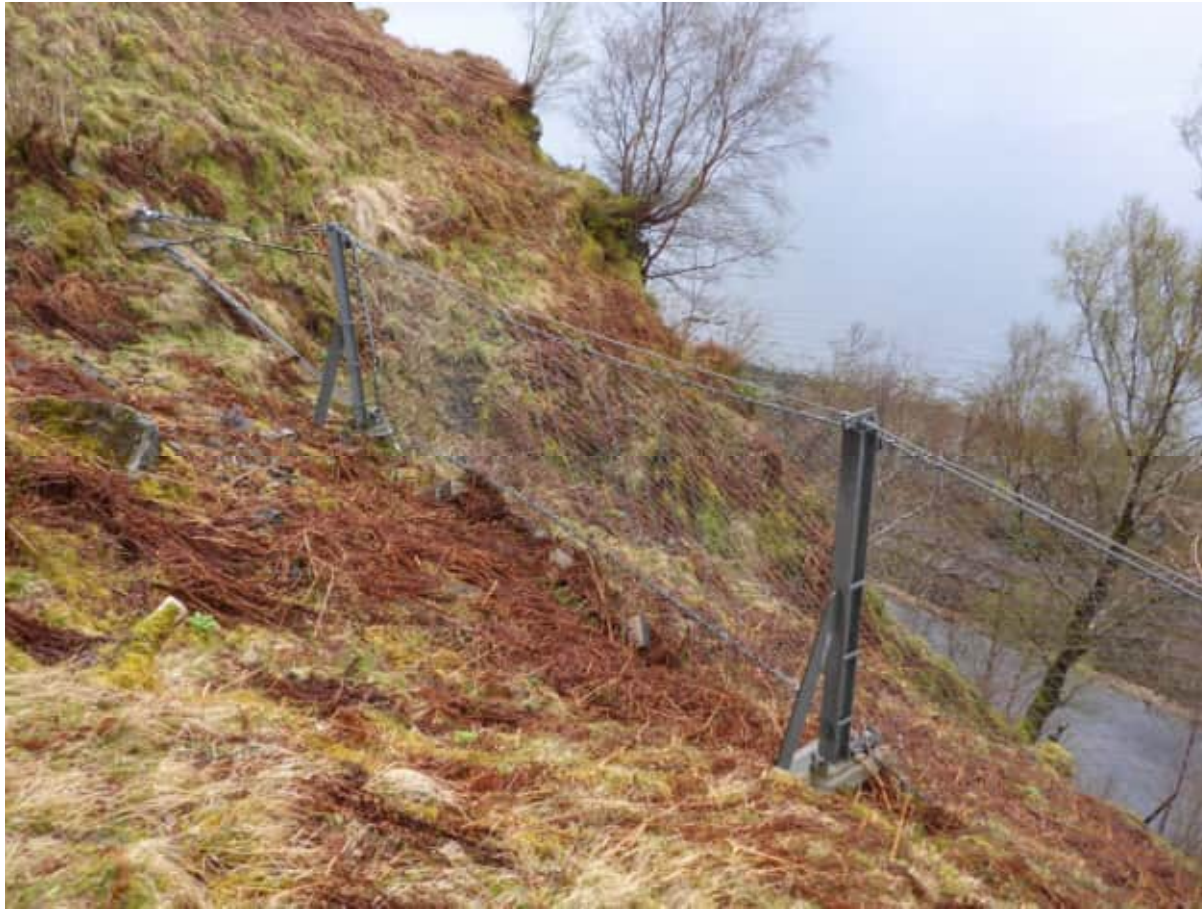
| AA6A-1 | <p>Ch. 1511:<br/>2026: Rope Access Inspection: To inspect the condition of the catch fences installed as part of the Phase 12 (2021) remedial works above AA6A.</p> <p>Findings:</p> <ul style="list-style-type: none"><li>• Debris flow catch fence in good condition with no obvious signs of corrosion or blocks retained by barrier; and</li><li>• Lower "temporary" catch fence in good condition with no obvious signs of corrosion.</li></ul> | Year First Observed: | 2021 |

| Recommended Remedial Works / Actions | | | | | | | |
|---|---|--|---|---|---|---|---|
| <ul style="list-style-type: none"> <li>Install roadside rock fall catch fence.</li> </ul> | | | N/A | | | <ul style="list-style-type: none"> <li>Complete clearance of blocks retained behind deer fence at Ch. 1505;</li> <li>Vegetation clearance is recommended across the whole slope;</li> <li>Removal of the tree resting against the debris flow catch fence upslope of Ch. 1511; and</li> <li>Improvement of the "temporary" lower debris flow catch fence upslope of Ch. 1511 by securing the mesh to the top cable with shackles.</li> </ul> | |

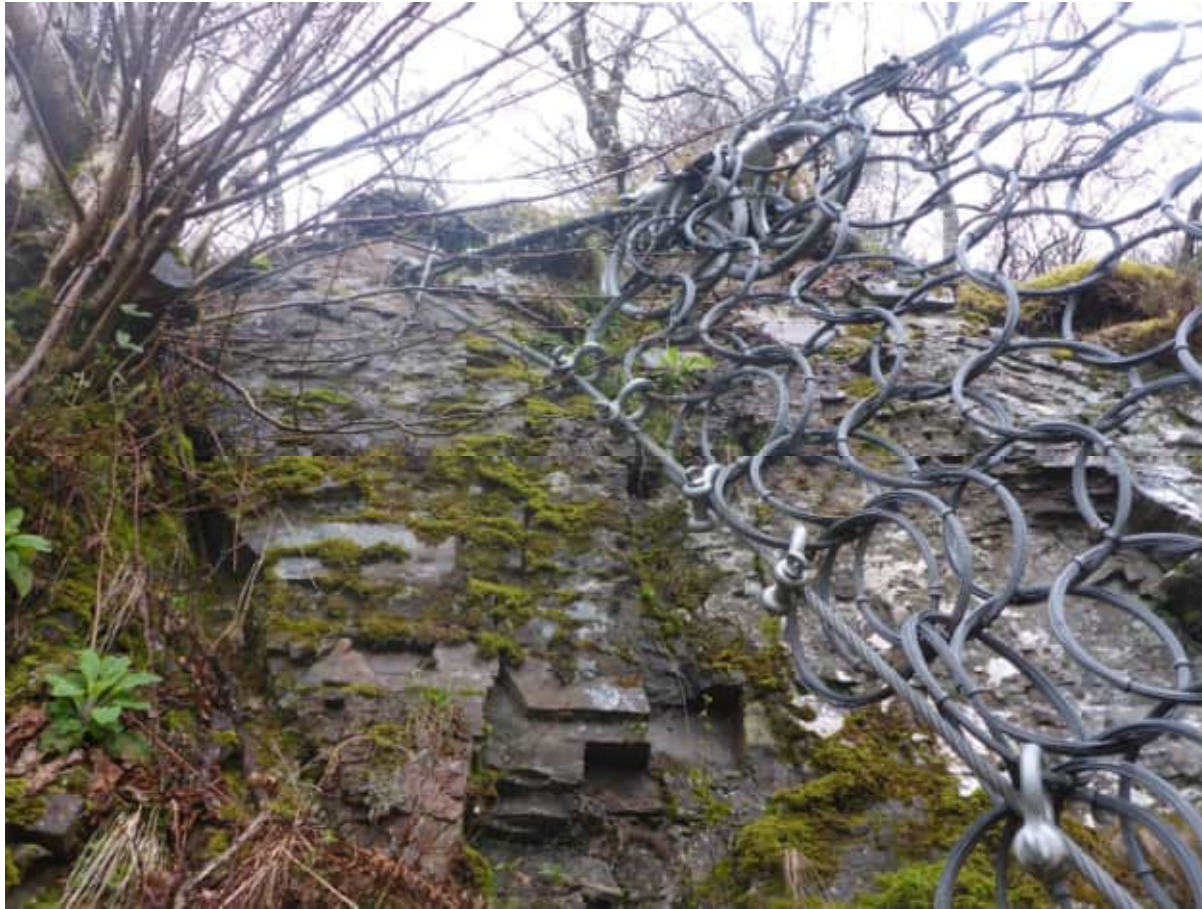
| AA6A-2 | <p>Ch. 1511:<br/>2026: Rope Access Inspection: To inspect the condition of the catch fences installed as part of the Phase 12 (2021) remedial works above AA6A.</p> <p>Findings:</p> <ul style="list-style-type: none"><li>• Debris flow catch fence in good condition with no obvious signs of corrosion or blocks retained by barrier; and</li><li>• Lower "temporary" catch fence in good condition with no obvious signs of corrosion.</li></ul> | Year First Observed: | 2021 |

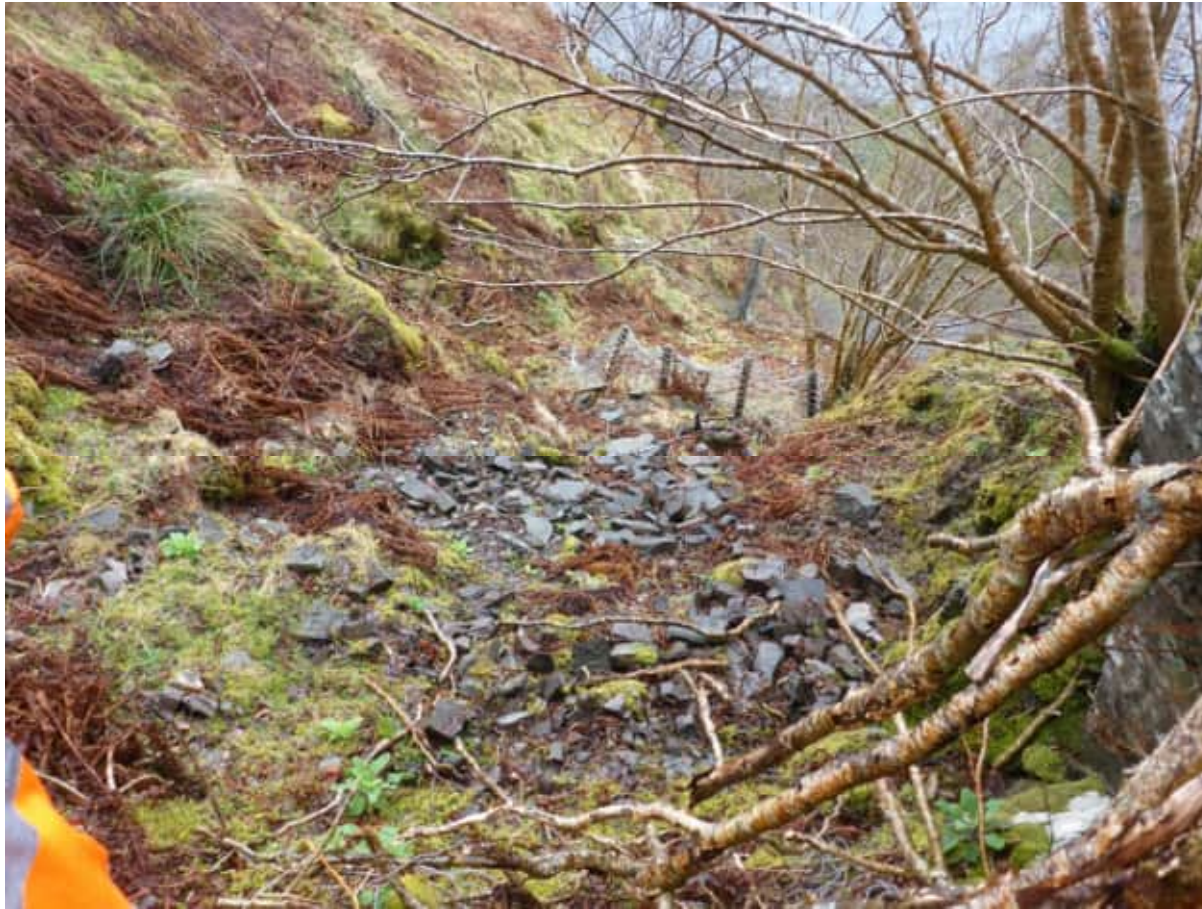
| AA6A-3 | <p>Ch. 1511:<br/>2026: Rope Access Inspection: To inspect the condition of the catch fences installed as part of the Phase 12 (2021) remedial works above AA6A.</p> <p>Findings:</p> <ul style="list-style-type: none"><li>• Debris flow catch fence in good condition with no obvious signs of corrosion or blocks retained by barrier; and</li><li>• Lower "temporary" catch fence in good condition with no obvious signs of corrosion.</li></ul> | Year First Observed: | 2021 |

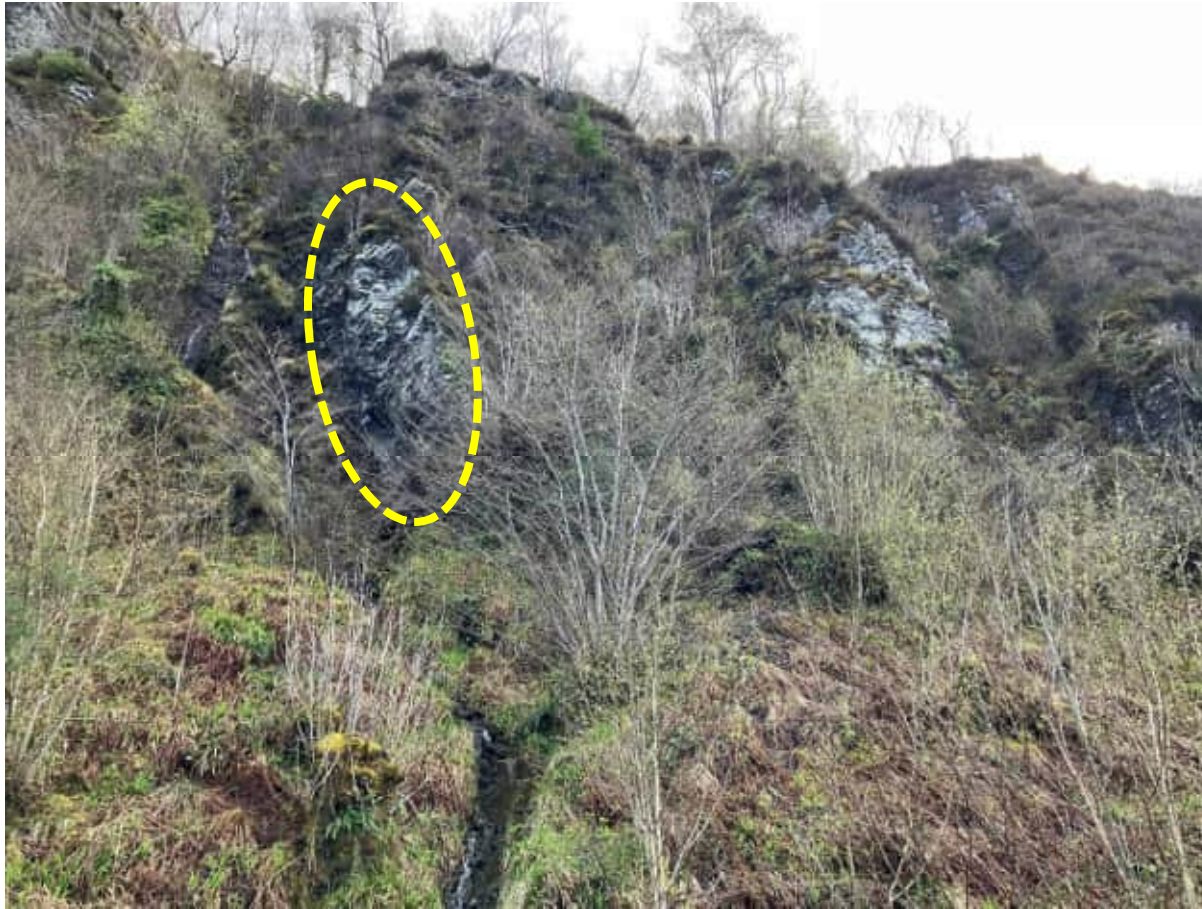
AA7-1

2025 – Phase 13 works – Ch. 1820 to 1826:

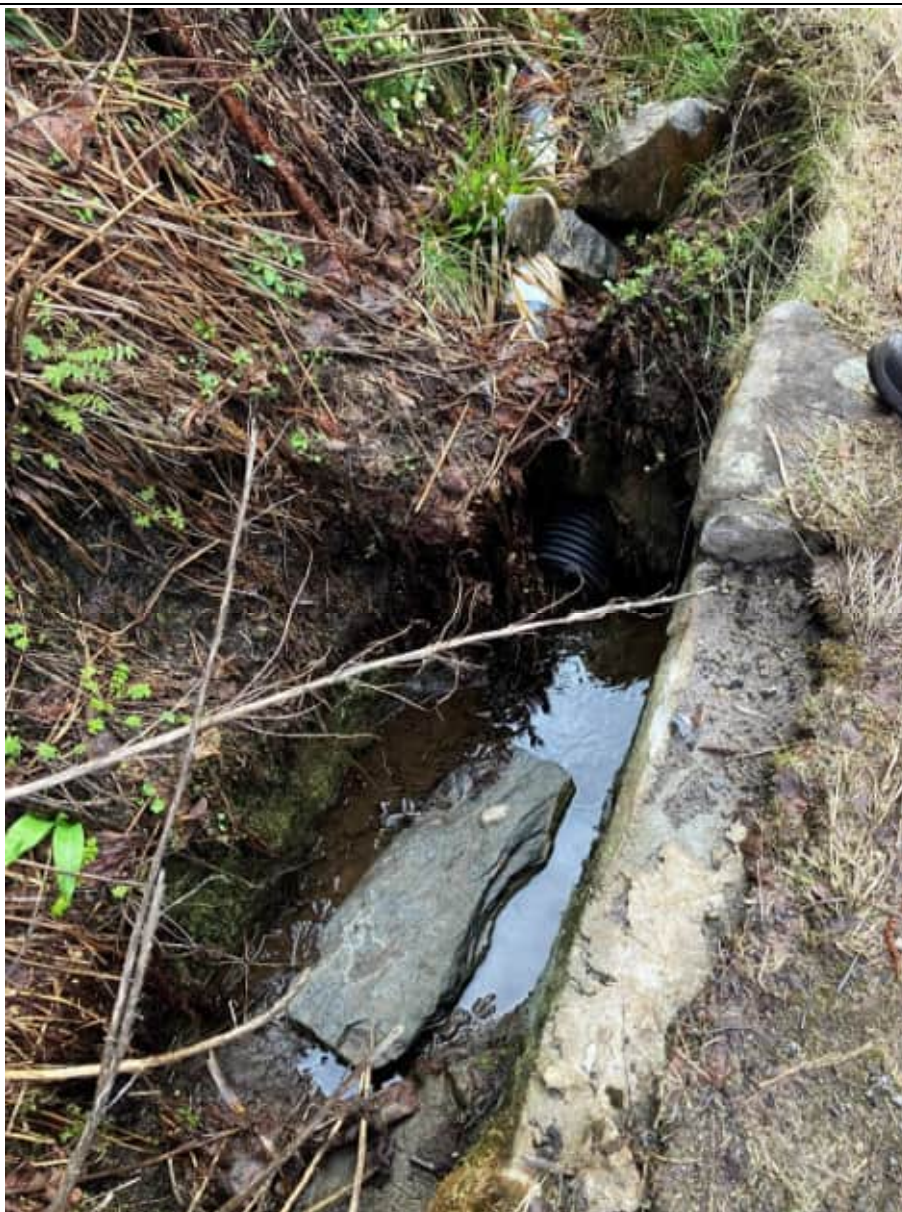
| AA7-5 | <p>Ch. 1832:</p> <p>2024: Debris in drainage gully is nearly at full capacity and would benefit from being cleared.</p> <p>2026: Drainage gully is fully blocked with organic material; a bollard and structural stone is also present in the gully, likely as a result of a vehicle strike.</p> | Year First Observed: | 2024 |

| Recommended Remedial Works / Actions | | | | | | | |
|---|---|---|---|---|---|---|---|
| N/A | | N/A | | | <ul style="list-style-type: none"> <li>Replace missing marker for Ch. 1800;</li> <li>Clearance of drainage gullies at Ch. 1824 and 1832;</li> <li>Repair stonework and bollard at the drainage gully at Ch. 1832; and</li> <li>Vegetation clearance is recommended across the whole slope.</li> </ul> | | |

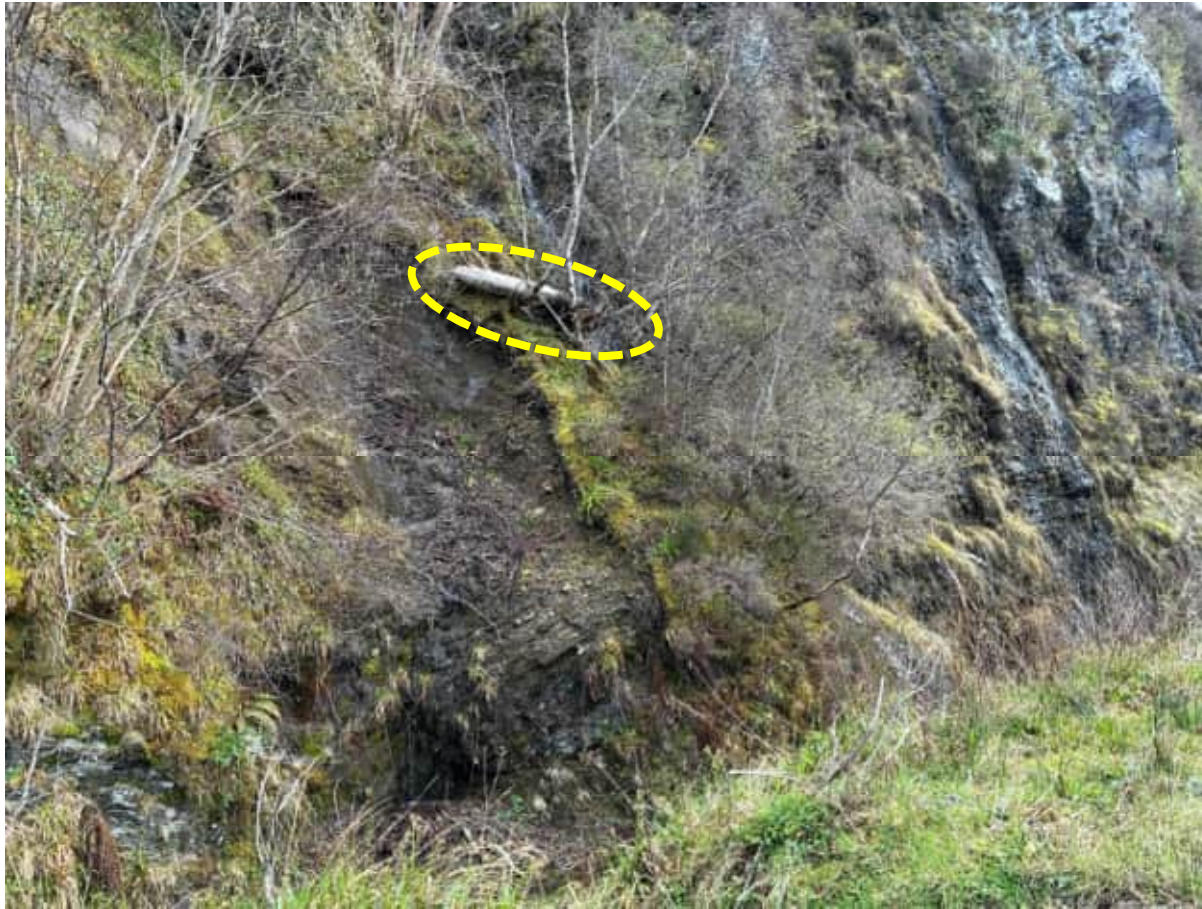
| AA8-1 | <p>Ch. 1880:</p> <p>2021: Minor accumulations of gravel sized rock at base of gully but still plenty of capacity in ditch.</p> <p>2022: Soil slip/washout from 8 m above ground level. There is a large ditch below with sufficient capacity.</p> <p>2024: Some additional soil washout and associated debris accumulation, however, ditch still has capacity to retain debris.</p> <p>2026: Large log present above the area of washout. Log is old and the source is unclear. The large ditch at the toe of the slope would catch the log should it become mobilised and fall further downslope. Not considered to represent risk to the road.</p> | Year First Observed: | 2021 |

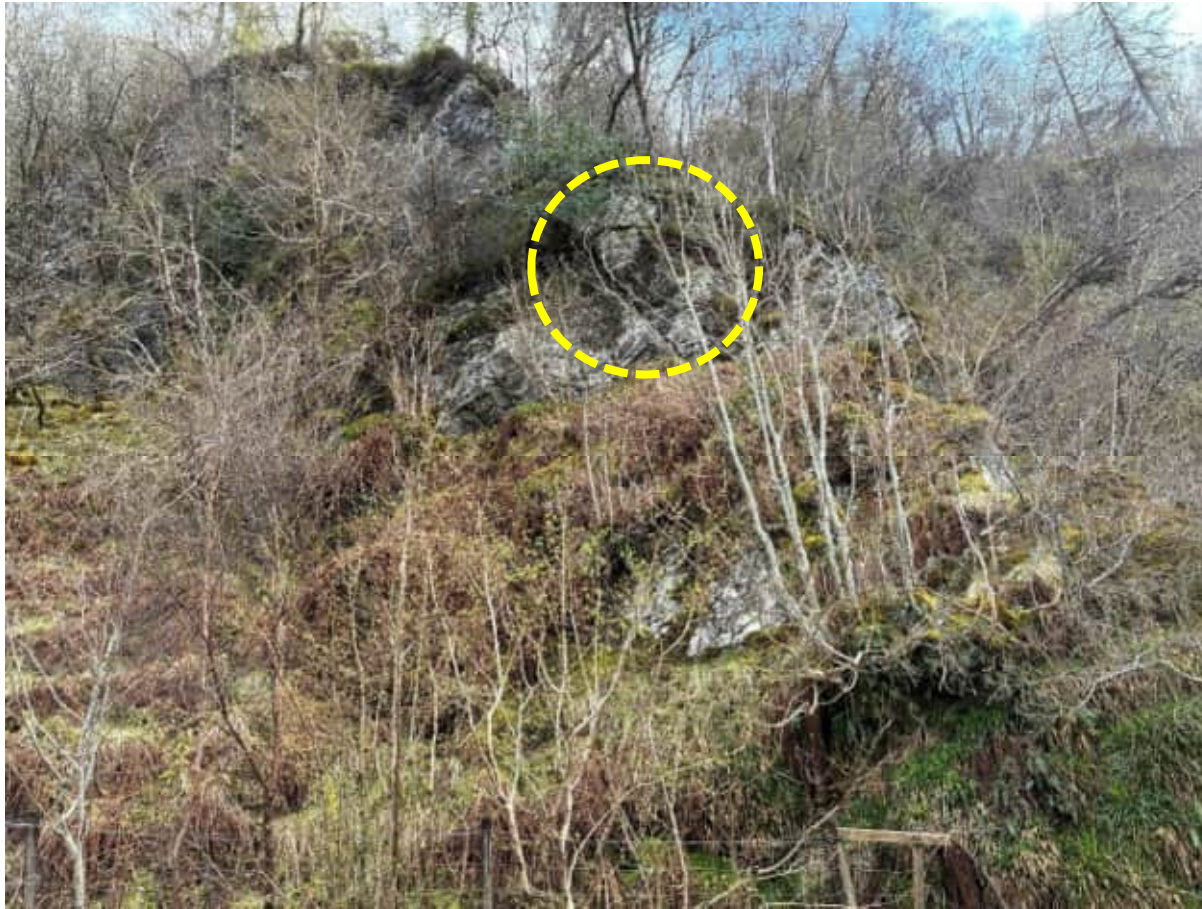
| Hazards Observed: | | | |
|---|---|---|---|
| Ch. 2130 | <b>2018 Inspection:</b> Potential wedge failure observed ~15 m above road level. Potential for root jacking and release joints observed. The trajectory of a potential failure is difficult to predict, with the probable pathway to the left of the roadside outcrop. Potential failure volume is large enough to burst through the deer fence and may either come to rest in the ditch or at the edge of the road. | No changes observed during 2026 inspection. | AA10-5 |

| AA10-5 | <p>Ch. 2130:</p> <p>2018: Potential wedge failure observed ~15 m above road level. Potential for root jacking and release joints observed. The trajectory of a potential failure is difficult to predict, with the probable pathway to the left of the roadside outcrop. Potential failure volume is large enough to burst through the deer fence and may either come to rest in the ditch or at the edge of the road.</p> <p>2026: No changes observed during 2026 inspection.</p> | Year First Observed: | 2018 |

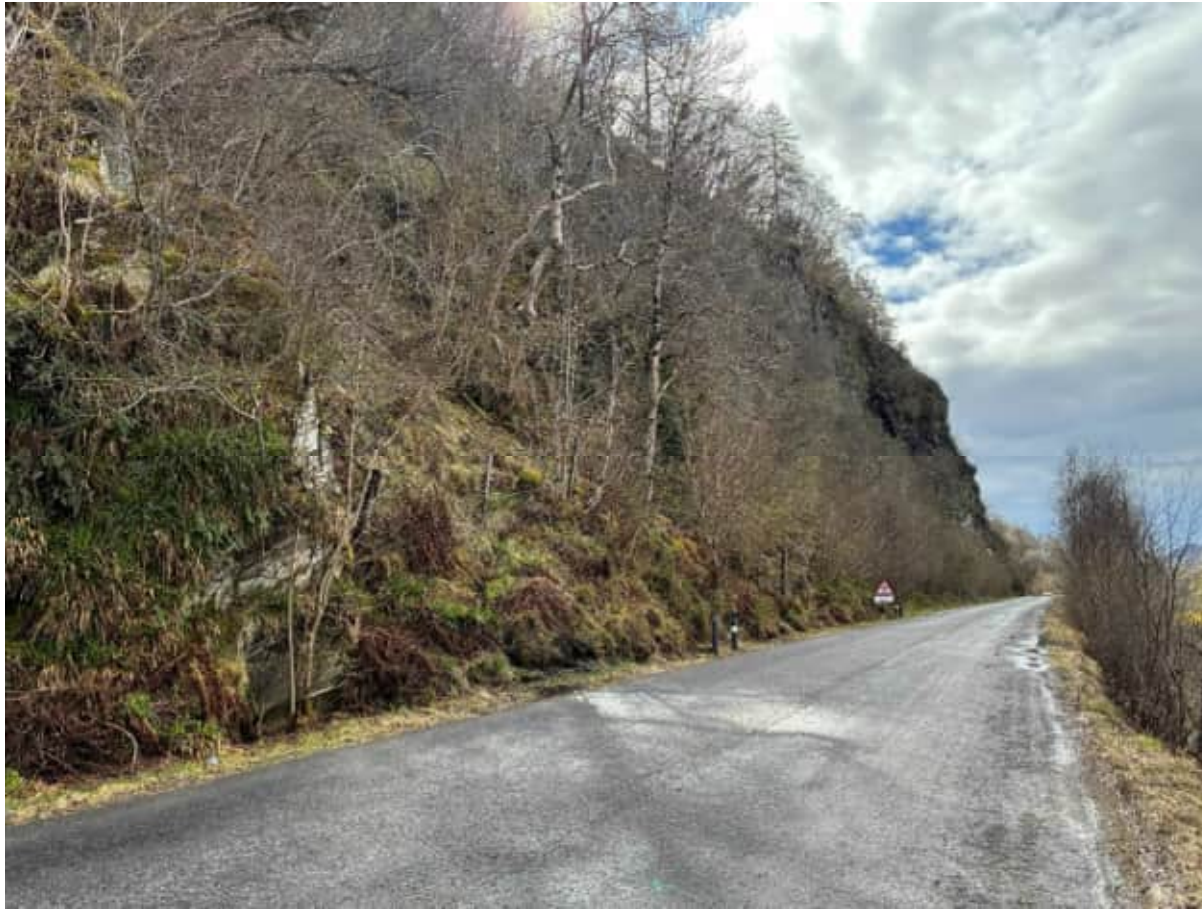
| Hazards Observed: | | | |
|---|---|---|---|
| Ch. 2140 to 2163 | <b>2025 Inspection:</b> Observation from road level: Small debris flow (in gully) c. 15 m above road level but set back by c. 40 m. Debris on slope, spray paint marker at road level. One block noted at the deer fence (c. 0.4 m) and a fallen tree is present on the slope. Correlates with location of THC observed landslide reported in January 2025. See additional notes under rope access inspection. | Further tree falls have occurred. No significant changes to risk assessment. | AA10-6<br>AA10-7<br>AA10-8 |

| AA10-6 | <p>Ch. 2140 to 2163:</p> <p>2025: Observation from road level: Small debris flow (in gully) c. 15 m above road level but set back by c. 40 m. Debris on slope, spray paint marker at road level. One block noted at the deer fence (c. 0.4 m) and a fallen tree is present on the slope. Correlates with location of THC observed landslide reported in January 2025. See additional notes under rope access inspection.</p> <p>2026: Further tree falls have occurred. No significant changes to risk assessment.</p> | Year First Observed: | 2025 |

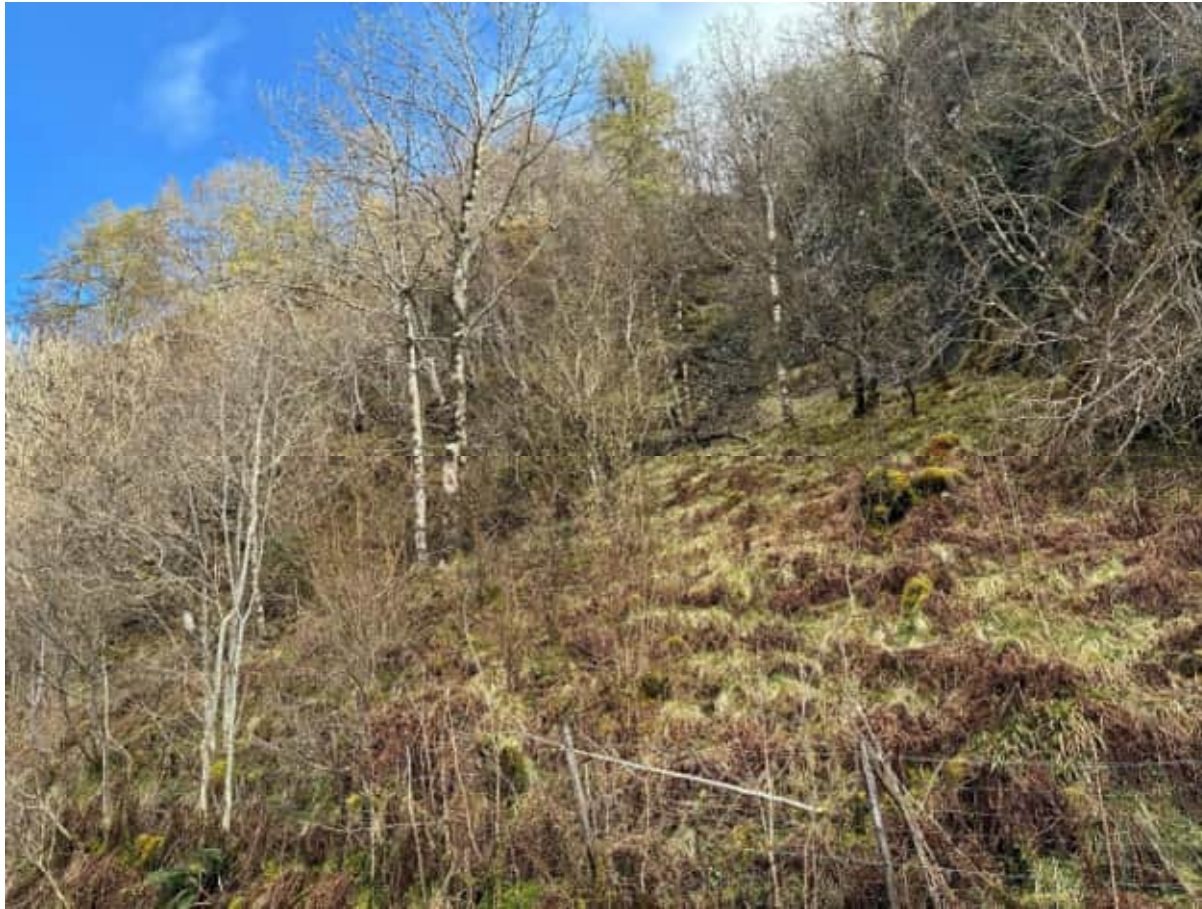
| AA10-7 | <p>Ch. 2140 to 2163:</p> <p>2025: Observation from road level: Small debris flow (in gully) c. 15 m above road level but set back by c. 40 m. Debris on slope, spray paint marker at road level. One block noted at the deer fence (c. 0.4 m) and a fallen tree is present on the slope. Correlates with location of THC observed landslide reported in January 2025. See additional notes under rope access inspection.</p> <p>2026: Further tree falls have occurred. No significant changes to risk assessment.</p> | Year First Observed: | 2025 |

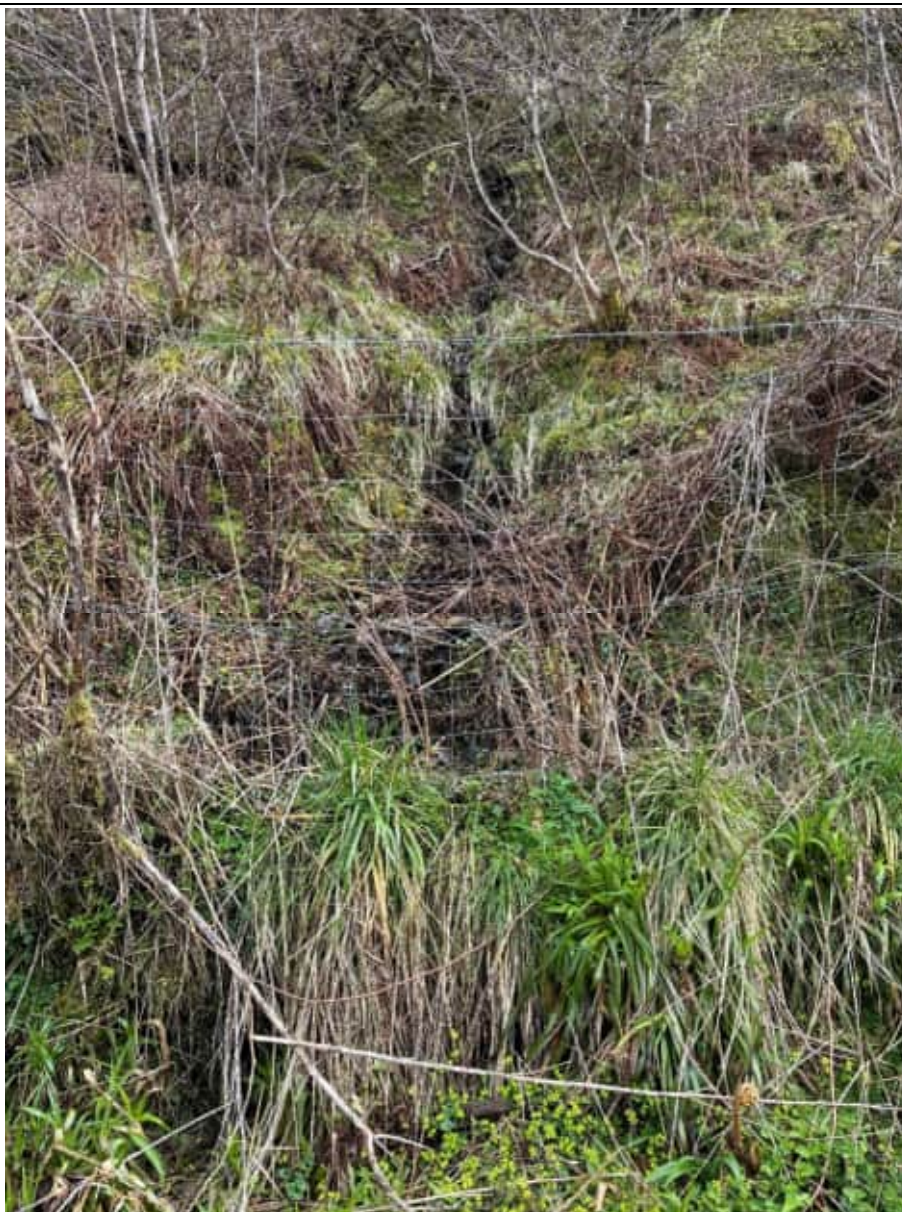
| AA10-9 | <p>Ch. 2185:</p> <p>2021: Small accumulation of gravel to cobble sized blocks at fence transported by intermittent waterflow in gully. No rocks past fence and at roadside so risk not considered to be significant.</p> <p>2024: Accumulation of blocks has slightly increased since 2023.</p> <p>2026: No changes observed during 2026 inspection.</p> | Year First<br>Observed: | 2021 |

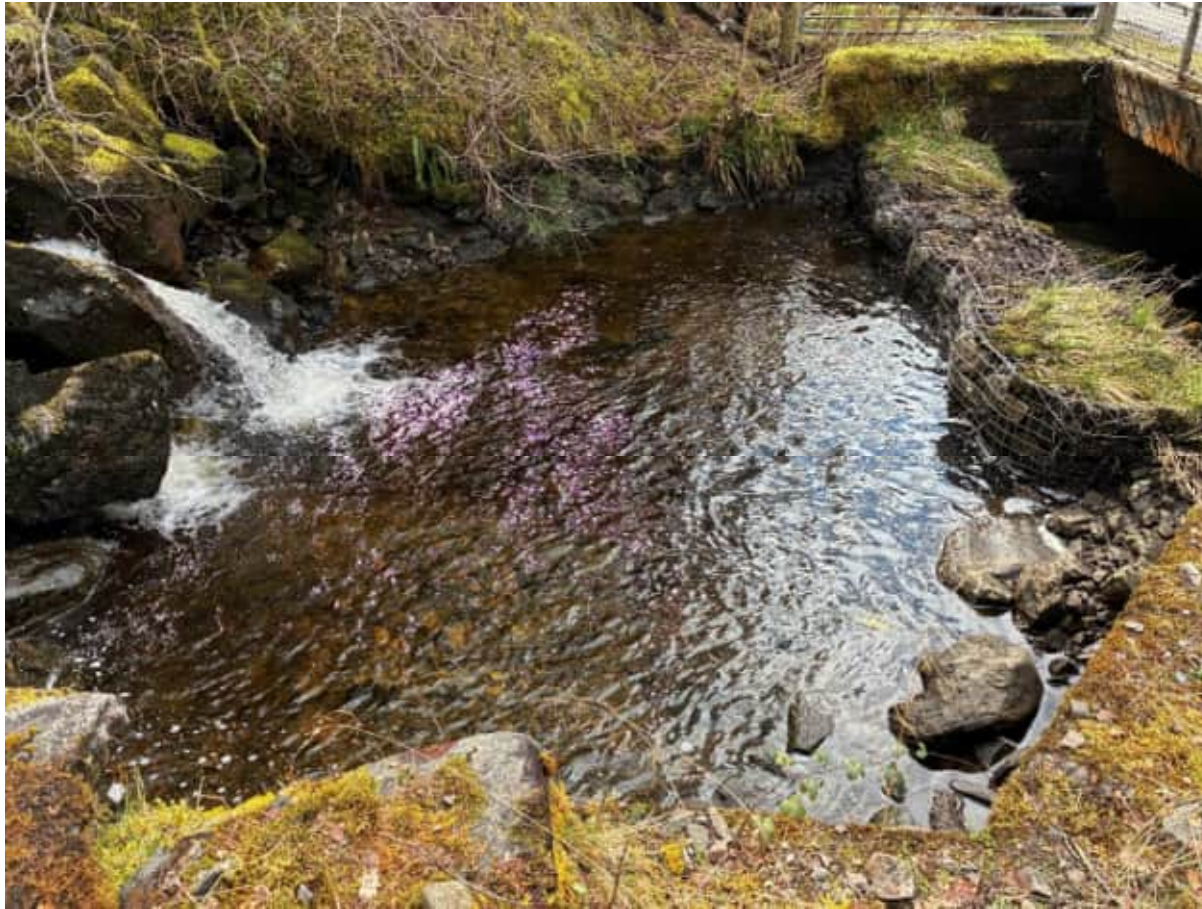
| FB-2 | <p>Ch. 2315:</p> <p>2021: Water levels are low. Both the lower and upper catchpits have good capacity.</p> <p>2020: Upper basin 50% full and lower basin 25% full but high-water level so harder to visually access. Appears that debris may have been recently cleared out.</p> <p>2025: Lower catch basin 25% full.</p> <p>2026: Lower catch basin appears to be approx. 25% full, however, the water level is significantly higher than in 2025, so it is harder to visually assess.</p> | Year First Observed: | 2021 |
