# A890 Strome ferry Bypass

Annual Slope Inspection 2026

The Highland Council

Project number: 60685712  
AECOM Report Ref.: GLRP0013

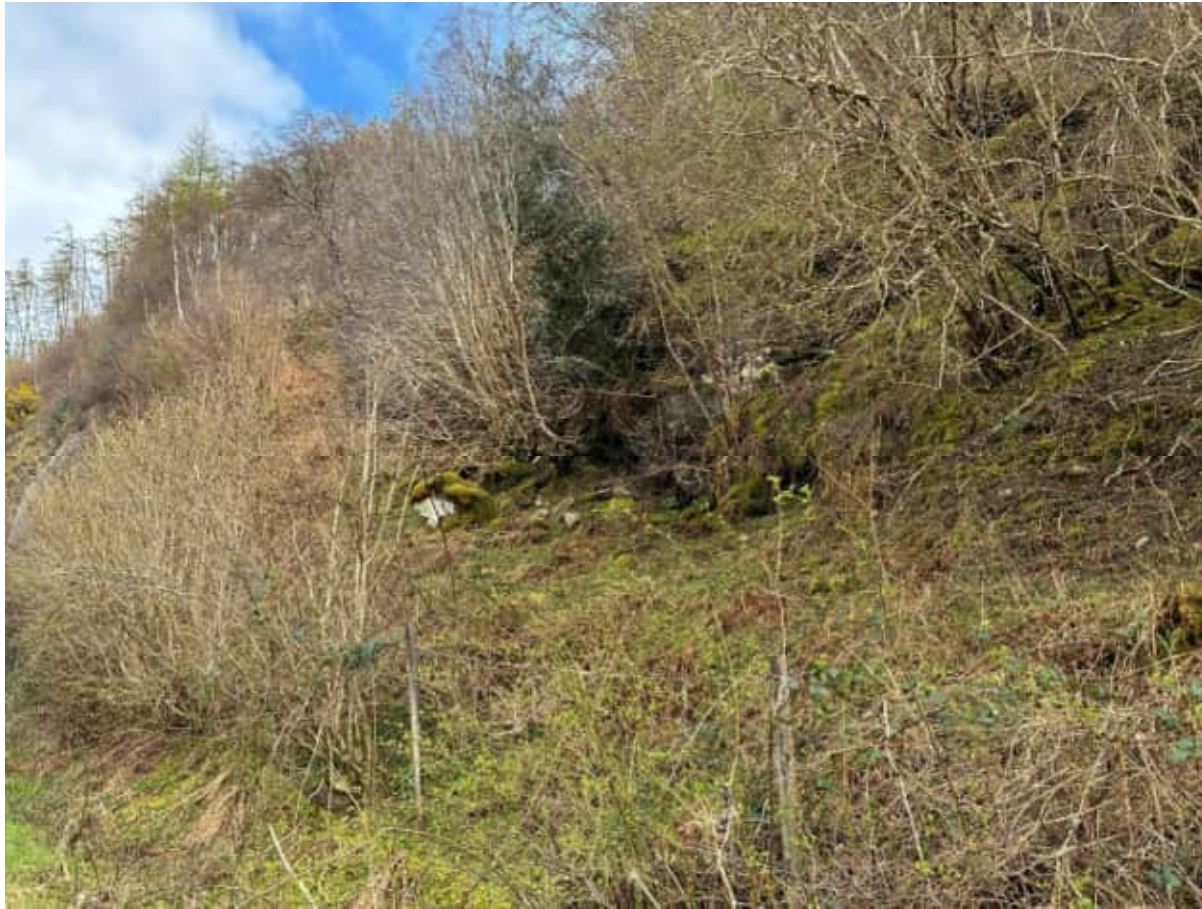
| FB-3 | <p>Ch. 2340:</p> <p>2020: Failure reported by THC. Minor root jacking on face c. 10 m back from road edge. Potential for additional material to fail (c. 1 m<sup>3</sup>).</p> <p>2024: Possibly some new blocks present but well set back from the road.</p> <p>2025: Potentially some new blocks present but well set back from the road. No significant risk to the road / road users.</p> <p>2026: No changes observed during 2026 inspection.</p> | Year First Observed: | 2025 |

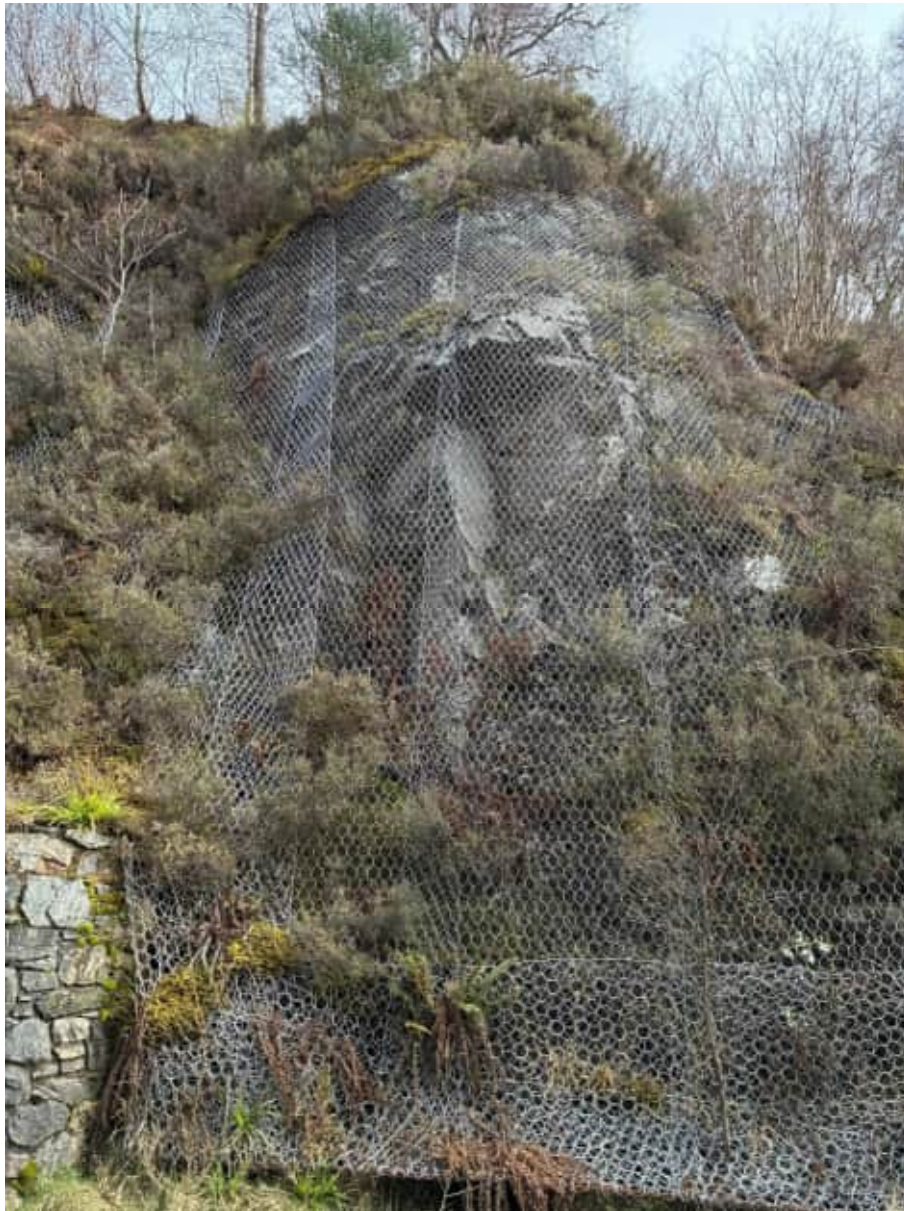
| AA11-1 | <p>Ch. 2364:</p> <p>2018: Wedge failure identified, comprising an overhanging column of rock c. 6 to 8 m above road level. Wedge of rock below has previously failed, possibly during construction but joints are tight and overhang. Not at imminent risk of failure.</p> <p>2026: No changes observed during 2026 inspection.</p> | Year First Observed: | 2018 |

| Recommended Remedial Works / Actions | | | | | | | |
|---|---|---|---|---|---|---|---|
| N/A | | N/A | | | <ul style="list-style-type: none"> <li>Vegetation clearance is recommended across the whole slope.</li> <li>Install bimetallic corrosion protection between existing galvanised cable and stainless-steel eye nuts;</li> <li>Replace bottom cable and install additional bottom anchors; and</li> <li>Replace dropper cables (allow 10no. 10 m long) and install additional anchors (allow 6no.).</li> </ul> | | |

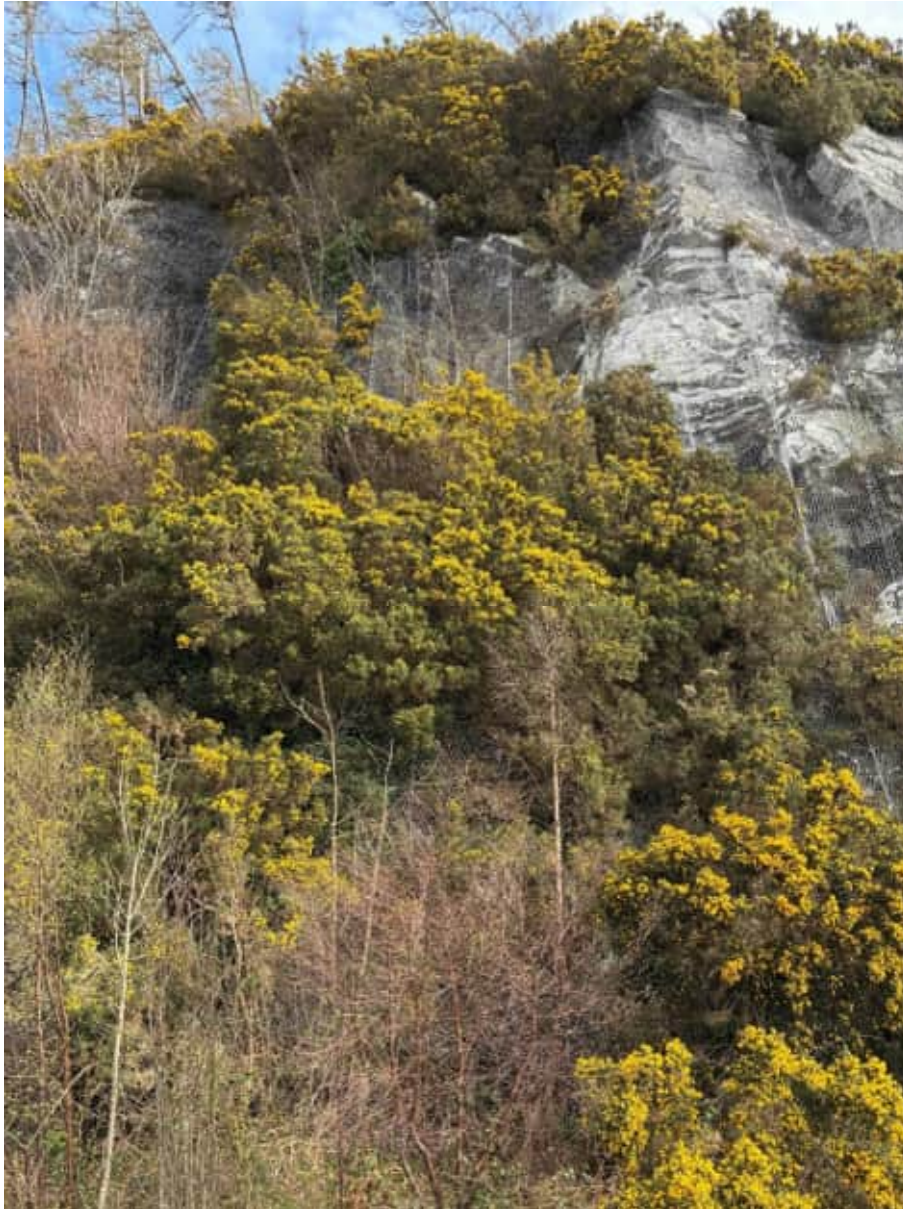
| AA13-1 | <p>Ch. 2535:</p> <p>2021: Overhanging area c. 12 to 15 m above toe with gaping mesh below. Potentially some dilated fractures around base of overhang. Large verge and ditch at toe mean low risk to road.</p> <p>2026: No changes observed during 2026 inspection from road level.</p> | Year First Observed: | 2021 |

| Recommended Remedial Works / Actions | | | | | | | |
|---|---|---|---|---|---|---|---|
| N/A | | N/A | | | <ul style="list-style-type: none"> <li>Vegetation clearance is recommended across the whole slope; and</li> <li>Replace corroded cable clamps, re-tension and install additional Spenax rings on vertical reinforcing cables between Ch. 2513 and 2528.</li> </ul> | | |

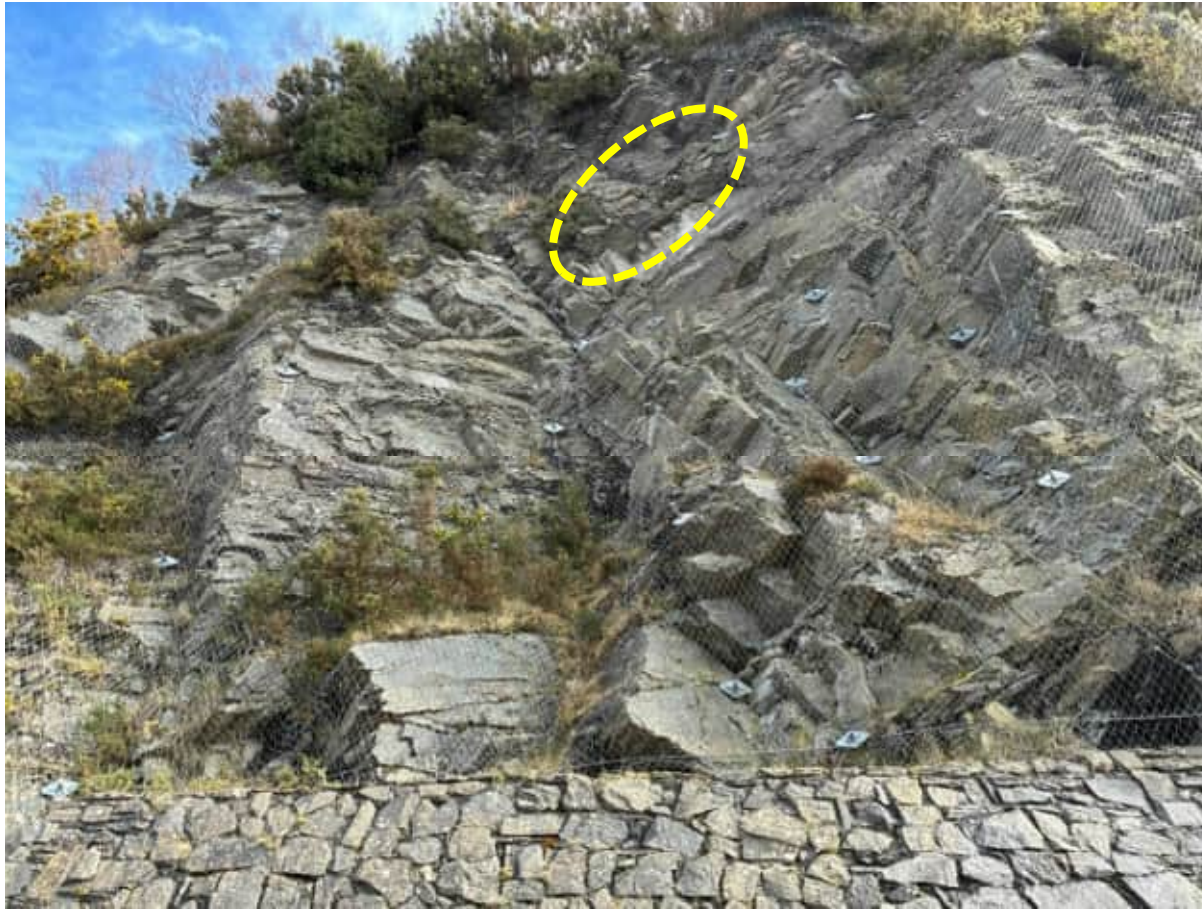
AA14-W-1

Ch. 2610:

| Recommended Remedial Works / Actions | | | | | | | |
|---|---|--|---|---|---|---|---|
| N/A | | | N/A | | | <ul style="list-style-type: none"> <li>Vegetation clearance is recommended across the whole slope.</li> </ul> | |

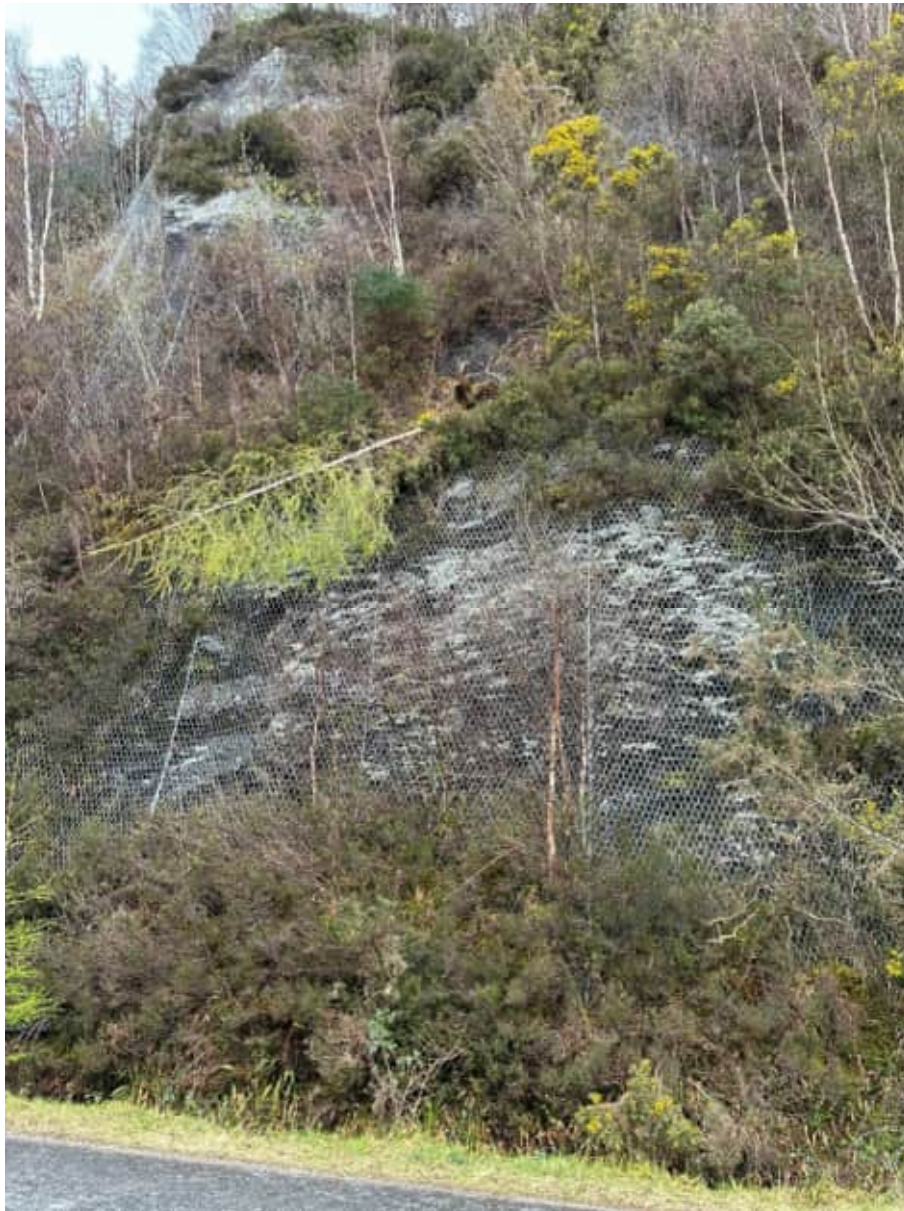
| AA15-1 | Ch. 2700:<br>2026: A fallen tree at approx. 6 m above road level has torn the netting. No evidence of fallen blocks. The tree should be removed and the netting patched. | Year First<br>Observed: | 2026 |

| Recommended Remedial Works / Actions | | | | | | | |
|---|---|--|---|---|---|---|---|
| N/A | | | <ul style="list-style-type: none"> <li>The fallen tree at Ch. 2700 should be removed and the torn netting patched.</li> </ul> | | | <ul style="list-style-type: none"> <li>Vegetation clearance is recommended across the whole slope; and</li> <li>Replace missing Ch. 2700 marker.</li> </ul> | |

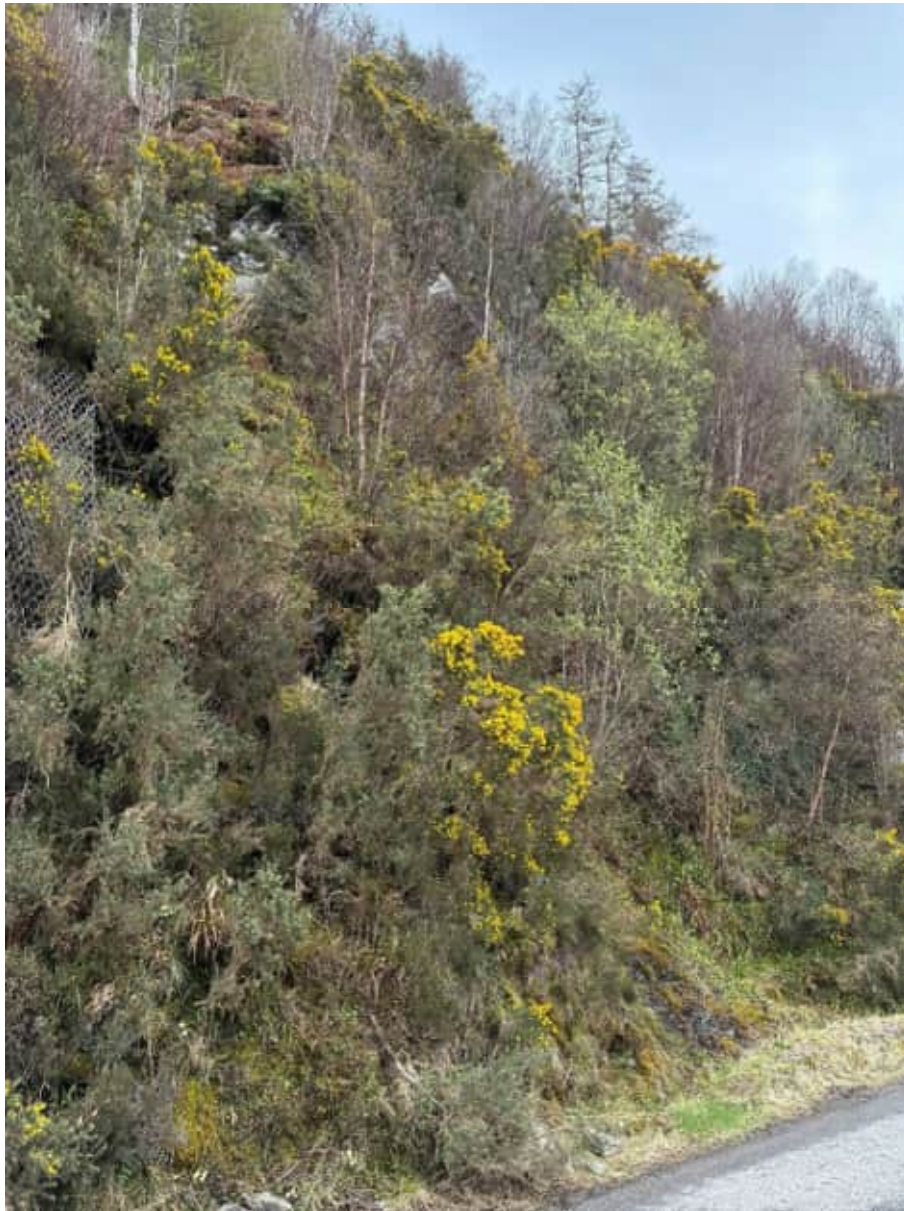
| Hazards Observed: | | | |
|---|---|---|---|
| Ch. 2888 | <b>2016 Inspection:</b> Broken section of rock mass 5 to 10 m above road level with potential to fail if root jacking continues. Block size typically ~0.1 m <sup>3</sup> but total failure volume could be 2 to 3 m <sup>3</sup> . May exceed capacity of mesh if all fails at same time. Verge quite narrow so could reach road. | No changes observed during 2026 inspection. | AA16-2 |

| AA16-2 | <p>Ch. 2888:</p> <p>2016: Broken section of rock mass 5 to 10 m above road level with potential to fail if root jacking continues. Block size typically ~0.1 m<sup>3</sup> but total failure volume could be 2 to 3 m<sup>3</sup>. May exceed capacity of mesh if all fails at same time. Verge quite narrow so could reach road.</p> <p>2026: No changes observed during 2026 inspection.</p> | Year First Observed: | 2016 |

| Recommended Remedial Works / Actions | | | | | | | |
|---|---|---|---|---|---|---|---|
| N/A | | <ul style="list-style-type: none"> <li>Coppice trees growing within broken rock mass at Ch. 2888.</li> </ul> | | | <ul style="list-style-type: none"> <li>Vegetation clearance / tree coppicing across slope.</li> <li>Build-up of debris in ditch should be monitored, and clearance works undertaken as required to maintain its capacity.</li> </ul> | | |

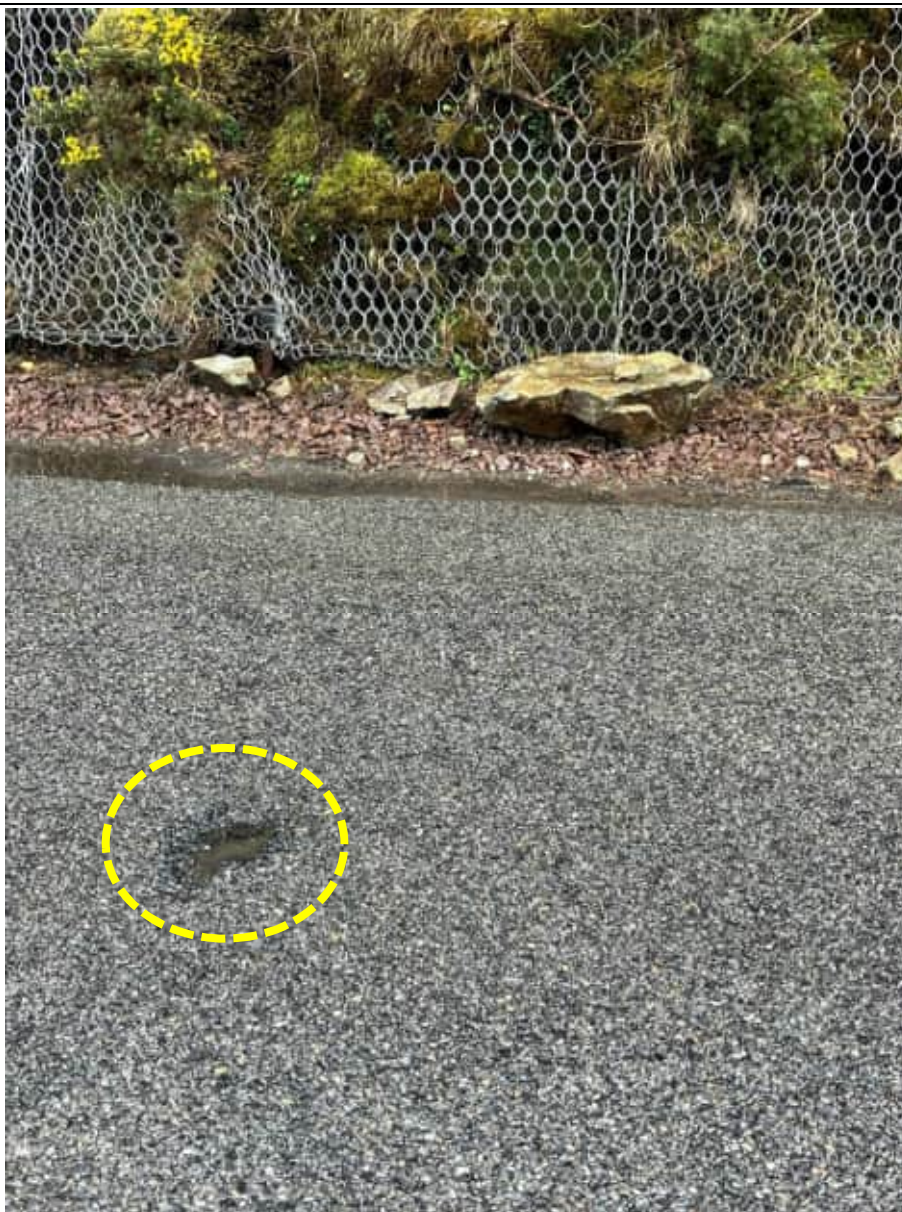
| AA17-1 | <p>Ch. 2929:</p> <p>2026: A large block is present on the verge at the toe of the slope of approx. dimensions 1.0 x 0.4 x 0.4 m. Approx 10no. smaller blocks are also present, and there is a significant indentation on the road hardstanding. In person conversations with THC on-site indicates the rockfall occurred in autumn 2025. Given the netting is intact in this area, the blocks are inferred to have fallen from be above the slope crest. The potential for further rockfalls from above the slope crest cannot be ruled out; a rope access inspection above the slope crest should be considered as part of the 2027 inspection works to assess the presence of further blocks with the potential to fall and impact the road.</p> | Year First Observed: | 2026 |

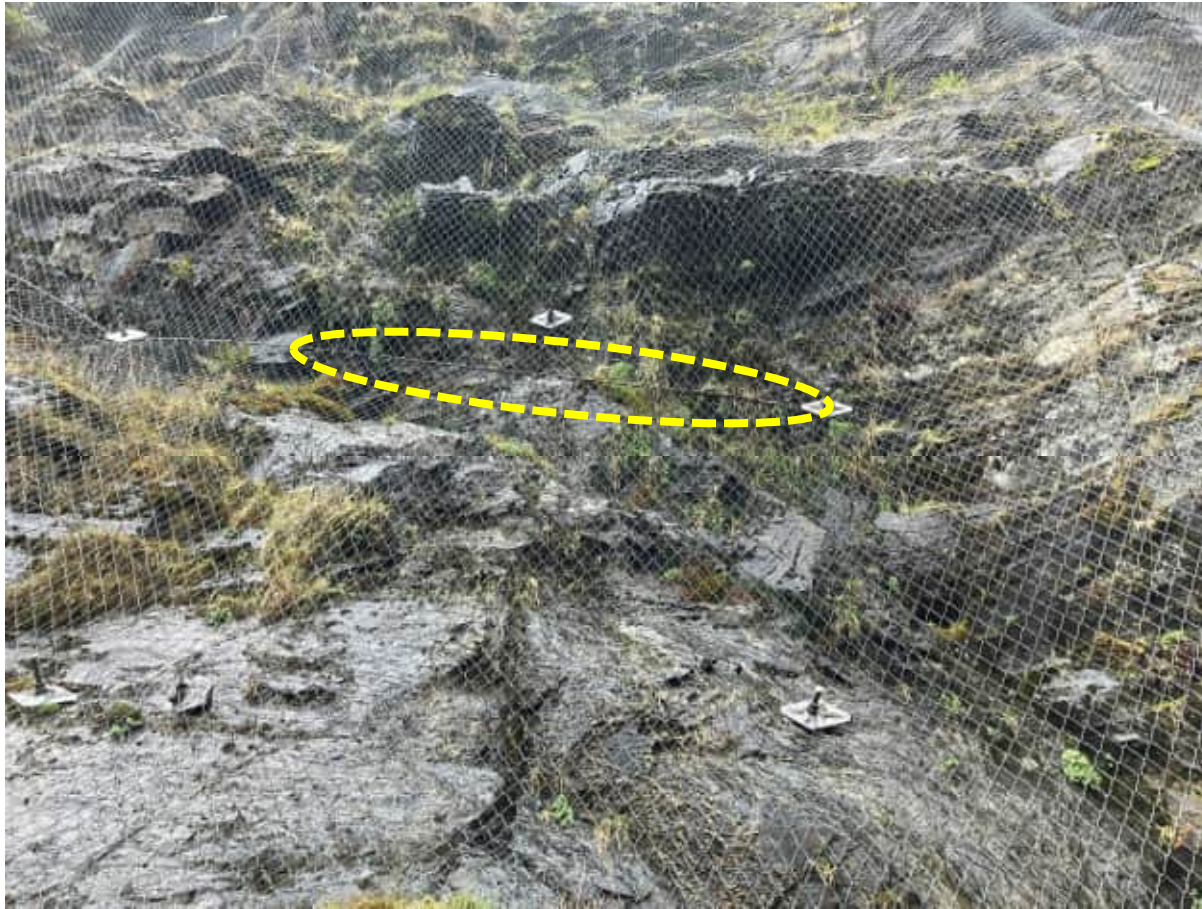
| AA18-1 | <p>2018 – Phase 10 works:</p> <p>2022: Potential corrosion of netting mid-slope, mid-slope profiling cable, and bottom cable observed at Ch. 3032.</p> <p>2024: Wire rope grip bolts and threaded ends are showing signs of local corrosion.</p> <p>2025: Mid-slope profiling cable at Ch. 3032 highly discoloured – corrosion level to be assessed in future annual inspections.</p> <p>2026: Wire rope grips on the mid-slope profiling cable at Ch. 3032 display significant surface corrosion.</p> | Year First Observed: | 2018 |

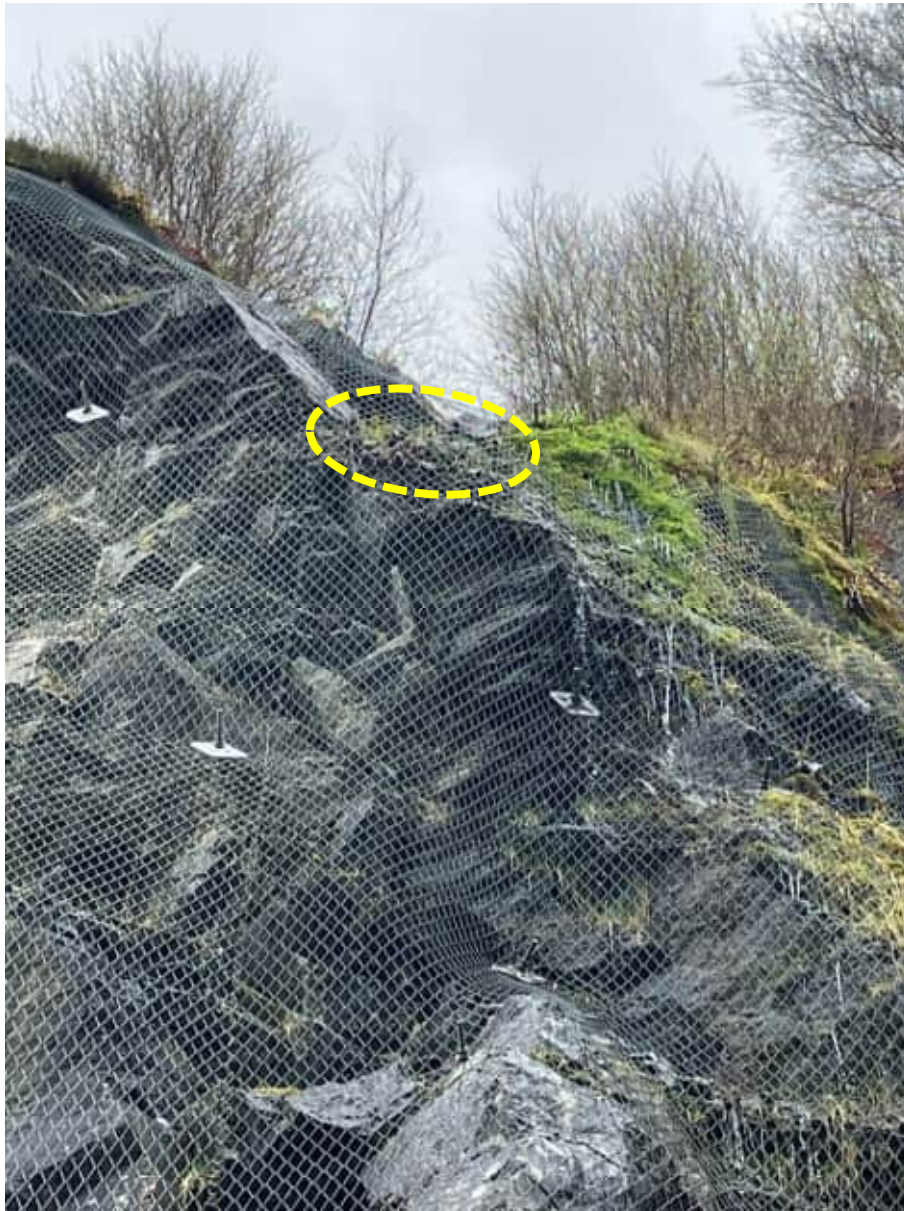
| AA18-2 | <p>Ch. 2990:</p> <p>2021: Some loose blocks behind netting near crest. One block c. 0.15 x 0.15 x 0.15 m caught behind netting and pulling netting out slightly from slope. Several smaller blocks resting on slope adjacent to spike plate. Would be beneficial to move block down behind the netting. Source is likely to be the slight overhang at crest. Keep under observation for additional debris.</p> <p>2026: No changes observed during 2026 inspection.</p> | <p>Year First Observed:</p> | 2021 |

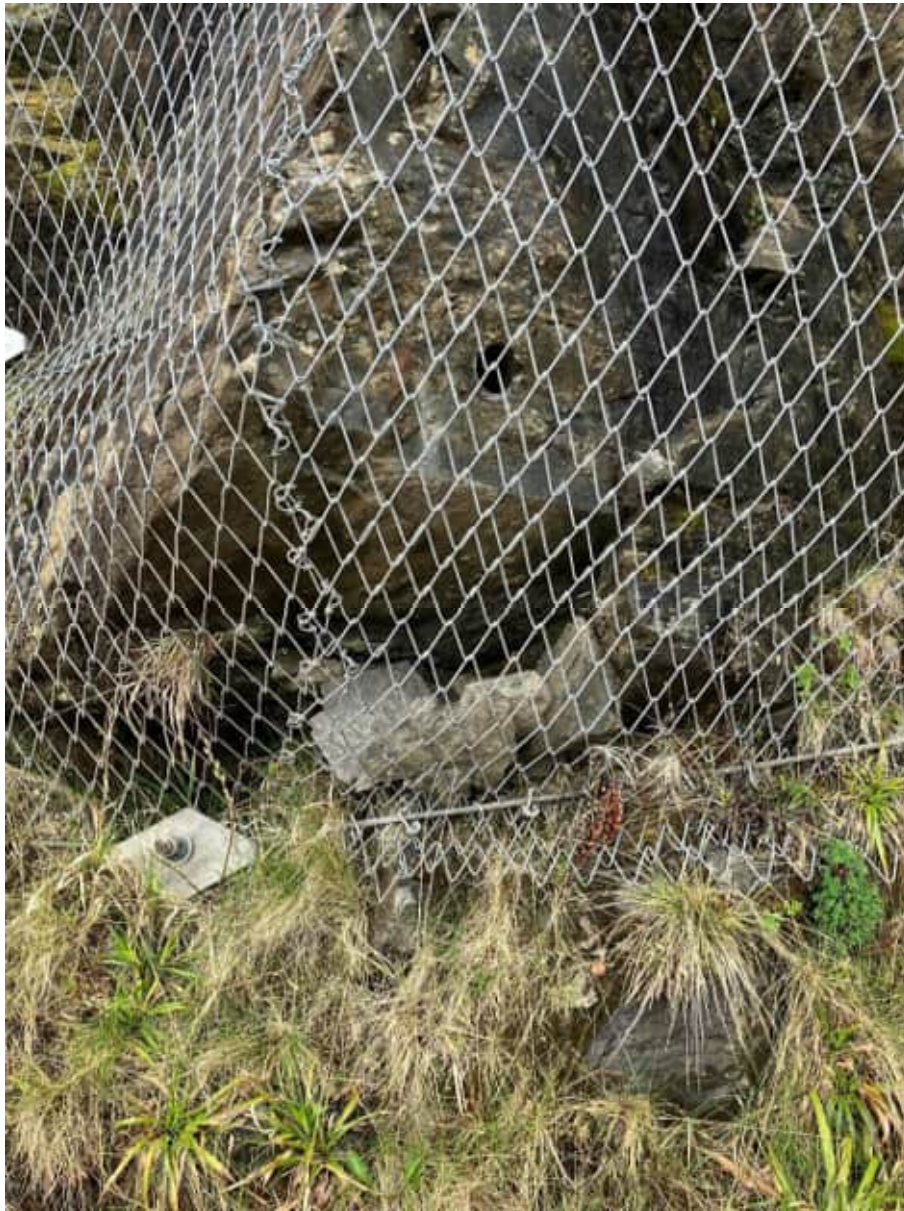
| AA18-2 | <p>Ch. 3001:</p> <p>2026: A small number of thin, tabular blocks have fallen and are retained within the netting circa 1 m above the toe of the slope. The source of the rockfall is 0.5 m above, with the blocks having delaminated from a small overhang. The blocks do not pose a risk to the road and are not straining the netting system.</p> | <p>Year First Observed:</p> | 2021 |

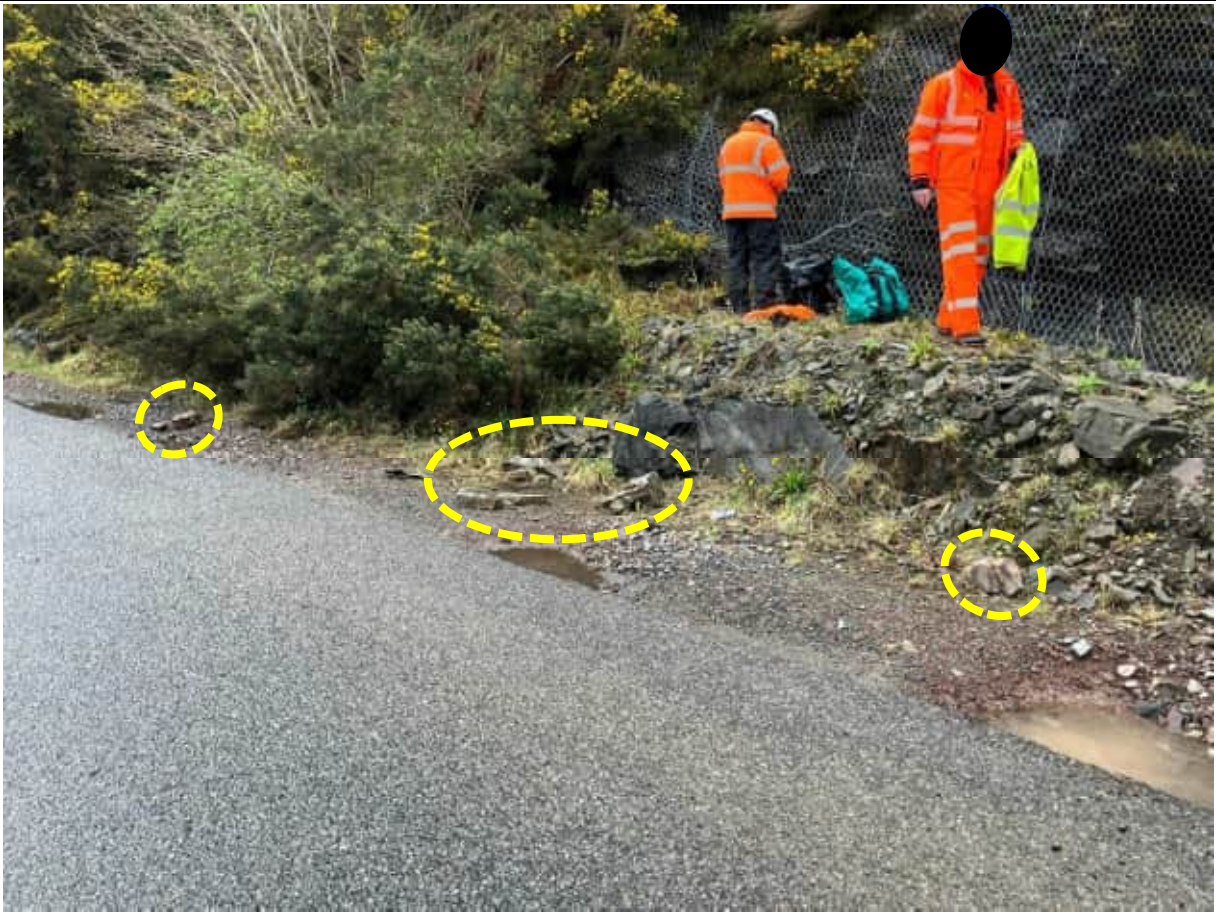
| AA18/19-2 | <p>Ch. 3051 to 3068 (concentrated at approx. Ch. 3056):</p> <p>2026: A recent rockfall has occurred and the fallen blocks have been moved to the roadside. Numerous blocks are present within the catchpit, on the rim of the catchpit, and on both sides of the road; material is not present on the road itself and is suspected to have been pushed to the roadsides (debris seen on drone survey completed 07/04/2026, suspected to have fallen during Storm Dave between 04/04/2026 and 05/04/2026). The largest block is approx. 0.5 x 0.3 x 0.2 m. The total volume of the rockfall material is estimated to be 0.5 m³. The source of the rockfall material is inferred to be the upper crags.</p> | Year First Observed: | 2026 |

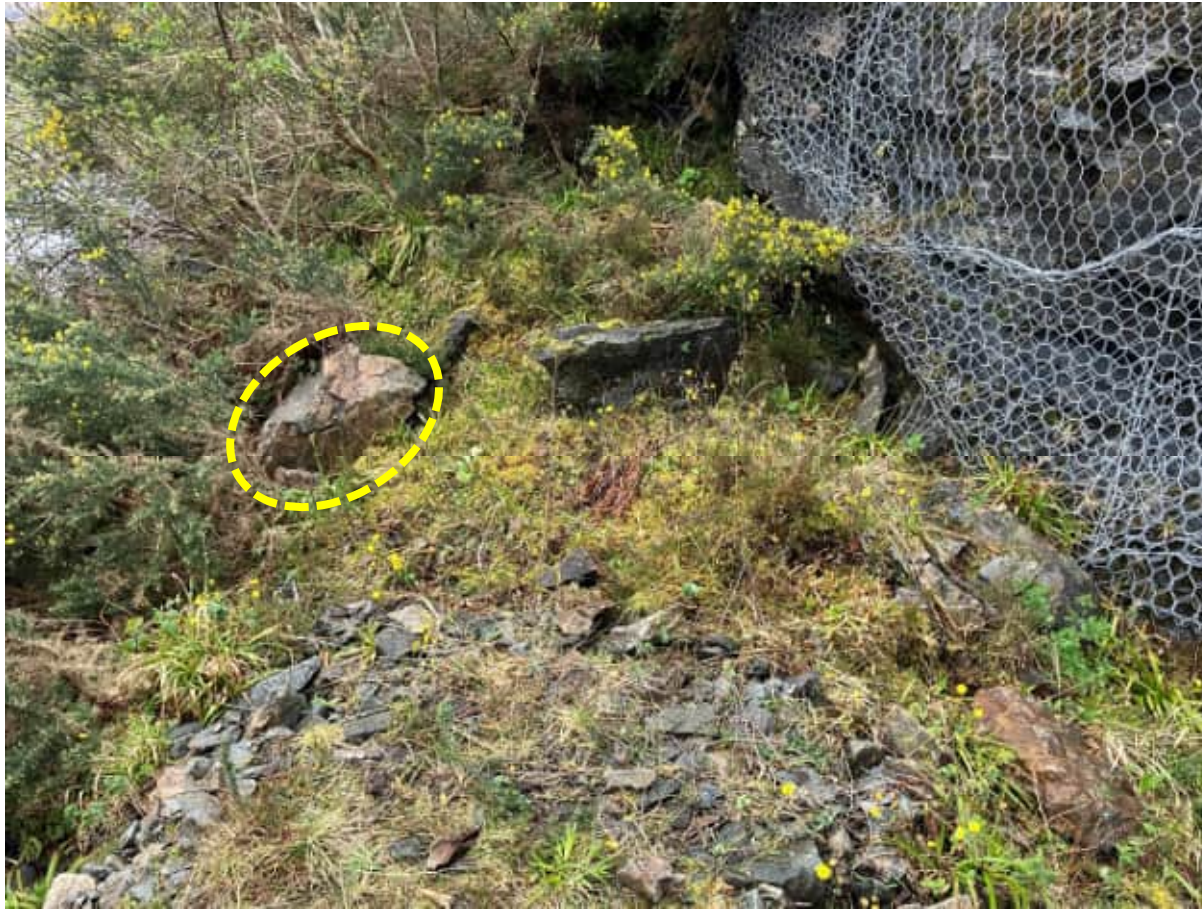
AA18/19-3

Ch. 3051 to 3068 (concentrated at approx. Ch. 3056):

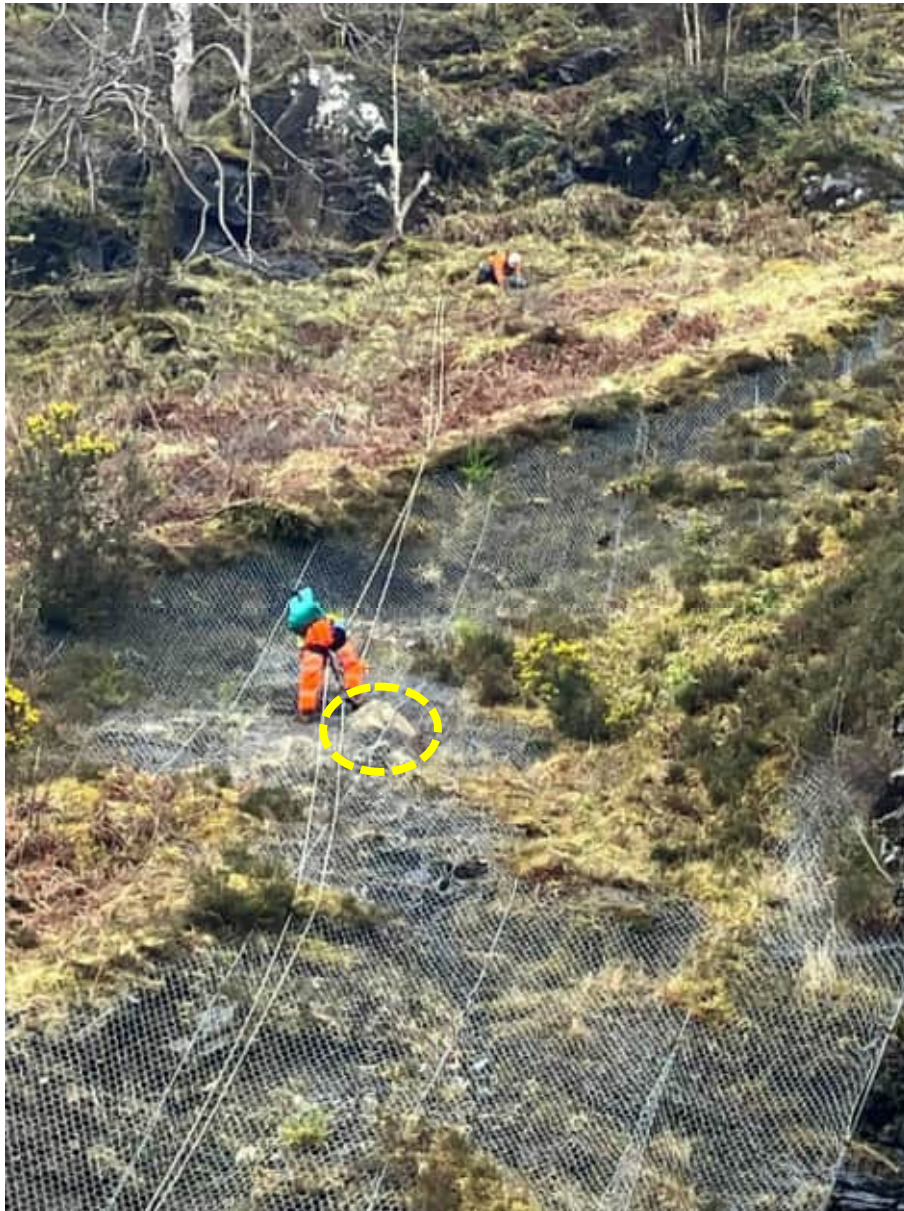
| AA18/19-5 | <p>Ch. 3059</p> <p>2024: Large block 5 m down slope from the top netting. Dimension 0.5 m wide. Weathered out from soil.</p> <p>2026: Block has slid approx. 1 m further downslope. Not considered to pose a risk to the road as the block is inside the netting.</p> | Year First Observed: | 2024 |

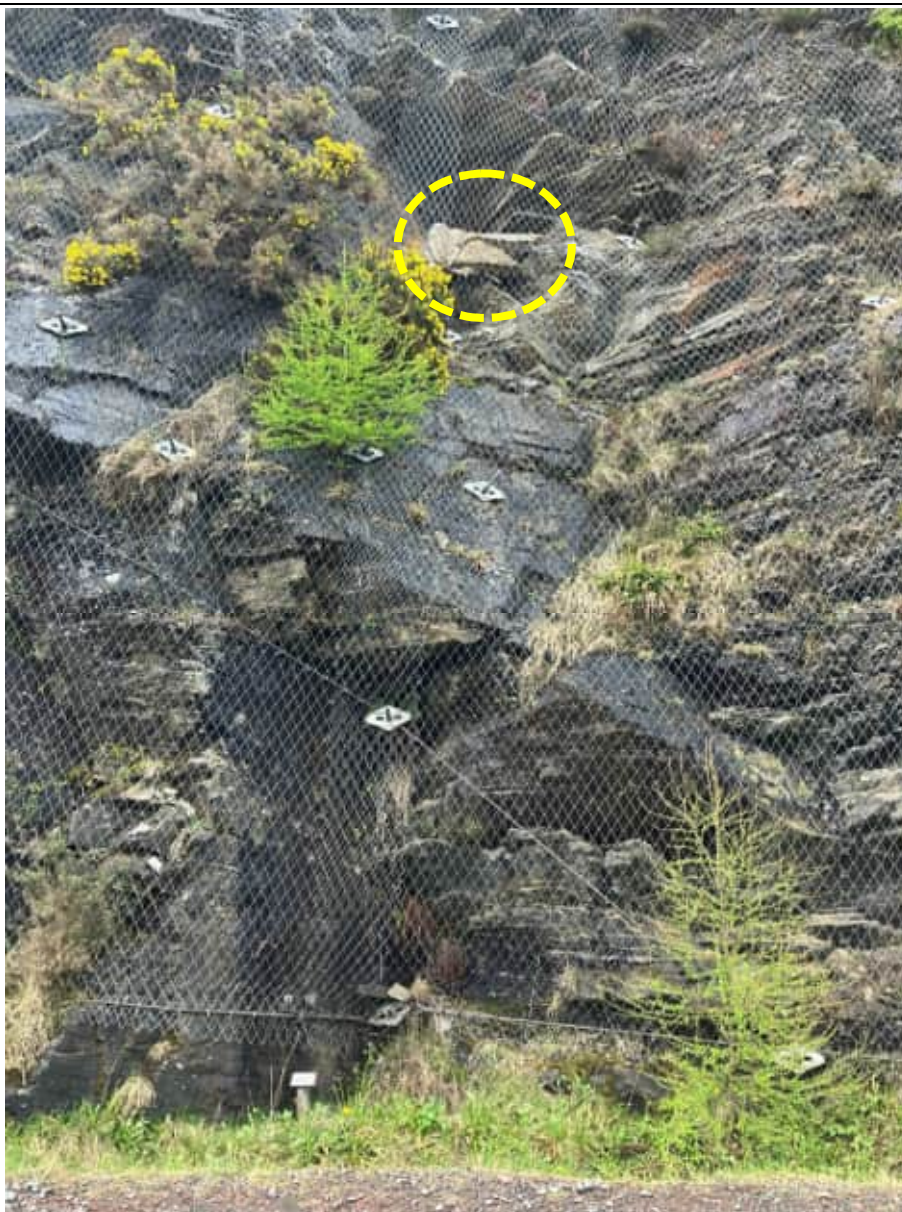
| AA19-1 | <p>Ch.3100:</p> <p>2018: Failure of c. 0.25 m<sup>3</sup> observed 6 to 8 m above road level and has been retained by mesh. Fractured overhanging block of c. 0.5 m<sup>3</sup> could also fail in future but would be retained by mesh. Debris is not currently overloading the system so no remedial works are required at this stage. Keep under observation during future inspections.</p> <p>2026: No changes observed during 2026 inspection.</p> | Year First Observed: | 2018 |

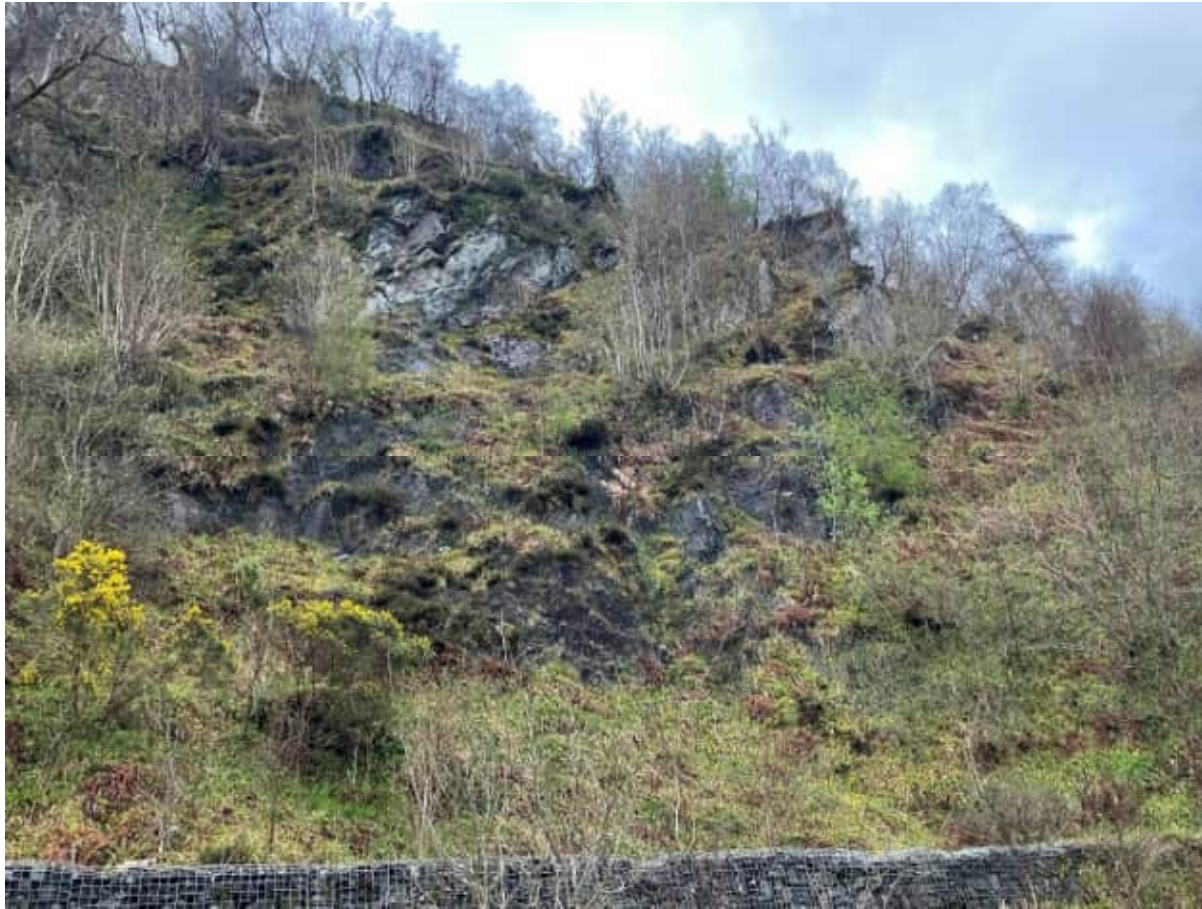
| AA19-3 | <p>Ch. 3145 (above gabions and TECCO netting):</p> <p>2023: Rope access identified sporadic areas of rock exposure with occasional dilated joints and root jacking potential. Risk of occasional block falling (max. 0.5 x 0.5 x 0.5 m).</p> <p>2026: No changes observed during 2026 inspection.</p> | Year First Observed: | 2023 |

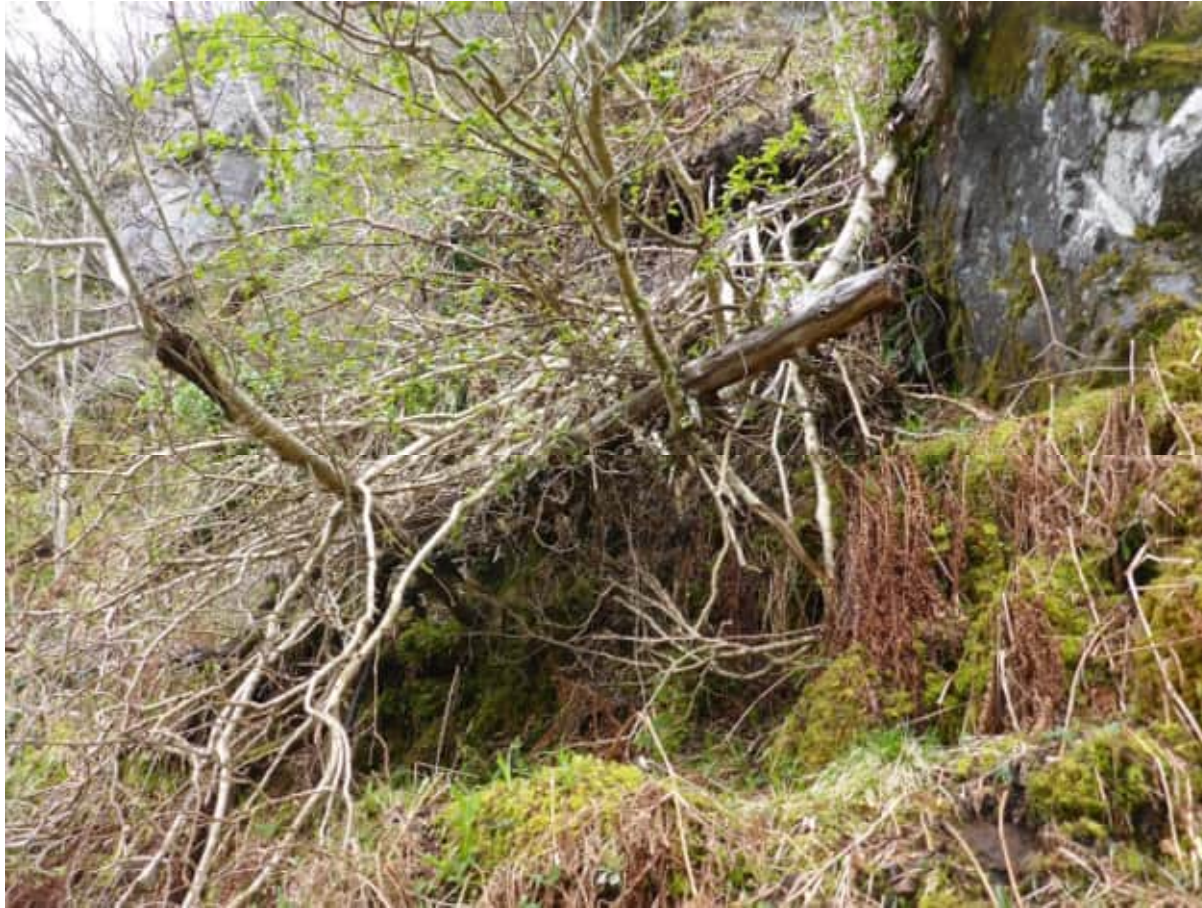
| AA19-U-1 | <p>Ch. 3060 to 3070:<br/>To assess the source of the rockfall material encountered at road level at slope AA18/19.</p> <p>Findings:</p> <ul style="list-style-type: none"> <li>• Weathered rock continues to spall from the upper crags.</li> <li>• Ephemeral water flow down the upper slope in periods of heavy rain has further eroded an area of poor bedrock and washed some material down to the road, with accumulations remaining on the mid-slope ledge at the top of the Maccaferri mesh.</li> <li>• Fallen trees and/or bushes were also observed on the slope.</li> </ul> | Year First Observed | 2023 |

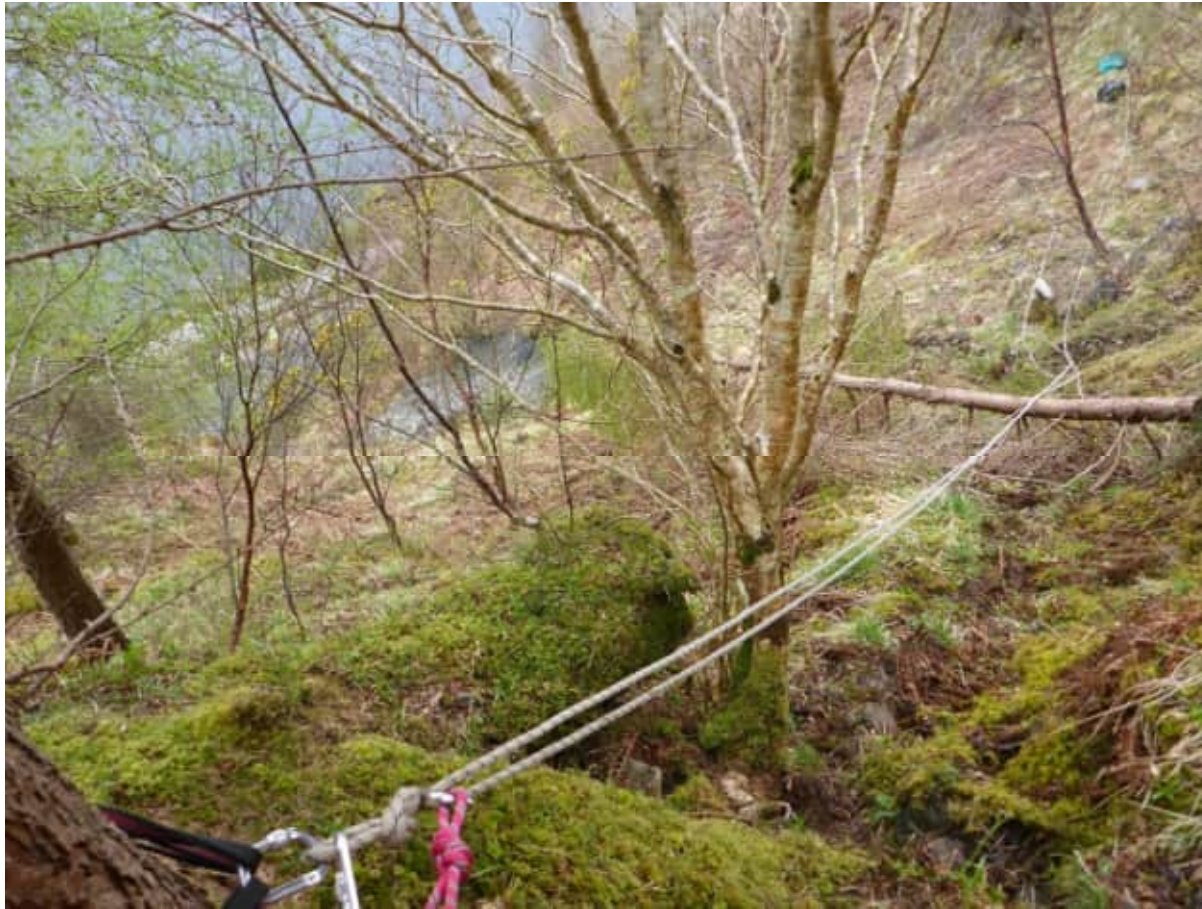
AA19-U-2

Ch. 3060 to 3070:

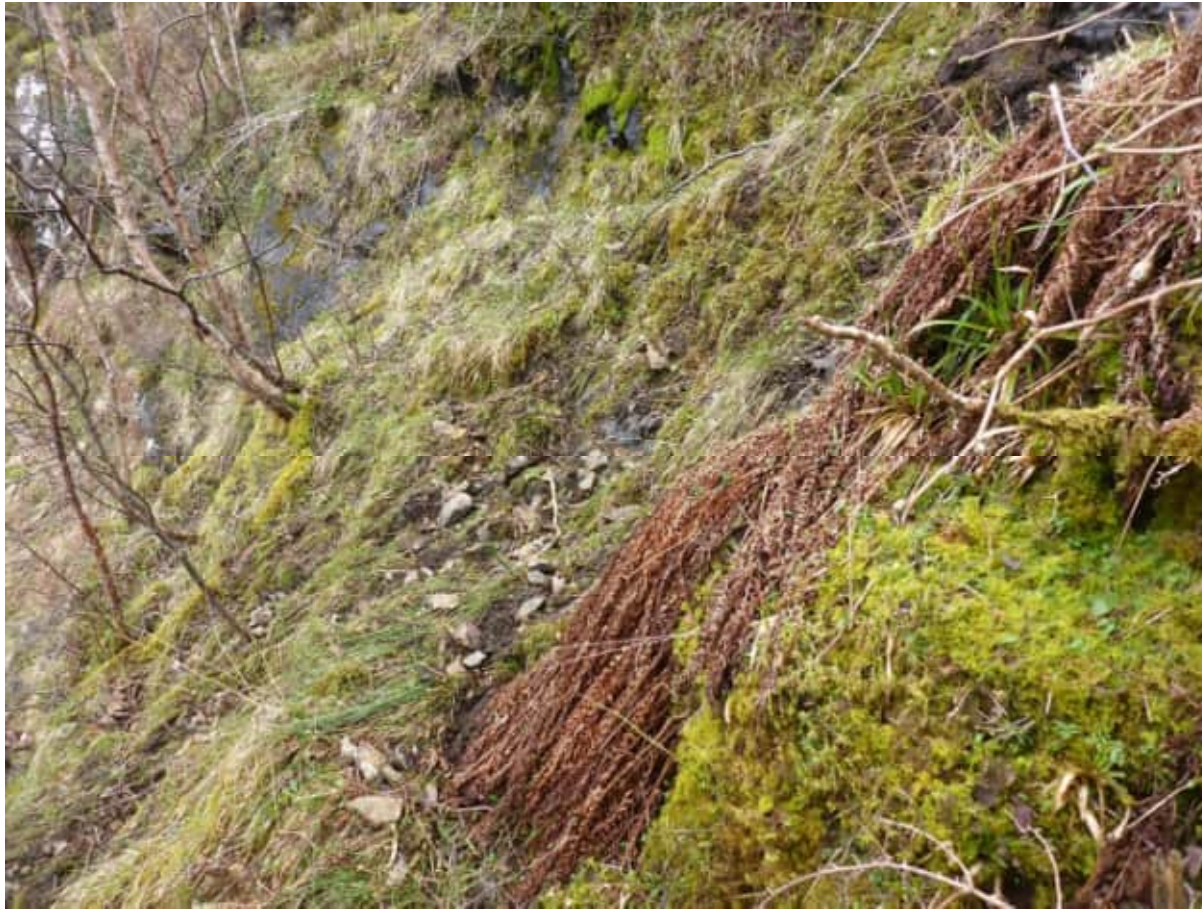
| AA19-U-1 | <p>Ch. 3060 to 3070:</p> <p>To assess the source of the rockfall material encountered at road level in slope AA18/19.</p> <p>Findings:</p> <ul style="list-style-type: none"> <li>• Weathered rock continues to spall from the upper crags.</li> <li>• Ephemeral water flow down the upper slope in periods of heavy rain has further eroded an area of poor bedrock and washed some material down to the road, with accumulations remaining on the mid-slope ledge at the top of the Maccaferri mesh.</li> <li>• Fallen trees and/or bushes were also observed on the slope.</li> </ul> | Year First Observed | 2023 |
