# A890 Strome ferry Bypass

Annual Slope Inspection 2026

The Highland Council

Project number: 60685712  
AECOM Report Ref.: GLRP0013

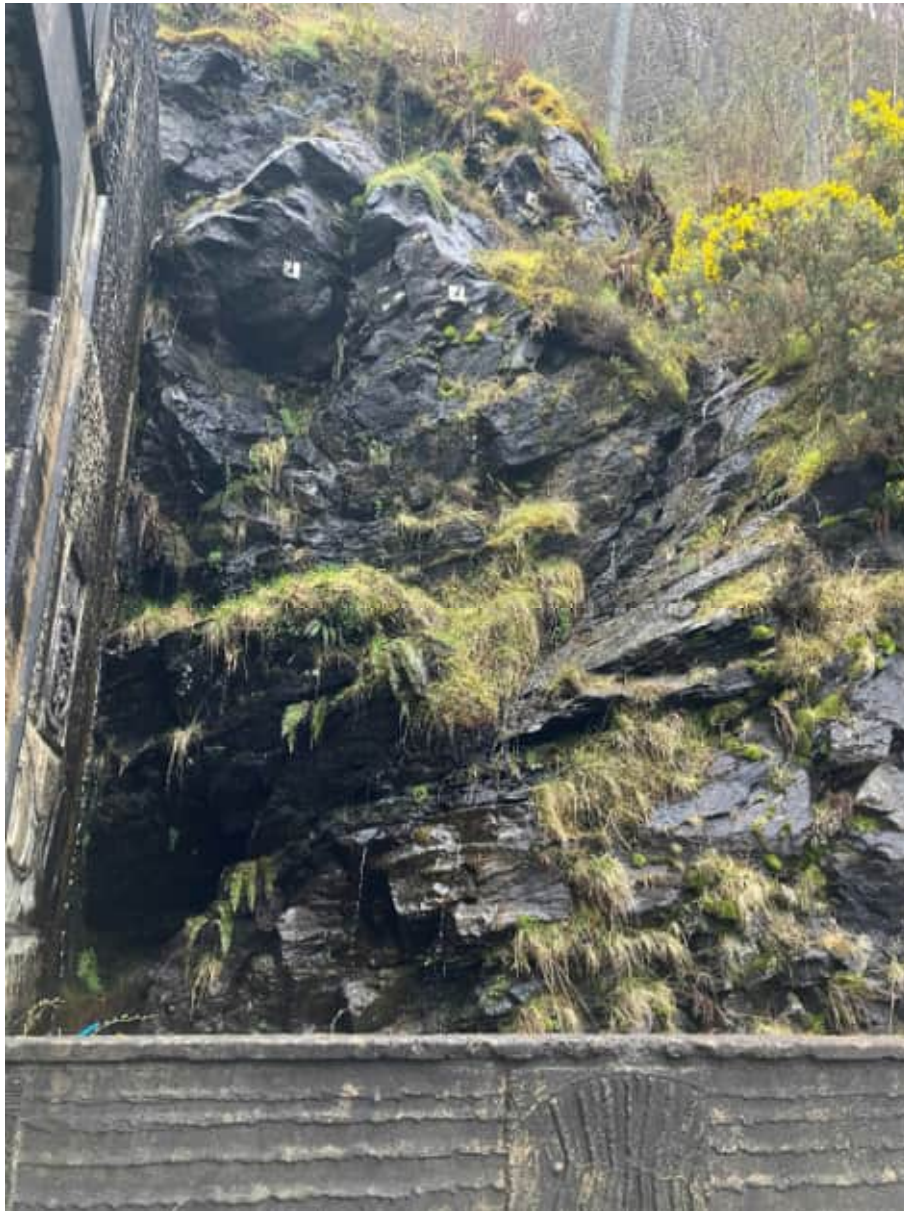
| AA20-1 | <p>Ch. 3203 (between wall and avalanche shelter):</p> <p>2017: Large potential wedge failure located approximately 2 m above road level. Verge at this location is ~0.5 m with no ditch.</p> <p>2026: A dowel is installed within the rock at Ch. 3203; not considered the represent an active or potentially active wedge failure.</p> | Year First Observed: | 2017 |

| Recommended Remedial Works / Actions | | | | | | | |
|---|---|---|---|---|---|---|---|
| N/A | | <ul style="list-style-type: none"> <li>Install passive rock fall netting system over rock face prone to ravelling at Ch. 3200 to 3205.</li> <li>Light scale and dowel blocks above wall at Ch. 3175.</li> </ul> | | | <ul style="list-style-type: none"> <li>Clear out gully above Ch. 3167.</li> </ul> | | |

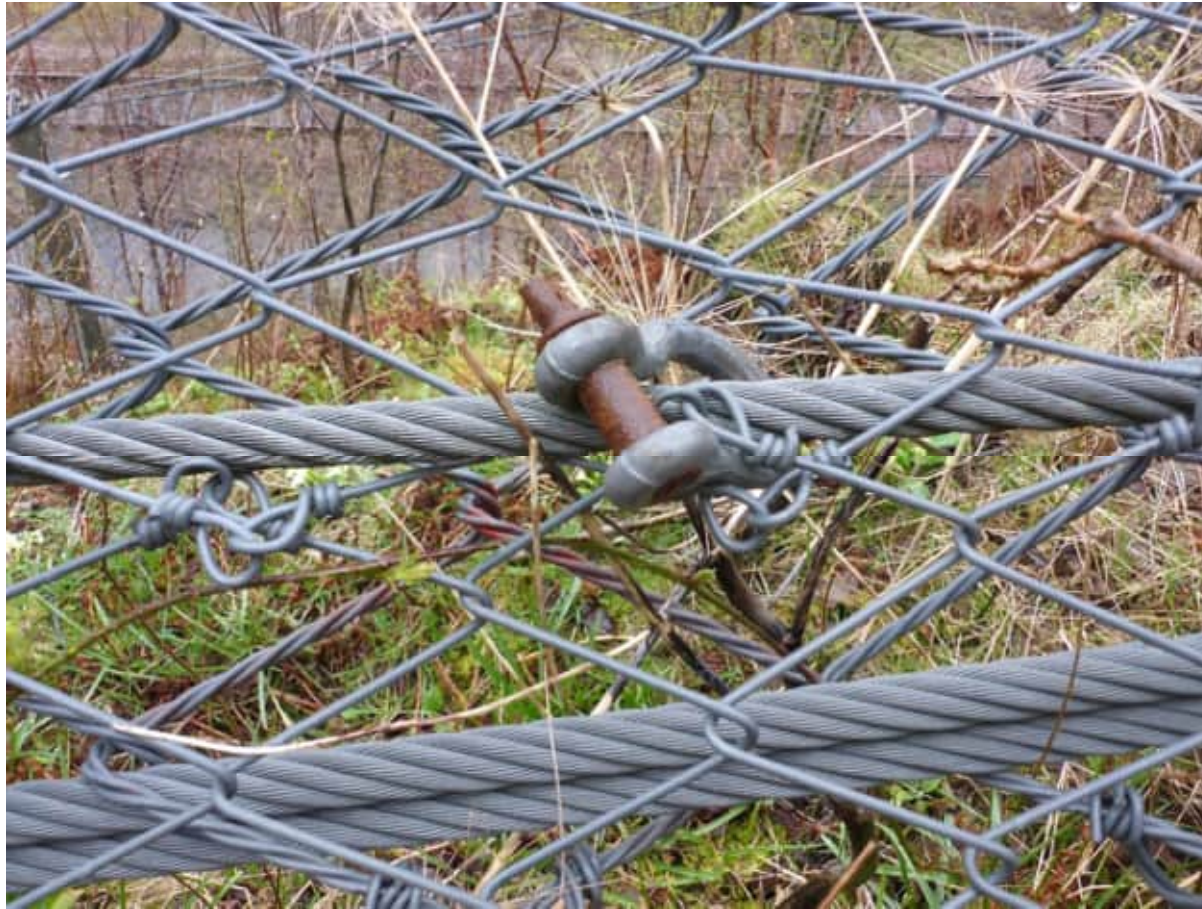
| AA20-U-2 | <p>2021 – Phase 12 works: 30 m wide x 6 m high rock fall catch fence installed c. 15 m above road level between Ch. 3170 to 3215:</p> <p>2023: New catch fence assessed and noted to be in good condition. There is some surface corrosion evident on shackle bolts. Additionally, there are a few small blocks which have been retained behind the fence.</p> <p>2024: Catch fence pins in large shackles along bottom rope of catch fence exhibiting surface corrosion.</p> <p>2025: Surface corrosion of bottom rope shackle bolts; otherwise fence and all attachments in good condition. A small number of small blocks have been caught in the base of the fence.</p> <p>2026: No significant changes observed during 2026 inspection. Slight corrosion of shackles along the lower rope.</p> | Year First Observed | 2021 |

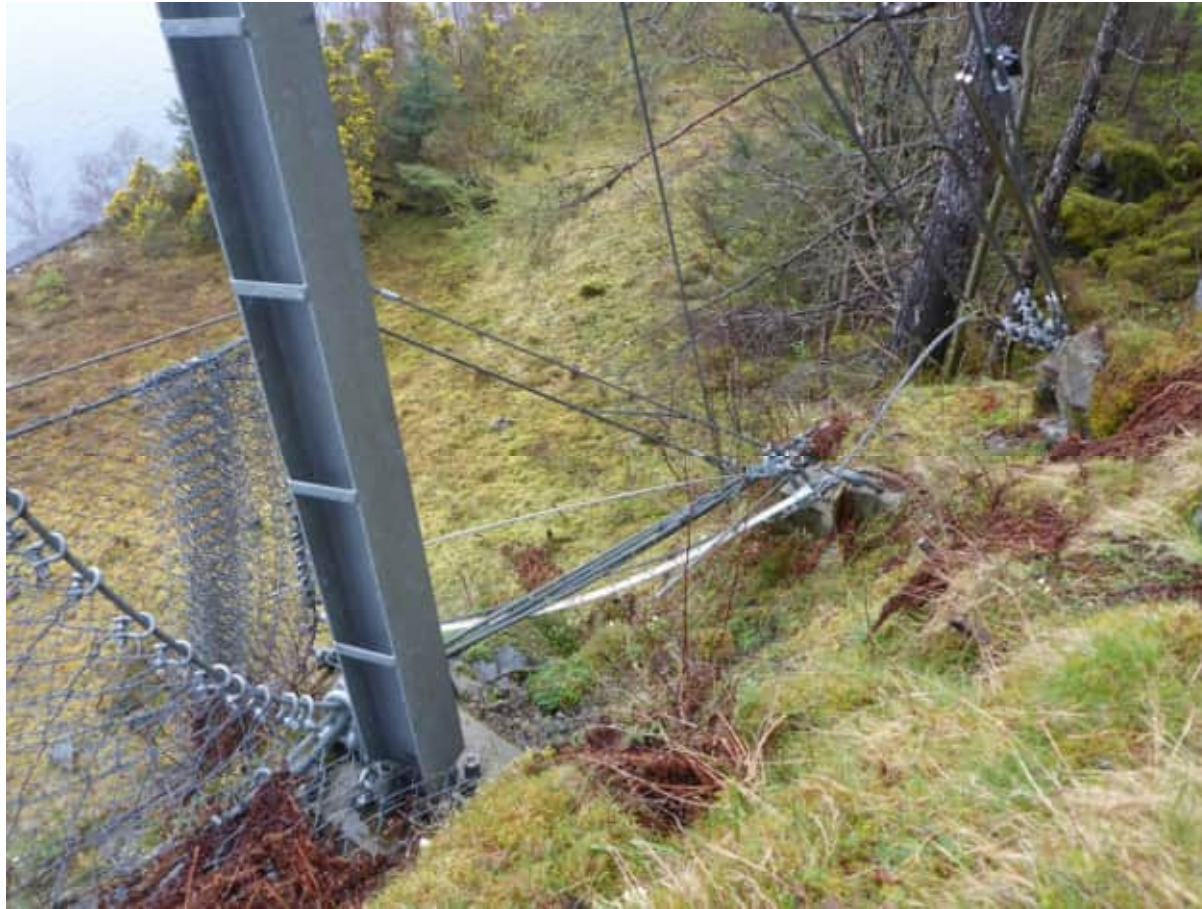
| AA20-U-3 | <p>2021 – Phase 12 works: 30 m wide x 6 m high rock fall catch fence installed c. 15 m above road level between Ch. 3170 to 3215:</p> <p>2023: New catch fence assessed and noted to be in good condition. There is some surface corrosion evident on shackle bolts. Additionally, there are a few small blocks which have been retained behind the fence.</p> <p>2024: Catch fence pins in large shackles along bottom rope of catch fence exhibiting surface corrosion.</p> <p>2025: Surface corrosion of bottom rope shackle bolts; otherwise fence and all attachments in good condition. A small number of small blocks have been caught in the base of the fence.</p> <p>2026: No significant changes observed during 2026 inspection. Slight corrosion of shackles along the lower rope.</p> | Year First Observed | 2021 |

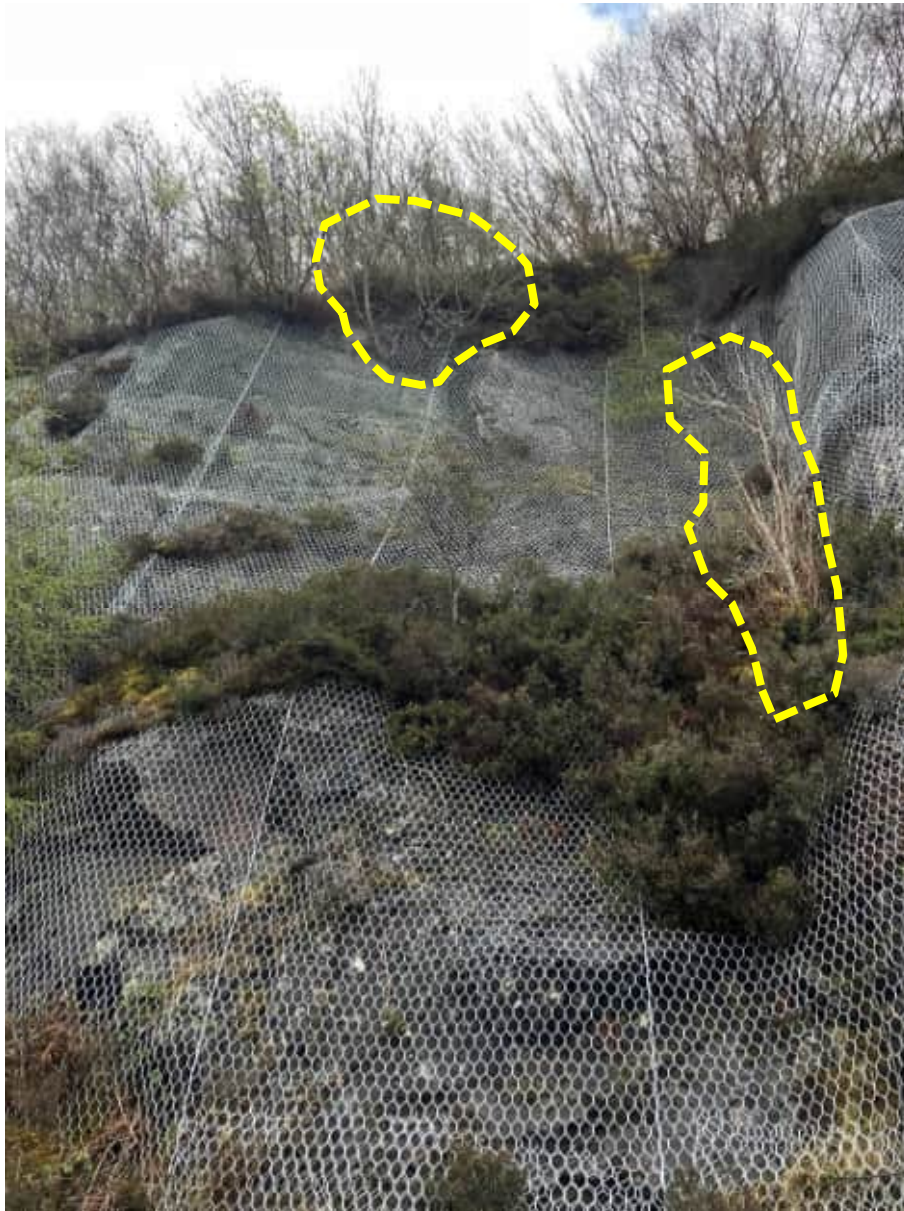
| Hazards Observed: | | | |
|---|---|---|---|
| Ch. 3363 | <b>2016 Inspection:</b> Broken rock mass at crest. Root jacking an issue. Potential failure volume around 1 m <sup>3</sup> (multiple blocks). Mesh should contain but would benefit from coppicing and light scaling. | No changes observed during 2026 inspection. | AA21-6 |

| AA21-6 | <p>Ch. 3363:</p> <p>2016: Broken rock mass at crest. Root jacking an issue. Potential failure volume around 1 m<sup>3</sup> (multiple blocks). Mesh should contain but would benefit from coppicing and light scaling.</p> <p>2026: No changes observed during 2026 inspection. Root jacking an issue lower down the slope.</p> | <p>Year First Observed:</p> | 2016 |

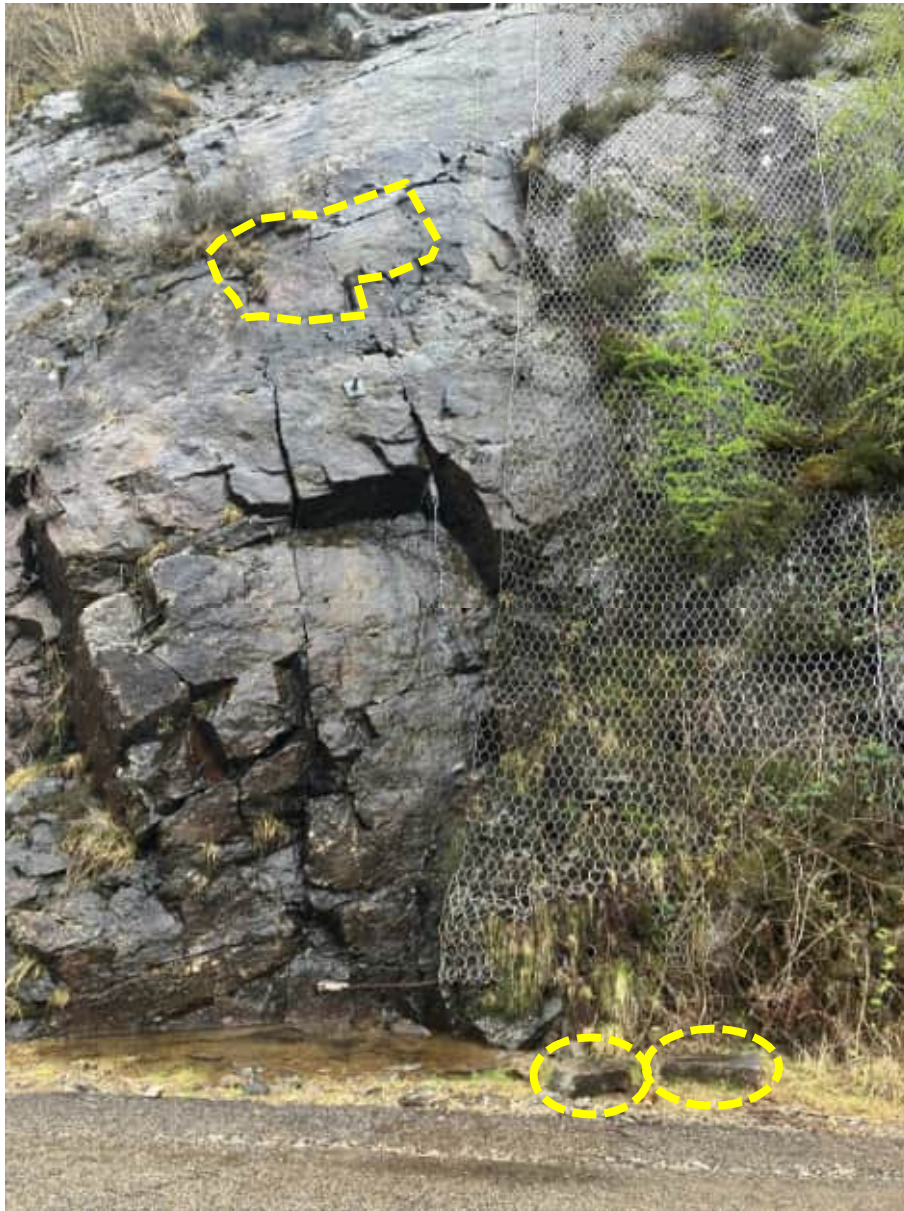
| Hazards Observed: | | | |
|---|---|---|---|
| Ch. 3371 to 3374 | <p><b>2021 Inspection:</b> Some dilated fractures on face of rock slope in area of water flow; freeze-thaw could lead to deterioration of some blocks.</p> <p><b>2025 Inspection:</b> Recent rock fall of 0.3 x 0.3 x 0.2 m block – beyond edge of netting system. Block has come to rest within ditch. Source c. 4 to 5 m above road level. Potential for failure of further material present across lower half of rock slope; most would likely land in the ditch. Long-term, suggest extension of rock netting.</p> | <p>Two tabular blocks present on the verge of dimensions 0.4 x 0.3 x 0.1 m and 0.3 x 0.2 x 0.1 m. Source of failure circa 5 m above road level, within an area of water flow and with a small area of soil and vegetation present in what would have been a dilated release joint. Angle of jointing is down and into the rockface, suggesting a toppling failure mechanism likely due to ice expansion.</p> <p>Whilst the dip direction of the jointing does not favour failure and rockfalls, the presence of water and likelihood of ice expansion within joints may lead to further failures of similar size in future.</p> <p>Given the width of the verge in this location, it is not thought that future failures would pose a significant risk to the road.</p> | AA21-7 |

| AA21-7 | <p>Ch. 3371 to 3374</p> <p>2021: Some dilated fractures on face of rock slope in area of water flow; freeze-thaw could lead to deterioration of some blocks.</p> <p>2025: Recent rock fall of 0.3 x 0.3 x 0.2 m block – beyond edge of netting system. Block has come to rest within ditch. Source c. 4 to 5 m above road level. Potential for failure of further material present across lower half of rock slope; most would likely land in the ditch. Long-term, suggest extension of rock netting.</p> <p>2026: Two tabular blocks present on the verge of dimensions 0.4 x 0.3 x 0.1 m and 0.3 x 0.2 x 0.1 m. Source of failure circa 5 m above road level, within an area of water flow and with a small area of soil and vegetation present in what would have been a dilated release joint. Angle of jointing is down and into the rockface, suggesting a toppling failure mechanism likely due to ice expansion.</p> | Year First Observed: | 2021 |

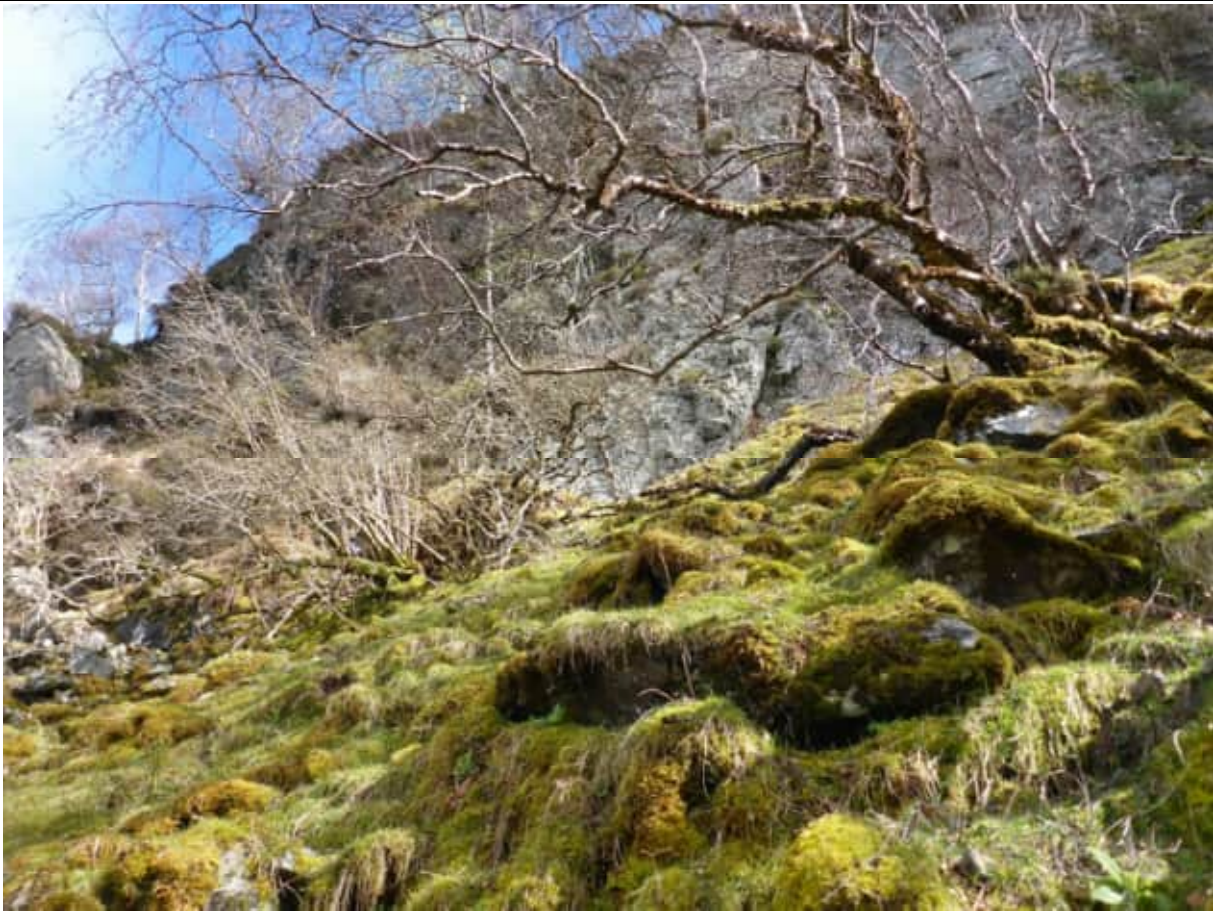
| AA21-8 | Above AA21 (NG 91497 37709):<br>2026: Boulder field beneath crags and on breaks in slope beneath. Field appears very old and carpeted by thick mosses. | Year First Observed | 2026 |

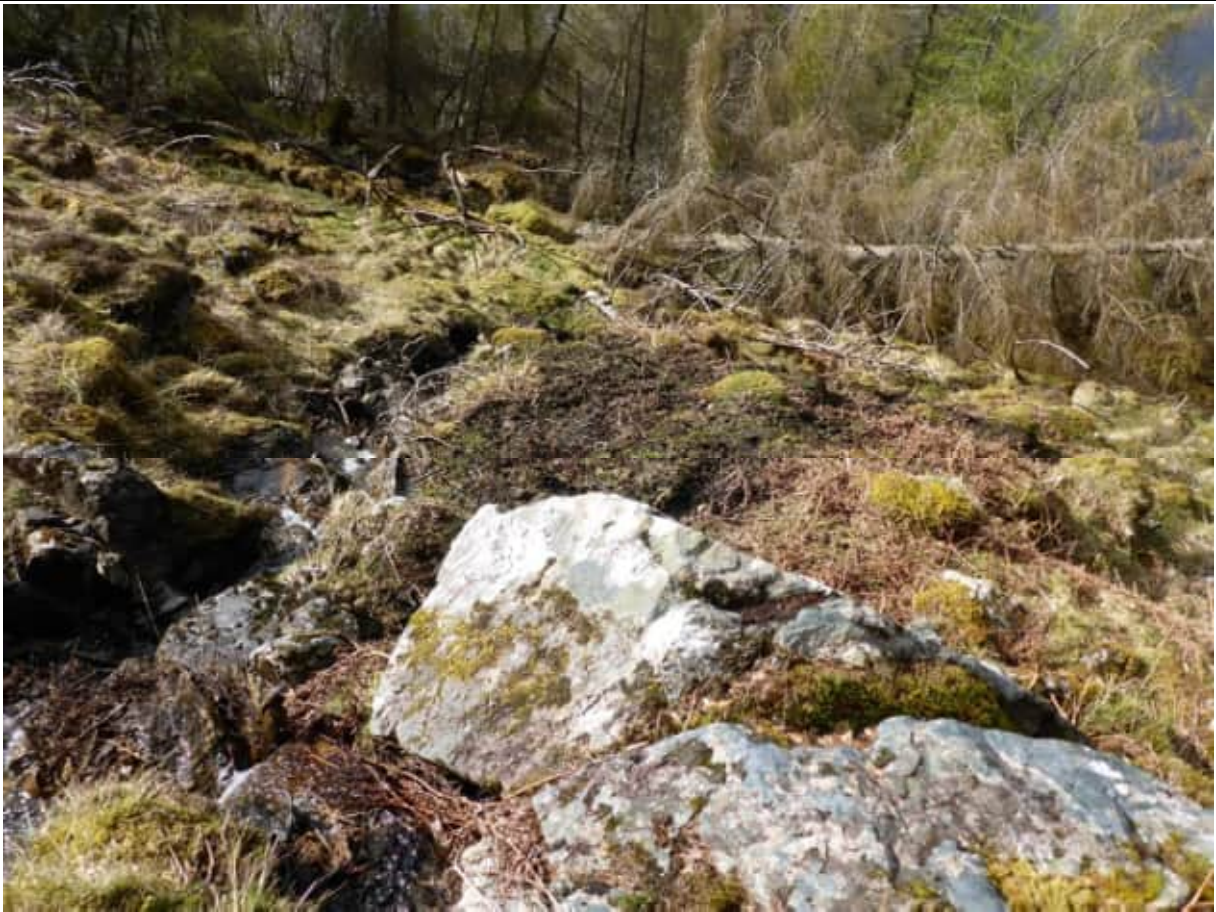
| AA21-9 | Above AA21:<br>2026: Watercourse has been altered by blockages and debris dams, diverting its course. Numerous fallen and leaning trees. | Year First Observed | 2026 |

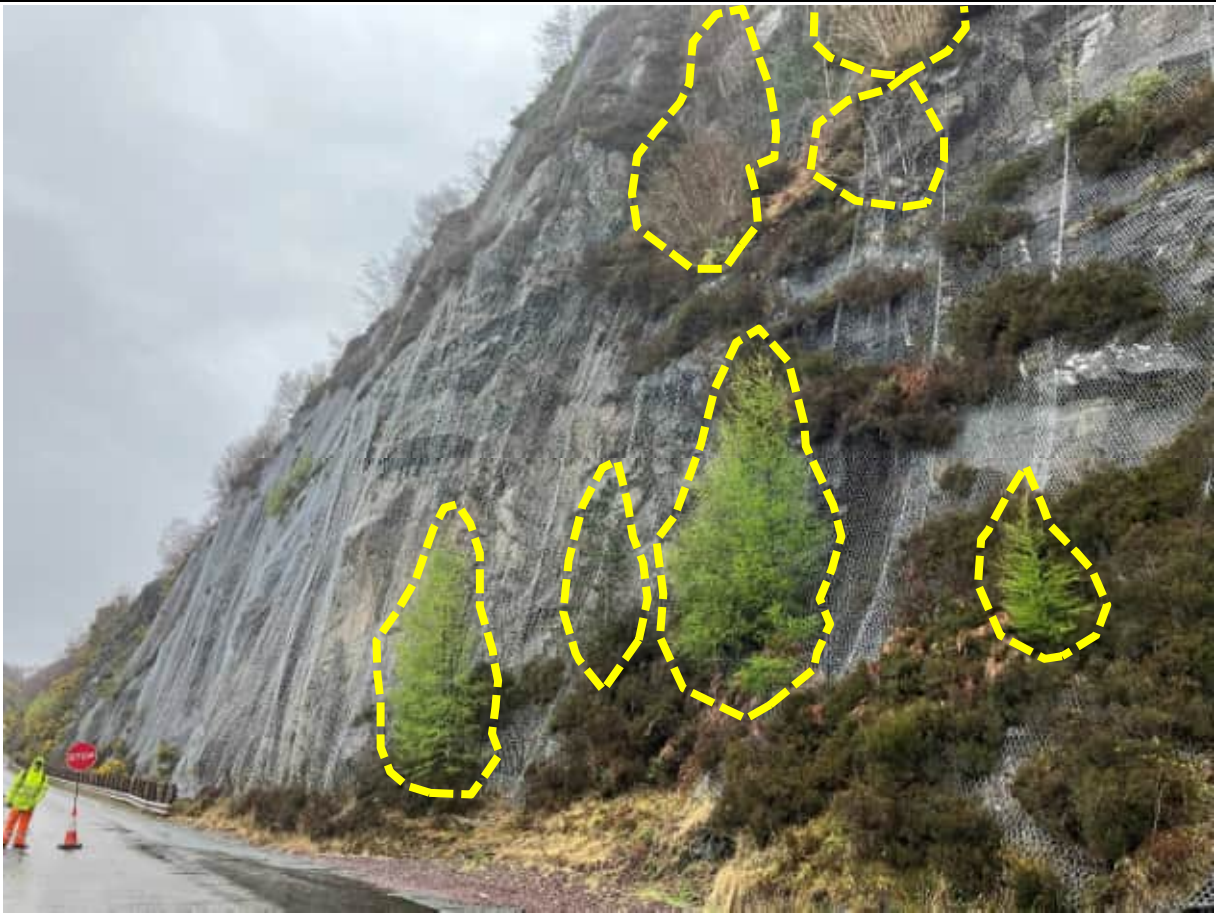
AA22B-1

Ch. 3434:  
Potential for root jacking related failures with several trees growing through the netting as well as numerous areas of locally thick heather.

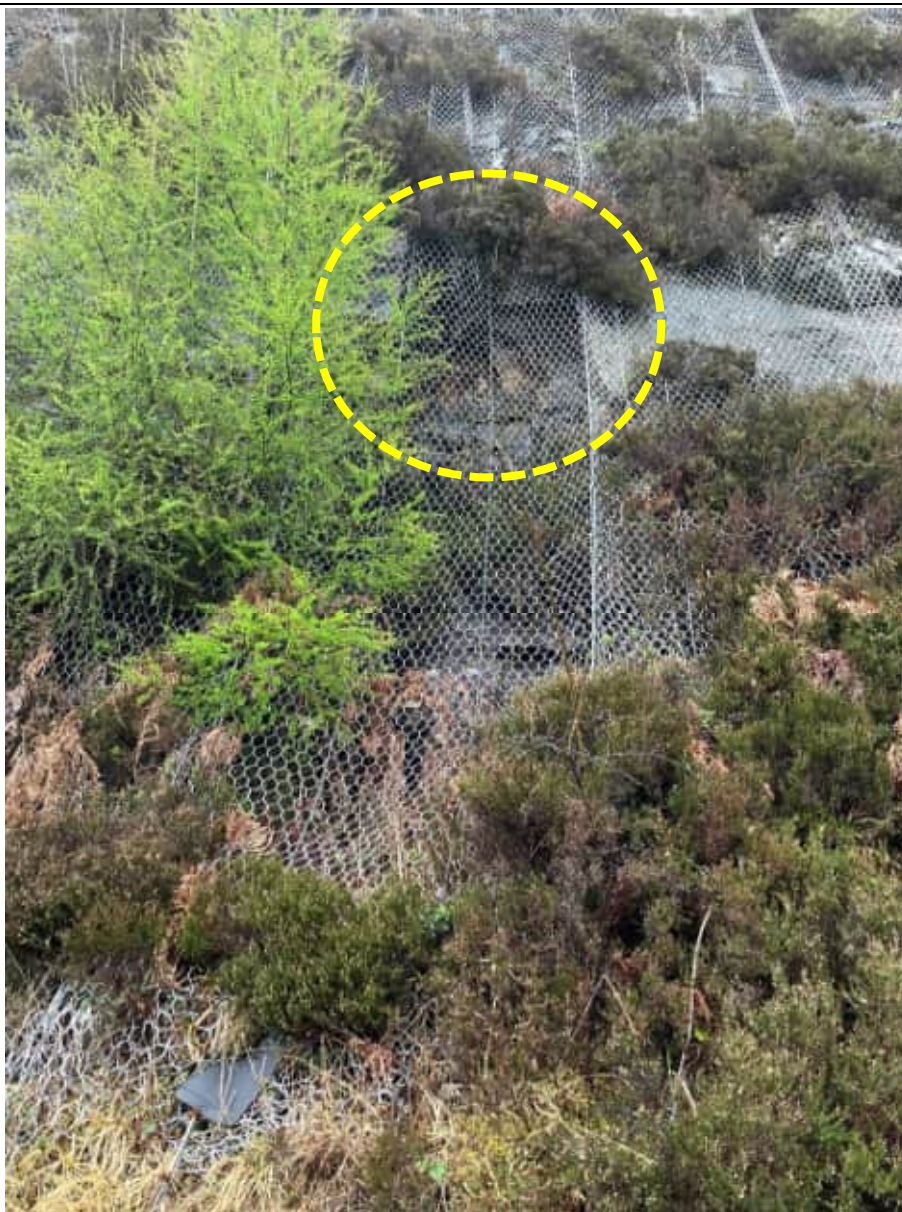
| AA22B-2 | <p>Ch. 3425:</p> <p>2021: Failure in 2021 originating c. 6 m above road level where blocks (c. 0.25 m<sup>3</sup>) have slid along a steep release plane and have come to rest at toe of slope behind netting. Water seepage in the area gives potential for further rock fall. It is likely that this would be a volume of c. 0.4 m<sup>3</sup> and a maximum block size of c. 0.3 x 0.3 x 0.3 m. Any future failure likely to be within the design capacity of netting but accumulation of further debris at toe of slope should be monitored.</p> <p>2026: No changes observed during 2026 inspection.</p> | Year First Observed: | 2021 |

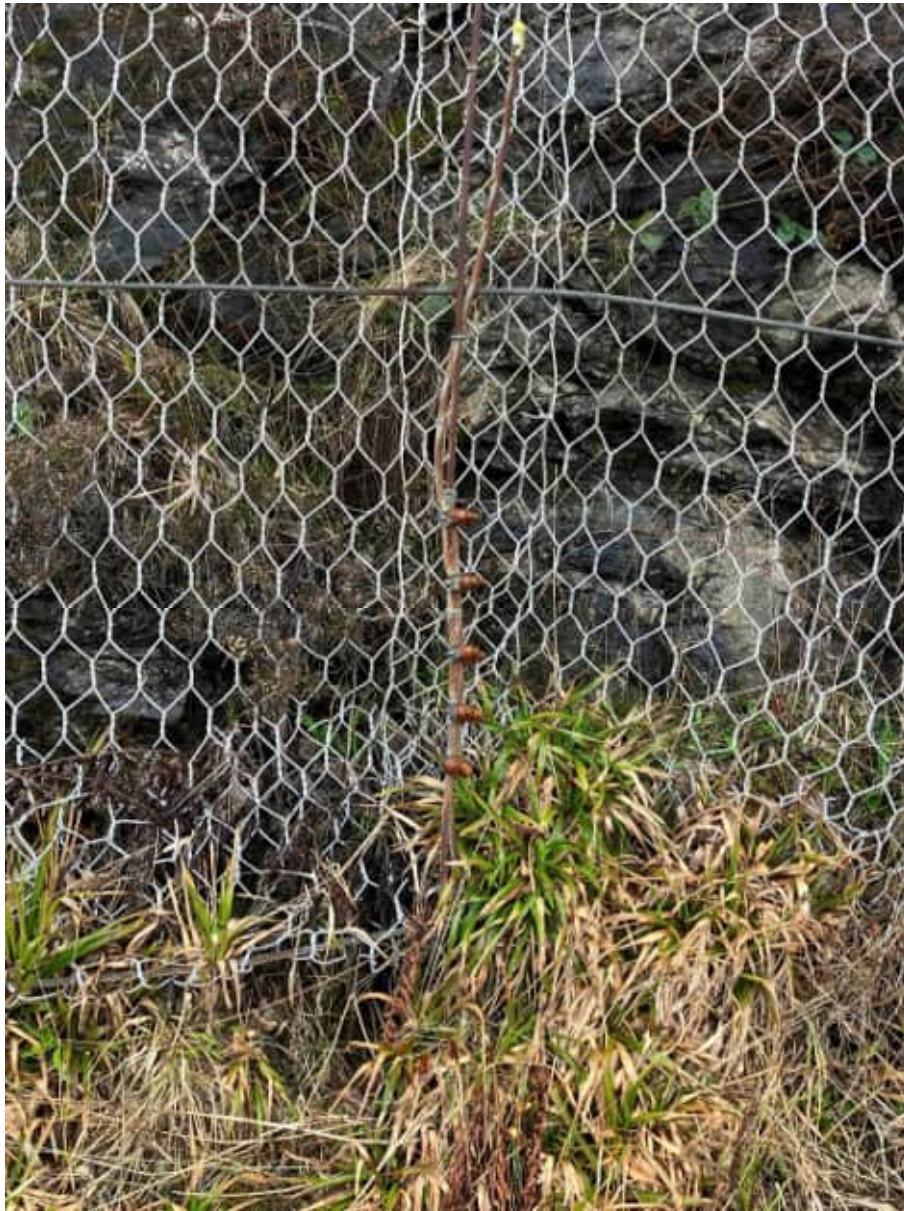
| AA22B-3 | <p>Ch. 3445:</p> <p>2025: Corroded nuts and cables observed.</p> <p>2026: No changes observed during 2026 inspection.</p> | Year First<br>Observed: | 2025 |

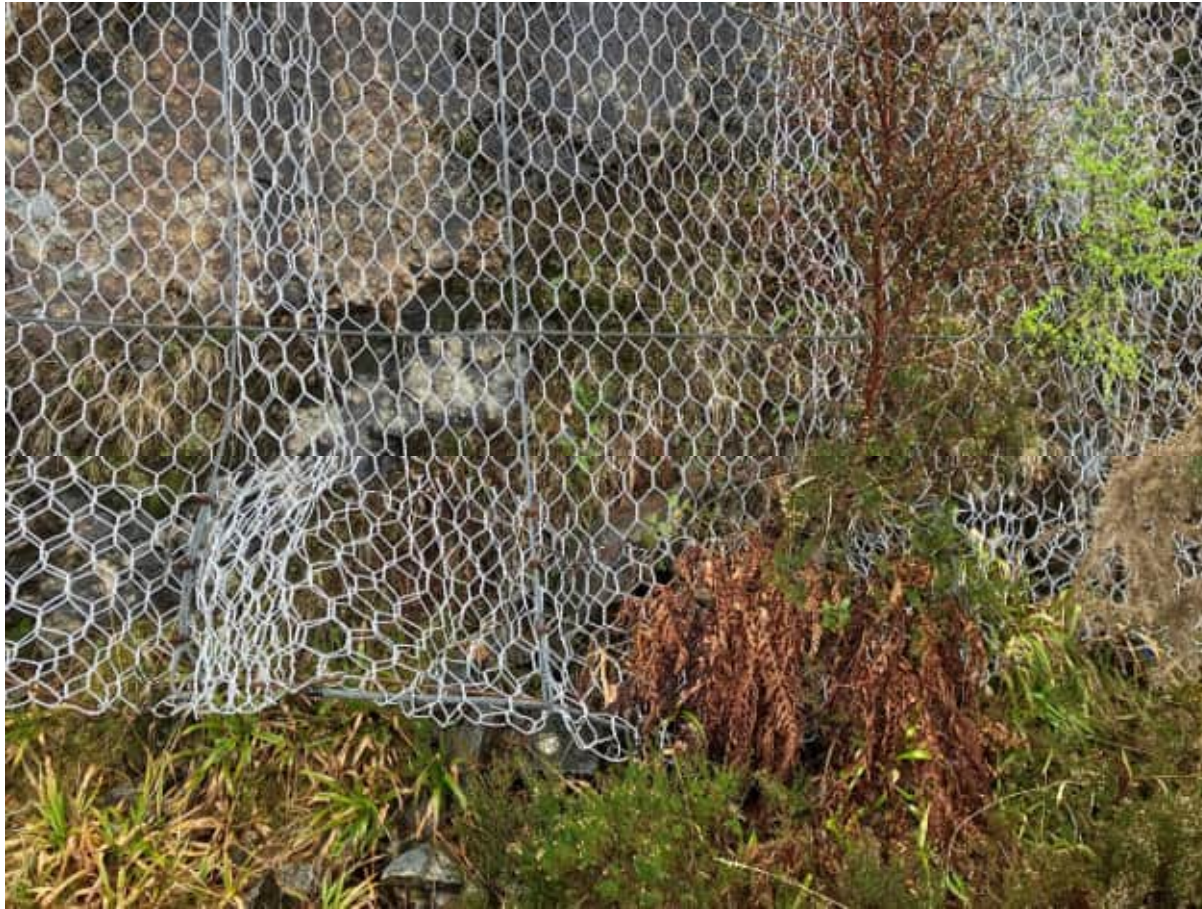
| AA22B-4 | <p>Ch. 3475 to 3478:</p> <p>2021: Minor rock fall with small blocks at base of netting system. Largest block c. 0.4 x 0.1 x 0.1 m. Seems to have originated from right-hand-side base of previously observed overhang. No damage to netting. Fractured rock with dilated joints apparent along base of overhang indicating potential for further failures in this area.</p> <p>2026: Some 'fresher' surfaces noted at height on the western side of the overhang, suggesting ongoing ravelling and/or delamination failures.</p> | Year First Observed: | 2021 |

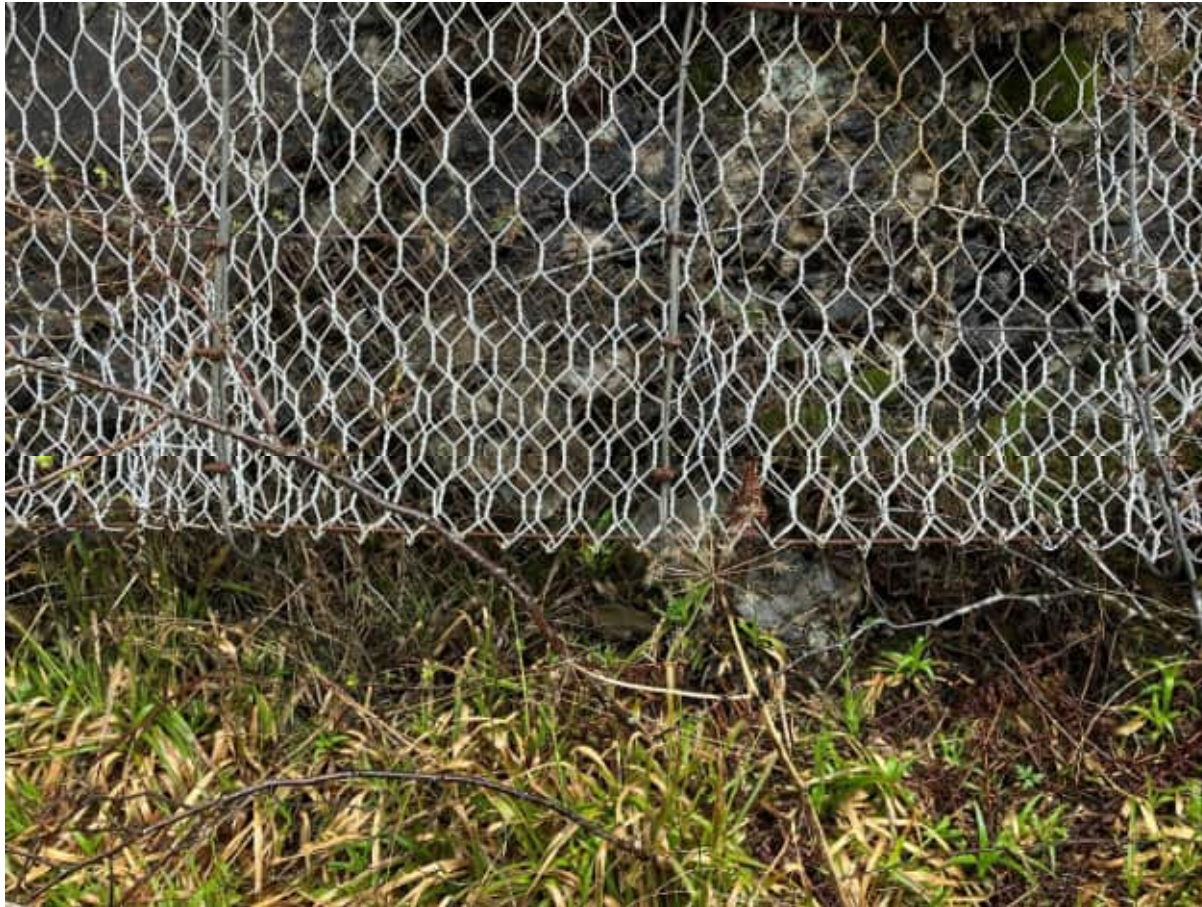
| AA22B-5 | <p>Ch. 3492:</p> <p>2026: Blocks up to 0.3 x 0.2 x 0.1 m noted in netting at the toe of the slope. Source of rockfall suspected to be 8 m above road level. Netting undamaged by the rockfall and does not appear to be straining. The risk to the road from further rockfall is considered to be low given the presence of the netting, effectiveness of the netting in this location, and the presence of the verge/ditch and crash barrier.</p> | Year First Observed: | 2026 |

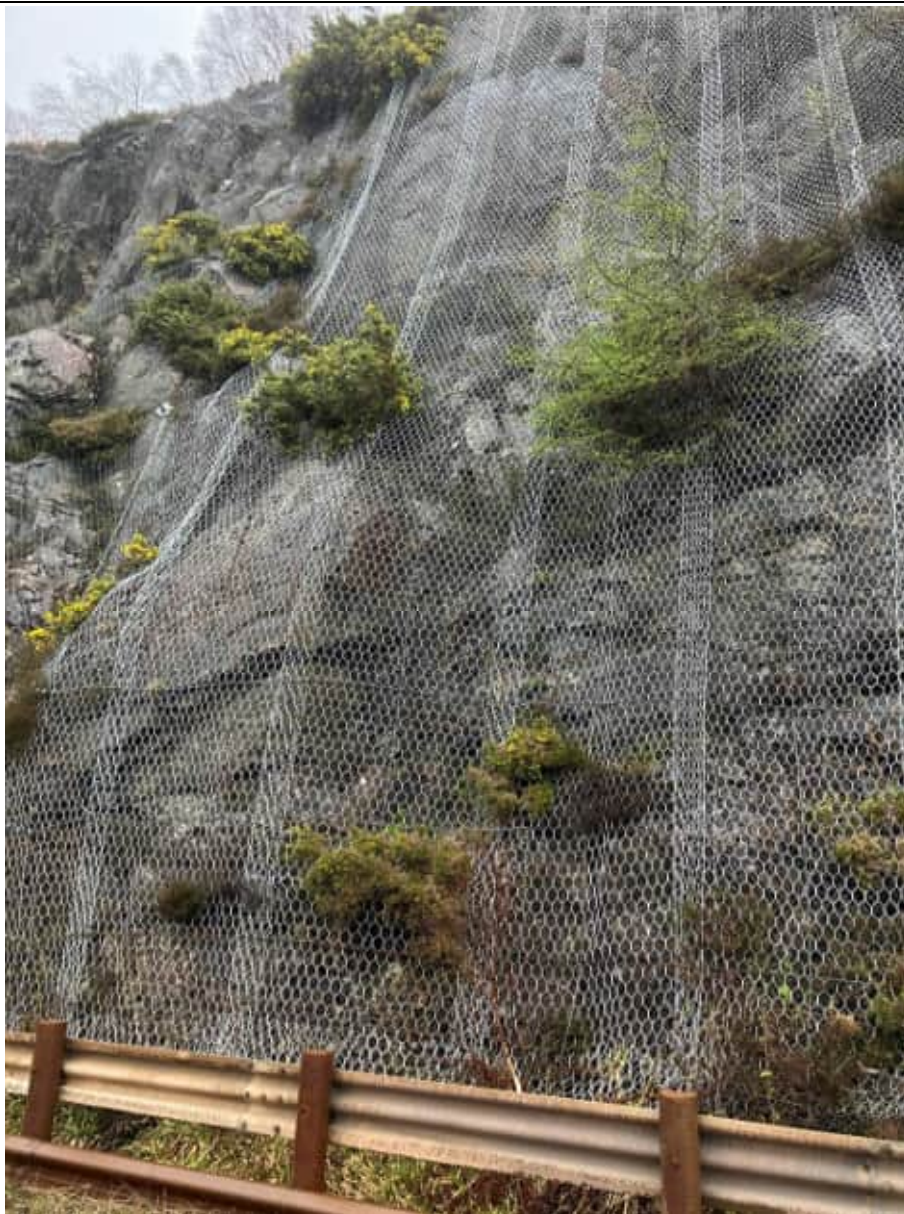
| AA22B-6 | <p>Ch. 3492:</p> <p>2026: Blocks up to 0.3 x 0.2 x 0.1 m noted in netting at the toe of the slope. Source of rockfall suspected to be 8 m above road level. Netting undamaged by the rockfall and does not appear to be straining. The risk to the road from further rockfall is considered to be low given the presence of the netting, effectiveness of the netting in this location, and the presence of the verge/ditch and crash barrier.</p> | <p>Year First Observed:</p> | 2026 |

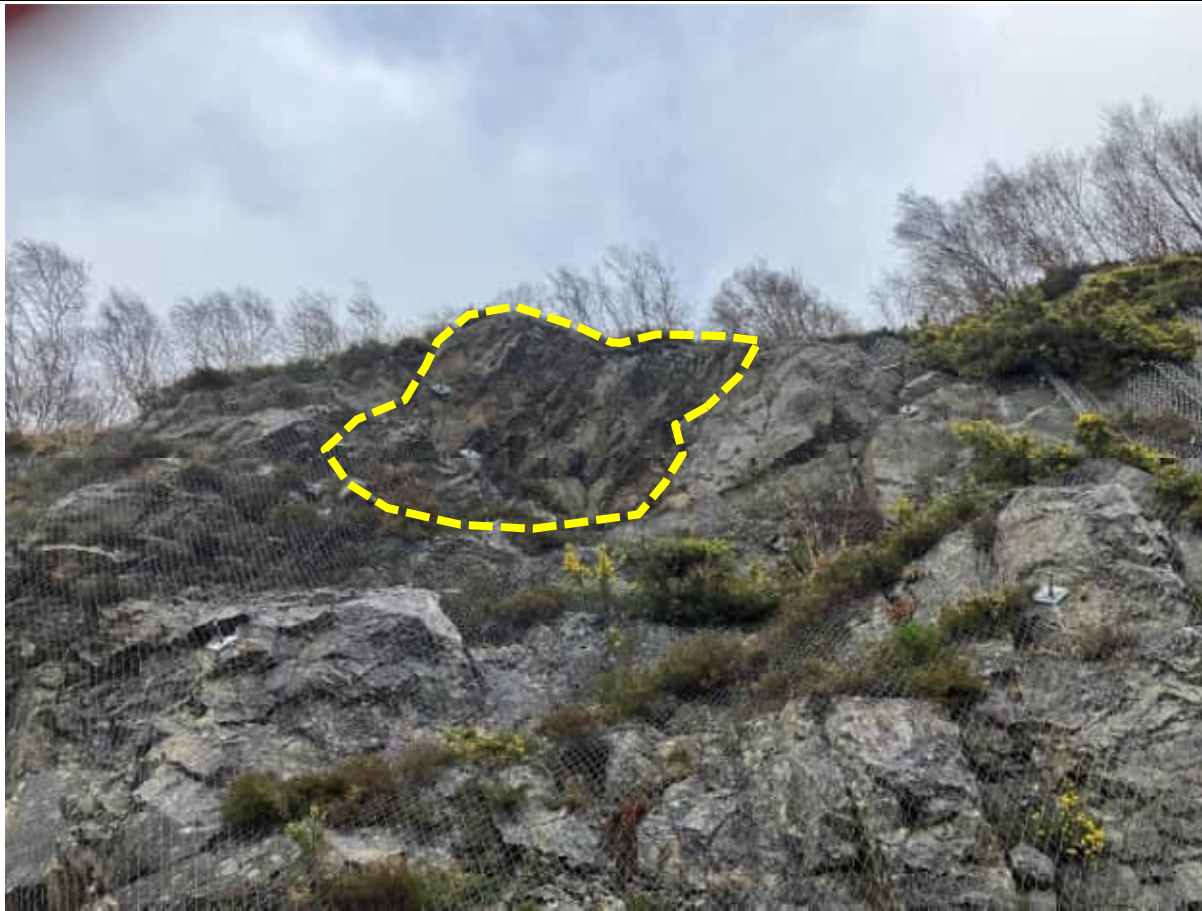
| AA22B-7 | <p>Ch. 3505:</p> <p>2026: Area of rock mass is heavily fractured and overhanging. Netting profiling anchors have been installed around the rock mass as the quality of the rock is suspected to be too weak to accept drilling. The netting in this location may not be sufficient to contain a catastrophic failure of the rock mass, however, it would likely be sufficient to protect the road from ongoing ravelling and delamination type failures.</p> | Year First Observed: | 2026 |

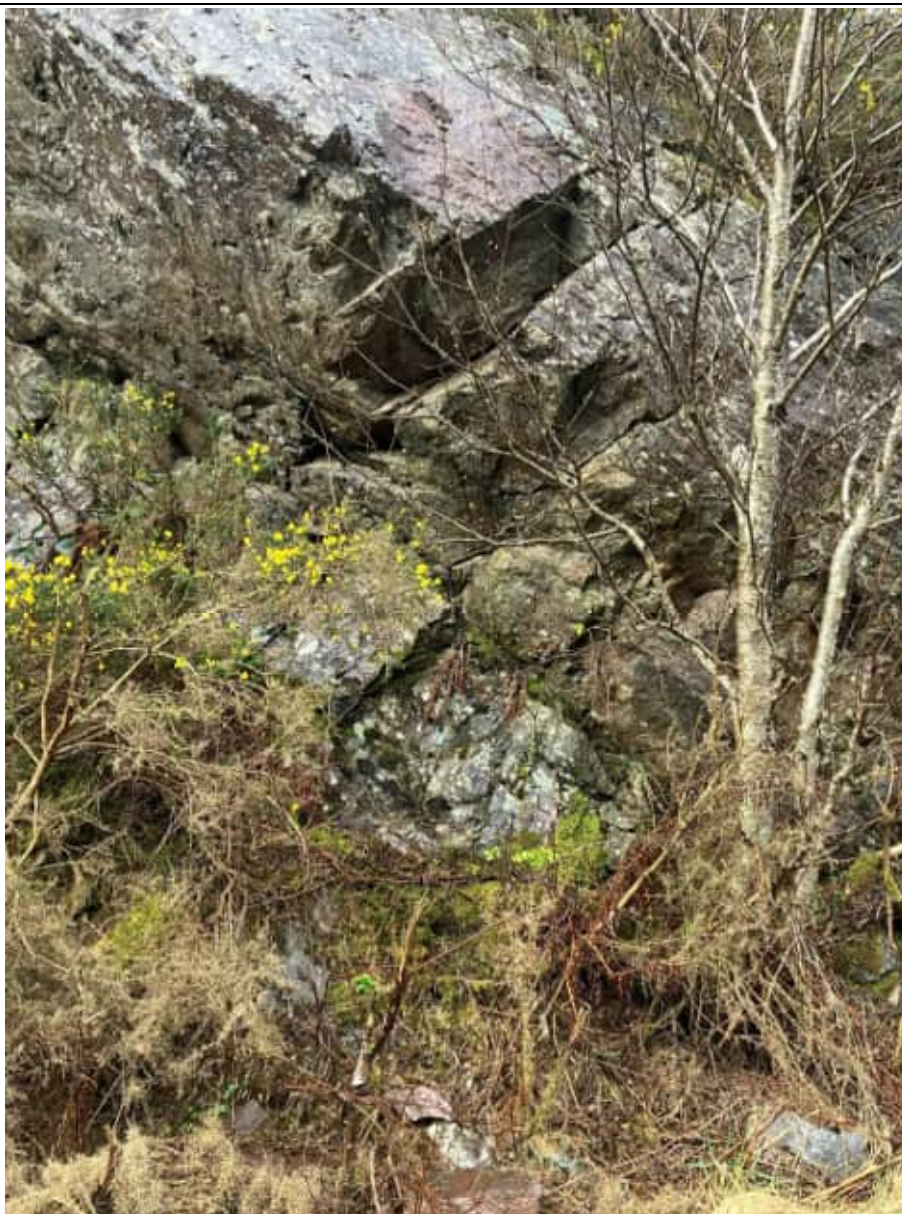
| AA23-N-1 | <p>Ch. 3669:</p> <p>2022: Block fall c. 0.4 x 0.4 x 0.3 m has landed in the ditch. Block originated c .2 m up rock slope.</p> <p>2026: No changes observed during 2026 inspection.</p> | <p>Year First Observed:</p> | 2022 |

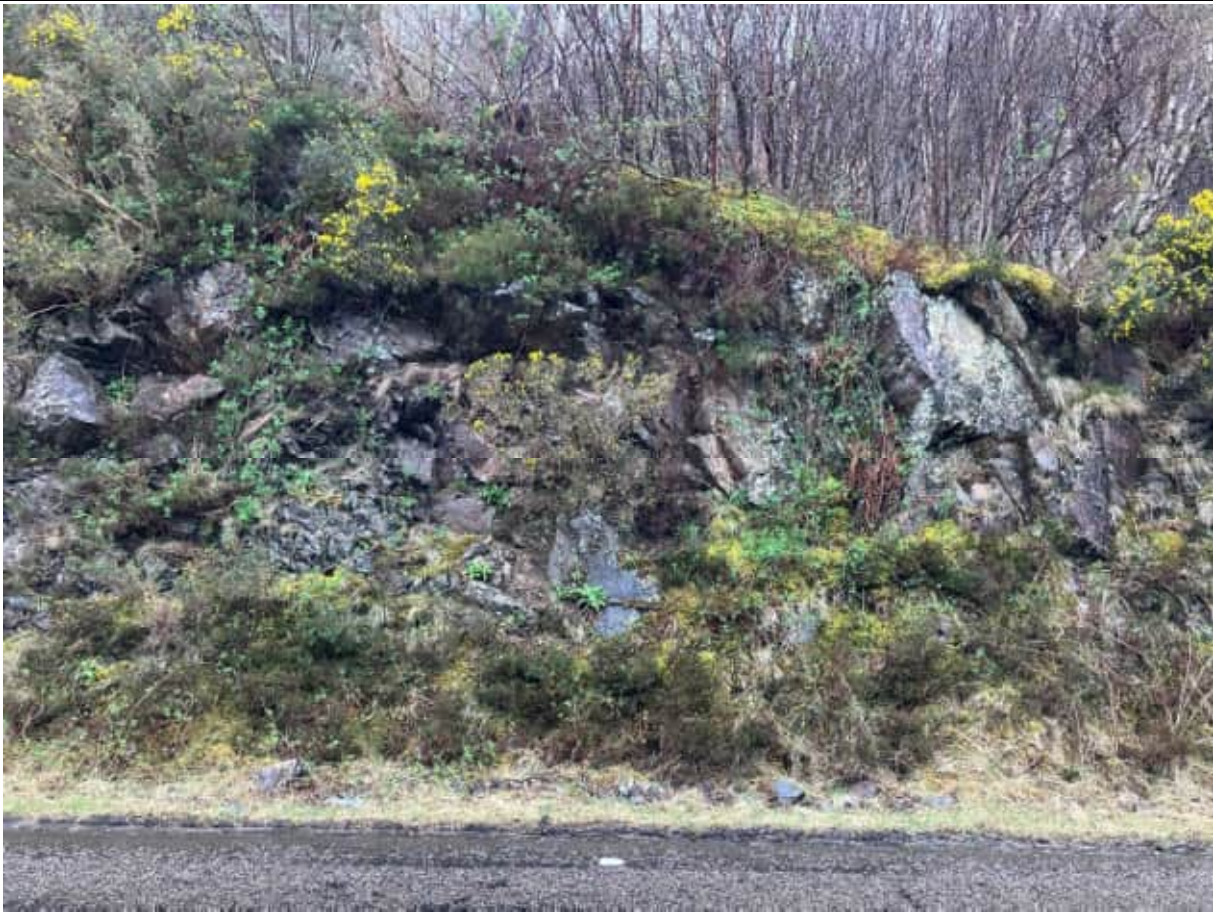
| AA23-S-1 | <p>Ch. 3655:</p> <p>2025: Overhanging block (0.5 x 0.75 x 0.4 m) at 3 to 4 m above road level. Separated from face by blast induced fractures. If it were to fall it would most likely land on the verge.</p> <p>2026: No changes observed during 2026 inspection.</p> | Year First Observed: | 2025 |

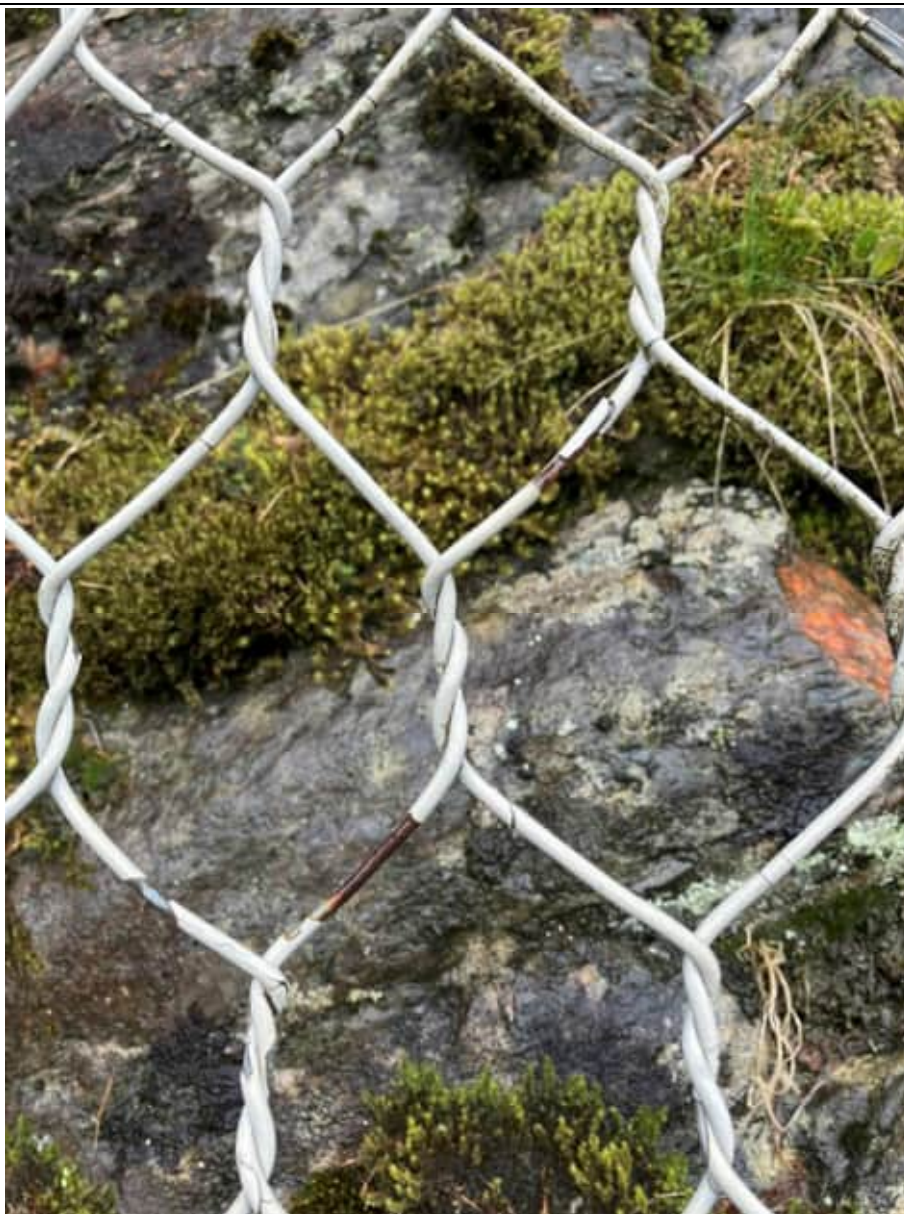
| AA24-1 | <p>Before AECOM involvement (i.e. pre-2012):<br/>Netting (only present across highest area of the rock slope between Ch. 3720 to 3760)</p> <p>2024: PVC coating is cracking and exposed wire is locally corroded.</p> <p>2026: The inner wire of the Maccaferri netting, exposed by the weathered and failed PVC coating, is beginning to corrode. Continuous deterioration of the inner wire can be expected, affecting the efficacy of the installed netting and limiting its effectiveness as a rockfall protection measure.</p> | Year First Observed: | 2024 |

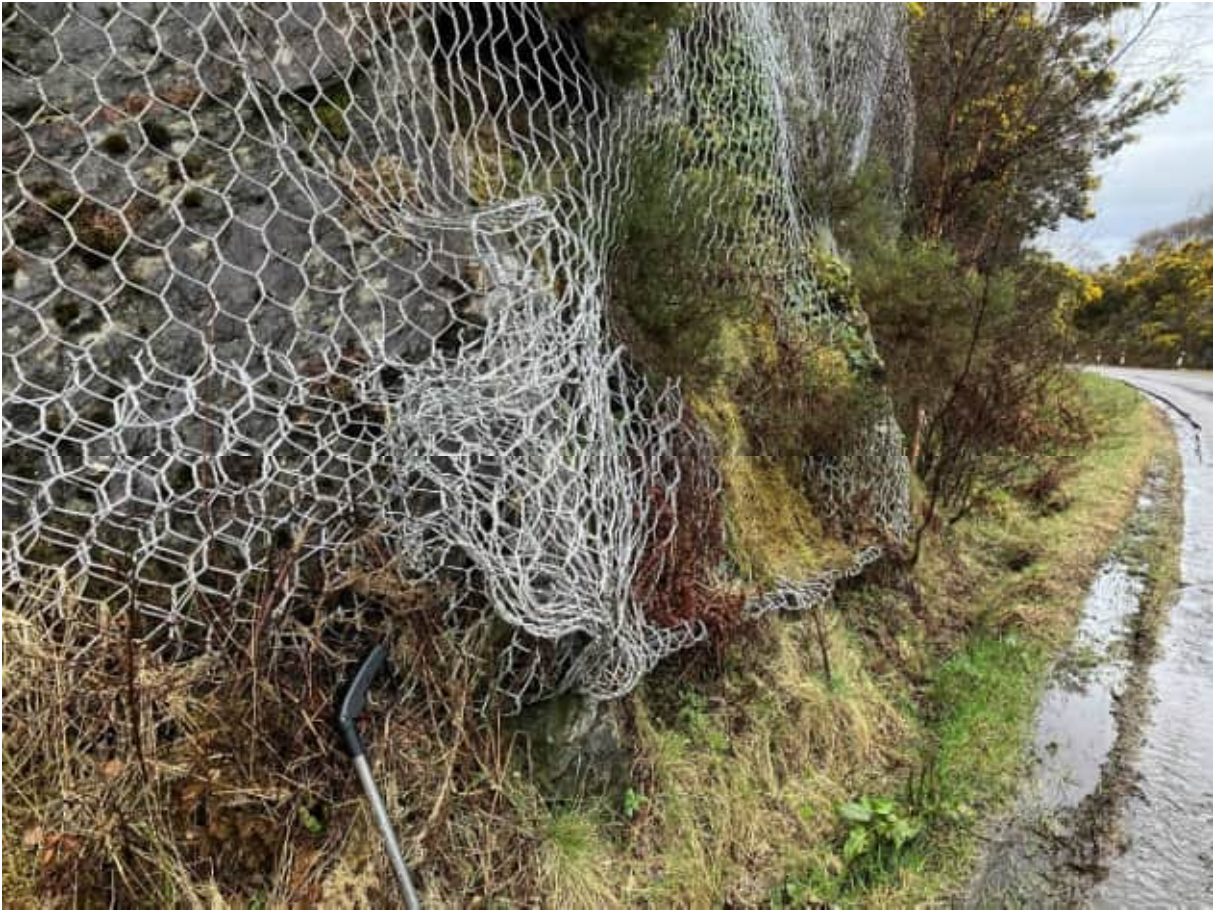
| AA24-2 | <p>Ch. 3733:</p> <p>2026: The netting at the toe of the slope has been significantly deformed and the PVC coating cracked in numerous locations. It is suspected that the grass-cutter has caught/snagged the netting, causing the deformation. Given the suspected age of the netting, and conditions elsewhere on the slope, it is likely that the PVC coating was brittle and has failed during this deformation.</p> | Year First Observed: | 2026 |
