# A890 Strome ferry Bypass

Annual Slope Inspection 2026

The Highland Council

Project number: 60685712  
AECOM Report Ref.: GLRP0013

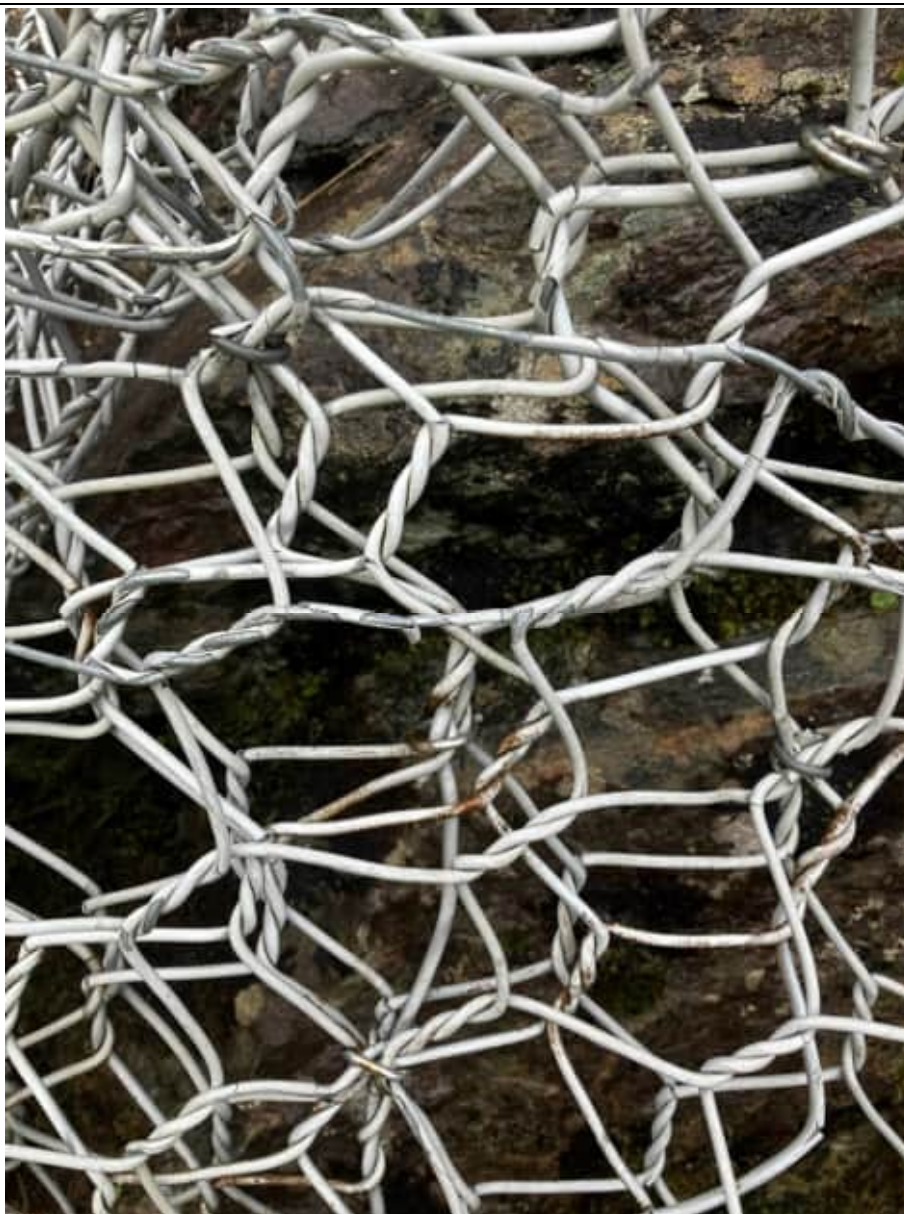
| AA24-3 | <p>Ch. 3733:</p> <p>2026: The netting at the toe of the slope has been significantly deformed and the PVC coating cracked in numerous locations. It is suspected that the grass-cutter has caught/snagged the netting, causing the deformation. Given the suspected age of the netting, and conditions elsewhere on the slope, it is likely that the PVC coating was brittle and has failed during this deformation.</p> | Year First Observed: | 2026 |

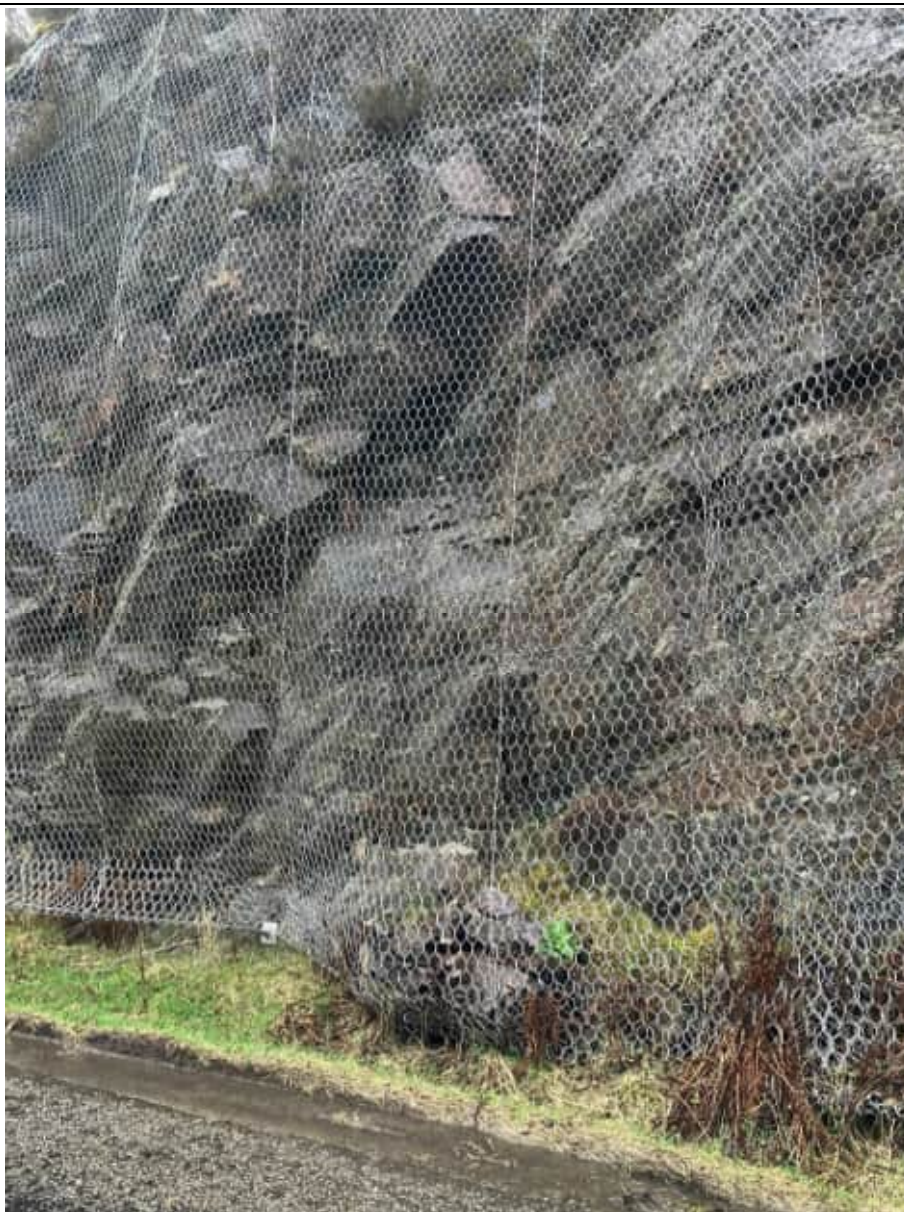
| AA24-5 | <p>Ch. 3745:</p> <p>2024: A rock fall has occurred which has been caught by the netting. Netting is now under tension but there is no damage to netting. Debris dimensions are 2.0 x 0.7 x 0.7 m. The source of the rock fall is c. 5 to 6 m above the toe of the slope from the base and side of an overhang.</p> <p>2026: Potentially additional rockfall material present within the netting at the toe of the slope. The netting is strained and should be cleared to ensure its long-term effectiveness.</p> | Year First Observed: | 2024 |

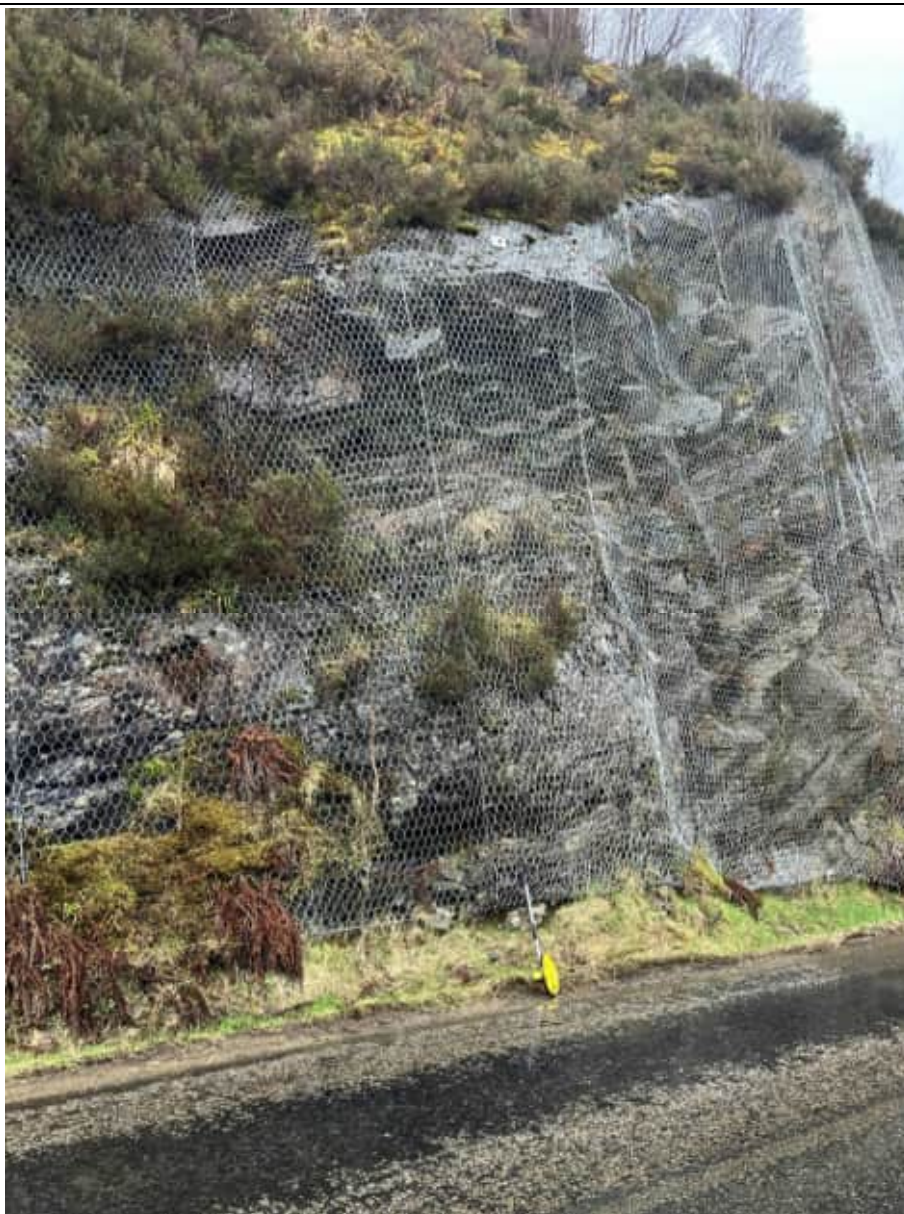
| AA24-6 | <p>Ch. 3753:</p> <p>2021: Small accumulation of debris at toe of slope behind netting c. 1 x 0.4 x 0.2 m. Source c. 4 m above toe. Material not loading net. Keep under observation.</p> <p>2026: No changes observed during 2026 inspection.</p> | <p>Year First Observed:</p> | 2021 |

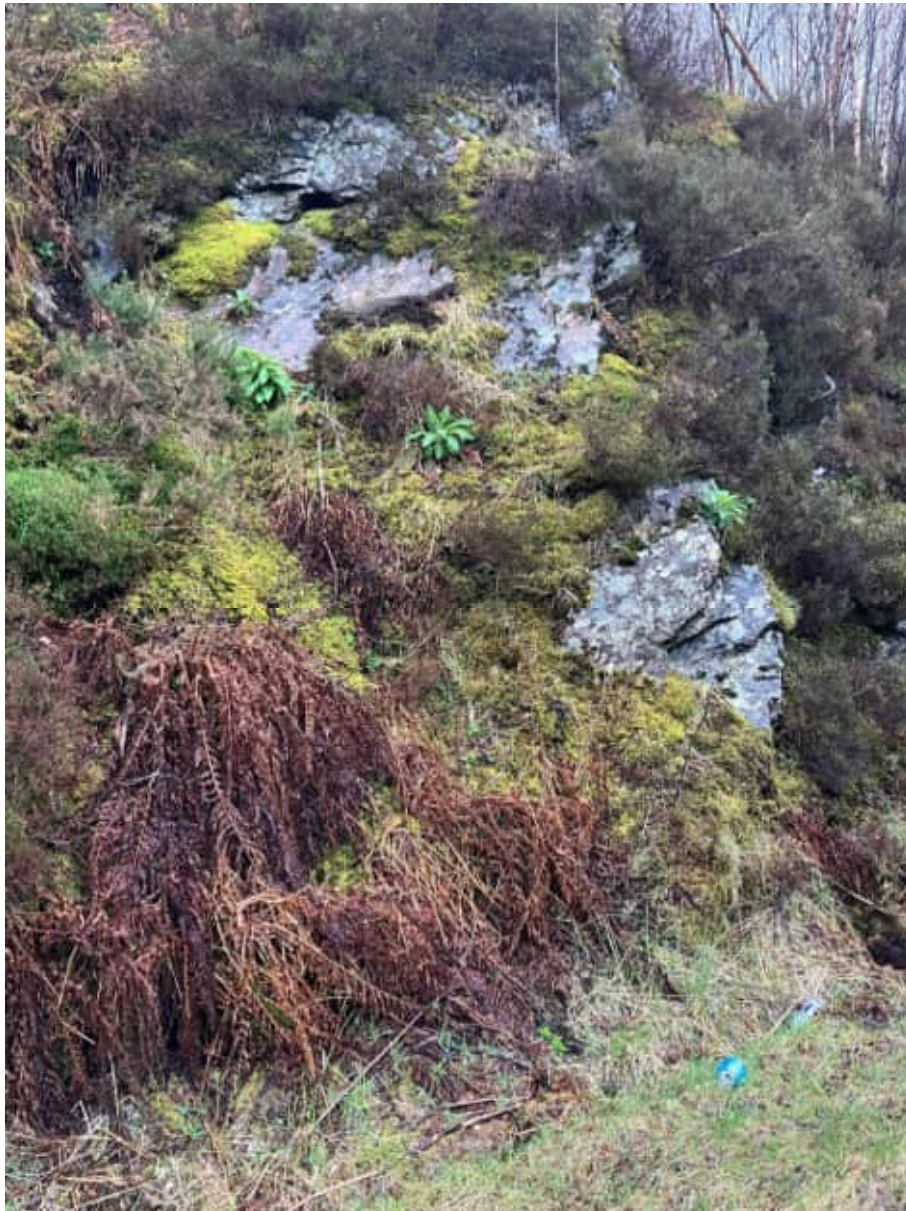
| AA24-7 | <p>Ch. 3778 to 3787:</p> <p>2016: Exposed soil slope 4 m above road level with boulders in back scar of previous failure which could weather out and reach road. Slumping is also noted upslope from back scar.</p> <p>2026: No changes observed during 2026 inspection.</p> | Year First Observed: | 2016 |

| Recommended Remedial Works / Actions | | | | | | | |
|---|---|---|---|---|---|---|---|
| N/A | | <ul style="list-style-type: none"> <li>Ch.3783 to 3790: Re-profile vertical soil slope and install erosion control matting.</li> </ul> | | | <ul style="list-style-type: none"> <li>Coppice trees within 5 m of crest of rock face between Ch. 3762 and 3800;</li> <li>Build-up of debris in ditch should be monitored and clearance works undertaken on drape netting as required to maintain its capacity;</li> <li>At Ch. 3745 light scaling and debris clearance; and</li> <li>Ch. 3892 – replace the sign with phone number to call in case of a rock fall.</li> </ul> | | |

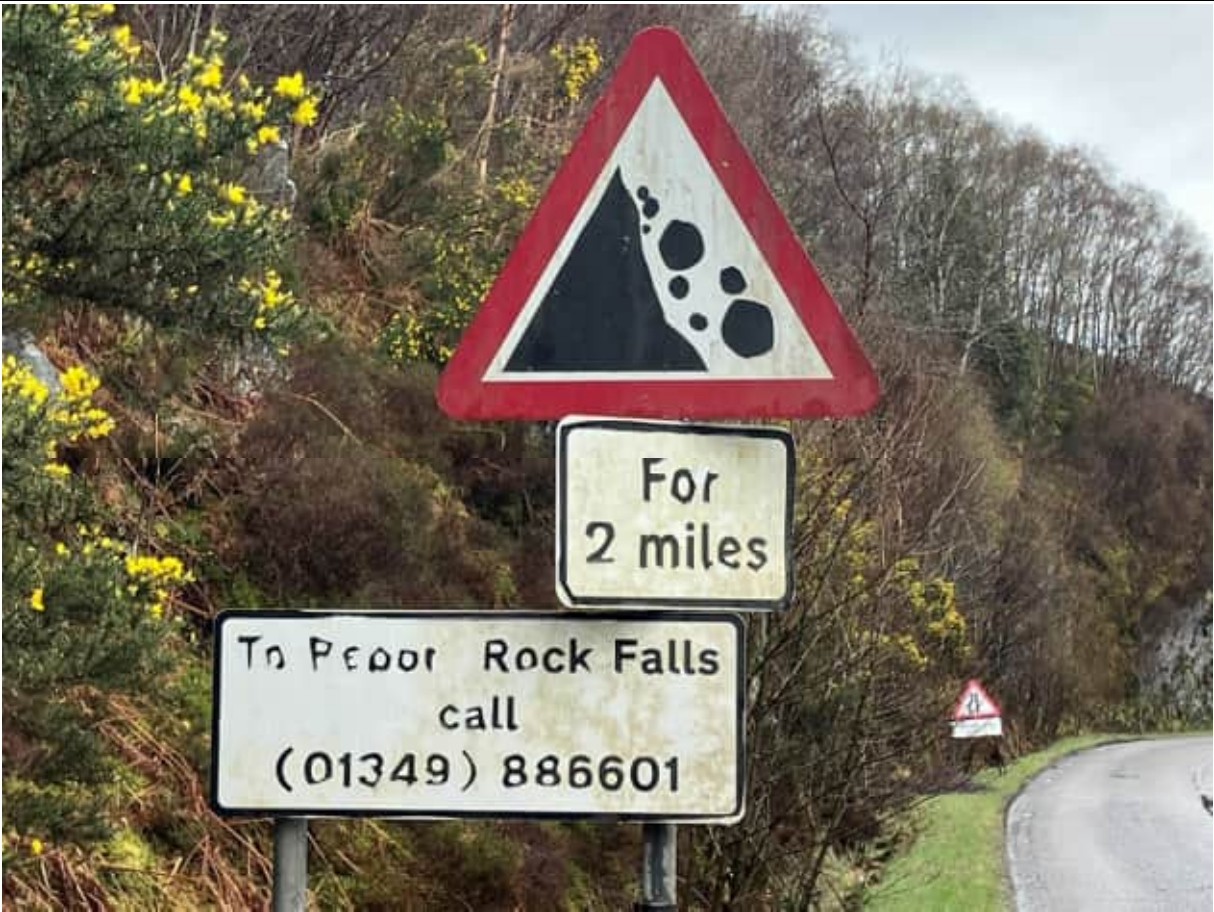
| Hazards Observed: | | | |
|---|---|---|---|
| Ch. 3870 | <p><b>2017 Inspection:</b> Potential planar failure 3 m above road. Small tabular blocks likely to be contained by ditch below.</p> <p><b>2023 Inspection:</b> A new block has landed in the ditch, confirming this ongoing planar failure mechanism.</p> | No changes observed during 2026 inspection. | AA24-8 |

| AA24-8 | <p>Ch. 3870:</p> <p>2017: Potential planar failure 3 m above road. Small tabular blocks likely to be contained by ditch below.</p> <p>2023: A new block has landed in the ditch, confirming this ongoing planar failure mechanism.</p> <p>2026: No changes observed during 2026 inspection.</p> | Year First Observed: | 2017 |
