# A890 Maman Hill

Annual Slope Inspection 2026

The Highland Council

Project number: 60685712  
AECOM Report Ref.: GLRP0012

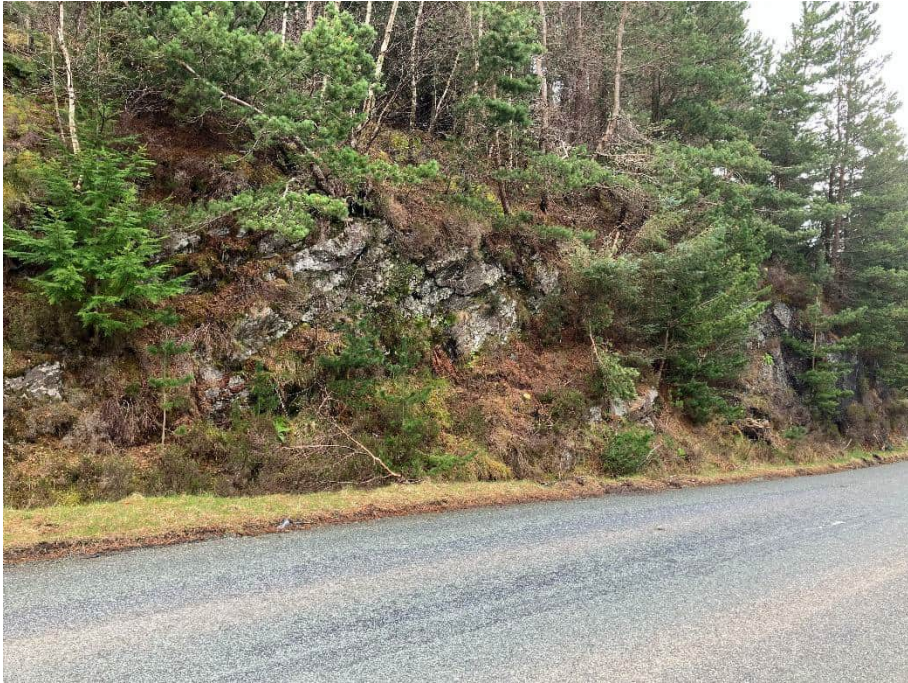
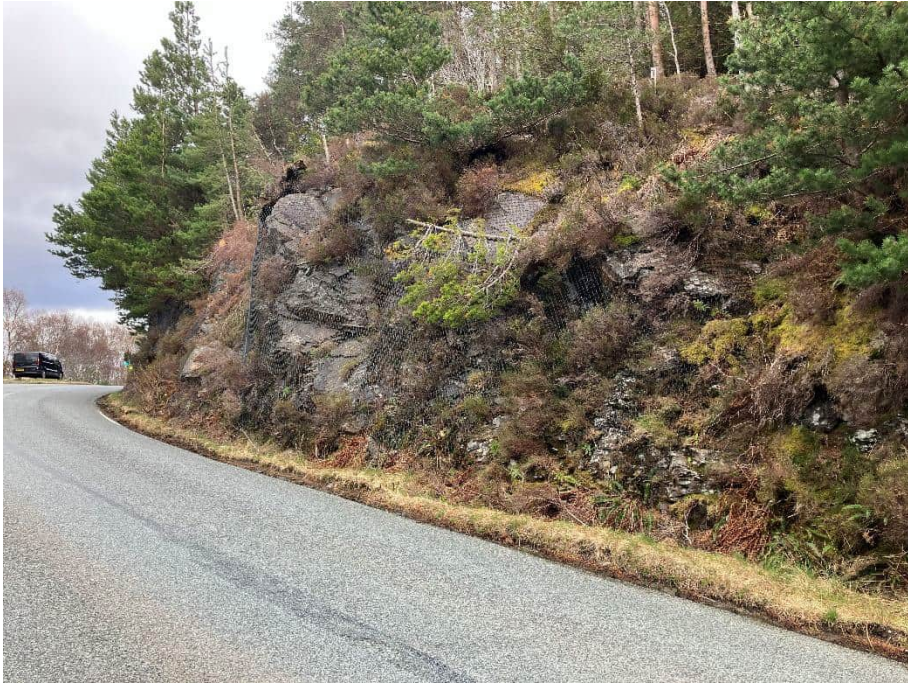
| Photo at Start Chainage (looking west) | Photo at End Chainage (looking east) |

| GEOTECHNICAL ASSESSMENT SHEET | | | | | | |
|---|---|---|---|---|---|--|
| Site: A890 Maman Hill | Slope Ref: M1 | Chainage: 015 – 075 | Start Grid Ref: NG 92612 39681 | End Grid Ref: NG 92572 39636 | Elevation: 50 – 55 m AOD | |

| Rock Slope Characteristics: | | | | | | | | | |
|---|---|---|---|---|---|---|---|--|--|
| Dip (°): 70 | Azimuth (°): 310 | Height (m): 7 | Length (m): 60 | Vegetation Cover: 30 to 50% of slope covered in heather and grass. Trees along crest. | Ditch Details: Ch. 0 to 30 – Shallow ditch – 1 m wide by 0.3 to 0.5 m deep. Ch. 30 to 75 – No ditch. | Roughness: Rough | Verge Width (m): 0.9 between Ch. 000 to 040 and 070 to 075. Very narrow between Ch. 040 and 070 | | |

| Other Comments |
|---|
| <p>No surface or groundwater flows.</p> <p>Rock mass generally in good condition, although dilated fractures noted locally. Potential for kinematic failure is low.</p> <p>Based on the current condition of the rock slope and the presence of a 0.9 m verge and localised ditch at the toe of the slope, the likelihood of debris from a rock fall landing on the road is considered to be relatively low, excluding between Ch. 040 and 070, where the verge is very narrow.</p> |

| RISK RATING | | Comments |
|---|---|---|
| Hazard Rating = | 2 | Generally limited to small scale ravelling although locally potential for larger block fall(s) associated with root jacking. Block size not expected to exceed 1 m <sup>3</sup> . |
| Risk Level = | Low | Between Ch. 030 and 075 the netting is completed corroded and is considered to be ineffective at retaining falling blocks; between Ch. 040 and 070 there is very little verge for falling blocks to land on. Taking cognisance of these factors, between Ch. 040 and 070, the Pathway Rating could locally be increased to 3 to reflect the increased likelihood of falling blocks reaching the roadside. However, in this slope sub-section the prevailing size of failure material is less than 0.02 m <sup>3</sup> and, as such, the Hazard Rating could be correspondingly reduced to 1. This would equate to an overall Risk Value of 3.6 (Low Risk Level) so no change has been made to the more conservative risk rating determined by consideration of the slope as a whole. |

| Recommended Remedial Works / Actions | | | | | | | |
|---|---|--|---|---|---|---|---|
| N/A | | | <ul style="list-style-type: none"> <li>Consider replacement of existing ineffective drape netting between Ch. 030 and Ch. 075.</li> </ul> | | | <ul style="list-style-type: none"> <li>Re-inspection by end of April 2027</li> <li>Felling of trees along crest and de-vegetation of the slope</li> <li>Scaling of loose rock behind netting (between Ch. 030 to 075)</li> </ul> | |

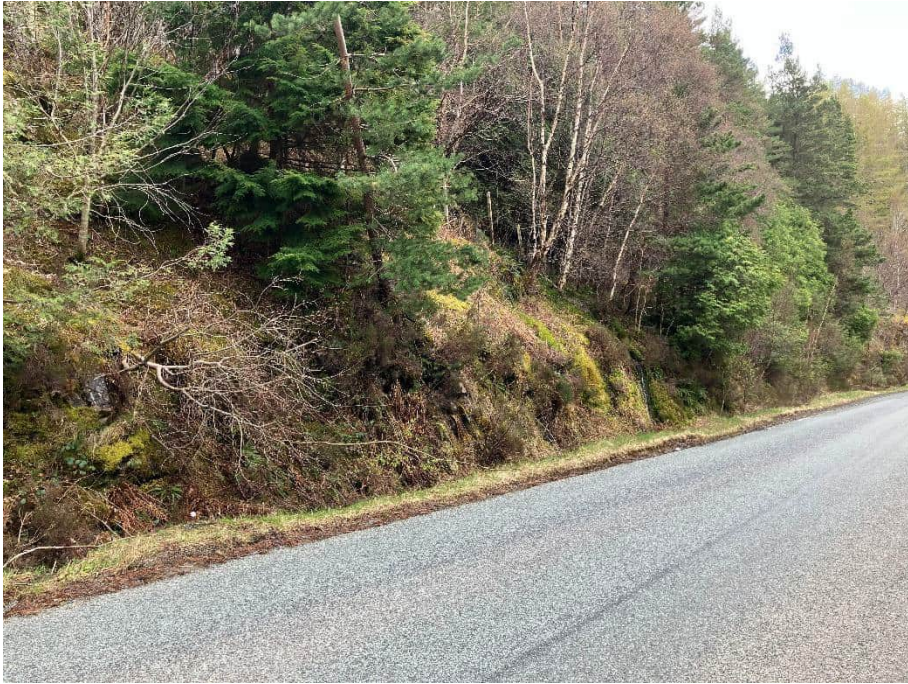
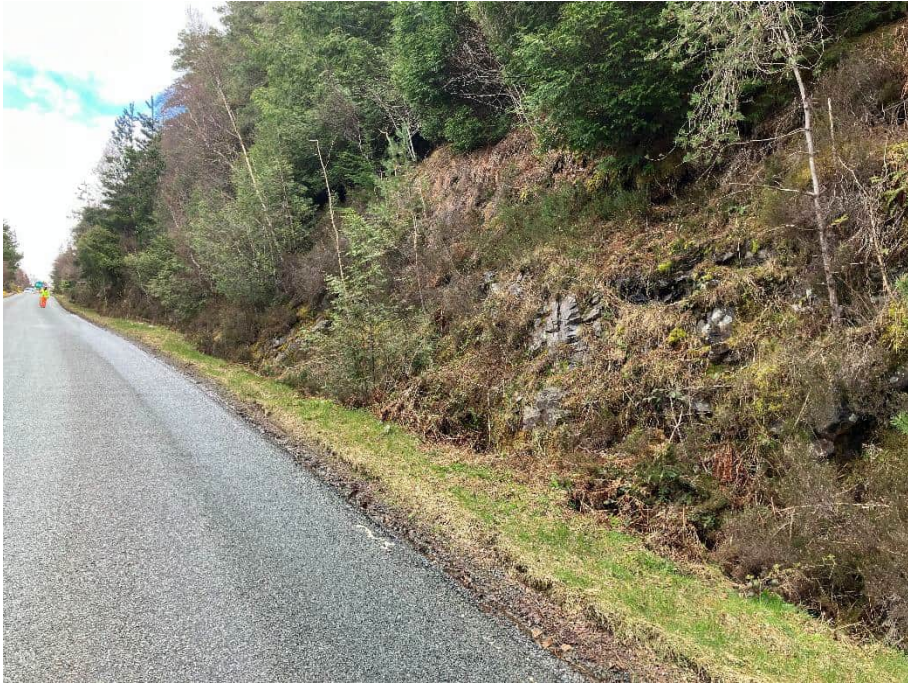
| GEOTECHNICAL ASSESSMENT SHEET | | | | | | |
|---|---|---|---|---|---|---|
| Photo at Start Chainage (looking west) | | | | Photo at End Chainage (looking east) | | |

| GEOTECHNICAL ASSESSMENT SHEET | | | | | | |
|---|---|---|---|---|---|---|
| | | | | | | Elevation: 30 – 35 m AOD |

| Rock Slope Characteristics: | | | | | | | |
|---|---|---|---|---|---|---|---|
| Dip (°): | 60 | Azimuth (°): | 305 | Height (m): | 2 | Length (m): | 80 |

| Location | Description of Hazard(s) from Previous Inspections | 2026 Inspection Observations | Photo Reference |
|---|---|---|---|
| Throughout M2 | <b>2019 Inspection:</b> Small scale (<0.02 m <sup>3</sup> ) ravelling / root jacking rock falls likely as rock mass continues to weather. However, ditch and verge at toe are considered effective and the associated likelihood of debris reaching the road is therefore low. | No change noted during the 2026 inspection. | N/A |
| Ch. 217 | <b>2025 Inspection:</b> Surface water flow appears to have been diverted upslope in forestry area, with the water flowing down slope ~4.0 m up chainage from the location of the existing culvert. | Surface water no longer flows towards and into the culvert. Craggs are noted circa 20 m above the road level. One block noted on the slope circa 25 m back from the road, although there does not appear to be any evidence of movement. | M2-1 |

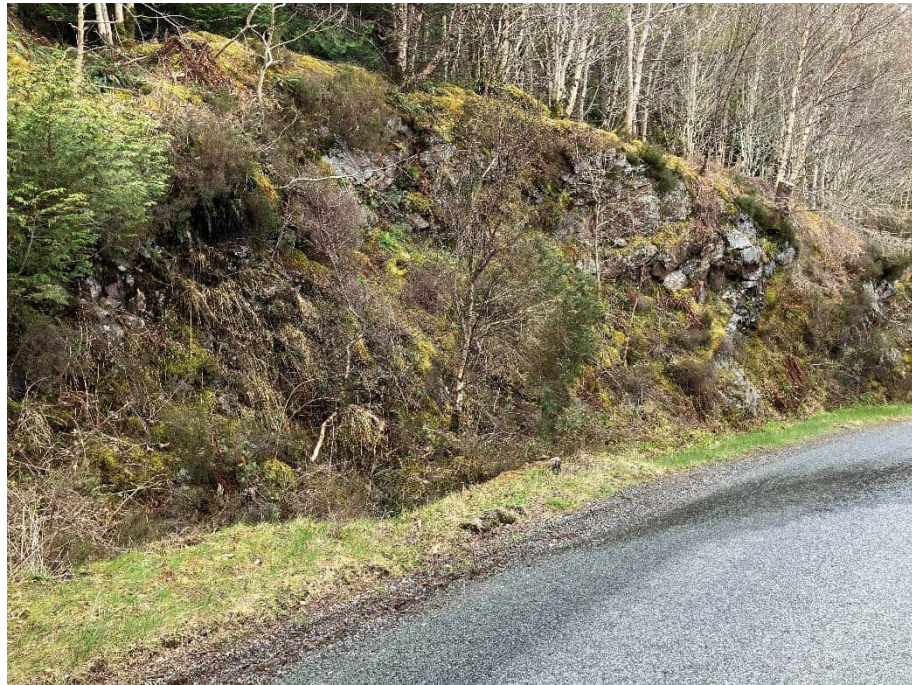
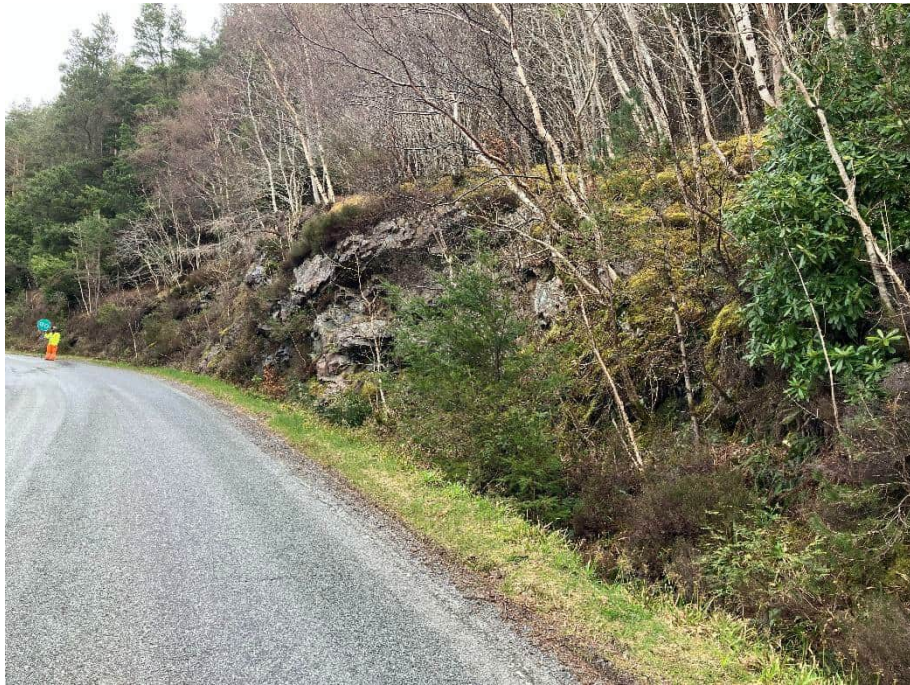
| GEOTECHNICAL ASSESSMENT SHEET | | | | | | | | | | | |
|---|---|---|---|---|---|---|--|---|--|---|--|
| Site: A890 Maman Hill | | Slope Ref: M3 | | Chainage: 280 – 330 | | Start Grid Ref: NG 92513 39431 | | End Grid Ref: NG 92493 39392 | | Elevation: 25 – 35 m AOD | |
| Dip (°): 65 | Azimuth (°): 300 | Height (m): 4 to 8 | Length (m): 50 | Vegetation Cover: 25% of slope covered in heather, grass and occasional small trees. Trees along crest. | Ditch Details: 0.4 to 0.75 m deep, minimum 1.2 m wide. Culvert at Ch. 288. | Roughness: Rough | | Verge Width (m): 1.0 | | | |

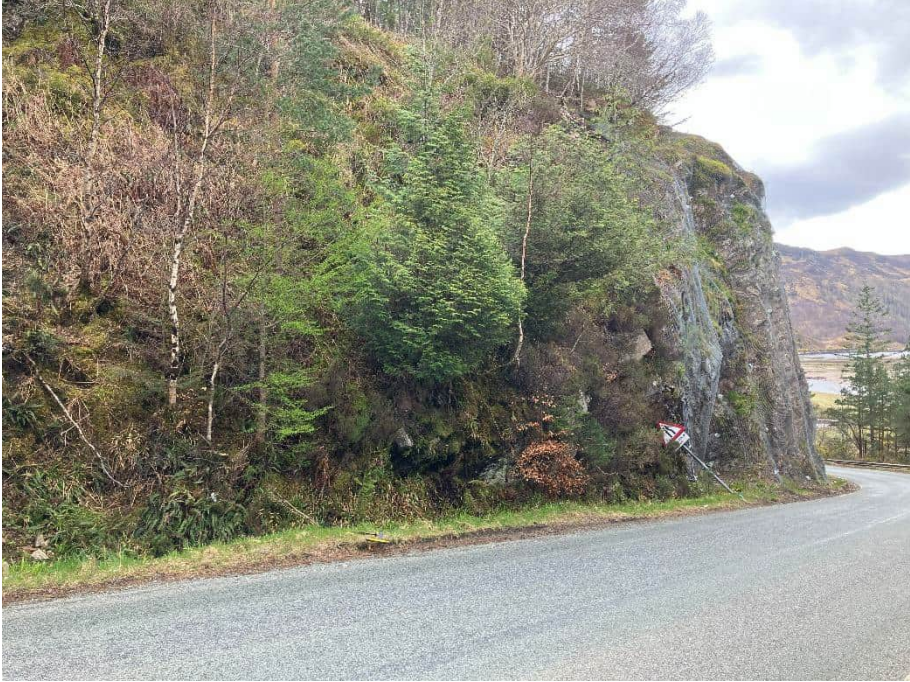
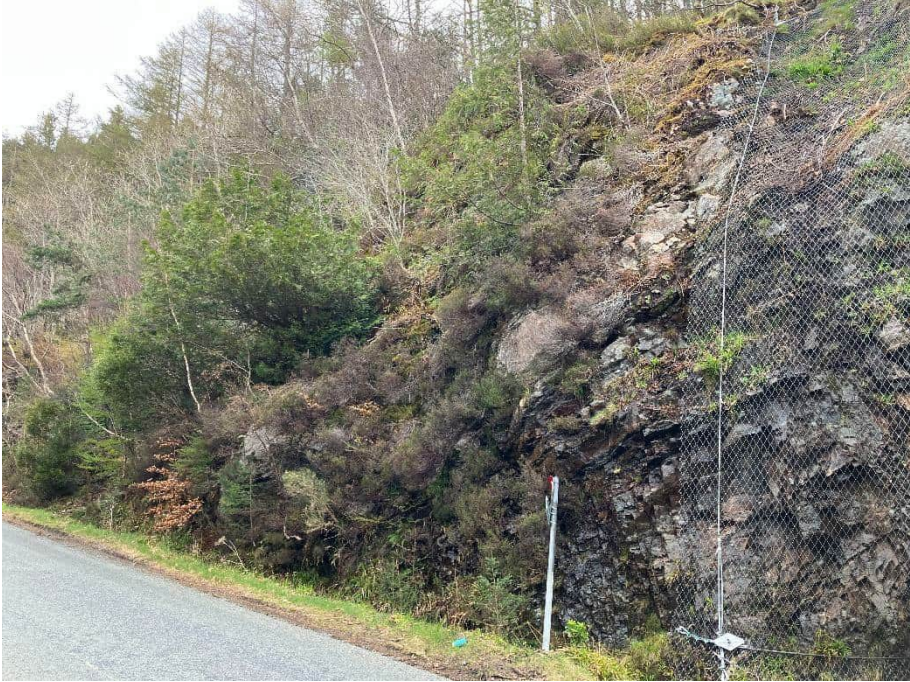
| GEOTECHNICAL ASSESSMENT SHEET | | | | | | | | | | | | | | | |
|---|---|---|---|---|---|---|---|---|---|---|---|---|---|---|---|
| Site: A890 Maman Hill | | Slope Ref: M4 | | Chainage: 330 – 353 | | Start Grid Ref: NG 92493 39392 | | End Grid Ref: NG 92480 39378 | | Elevation: 15 – 20 m AOD | | | | | |
| Dip (°): | 80 | Azimuth (°): | 300 | Height (m): | 4 to 10 | Length (m): | 23 | Vegetation Cover: | 70 to 80% of slope covered in trees and heather. | Ditch Details: | 1.5 m wide, 0.5 m deep | Roughness: | Rough | Verge Width (m): | 1.0 |

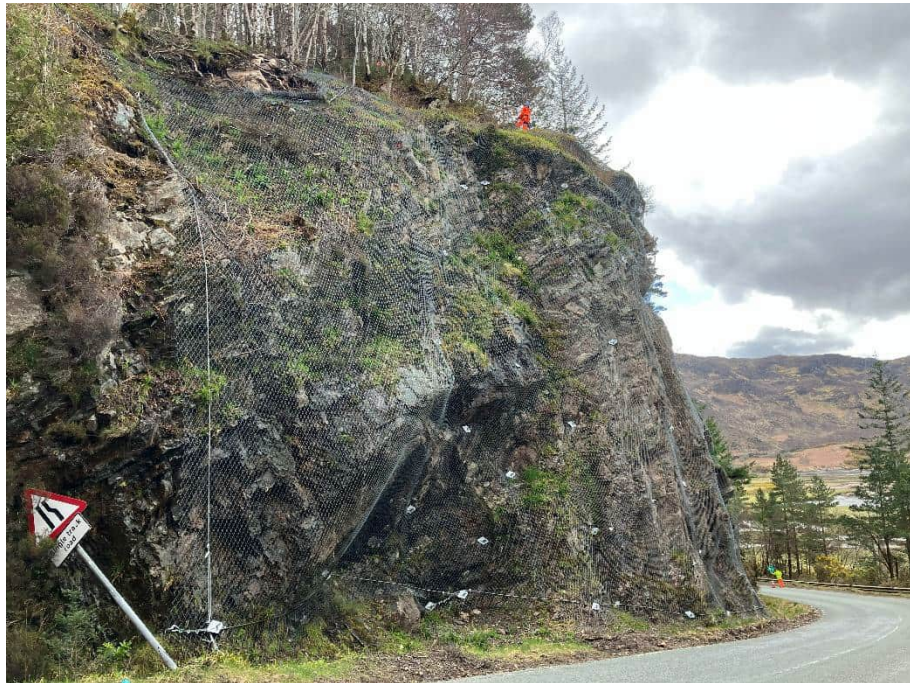
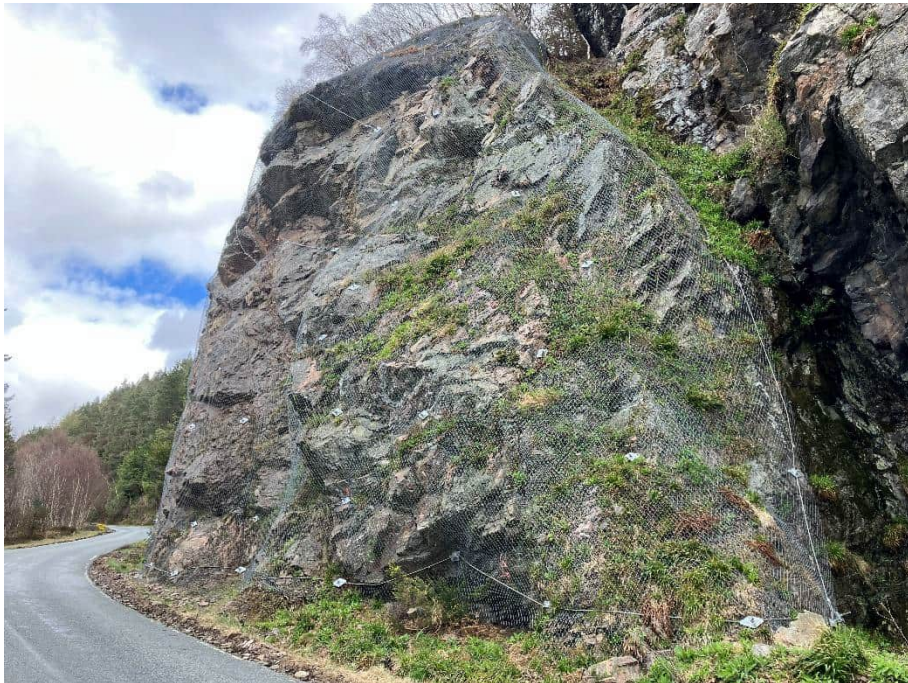
| GEOTECHNICAL ASSESSMENT SHEET | | | | | | | | | | | | | | | |
|---|--|---|--|---|--|---|--|---|--|---|--|---|--|---|--|
| Site: A890 Maman Hill | | | | Slope Ref: M4 | | Chainage: 353 – 395 | | Start Grid Ref: NG 92480 39378 | | End Grid Ref: NG 92452 39339 | | Elevation: 15 – 20 m AOD | | | |
| Dip 80 (°): | | Azimuth 300 (°): | | Height 10 to 15 (m): | | Length 42 (m): | | Vegetation Cover: 10% of slope covered in grass. | | Ditch Details: 0.0 to 0.4 m deep, 0.0 to 1.0 m wide. 2.0 m wide after Ch. 380 | | Roughness: Rough | | Verge Width 0.5 to 1.0 (m): | |

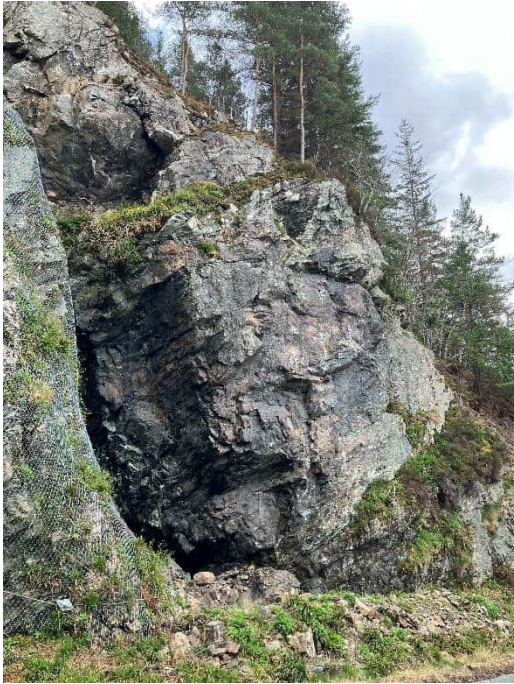
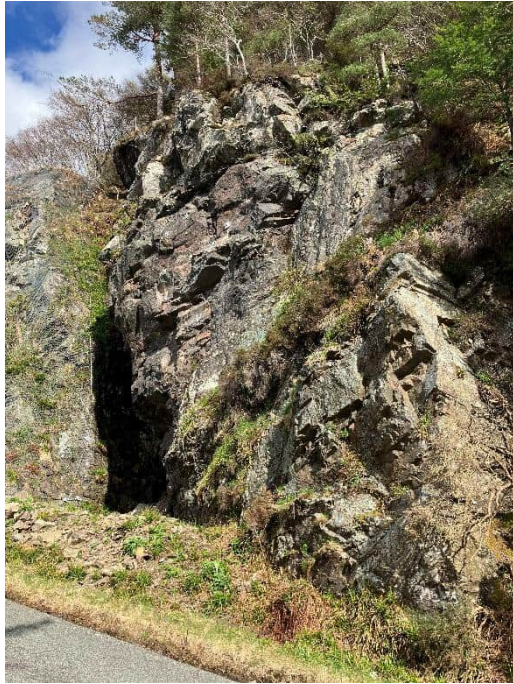
| GEOTECHNICAL ASSESSMENT SHEET | | | | | | | | | | | | | | | |
|---|---|---|---|---|---|---|---|---|---|---|---|---|---|---|---|
| <b>Site:</b> A890 Maman Hill | | <b>Slope Ref:</b> M5 | | <b>Chainage:</b> 395 – 415 | | <b>Start Grid Ref:</b> NG 92452 39339 | | <b>End Grid Ref:</b> NG 92445 39309 | | <b>Elevation:</b> 10 – 15 m AOD | | | | | |
| Dip<br>(°): | 80<br>to<br>90 | Azimuth<br>(°): | 315 | Height<br>(m): | 15<br>to<br>20 | Length<br>(m): | 20 | Vegetation<br>Cover: | <10% of slope is<br>vegetated. Localised<br>heather and grass. Trees<br>also present at crest. | Ditch<br>Details: | Road to Bund: 0.4 m deep<br>by 0.5 to 1 m wide<br><br>Bund to Slope: 1.3 m<br>deep by 2.5 m wide | Roughness: | Rough | Verge Width<br>(m): | 5, including 3 m<br>wide by 1.3 m high<br>Bund |

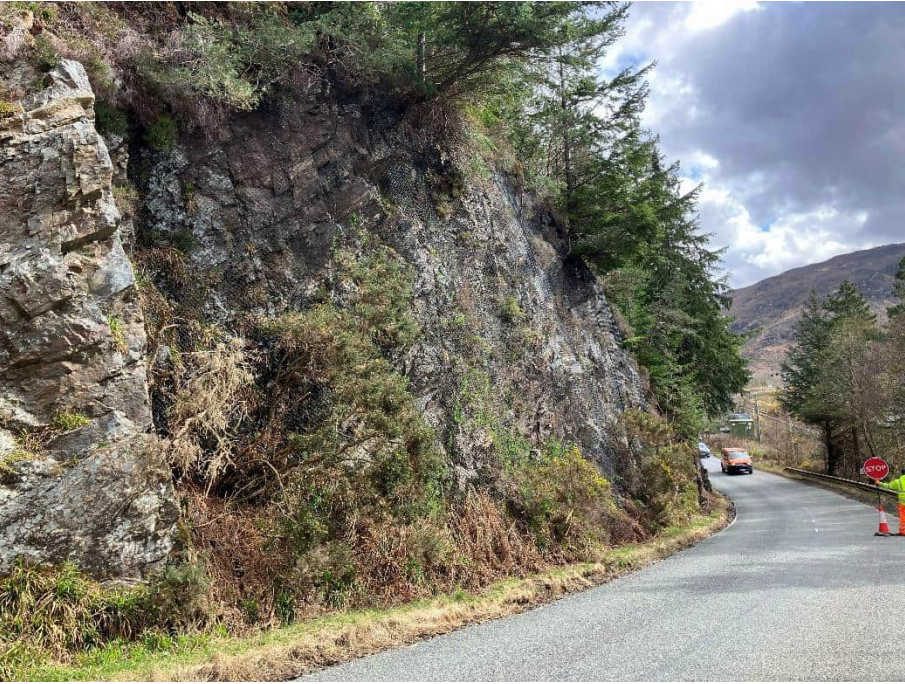
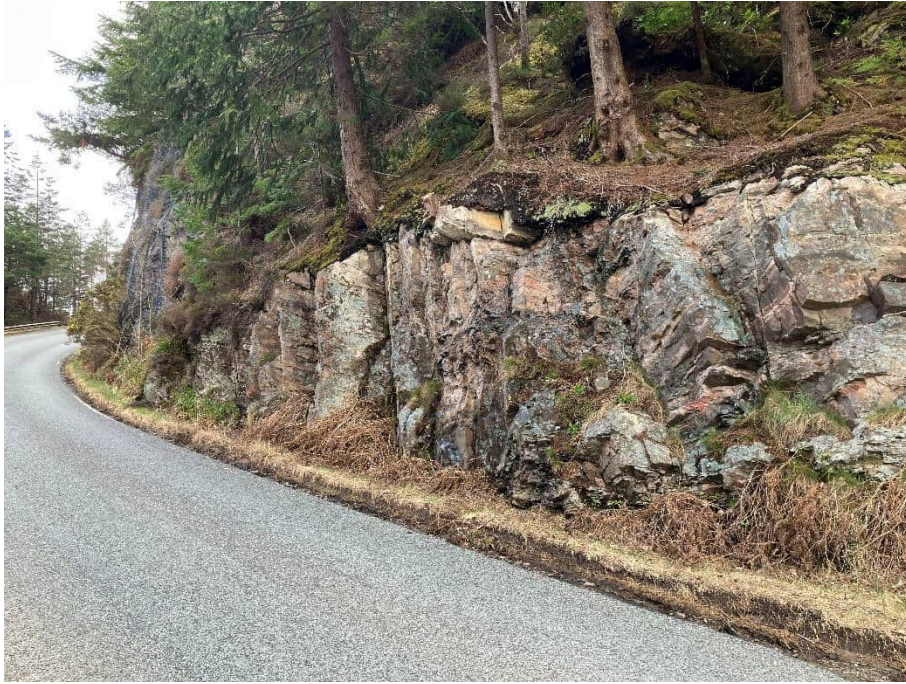
| GEOTECHNICAL ASSESSMENT SHEET | | | | | | | | | | | | | | | |
|---|---|---|---|---|---|---|---|---|---|---|---|---|---|---|---|
| Site: A890 Maman Hill | | Slope Ref: M6 | | Chainage: 415 – 460 | | Start Grid Ref: NG 92445 39309 | | End Grid Ref: NG 92450 39264 | | Elevation: 5 – 10 m AOD | | | | | |
| Dip (°): | 80 | Azimuth (°): | 285 | Height (m): | 3 to 10 | Length (m): | 45 | Vegetation Cover: | <15% vegetation cover – gorse, heather, and grass. Trees also present at crest. | Ditch Details: | No ditch | Roughness: | Smooth | Verge Width (m): | 0.5 to 1.0 |
