12 Conclusions and recommendations

This report summarises Stage 1 of the Inverness study and has provided a thorough understanding of the causes and key flood mechanisms that have played a role in causing the recent flooding. This report also provided suggested scheme and measures that need to be considered to reduce flood risk to the Smithton and Culloden Burn West.

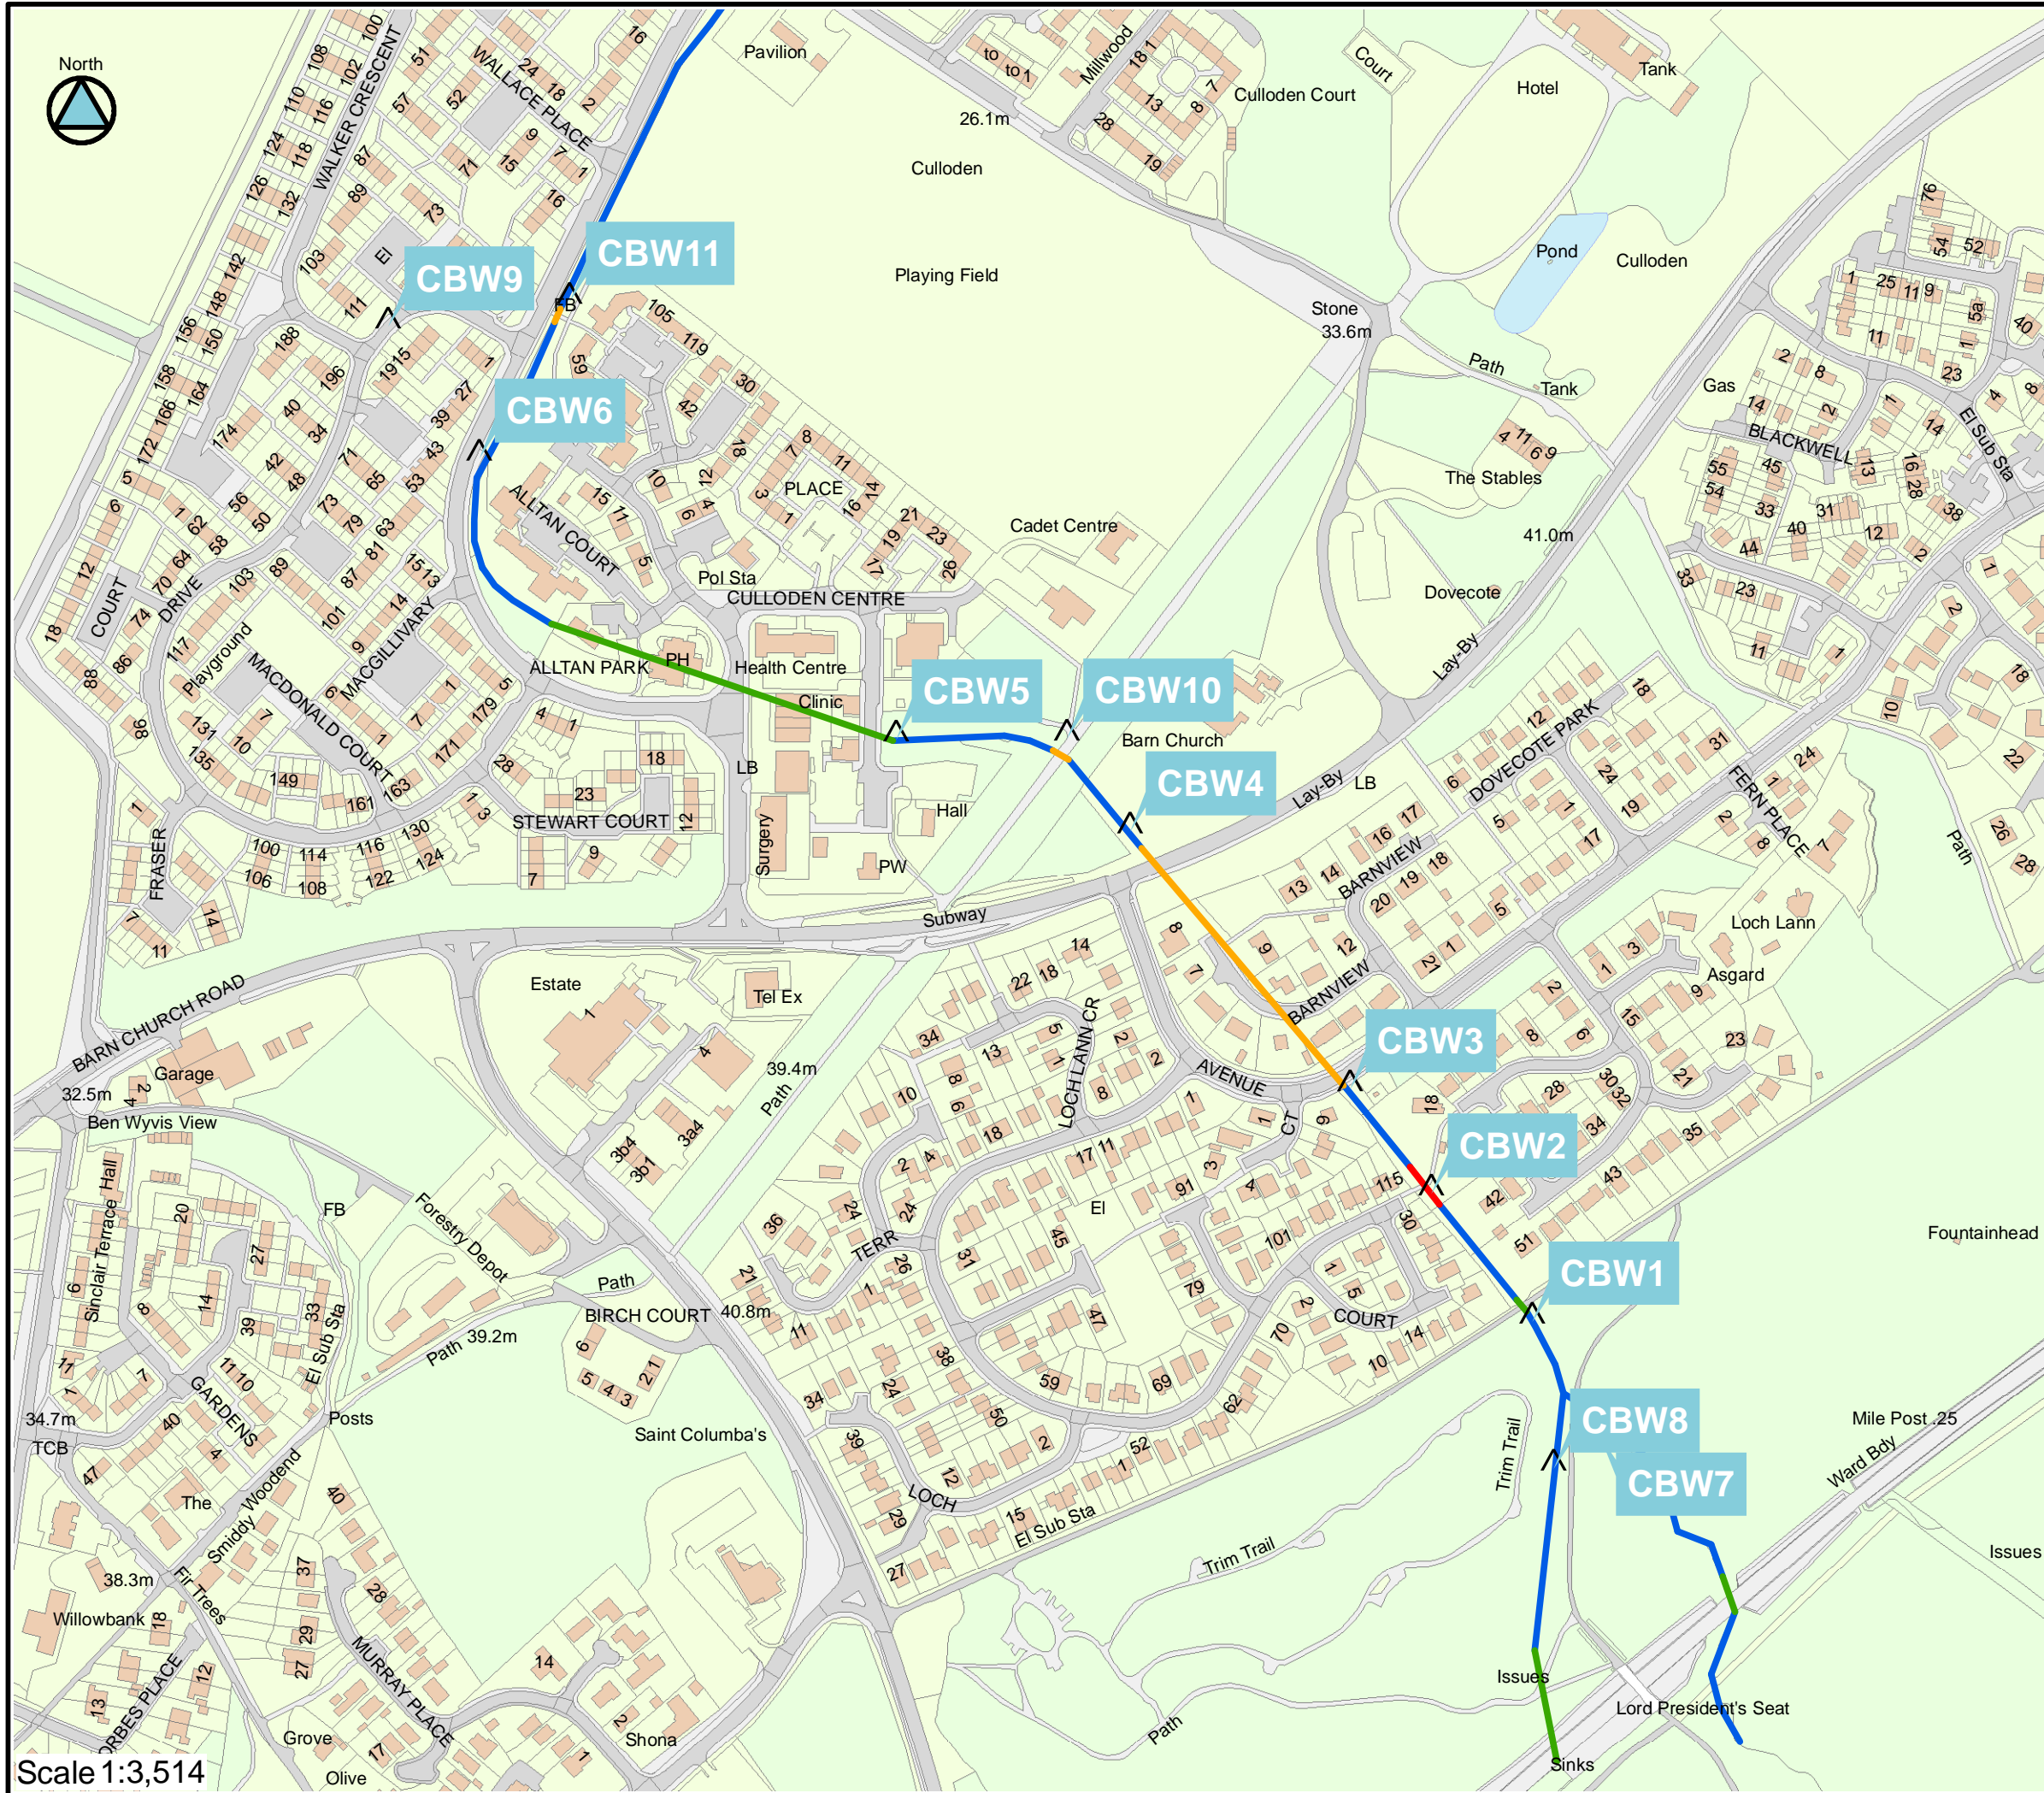
- Culloden Burn West (CBW)
- CBW Culverts**
- High Risk / Priority
- Medium Risk / Priority
- Low Risk / Priority
- △ CBW Options

FIGURE 15
Proposed Measures to Alleviate Flood Risk on the Culloden Burn West

26. It is recommended that in the short term careful consideration should be given to each structure to assess the probability and consequence of flooding and whether culvert removal or improved screen design and gravel traps/watercourse maintenance is the

preferred approach. We recommend that the removal of the Murray Terrace, Murray Road and Loch Lann culverts are investigated in the first instance.

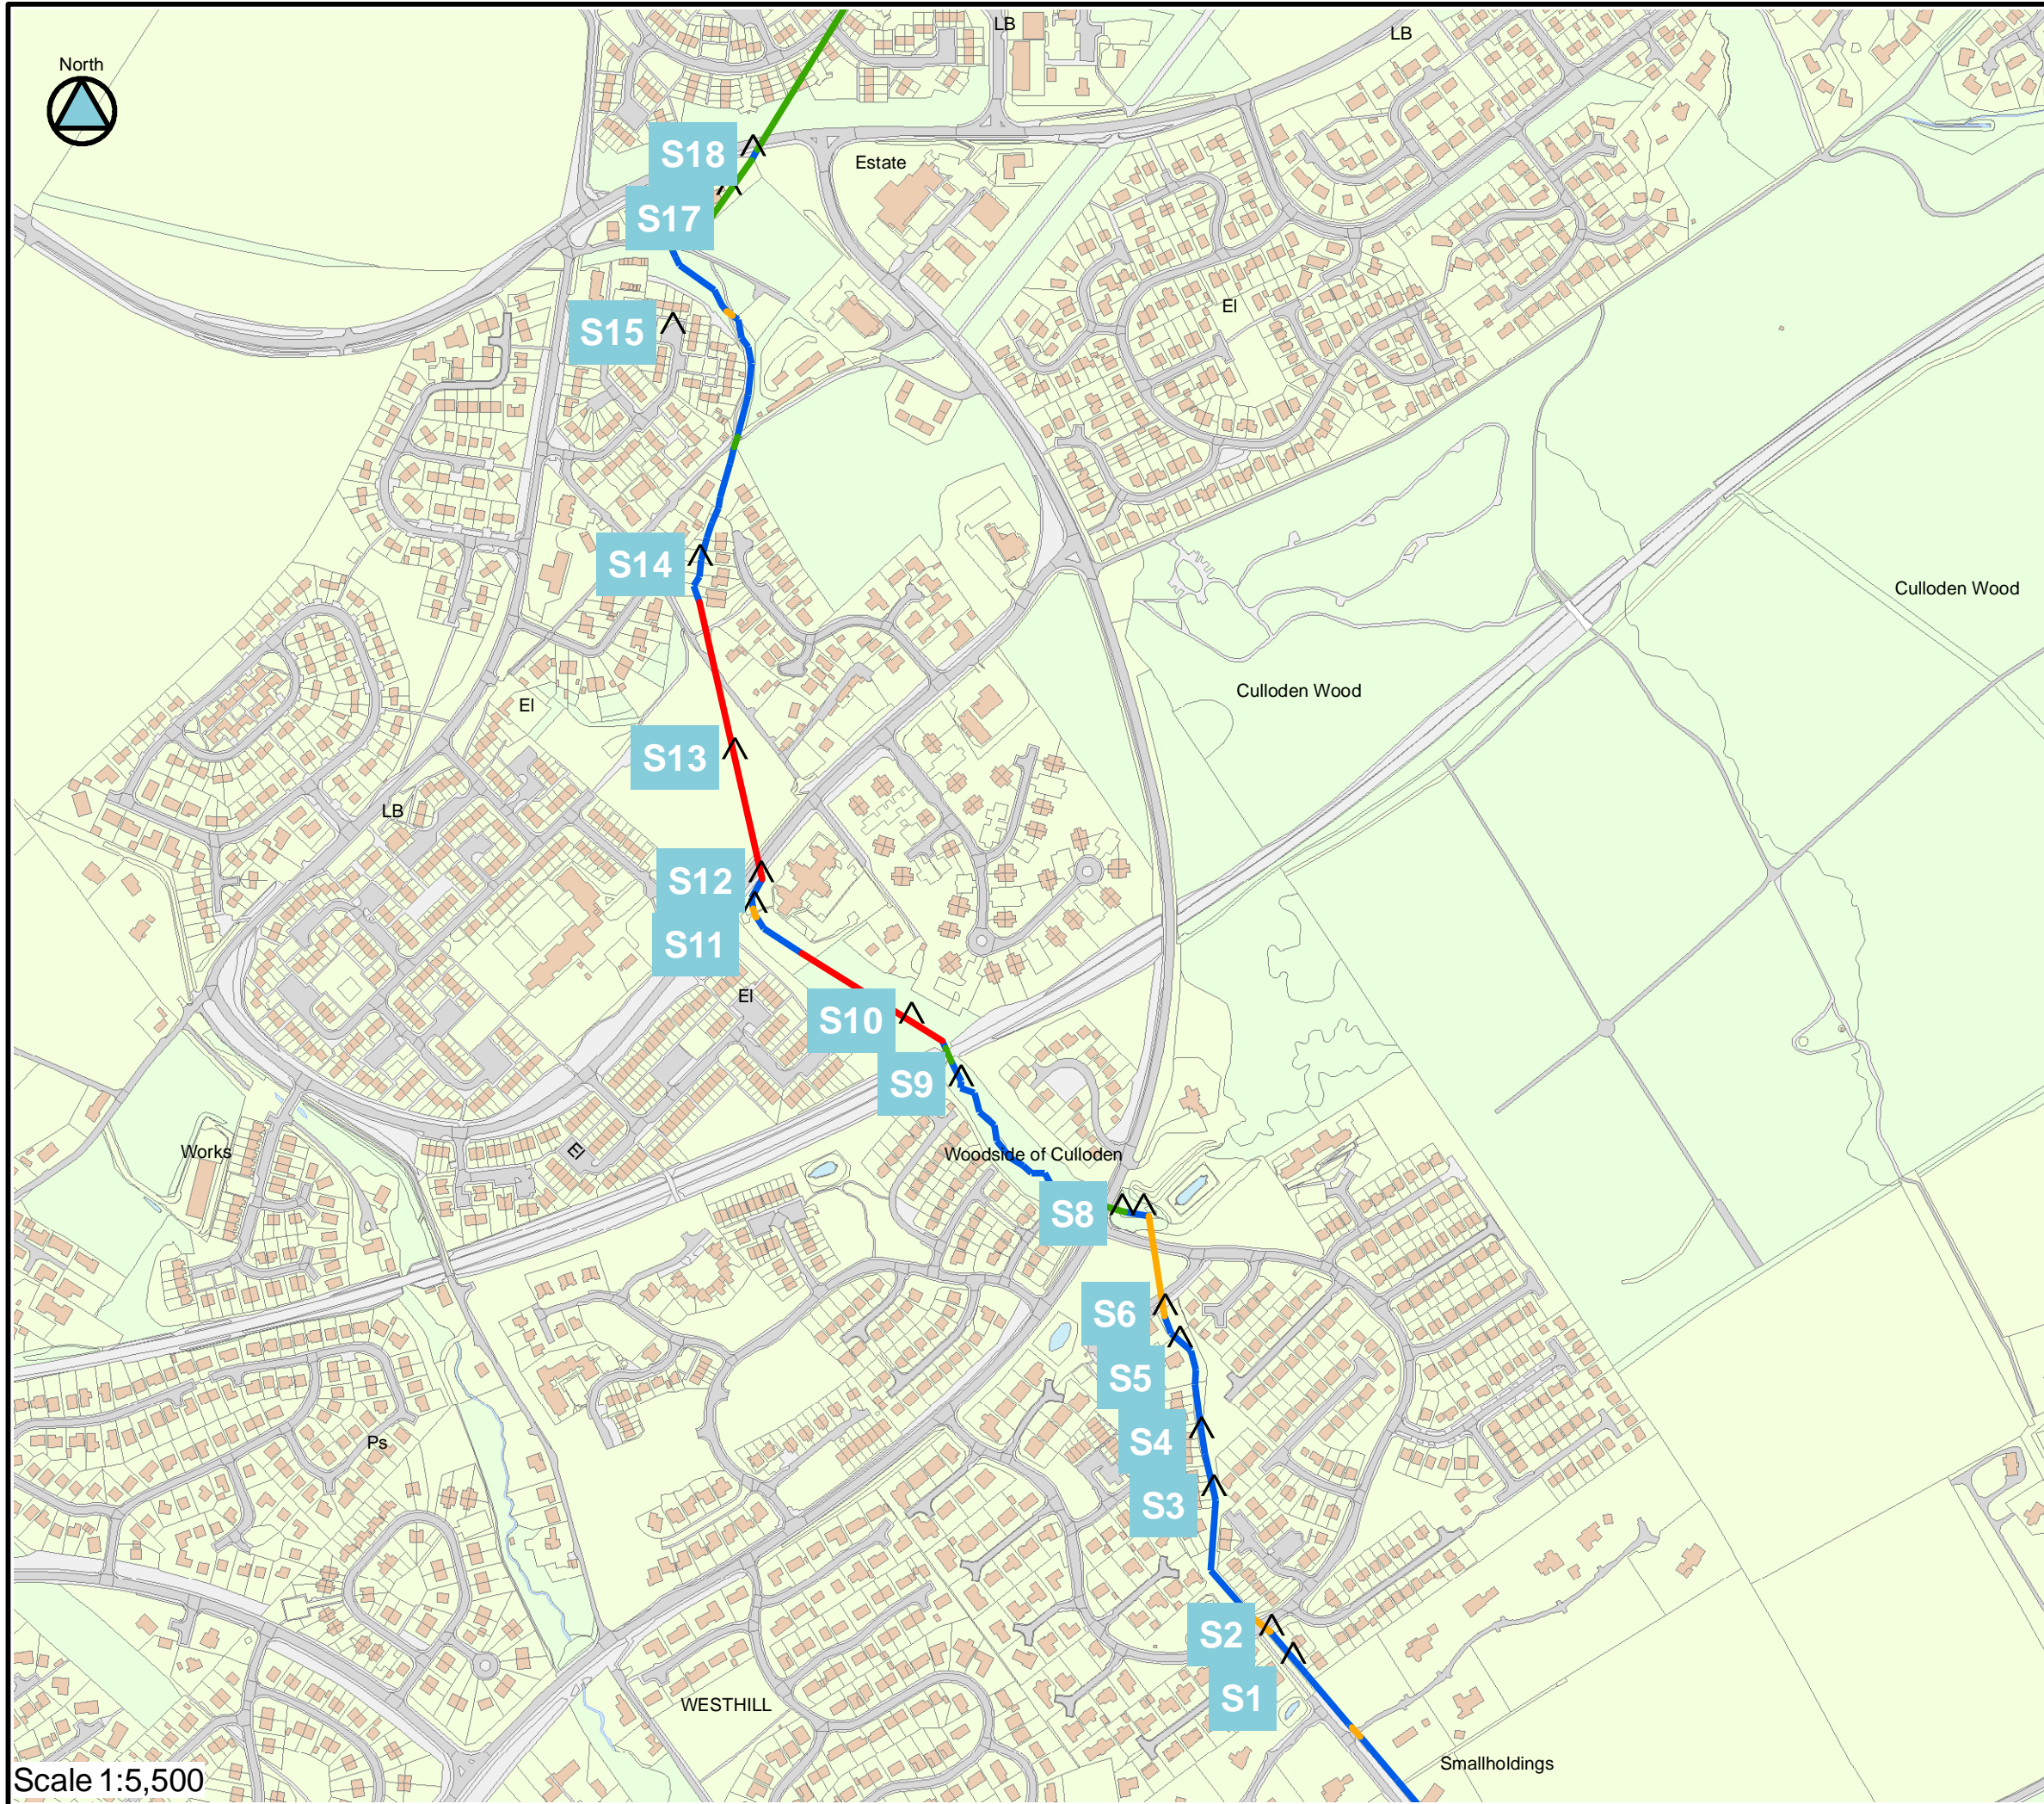
- Smithton Burn
- Smithton Burn Culverts
- Low Risk / Priority
- High Risk / Priority
- Medium Risk / Priority
- ^ Smithton Burn Options

Proposed Measures to Alleviate Flood Risk on the Smithton Burn
