HIGHLAND COUNCIL

Committee:	Lochaber Area Committee
Date:	28 September 2020
Report Title:	Area Road Structures Annual Report 2019/20
Report By:	Executive Chief Officer Infrastructure and Environment

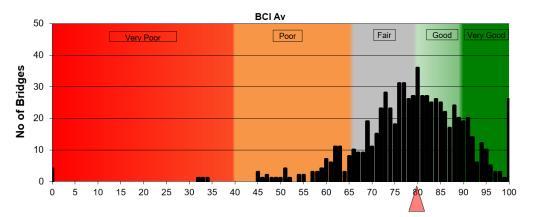
10.1 As inspections are completed, information gathered is used to calculate the Bridge Stock Condition Index (BSCI). Currently, principal inspection results are used as they generate a condition score for each bridge. The 2019/20 Highland BSCI average is 79.0 and BSCI critical is 64.0. The distribution of BCI average values for each bridge which has had a PI are shown in the diagram.
