3 What has been done to tackle the problem? (1)

The Highland Council and its partners have responded to the flood events.

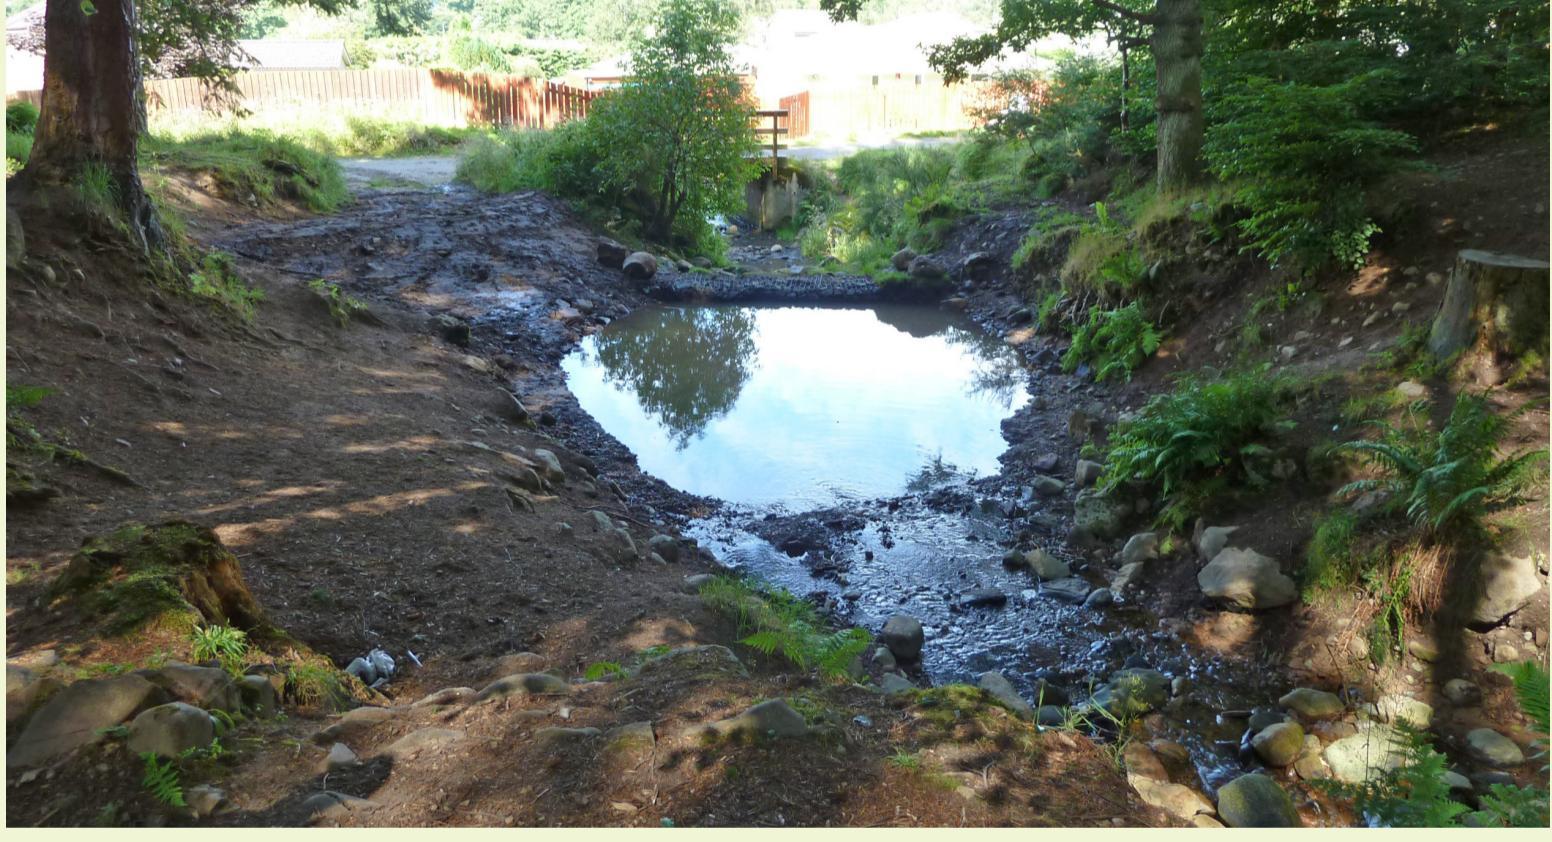
Before: silt trap in Culloden Woods. Silt traps starve downstream channels of sustainable sediments and encourage further erosion downstream

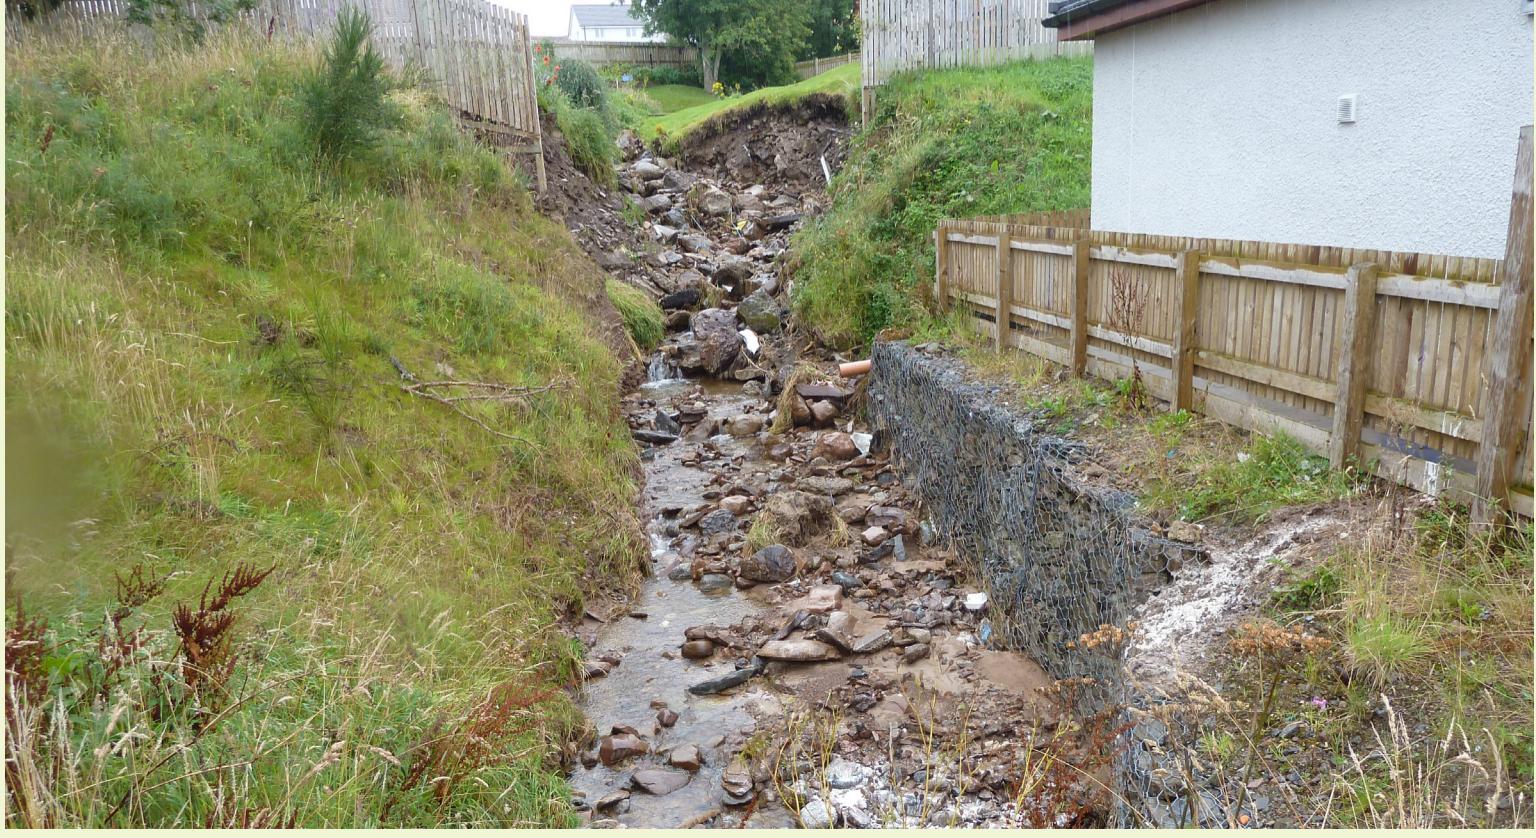
Before: Uncontrolled channel erosion during the 2011 floods increasing the risk of downstream blockage.

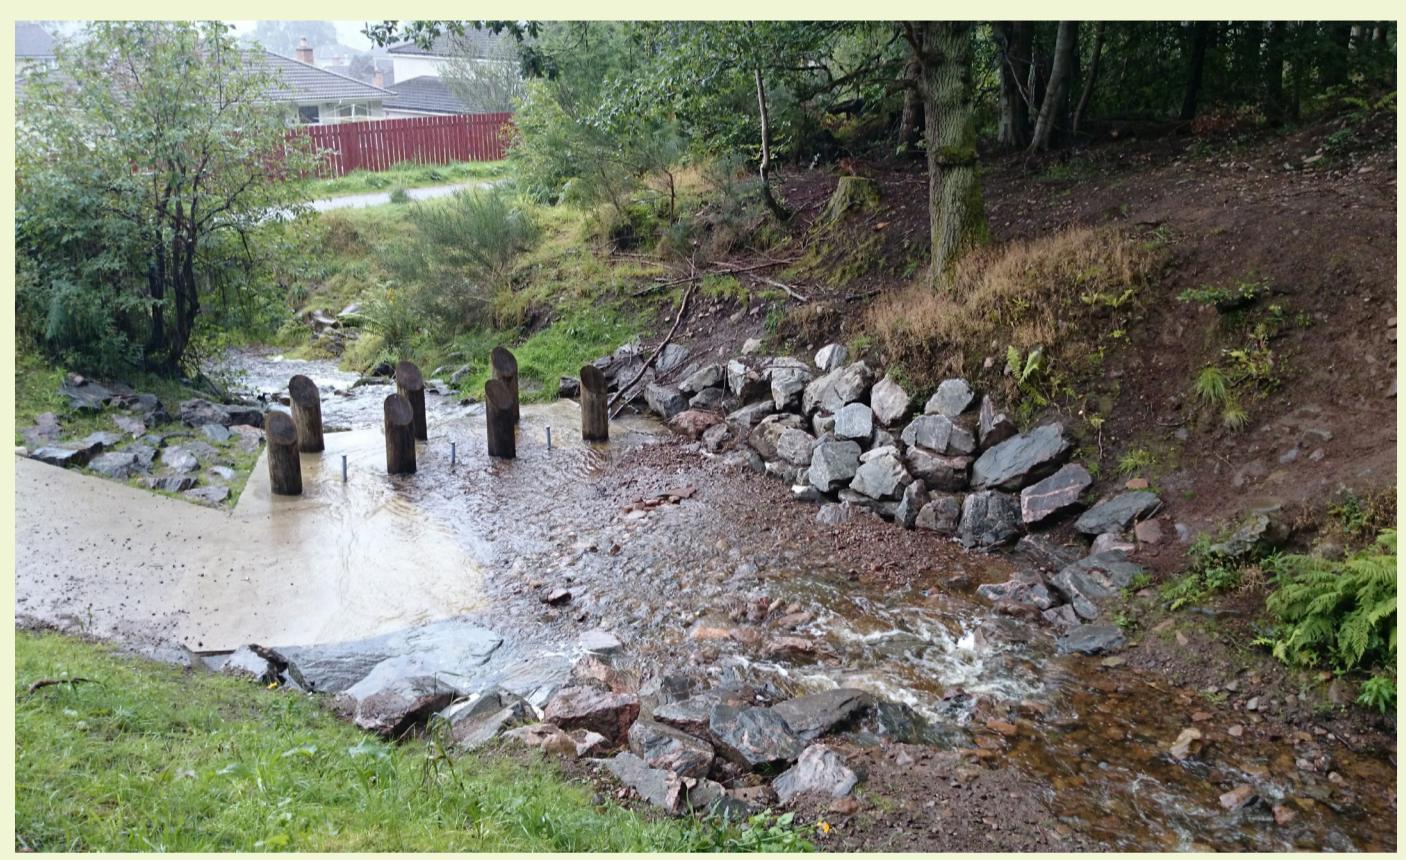
After: New coarse debris screen allows the sustainable movement of sediments, but retains larger material and debris that are likely to block structures.

Debris caught on the screen during the 2014 floods may have blocked downstream culverts and caused flooding.

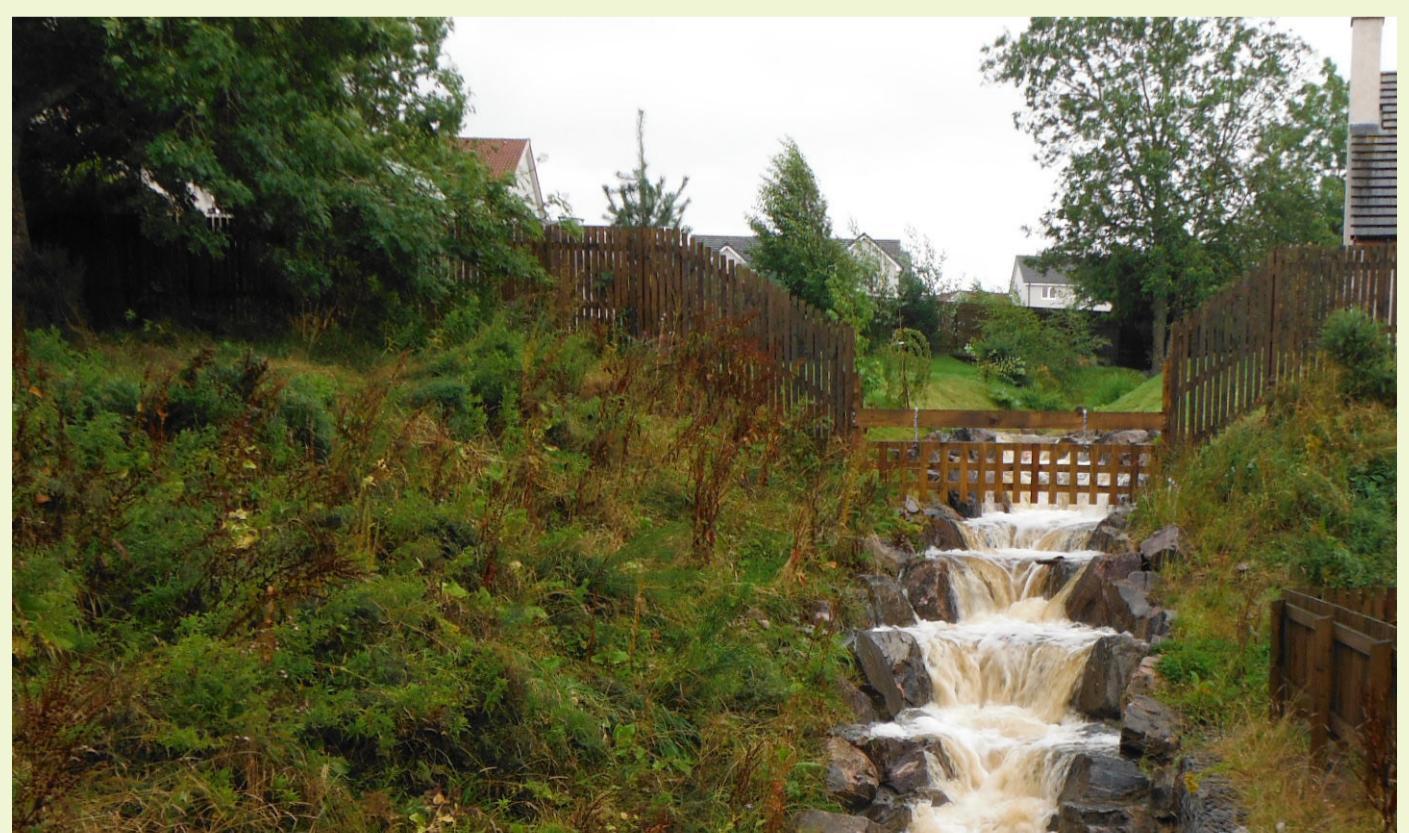
After: newly constructed step pools that dissipate flow energy and are erosion resistant

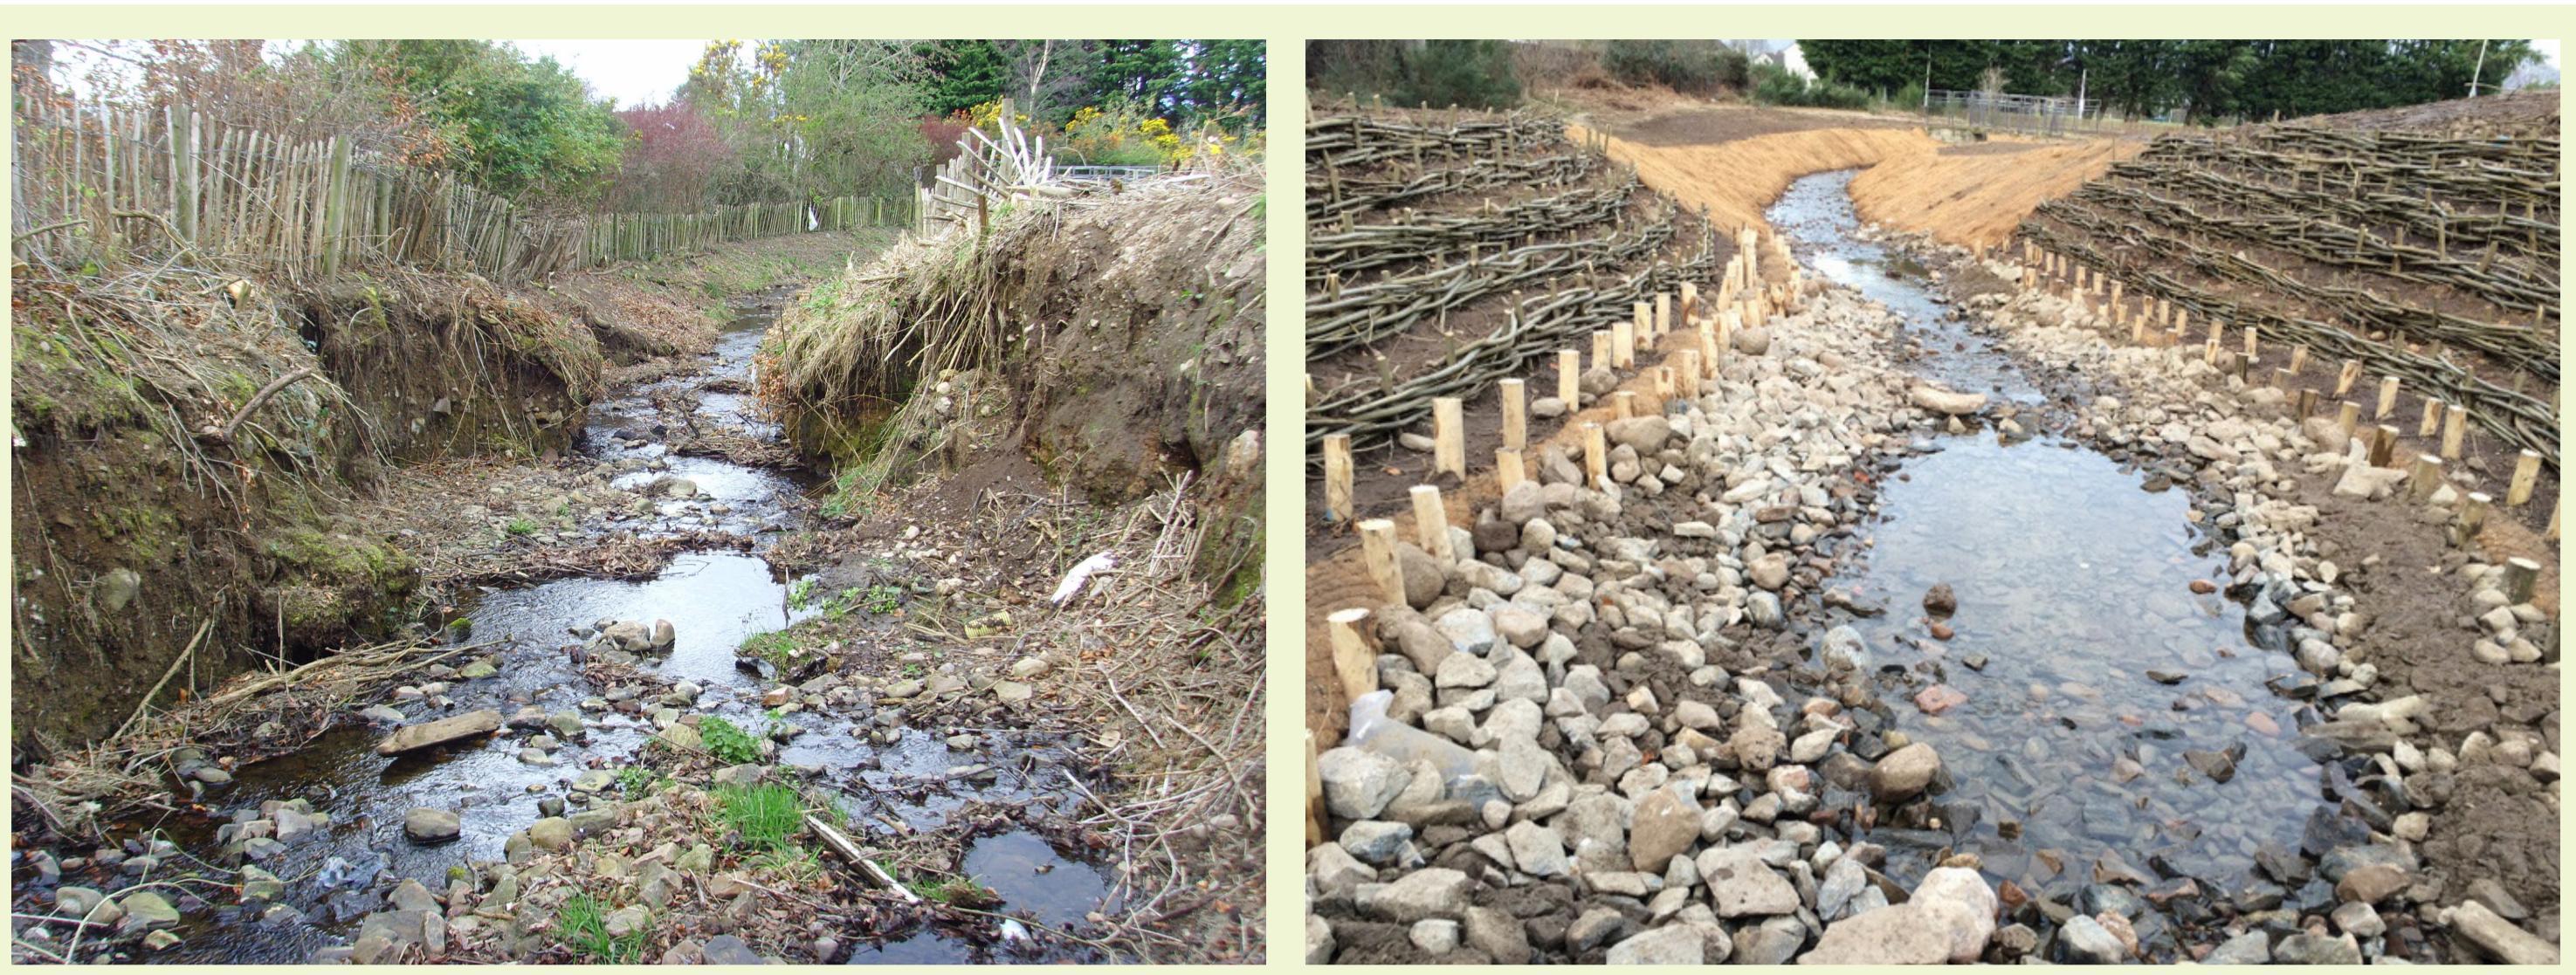
Before: Smithton Burn, with uncontrolled bank erosion increasing the risk of downstream blockage.

After: Channel re-sectioned to reduce flow velocities and protect the banks using natural 'living' products to stabilise the banks.

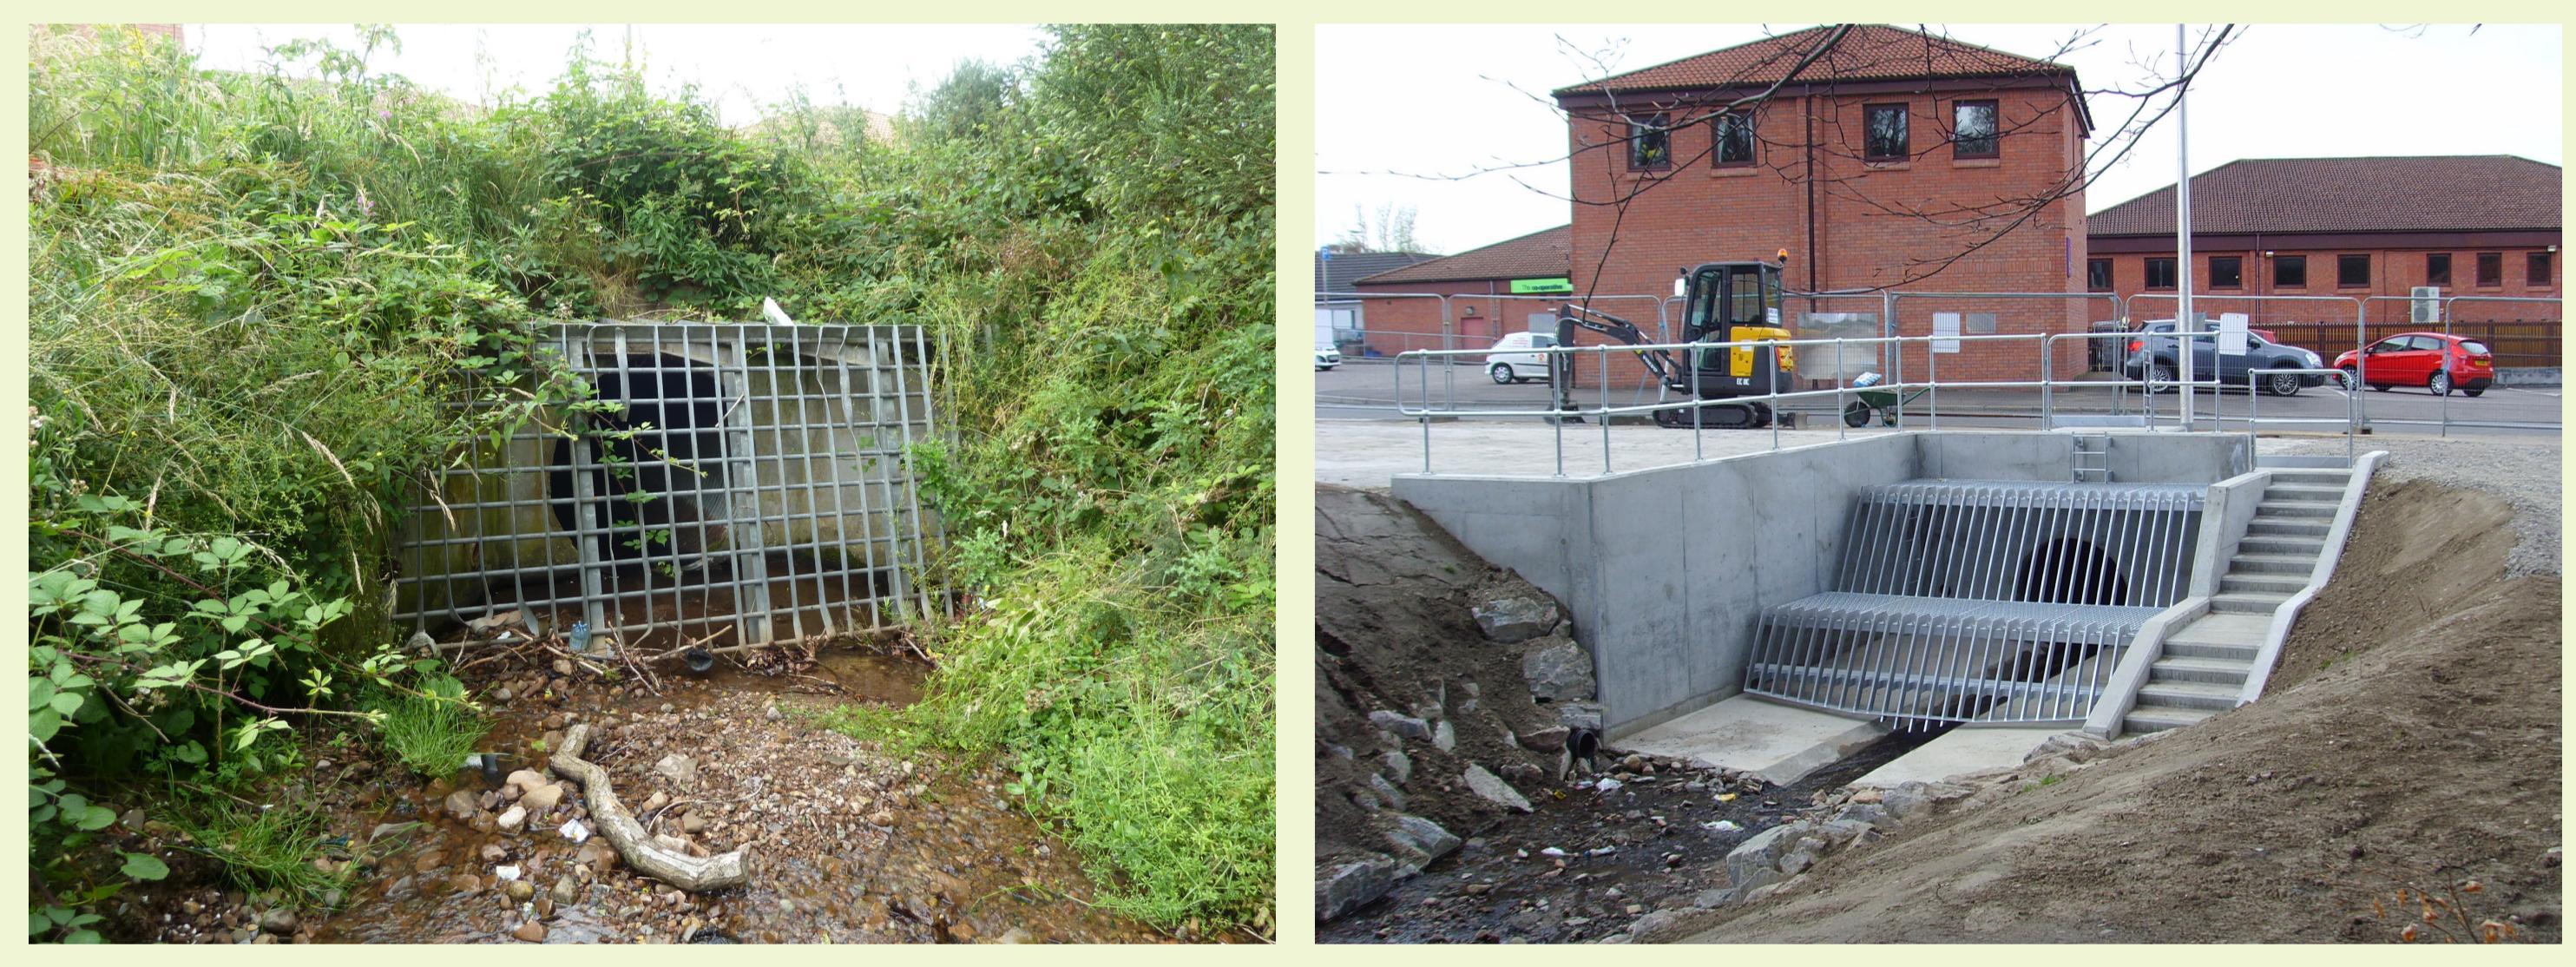
Before: debris screen at Culloden Centre, prone to blockage.

After: new debris screen designed to be resistant to blockage and allow some sediment to pass through the culvert.
