# Flood Bulletin

## Smithton & Culloden

November 2014

#### PHASE 3A WORKS COMPLETE

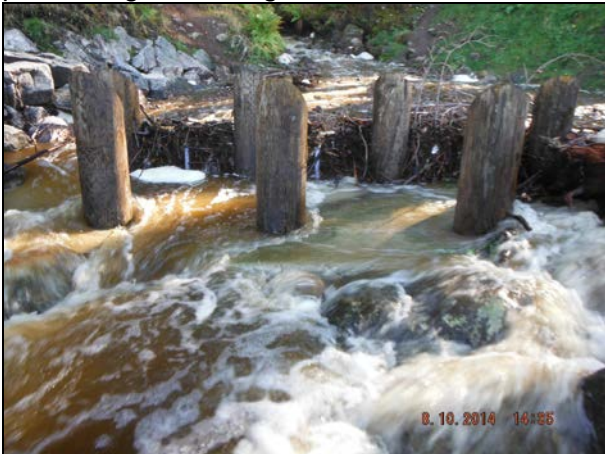
A new, 'coarse debris' trap has been constructed at Culloden Woods on the Culloden Burn West. During recent heavy rainfall, some large woody debris was trapped, preventing it blocking downstream culverts.

A similar coarse debris trap has also been constructed on the Tower Burn at Rowan Grove. The coarse debris traps consist of wooden poles projecting from a concrete base which will catch coarse debris such as tree trunks and branches that may cause blockages in culverts downstream. This will help reduce potential flooding.

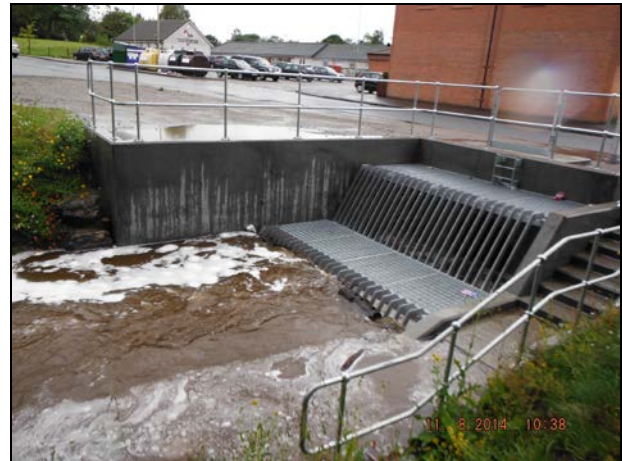
A new headwall and security/debris screen has been installed at the Culloden Centre.

The new screen meets current design standards and prevent blockages of the culvert inlet whilst allowing safer and easier future maintenance of the screen.

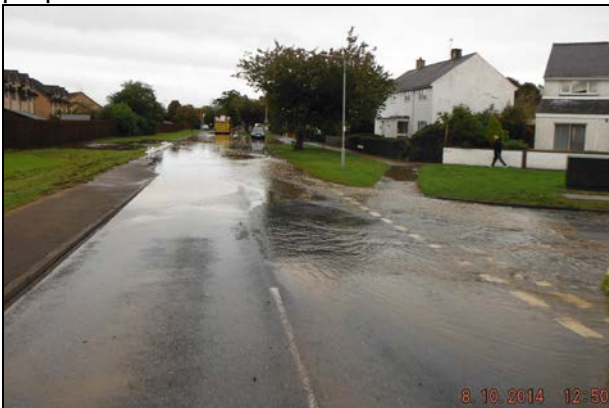
Flooding occurred in Smithton on 8<sup>th</sup> October. Large quantities of gravel and stones from upstream areas of erosion were washed down through the culvert below Smithton Park. This material was deposited at the culvert outlet in the rear gardens of Murray Place resulting in a blockage of the culvert and backing up of flow.

From this, overland flow towards Smithton Road and also towards Murray Place took place, resulting in flooding to a number of properties.

Community Services acted swiftly to remove the build-up of gravel and sediment from the outlet area and have re-visited this stretch to remove material. Access to undertake any future works has also been improved.

A new temporary screen has been installed at Murray Road (upstream of Murray Place) to reduce the volume of sediment and debris which is transported down the Smithton Burn through the culvert at Smithton Park. This will reduce the flood risk in the short term until a new screen is installed as part of the Phase 3B works.
