## Inverness West Link Stage 2 – January/ February 2020 Update

### Progress

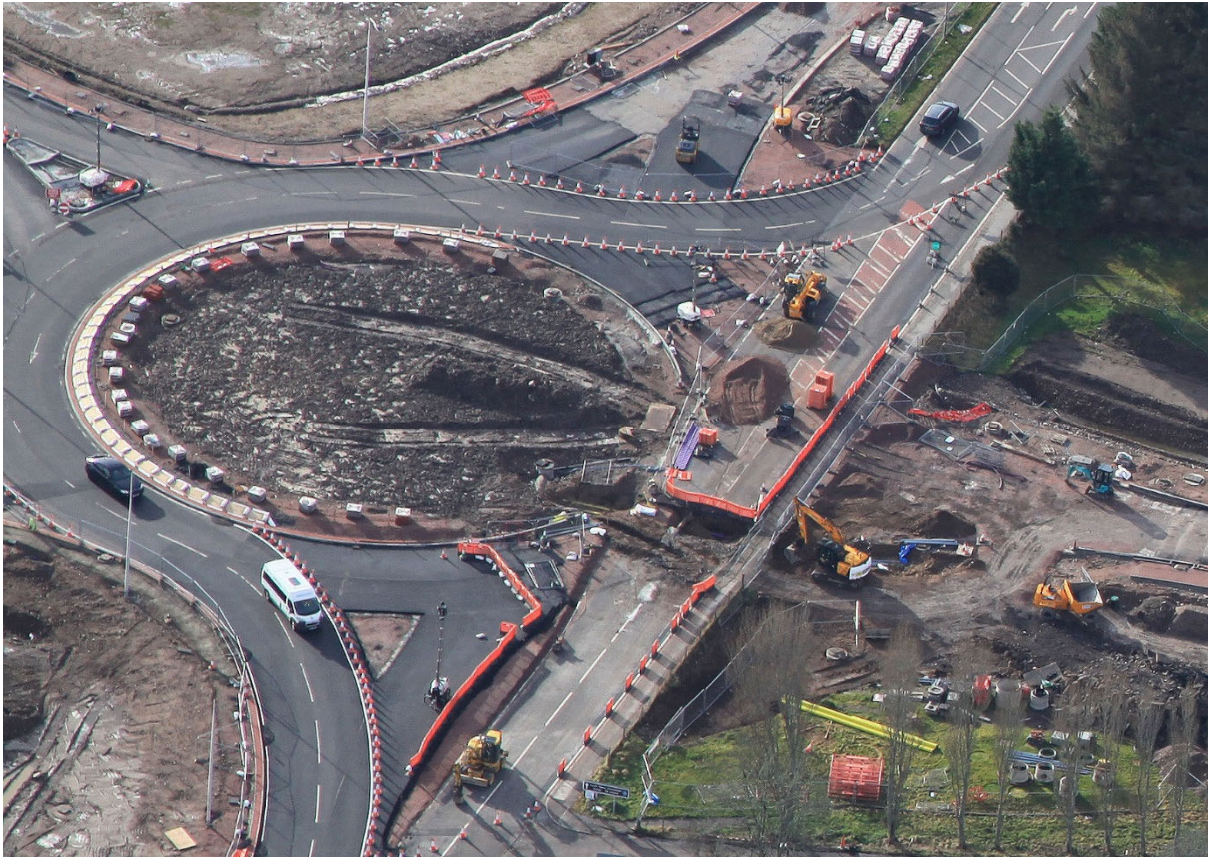
Diversion on the A82 to facilitate the installation of deep drainage and services to the North of the Roundabout

A diversion was installed on the A82 to allow the services and kerbing to be installed to the North of the roundabout. A swept path analysis of the diversion was undertaken which identified that articulated vehicles would struggle so a 7.5 tonne weight restriction is been applied along with 10mph speed limit.

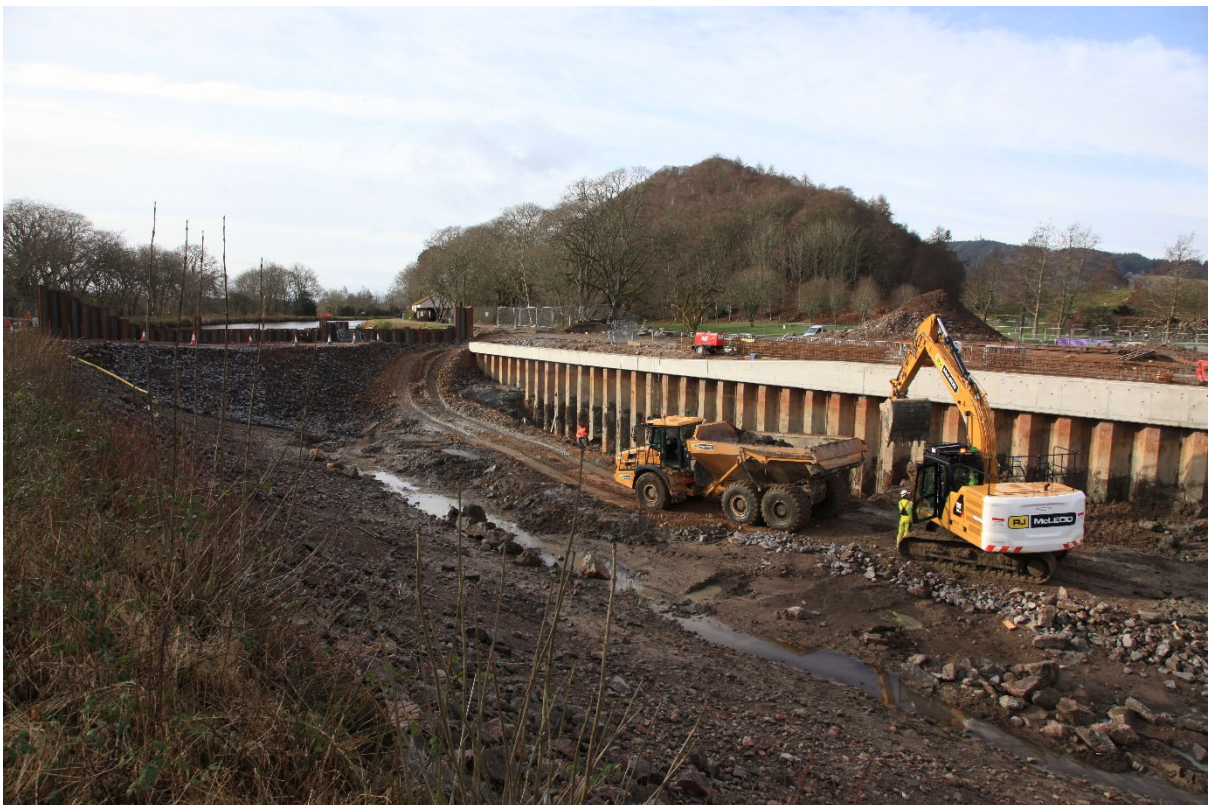
Excavation of canal invert along the front of the new wharf

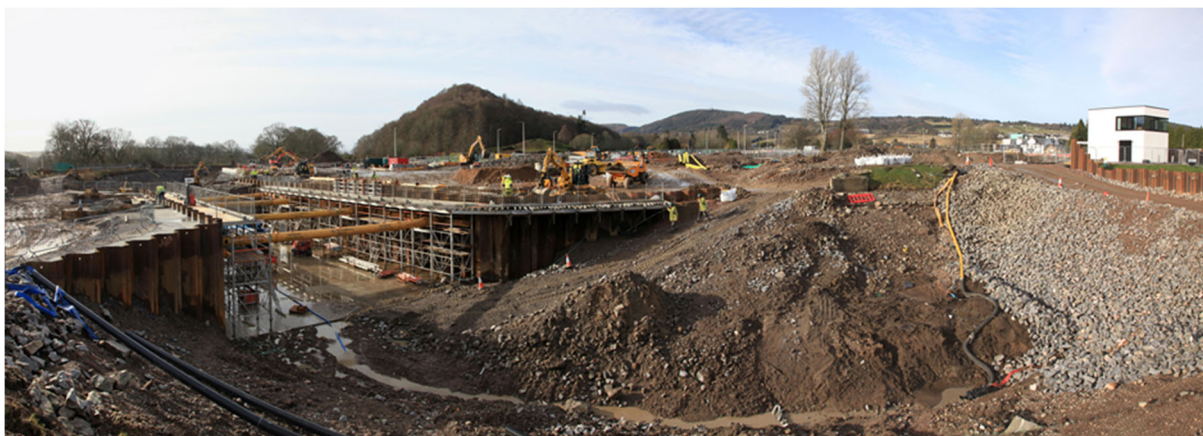
Falsework and propping to allow capping beam construction on the bridge abutments – canal dewatered

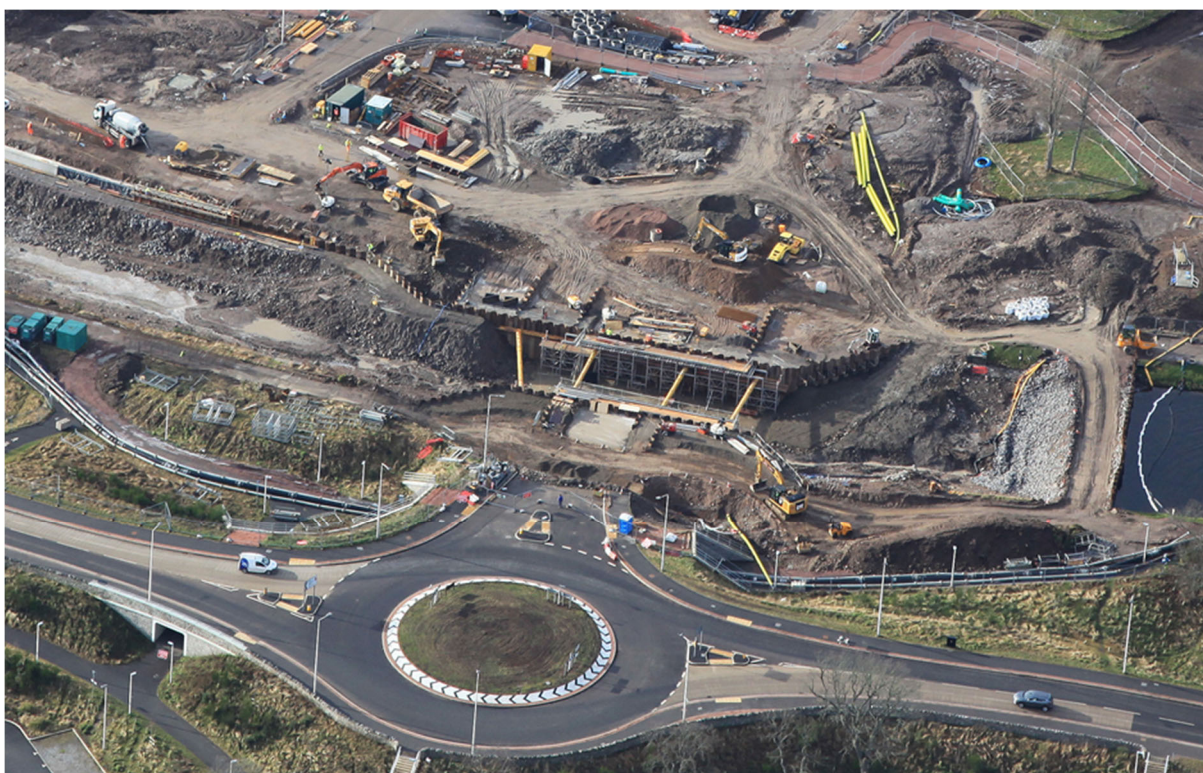
Works progressing on the bridge capping beams on either side of the dewatered canal
