WIND TURBINE RISK ASSESSMENT

STOER PRIMARY SCHOOL

The Highland Council Wind Turbine Risk Assessment Tool

Appendix J – Stoer Primary School - Site Condition Report

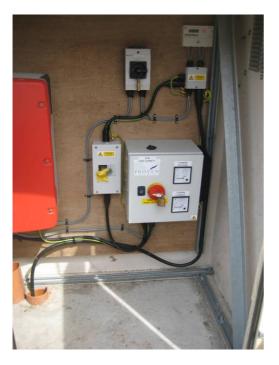
- Action: Review design details to ensure foundations designed to suit ground conditions
- Stoer Primary School
 - The spare ways in the local 'turbine' distribution board were not all safely sealed using blanks or similar.

Figure J11-wind turbine controller and local distribution board (note: a temporary seal to the distribution board is made by electrical tape)

Actions required to allow turbine switch-on;	Completed By;	Date	Sign Off
Install 1.8m weld mesh fence and padlock, to encompass gin pole.		TBC	
2. Provide handheld anemometer to RPO for high wind		TBC	Steve Barron 17/10/12
procedure 3. Refresh MO with emergency shutdown procedures	Martin Bell	16/08/12	17/10/12
4. Maintenance contractor to energise turbine, following annual service		TBC	
5. Maintenance contractor to attend to distribution board and labelling issues
