A890 Stromeferry Bypass

Annual Slope Inspection Report 2023

The Highland Council

11 July 2023

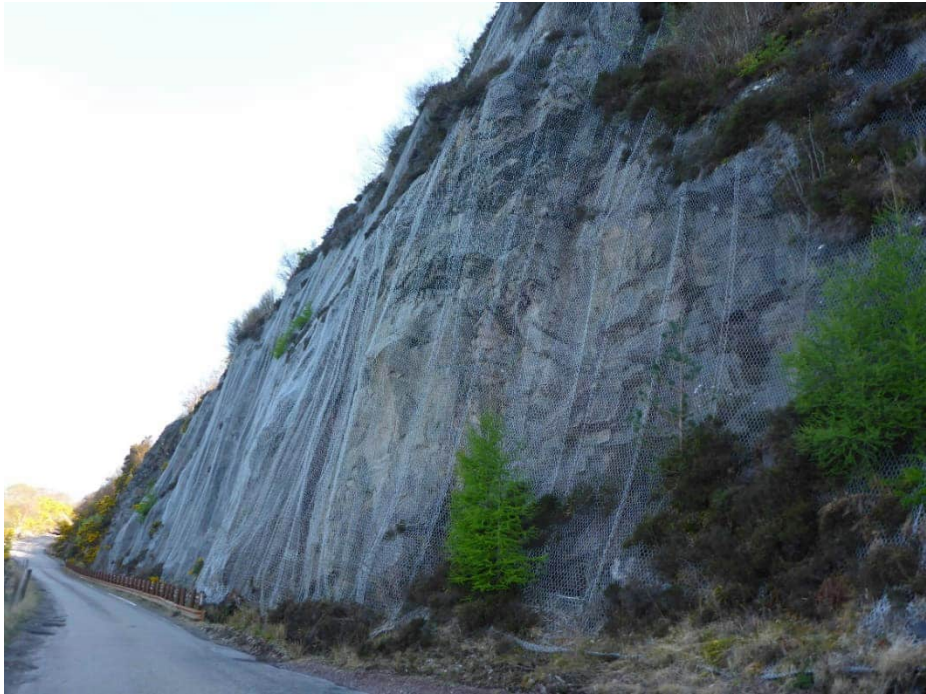
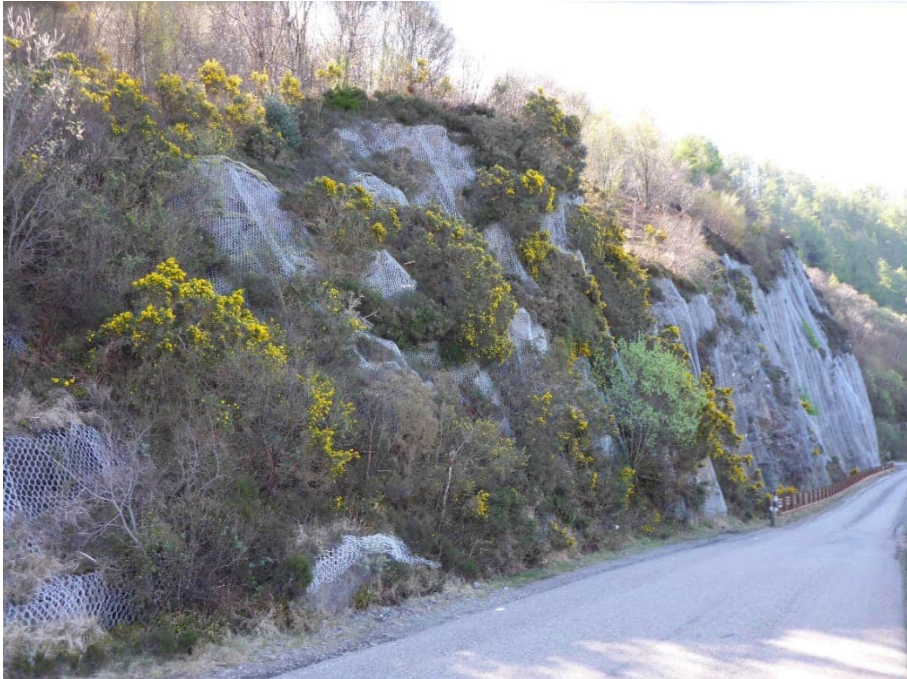
Photo at Start Chainage (looking east)	Photo at End Chainage (looking west)

Rock Slope Characteristics:															
Dip (°):	85	Azimuth (°):	296	Height (m):	20	Length (m):	177	Vegetation Cover:	20% on main cutting face; 60% on upper third of slope. Comprising of heather and saplings.	Ditch Details:	None but Armco barrier creates rock trap.	Roughness:	Rough	Verge Width (m):	Ch. 3415-3445 1.5m verge. 1m verge from 3445 (start of Armco)

Engineering Description of Rock:
Extremely strong dark grey and white irregular narrow banding crystalline coarse grained GNEISS. Particularly massive along this section of road.

Hazards Observed:			
Location	Description of Hazard (s) from Previous Inspections	2023 Inspection Observations	Photo Reference
Ch. 3425	2021 Inspection: Failure in 2021 originating c.6m above road level where blocks (c.0.25m ³) have slid along a steep release plane and have come to rest at toe of slope behind netting. Water seepage in the area gives potential for further rock fall. It is likely that this would be a volume of c.0.4m ³ and a maximum	No change noted during 2023 inspection	AA22B-2

Ch. 3485	2021 Inspection: 3 to 4 cobble sized blocks sitting on ledge behind netting c.7m above road level. No damage to netting observed. Source likely to be overhanging blocks near crest.	No change noted during 2023 inspection

RISK RATING		Comments
Overall Hazard Rating =	3	
Pathway Rating =	2	
Receptor Rating =	1	
Risk Value =	6	Re-assessed following completion of Phase 11 works and risk level reduced from high.
Risk Level =	Moderate

Recommended Remedial Works / Actions		
Large Scale Rock Fall Protection Works (Category 3)	Localised Targeted Rock Fall Protection Works (Category 2)	Ongoing Maintenance (Category 1)
N/A	N/A	<ul style="list-style-type: none"> - Replace corroded bottom anchors and install additional anchors to achieve maximum spacing of 5m. - Replace bottom cable between Ch. 3462 and 3500. - Replace corroded cable clamps on lateral and vertical reinforcing cables. Re-tension and install additional spenax rings. - Apply anti-corrosion paint on cut end bars as part of the TECCO netting system to prevent further corrosion.

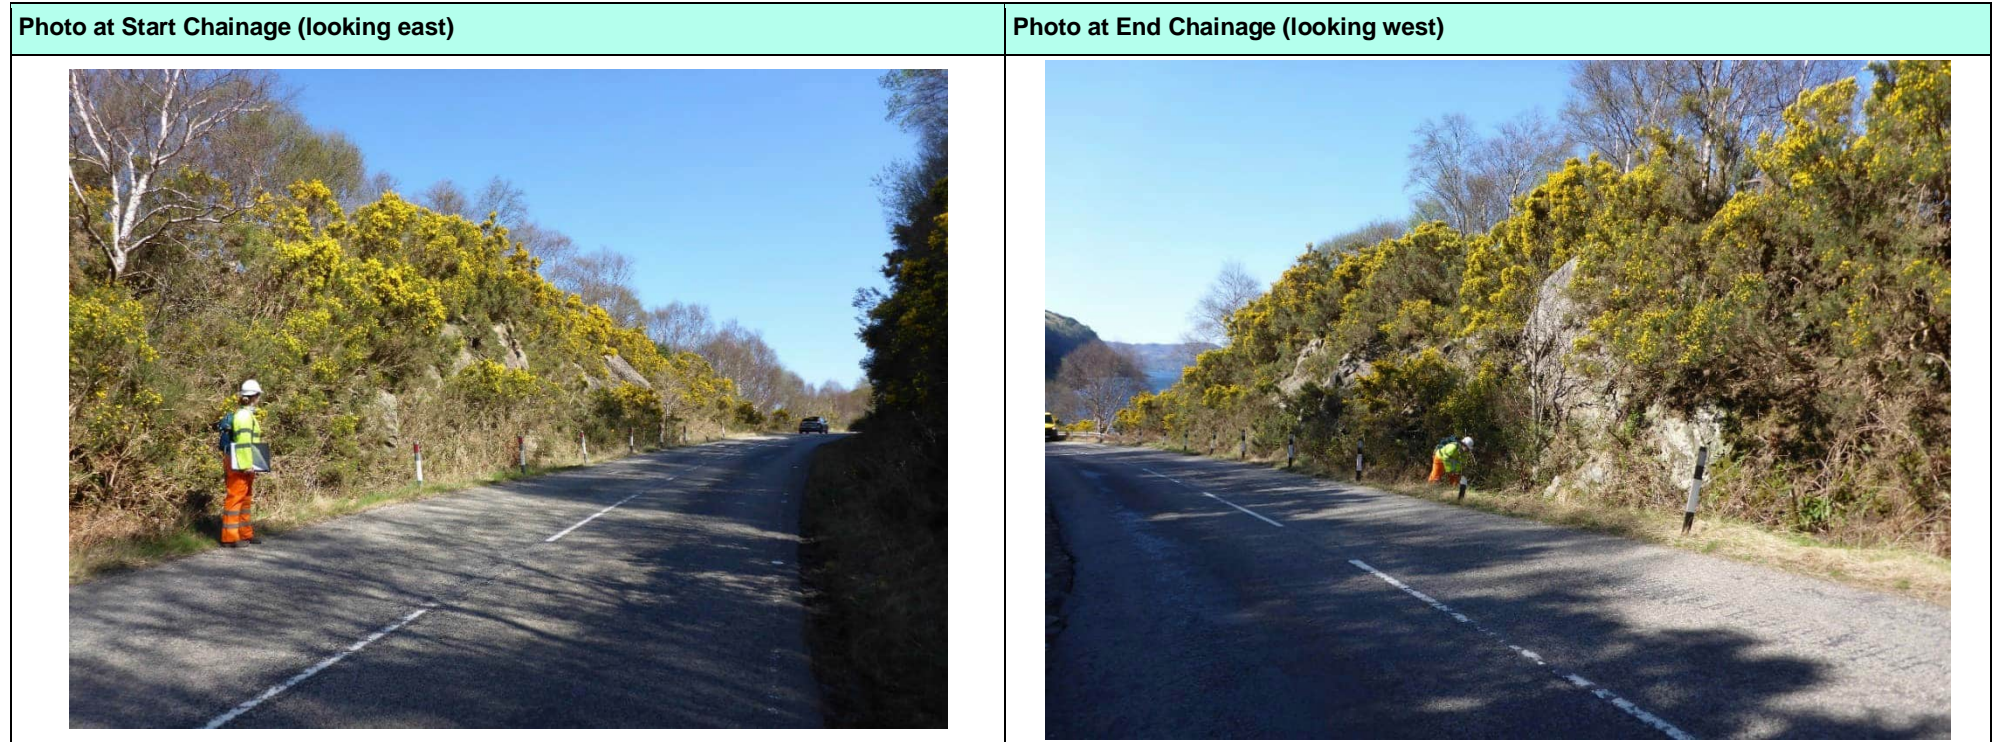
Rock Slope Characteristics:															
Dip (°):	60	Azimuth (°):	230	Height (m):	6	Length (m):	50	Vegetation Cover:	c.60% cover: predominantly gorse	Ditch Details:	1m wide, 0.2m deep	Roughness:	Rough	Verge Width (m):	0.5

Location	Description of Hazard (s) from Previous Inspections	2023 Inspection Observations	Photo Reference
Northern end of slope	2017 Inspection: Localised root jacking, however, small blocks will be retained by ditch.	No change noted during 2023 inspection	
Ch. 3669	2022 Inspection: Block fall c.0.4m x 0.4m x 0.3m has landed in the ditch. Block originated c.2m up rock slope.	No change noted during 2023 inspection	AA23N-1

RISK RATING		Comments
Overall Hazard Rating =	1	
Pathway Rating =	2	
Receptor Rating =	1.2	
Risk Value =	2.4	
Risk Level =	Low

Recommended Remedial Works / Actions		
Large Scale Rock Fall Protection Works (Category 3)	Localised Targeted Rock Fall Protection Works (Category 2)	Ongoing Maintenance (Category 1)
N/A	N/A	N/A

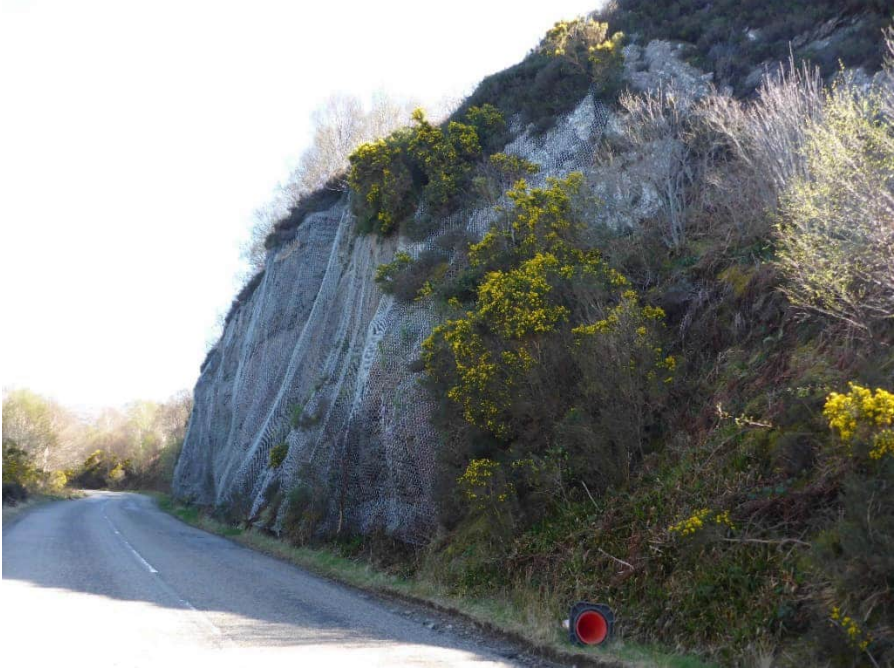
Photo at Start Chainage (looking east)	Photo at End Chainage (looking west)

Rock Slope Characteristics:															
Dip (°):	80	Azimuth (°):	340	Height (m):	12	Length (m):	184	Vegetation Cover:	30% cover over highest rock slope, increasing to 80% cover towards N of section. Generally comprised grass, ferns and gorse.	Ditch Details:	Typical width 0.5m, depth 0.3m From Ch.3790 2m wide, 0.6m deep.	Roughness:	Rough	Verge Width (m):	Typically 0.5m. From Ch.3790 1.5m

Engineering Description of Rock:
Very strong very thinly banded grey and white GNEISS with occasional quartz foliation.

THC Monthly Reports:			
Date	Location	Comments	Photo Reference
October 2020	Ch. 3740	Large rock has fallen down behind netting and come to rest in verge. First observed 08/10/20. Small puncture in netting ca. 5m above road and tear in netting at toe. Source not obvious.	AA24-1

Hazards Observed:			
Location	Description of Hazard (s) from Previous Inspections	2023 Inspection Observations	Photo Reference
Ch.3740 to 3745	2021 Inspection: Several blocks with dilated fractures and / or root jacking potential have been identified that are likely to fail in the future but should be contained by the Maccaferri netting.	No change noted during 2023 inspection	
Ch. 3748	2021 Inspection: Small accumulation of debris at toe of slope behind netting c.1m x 0.4m x 0.2m. Source c.4m above toe. Material not loading net. Keep under observation.	No change noted during 2023 inspection	
Ch. 3762-3800	2016 Inspection: Trees at crest of slope could cause block fall associated with root jacking/ uprooted trees.	No change noted during 2023 inspection	
Ch. 3783 - 3792	2016 Inspection: Exposed soil slope 4m above road level with boulders in back scar of previous failure which could weather out and reach road. Slumping is also noted upslope from back scar.	No change noted during 2023 inspection	AA24-2

RISK RATING		Comments
Overall Hazard Rating =	3	
Pathway Rating =	2	
Receptor Rating =	1.2	
Risk Value =	7.2	
Risk Level =	Moderate

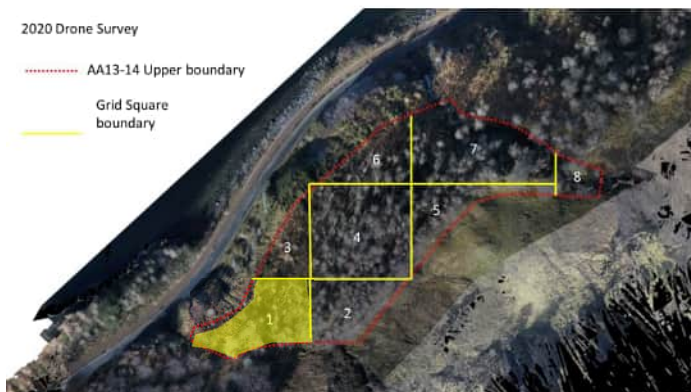
Grid Square 1

Approx. number of trees standing in 2020: 22

% of trees that have fallen: 9.1%

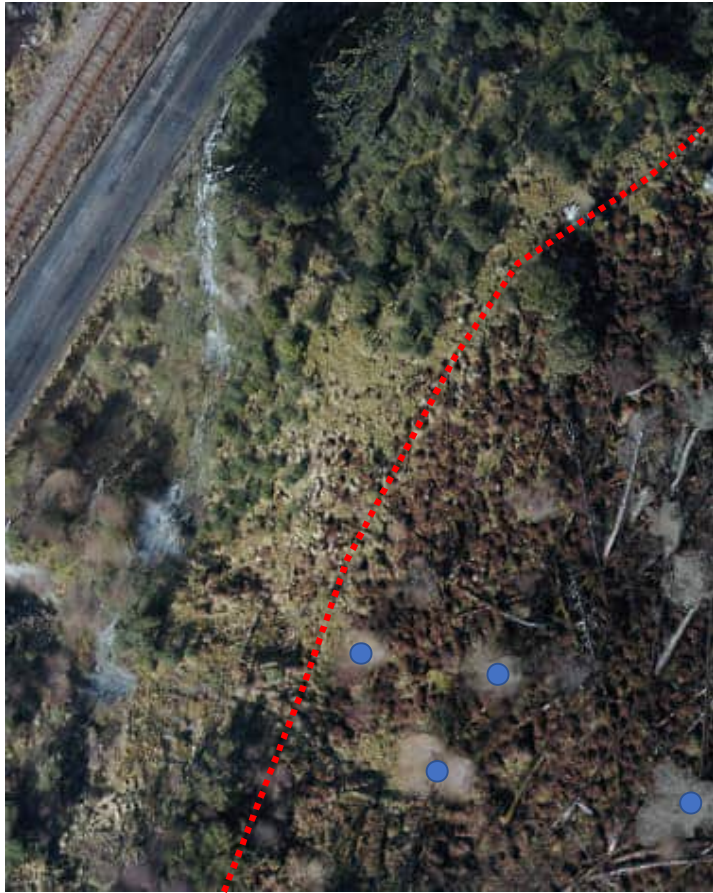
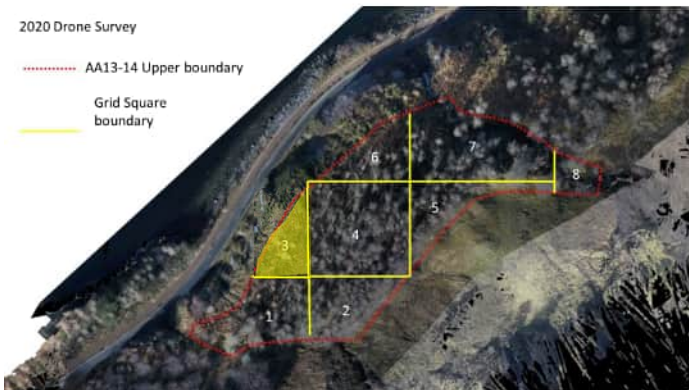
Grid Square 3

Approx. number of trees standing in 2020: 4

% of trees that have fallen: 25%

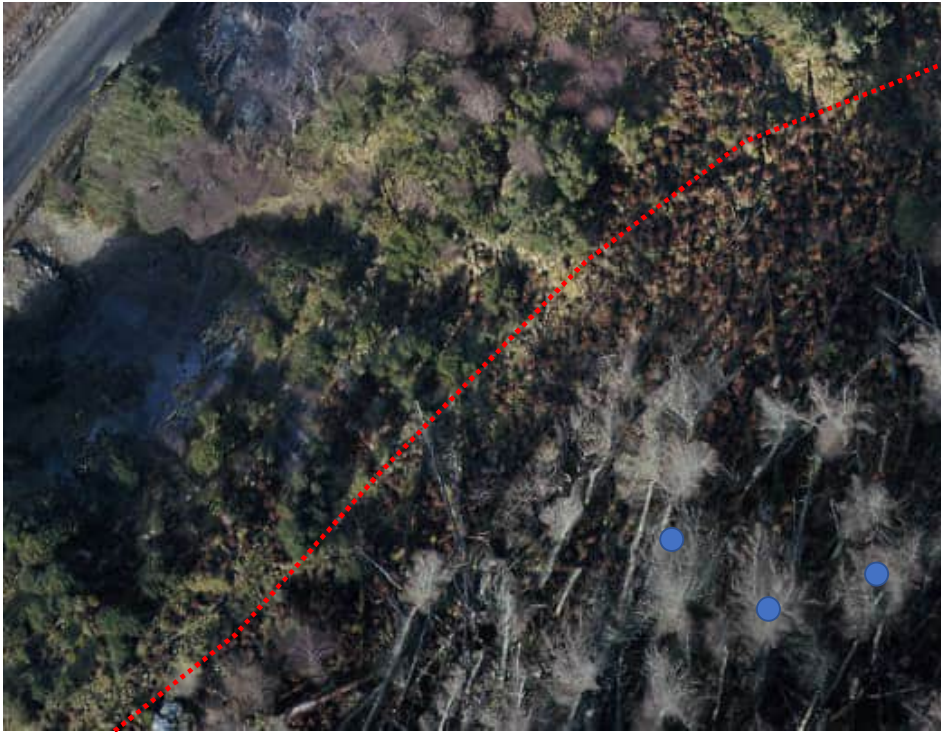
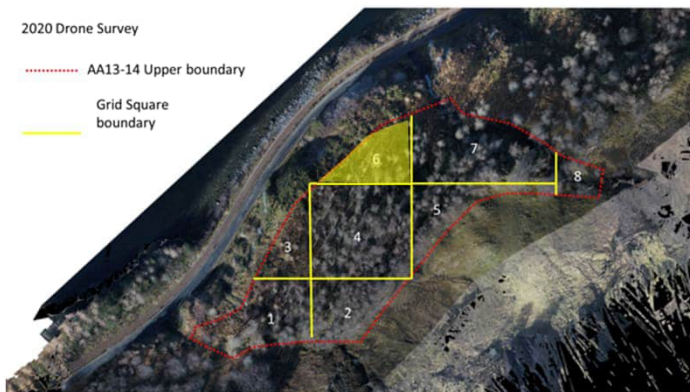
Grid Square 6

Approx. number of trees standing in 2020: 3

% of trees that have fallen: 0 %

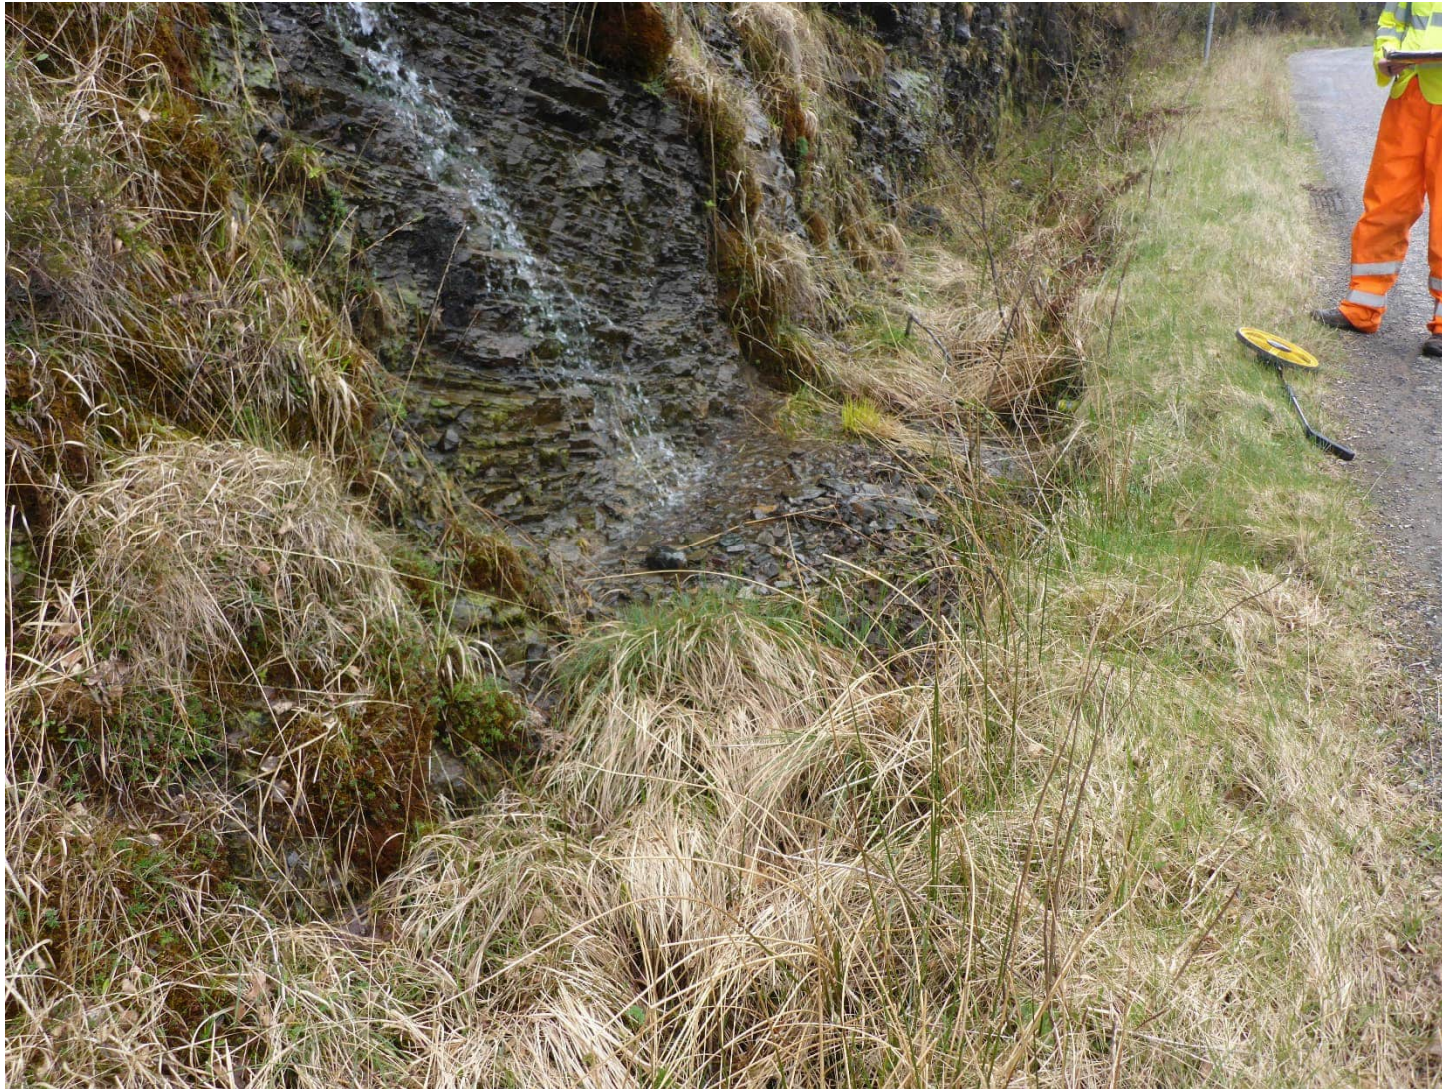
Photograph AA4-4

At Ch. 842 - Ditch would benefit from clearance
